Navajo Abandoned Uranium Mine

Site Screen Report

Plot 8 AUM Site

Navajo AUM Northern Region

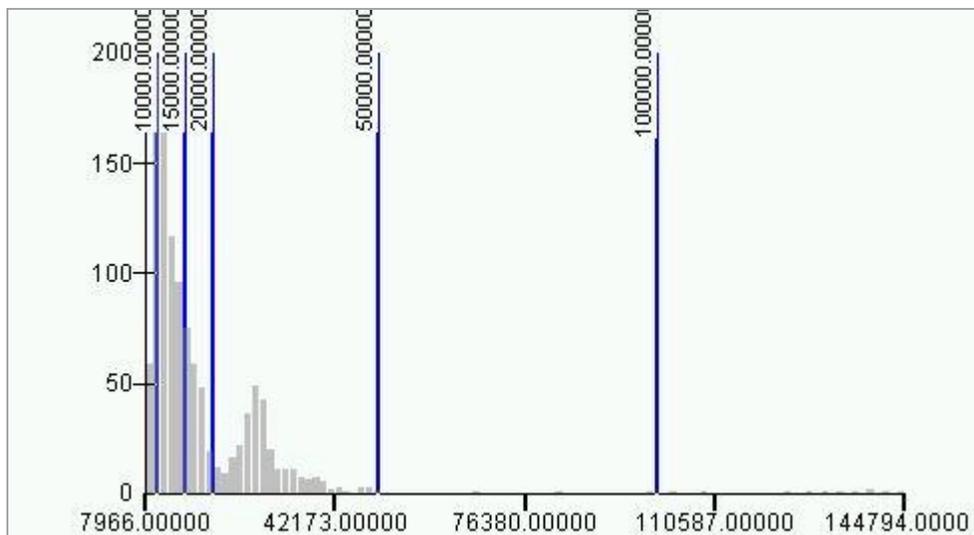
The following chart and statistics were generated by ESRI ArcGIS 9.3.1, and show the general distribution of the site gamma radiation measurements. The horizontal X axis represents the gamma radiation reading levels in cpm (lowest levels to the left). The vertical Y axis represents the frequency of each gamma radiation level.

Count:	1128
Minimum:	7966.00000
Maximum:	144794.00000
Sum:	20495932.00000
Mean:	18170.15248
Median:	13761.50000
Standard Deviation:	14198.05719

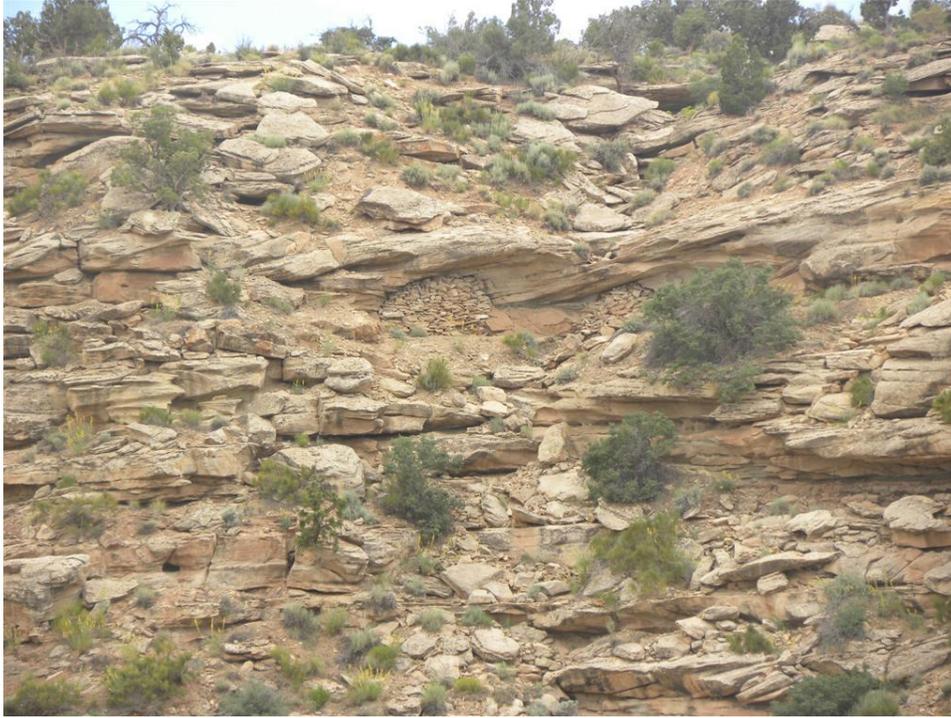
Scattered waste rock down drainage below adits, no definitive pile

Photo 1. Plot 8 site, steep drainage below adits

Sealed adits; unreclaimed scattered waste rock

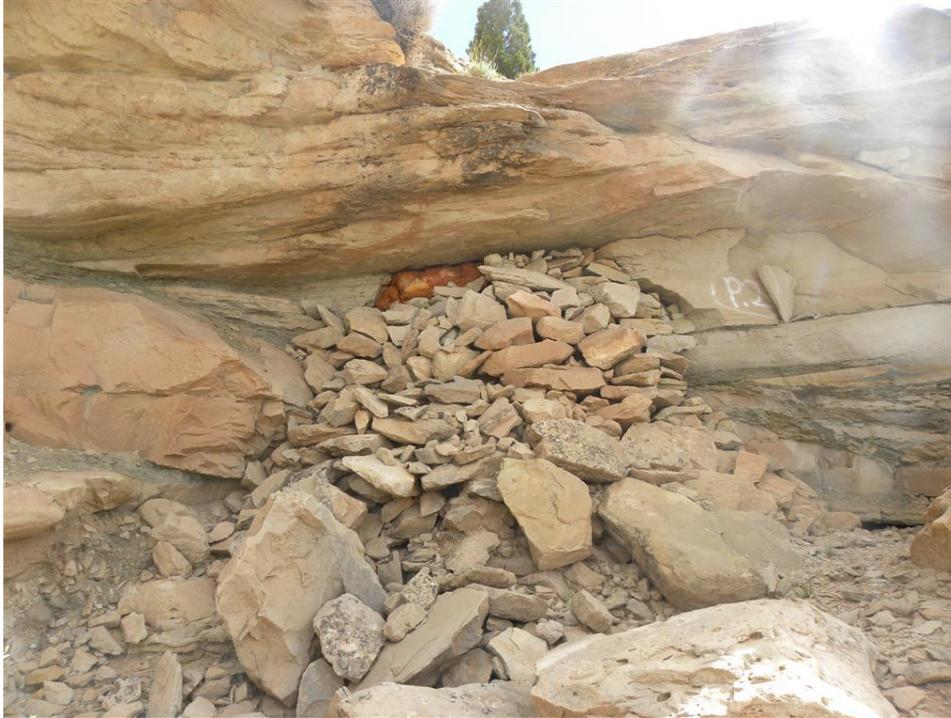
2 stone sealed adits, 6'x8' each, one labeled "P2", both above steep drainage into site #71

Photo 2. Plot 8 site, adit labeled "P2"

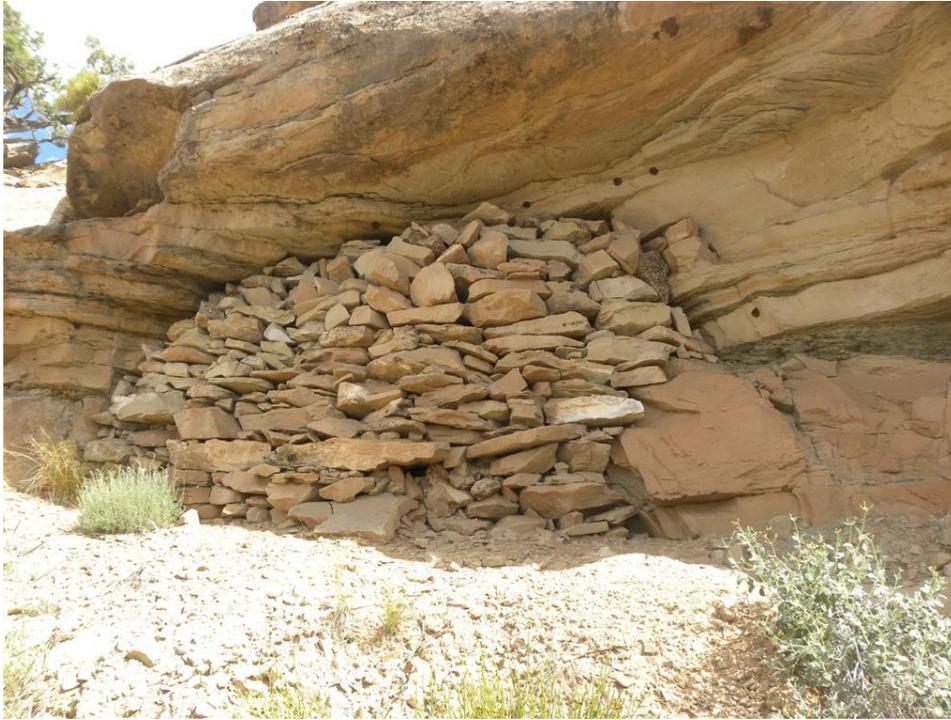
Photo 3. Plot 8 site, unlabeled adit

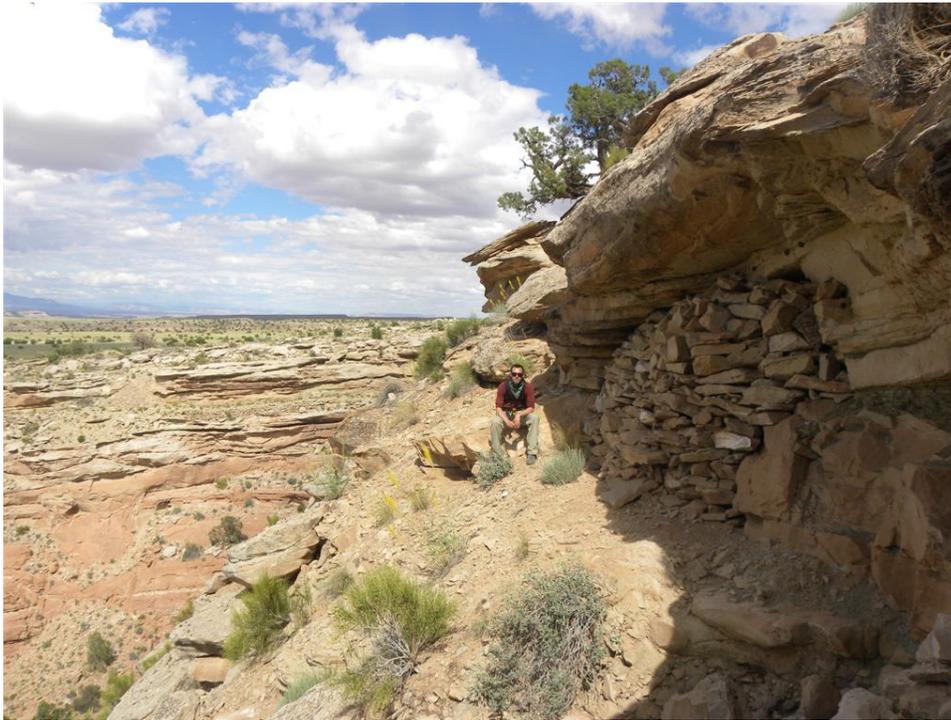
Photo 4. Plot 8 site, adits above canyon

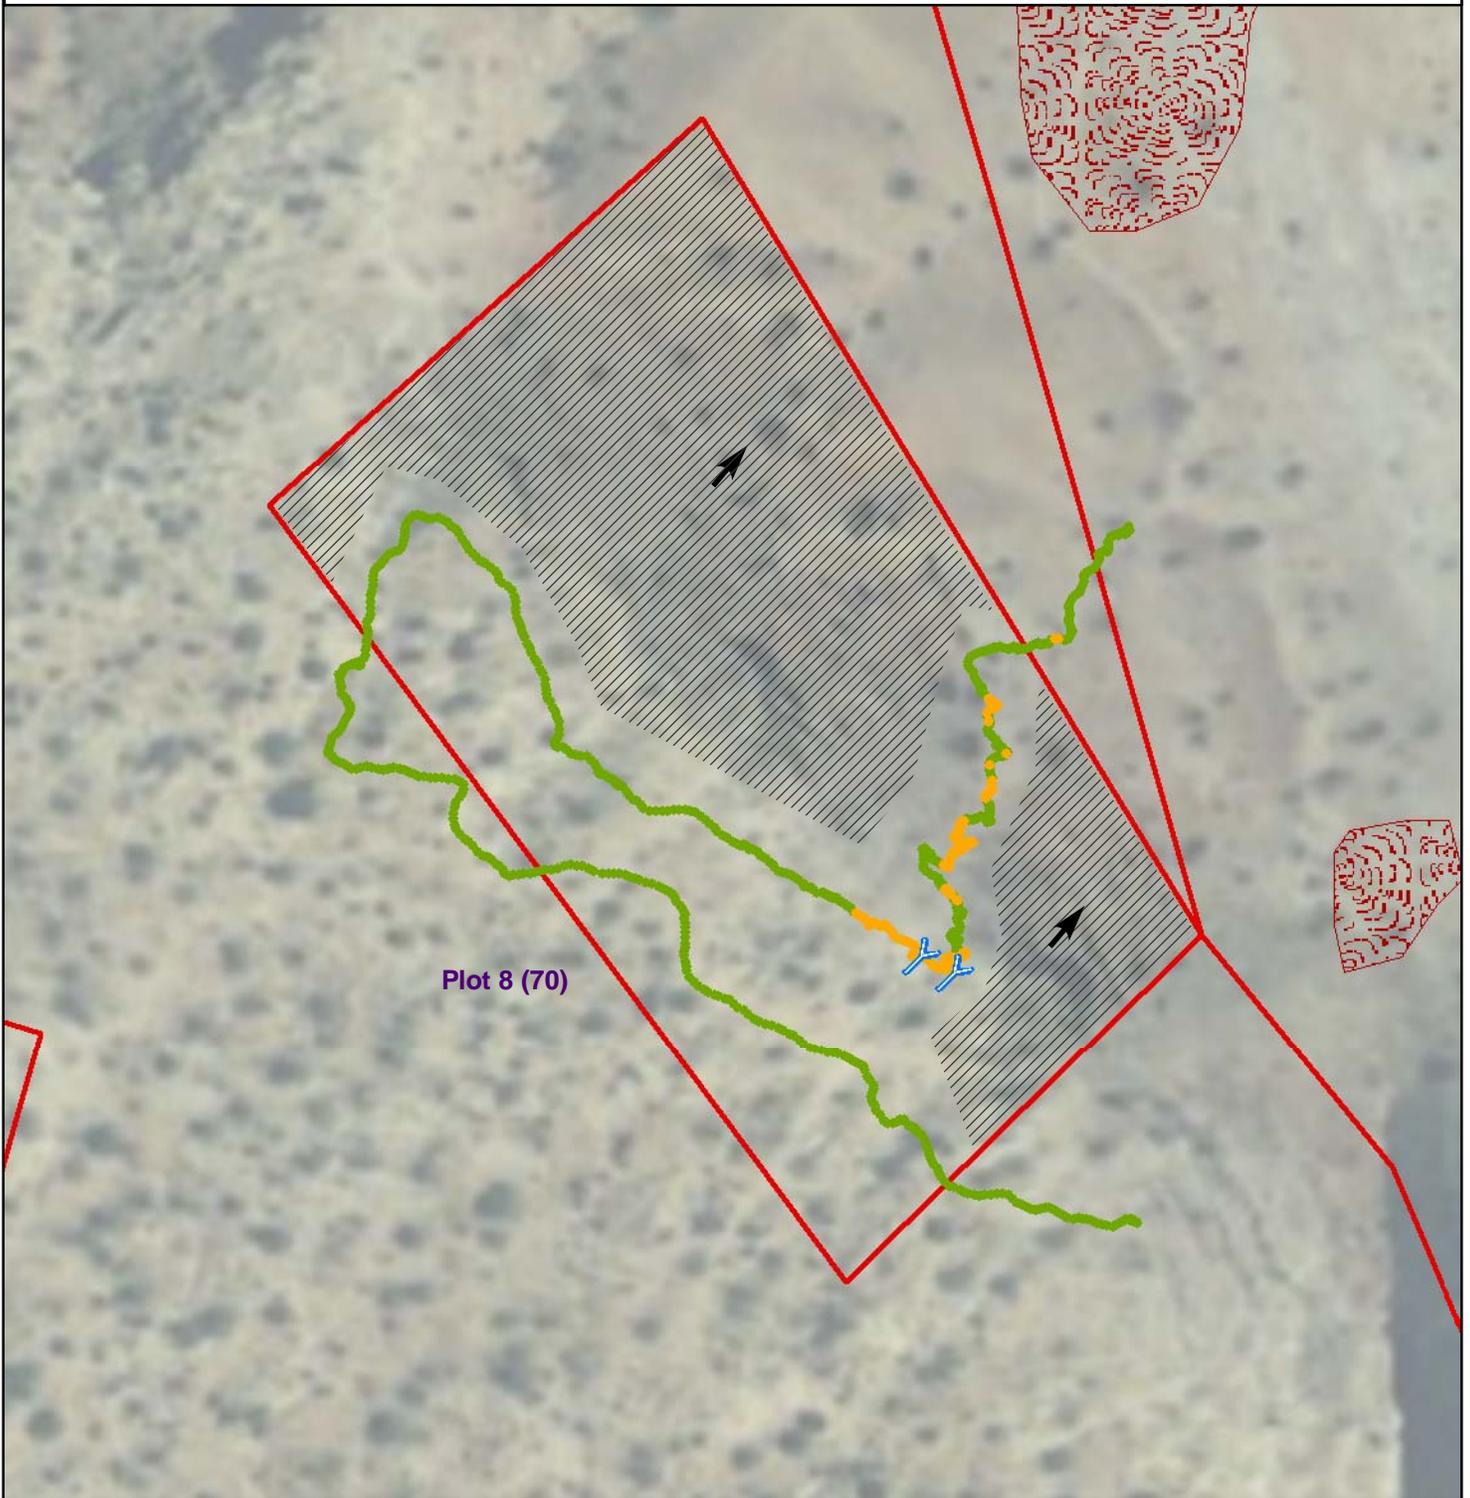
A total of 1,128 gamma radiation measurements were collected from the mine site, ranging from 7,966 cpm to 144,794 cpm. Measurements collected in the scattered waste rock in the drainage below the adits were found at levels up to approximately 140,000 cpm, and near the adit at levels up to approximately 40,000 cpm. The measurements are represented in Figures 1 and 2.

**Figure 1 - Gamma Radiation Measurements, Above Two Times Background
Plot 8 (70)
Teec Nos Pos Chapter, Navajo Nation**

Gamma survey conducted 06/2010
Measured as counts per minute (cpm)

Average background = 10,180 cpm

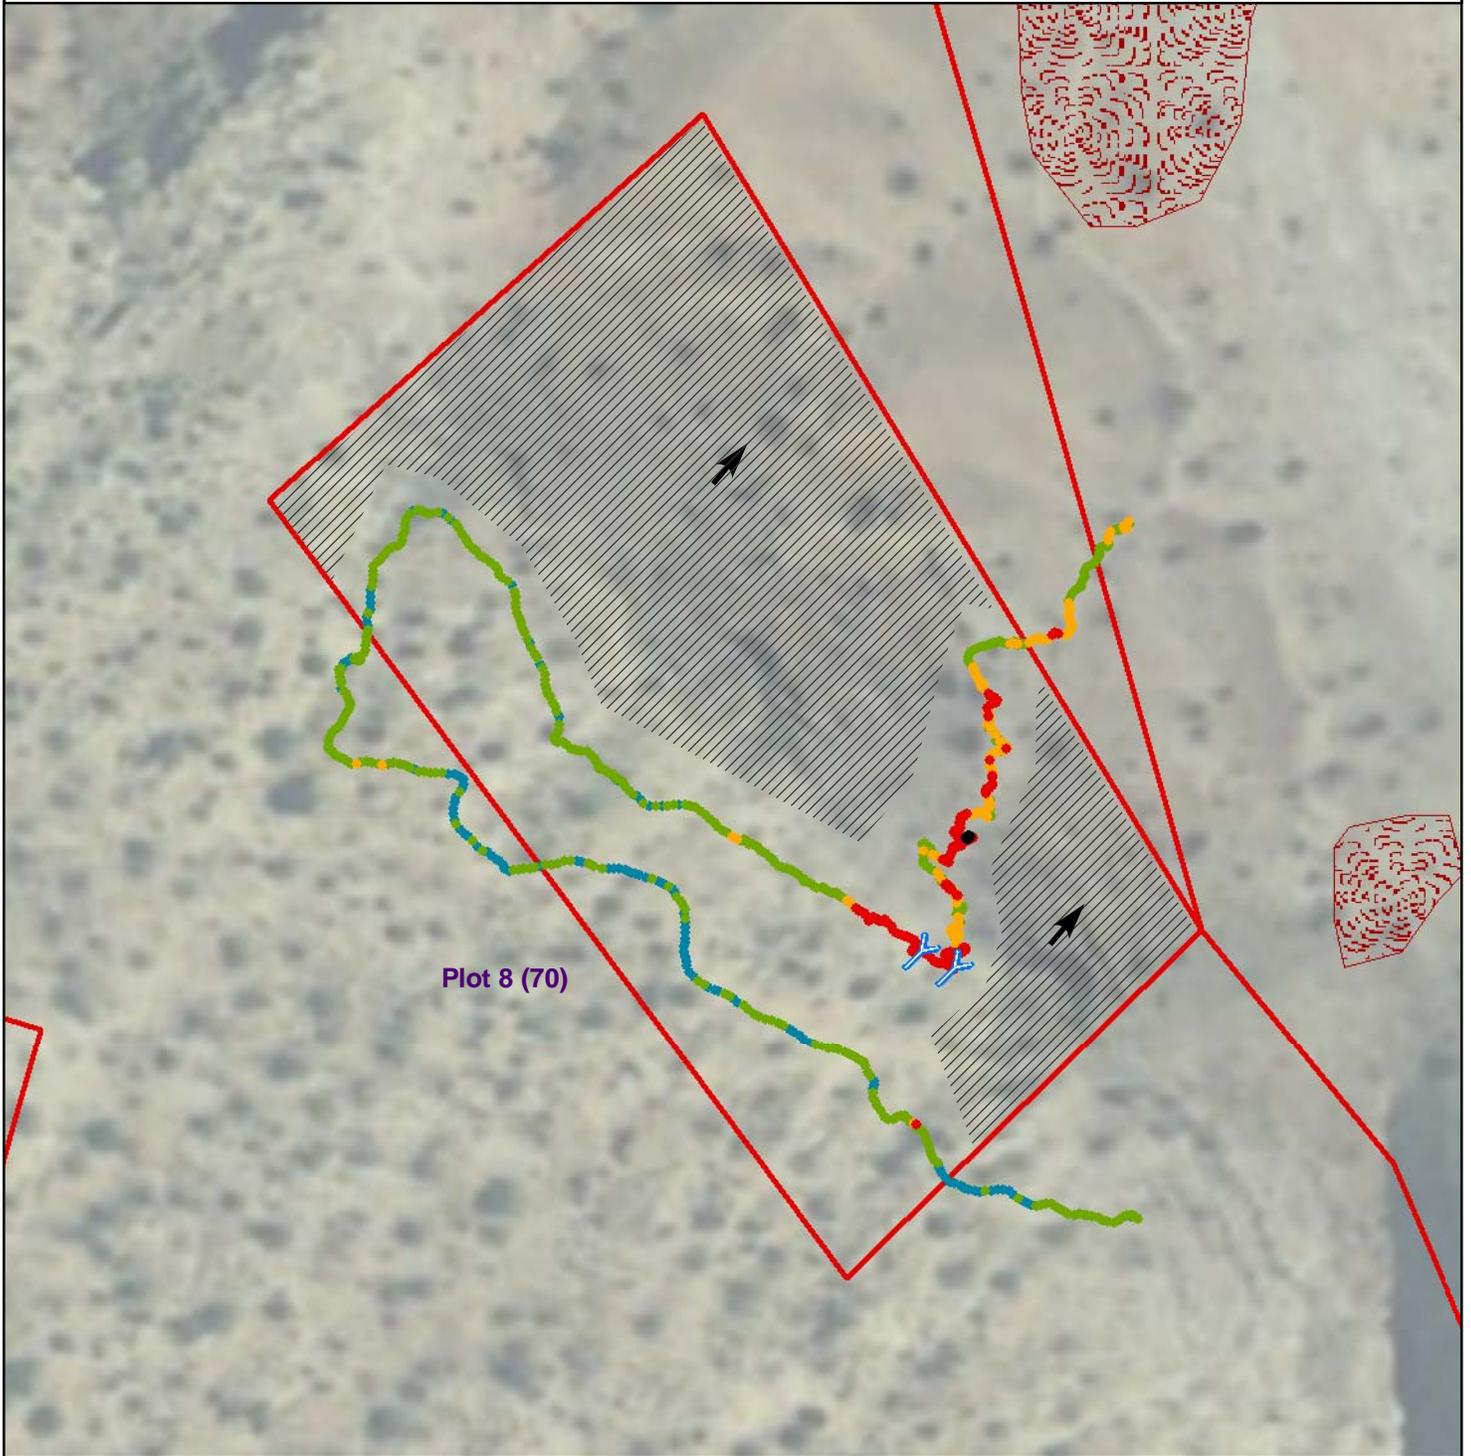
**Figure 2 - Gamma Radiation Measurements
Plot 8 (70)
Teec Nos Pos Chapter, Navajo Nation**

**Gamma survey conducted 06/2010
Measured as counts per minute (cpm)**

Average background 10,180 cpm
