Navajo Abandoned Uranium Mine

Site Screen Report

Mine Name: Rough Rock Slope No. 9
Mine ID: 77

August 2011

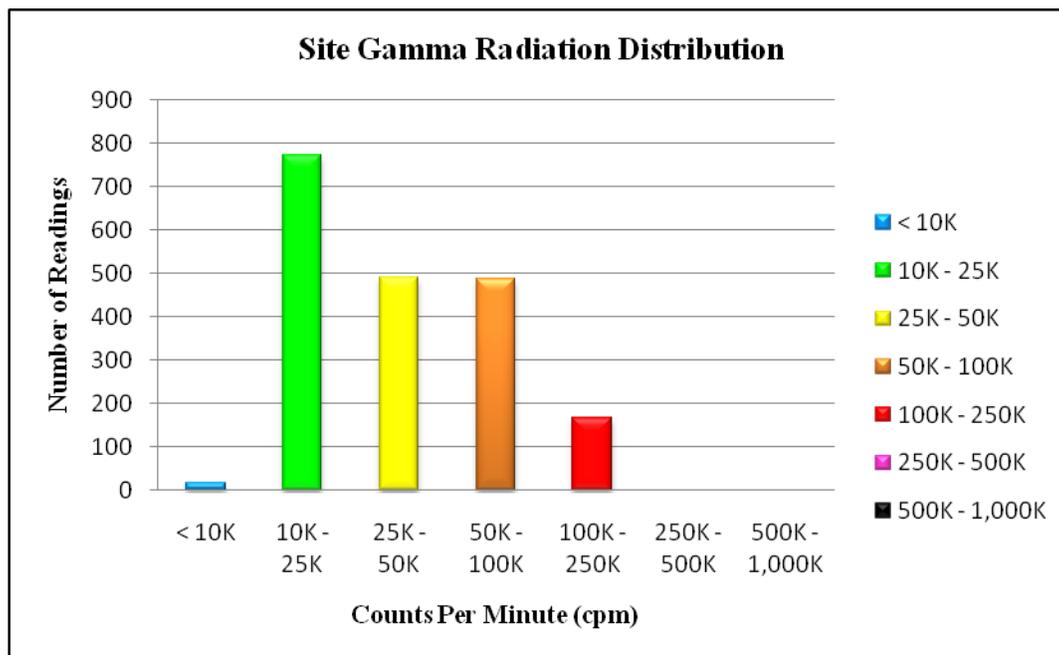
Distribution Chart and Statistics:

Site Gamma Radiation Statistics	
Number of Readings	1,932
Minimum (cpm)	8,489
Maximum (cpm)	164,385
Mean (cpm)	46,331
Median (cpm)	26,690
Standard Deviation	35,591

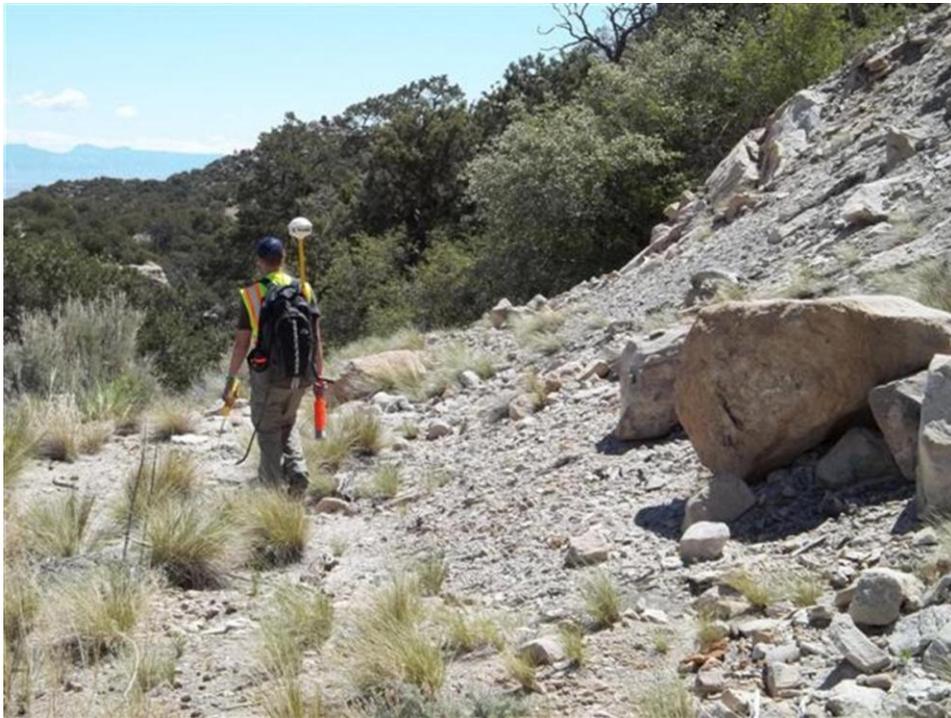
Photo 2: Mine Site #77; Bench cut

Bench cut/rim strip area

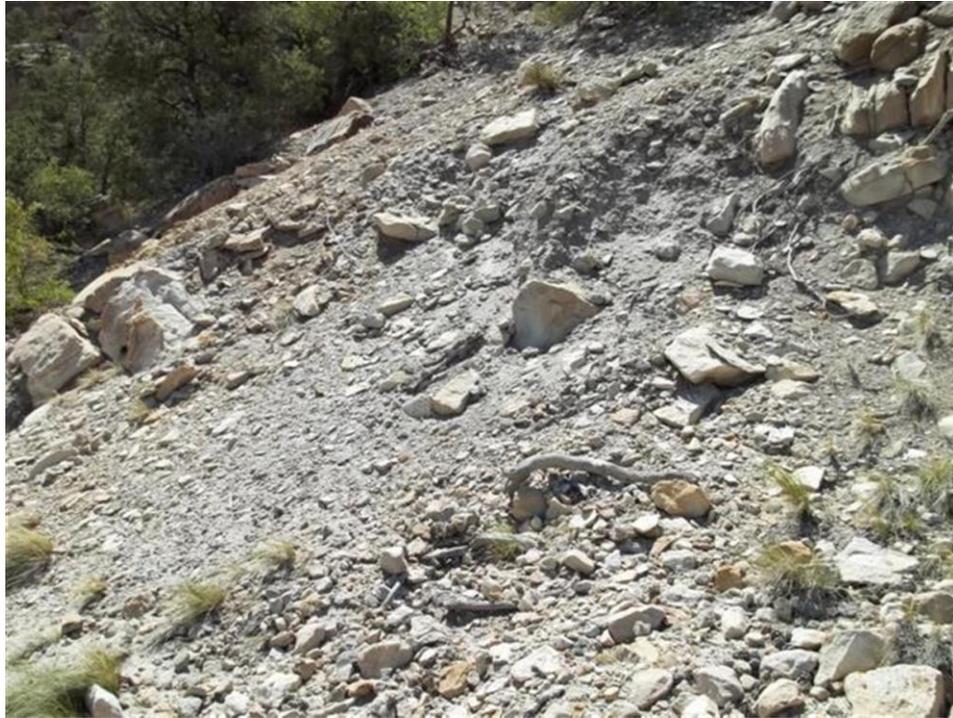
Photo 3: Mine Site #77; Waste rock

Waste rock area, approximately 100'x50'

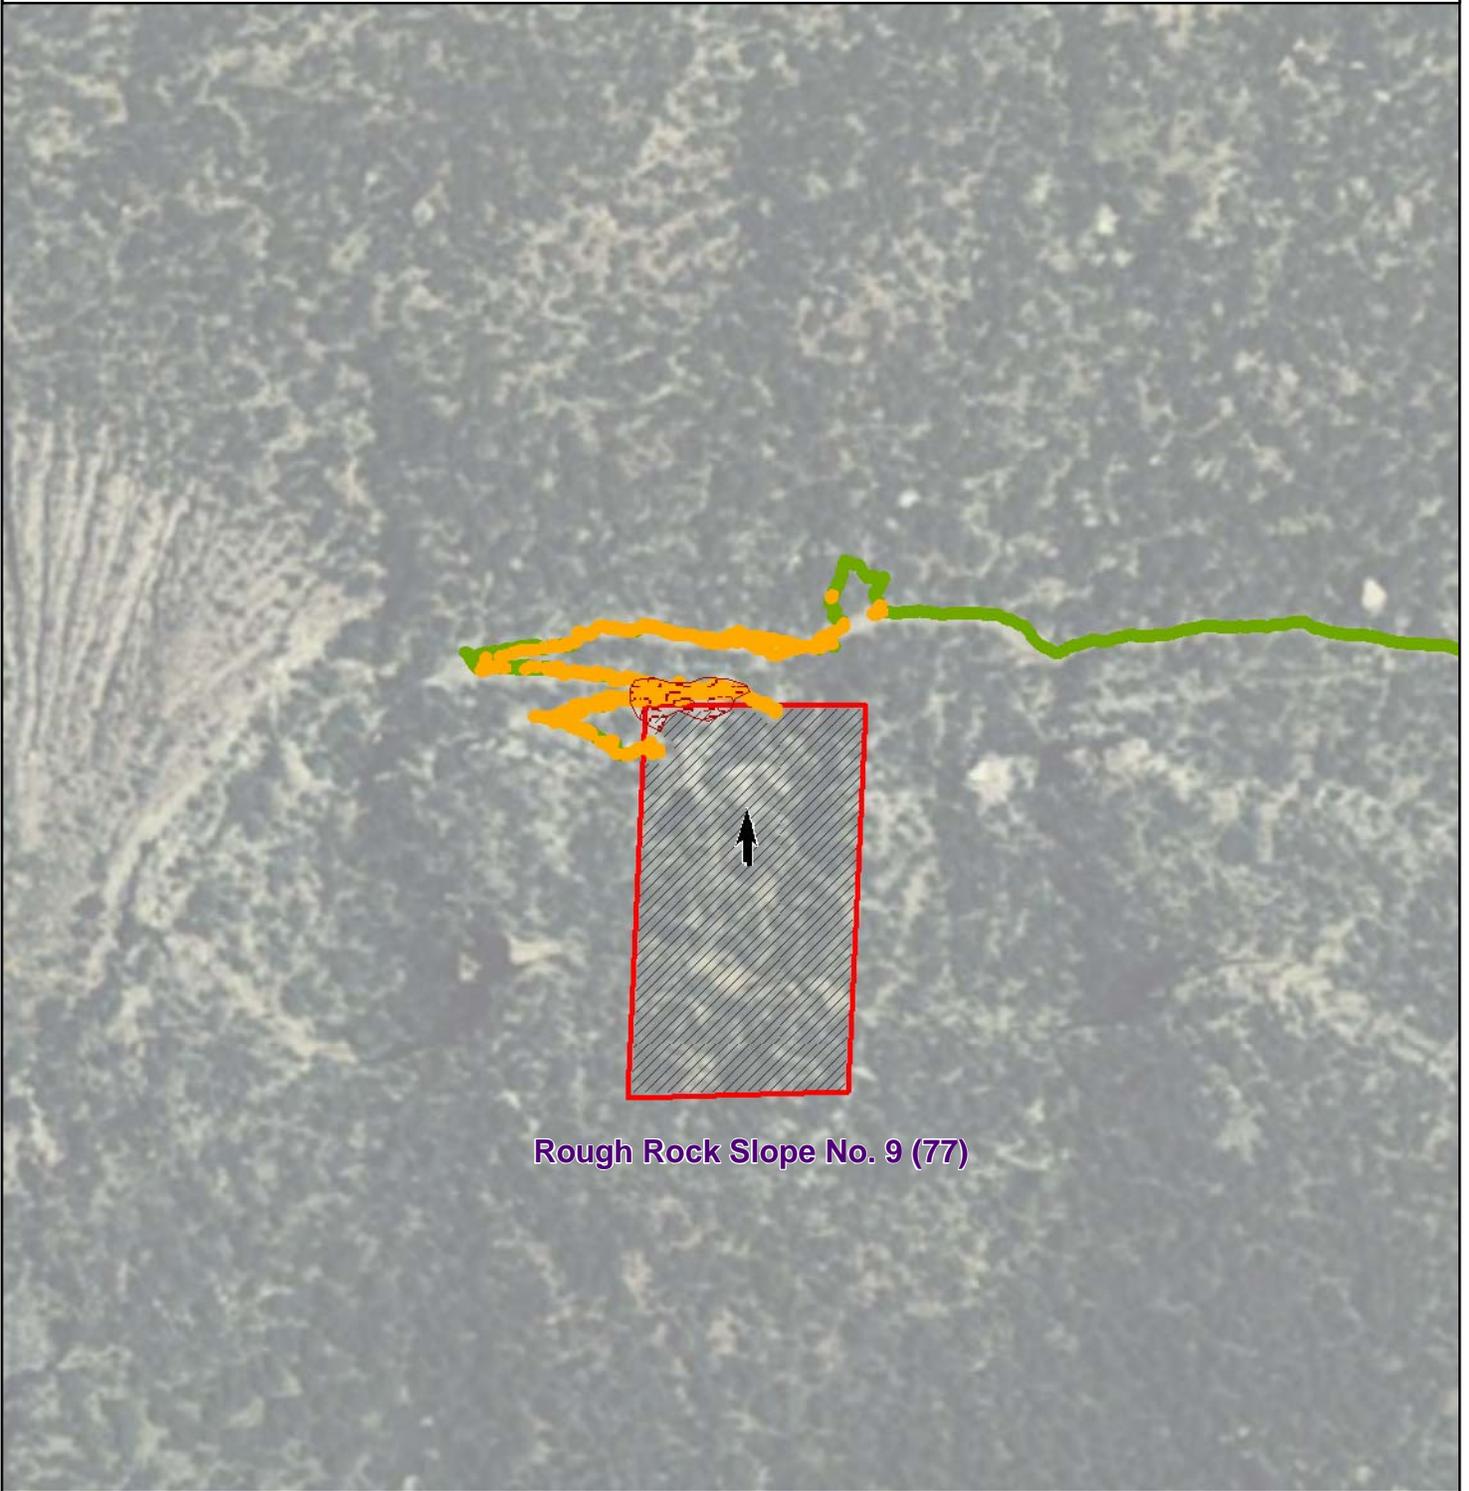
**Figure 1 - Gamma Radiation Measurements, Above Two Times Background
 Rough Rock Slope No. 9 (77)
 Rough Rock Chapter, Navajo Nation**

A total of 1,932 gamma radiation measurements were collected from the mine site, ranging from 8,489 cpm to 164,385 cpm. Measurements collected in the vicinity of the waste rock were found at a maximum level of approximately 150,000 cpm. The majority of the site was inaccessible due to steep grades. The measurements are represented in Figures 1 and 2.
