Subject: King Tutt Mesa Site, Reassessment Report
EPA ID NO.: NND986667434

**Reassessment Report
King Tutt Mesa Site
Oak Springs, Apache County, Arizona**

**EPA ID No.: NND986667434
USACE Contract No.: W91238-06-F-0083
Document Control No.: 12767.063.419.1650**

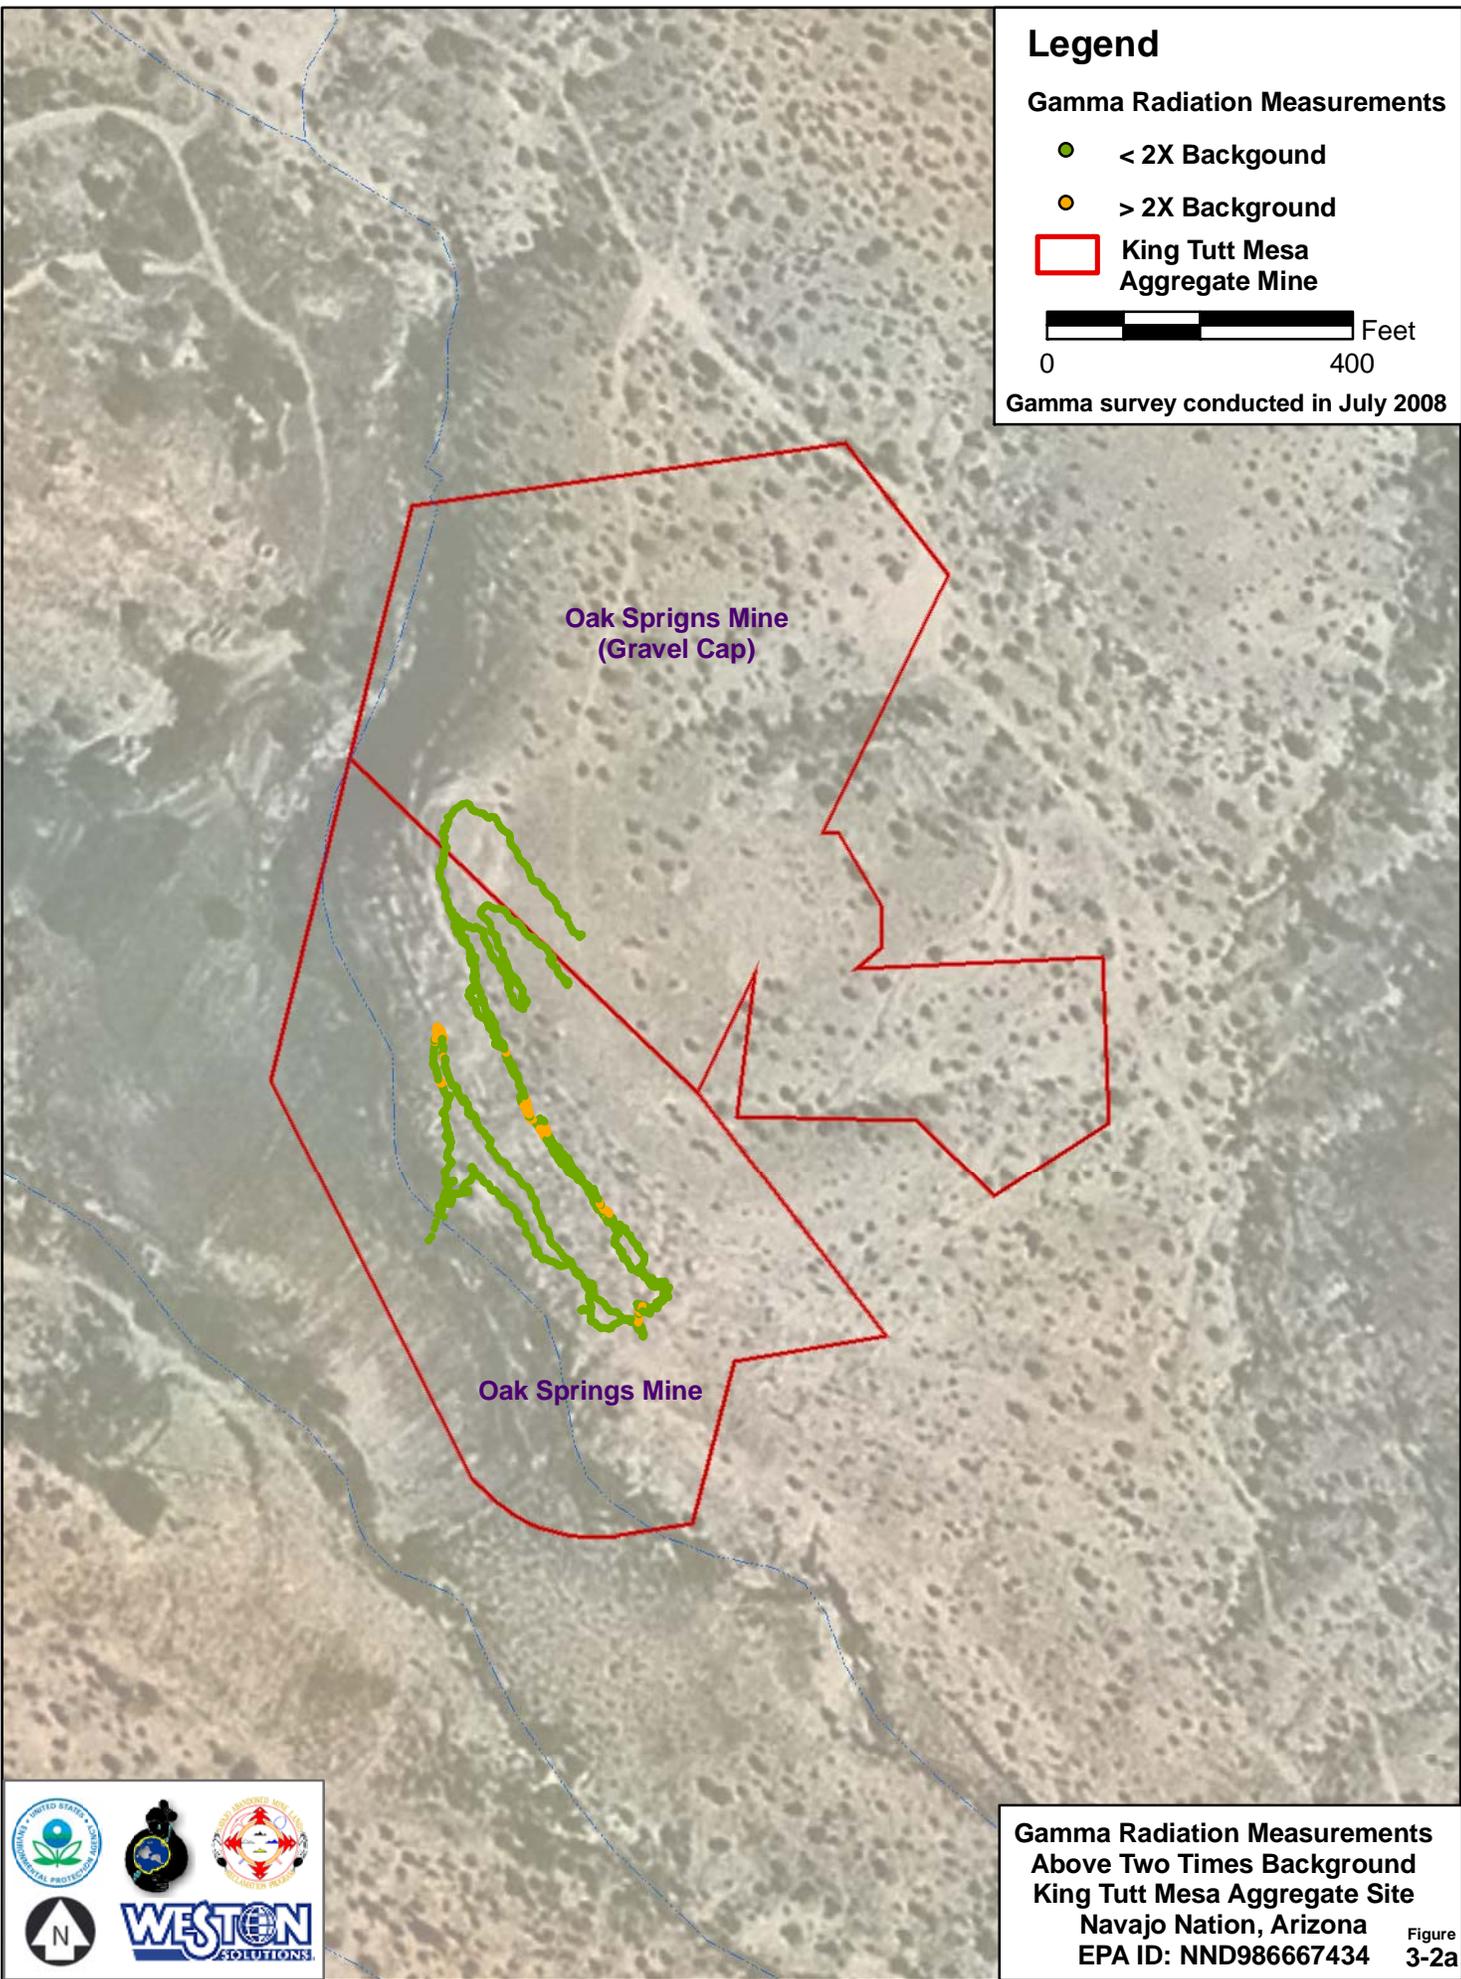
Gamma Radiation Measurements Above Two Times Background King Tutt Mesa Aggregate Site Navajo Nation, Arizona
EPA ID: NND986667434 Figure 3-2a

Gamma survey conducted in July 2008

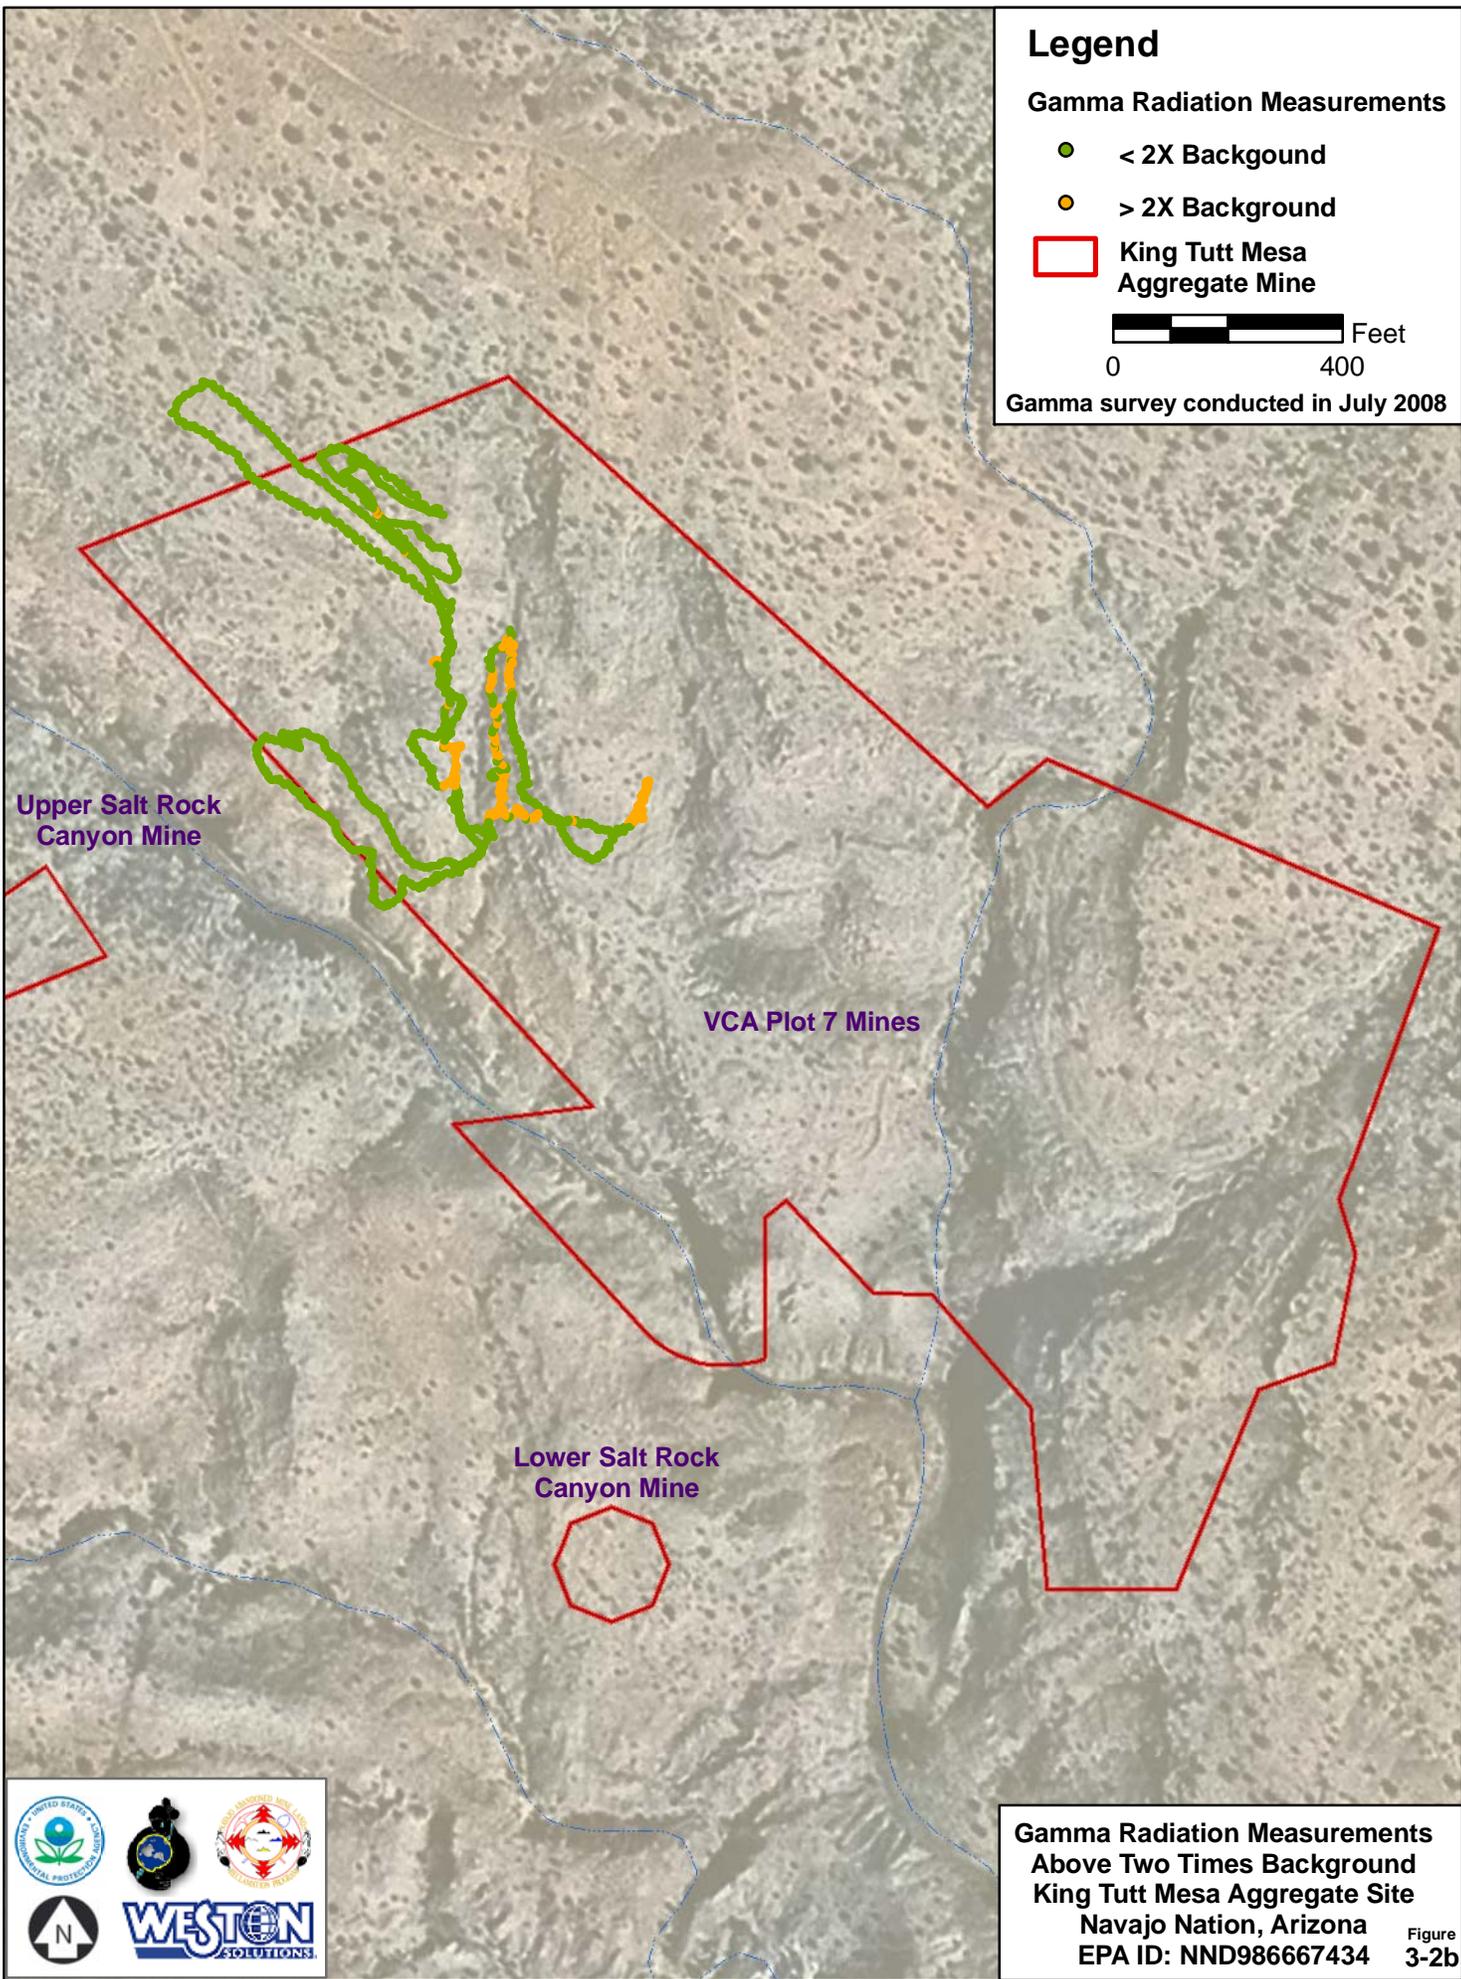
Gamma Radiation Measurements Above Two Times Background King Tutt Mesa Aggregate Site Navajo Nation, Arizona
EPA ID: NND986667434 Figure 3-2b

Gamma survey conducted in July 2008

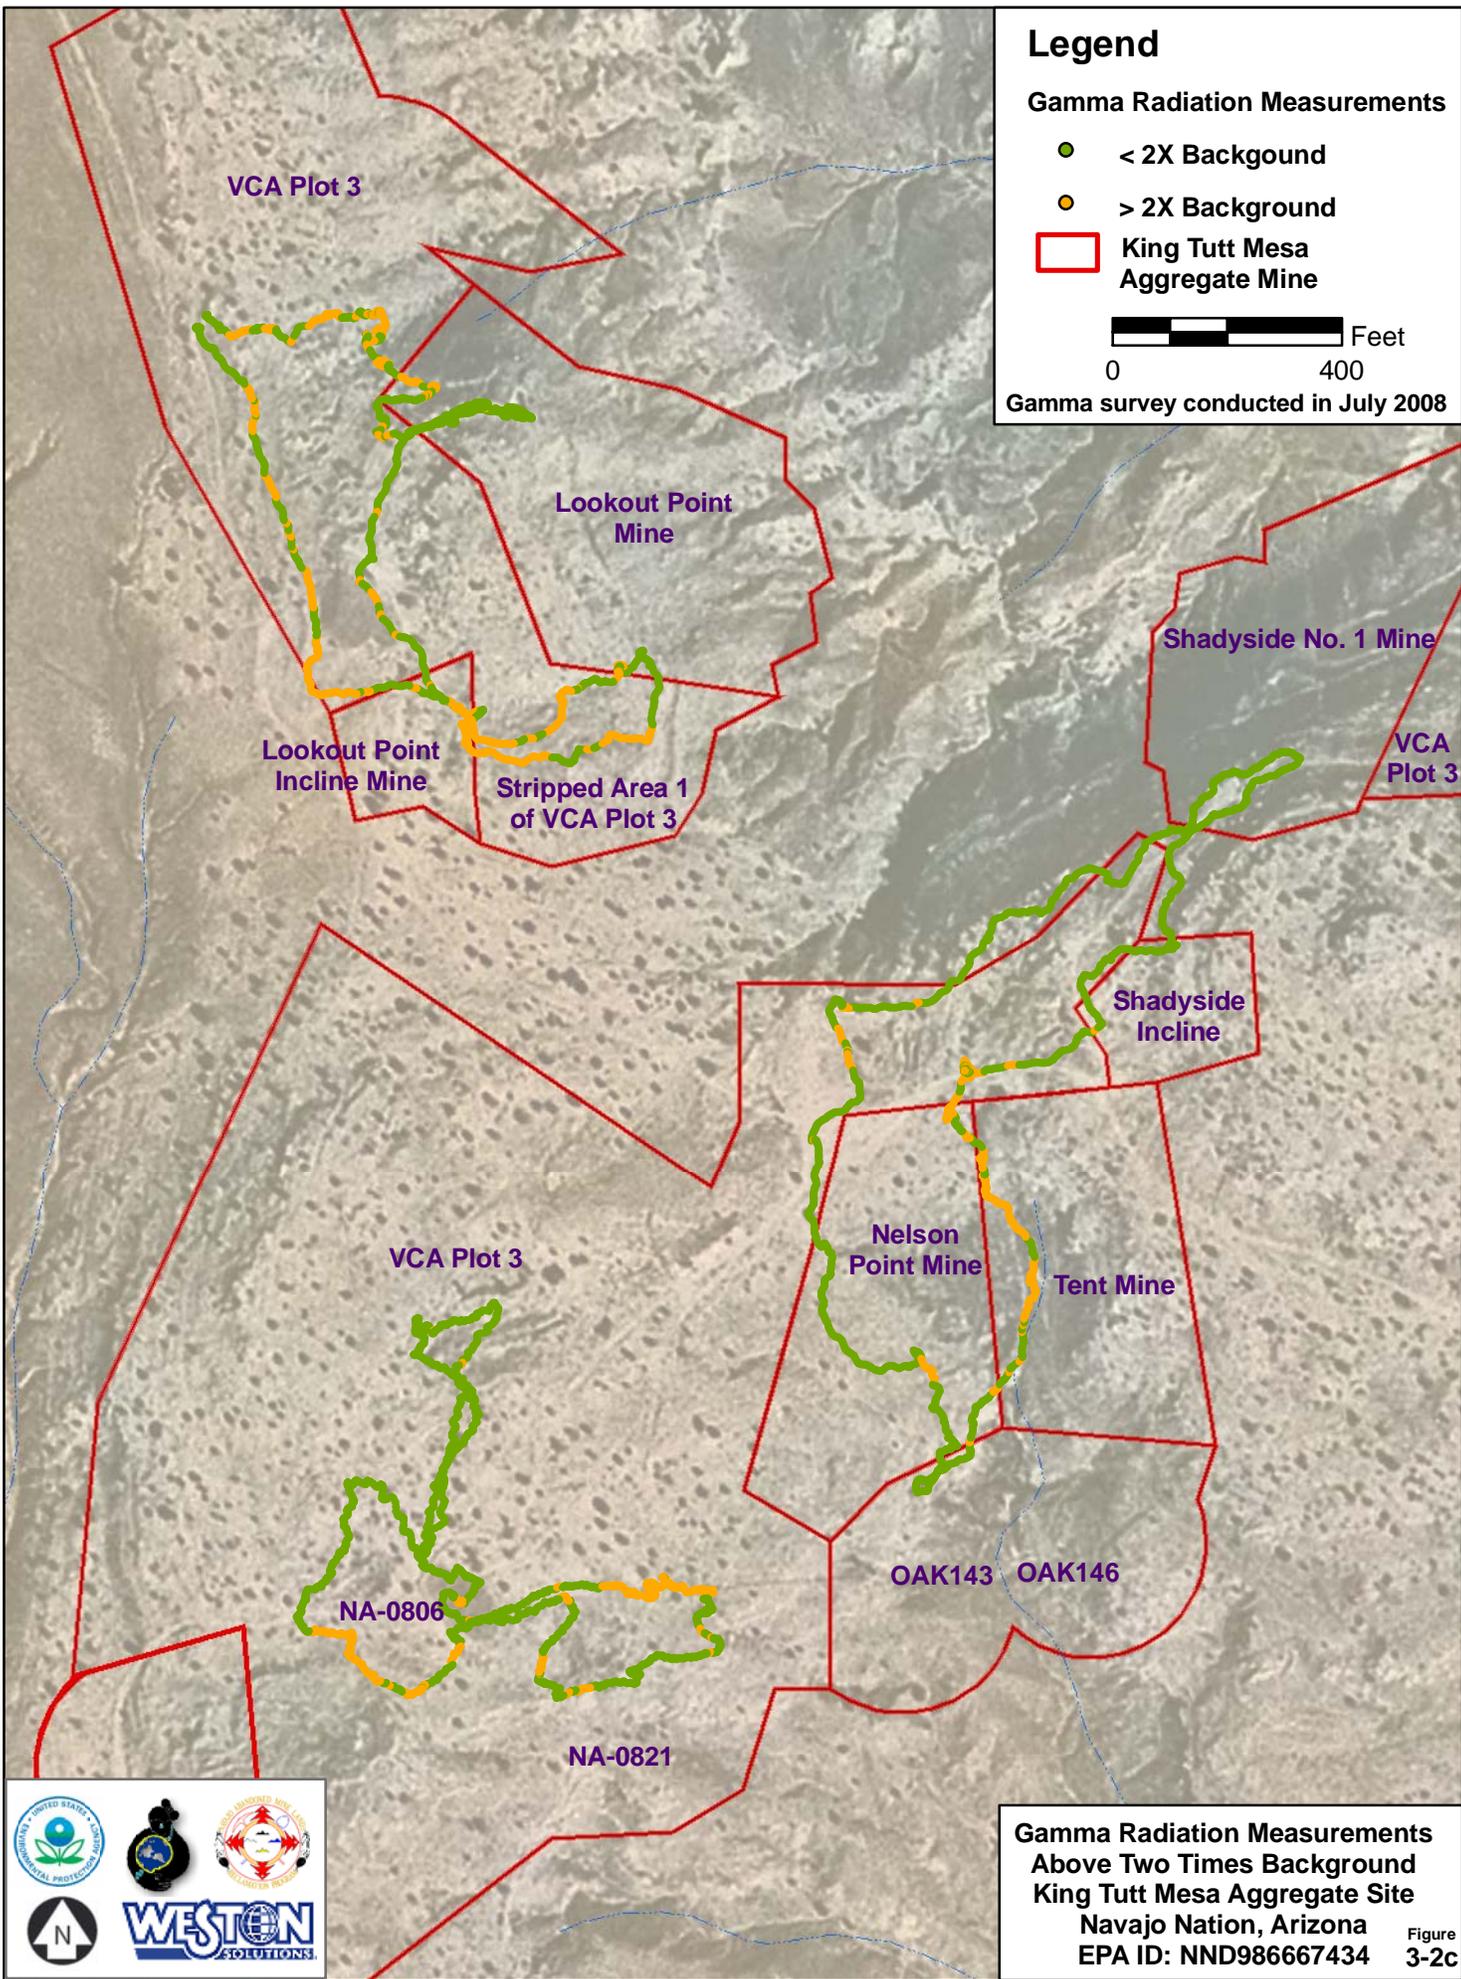
Gamma Radiation Measurements Above Two Times Background King Tutt Mesa Aggregate Site
Navajo Nation, Arizona
EPA ID: NND986667434
Figure 3-2c

Gamma survey conducted in July 2008

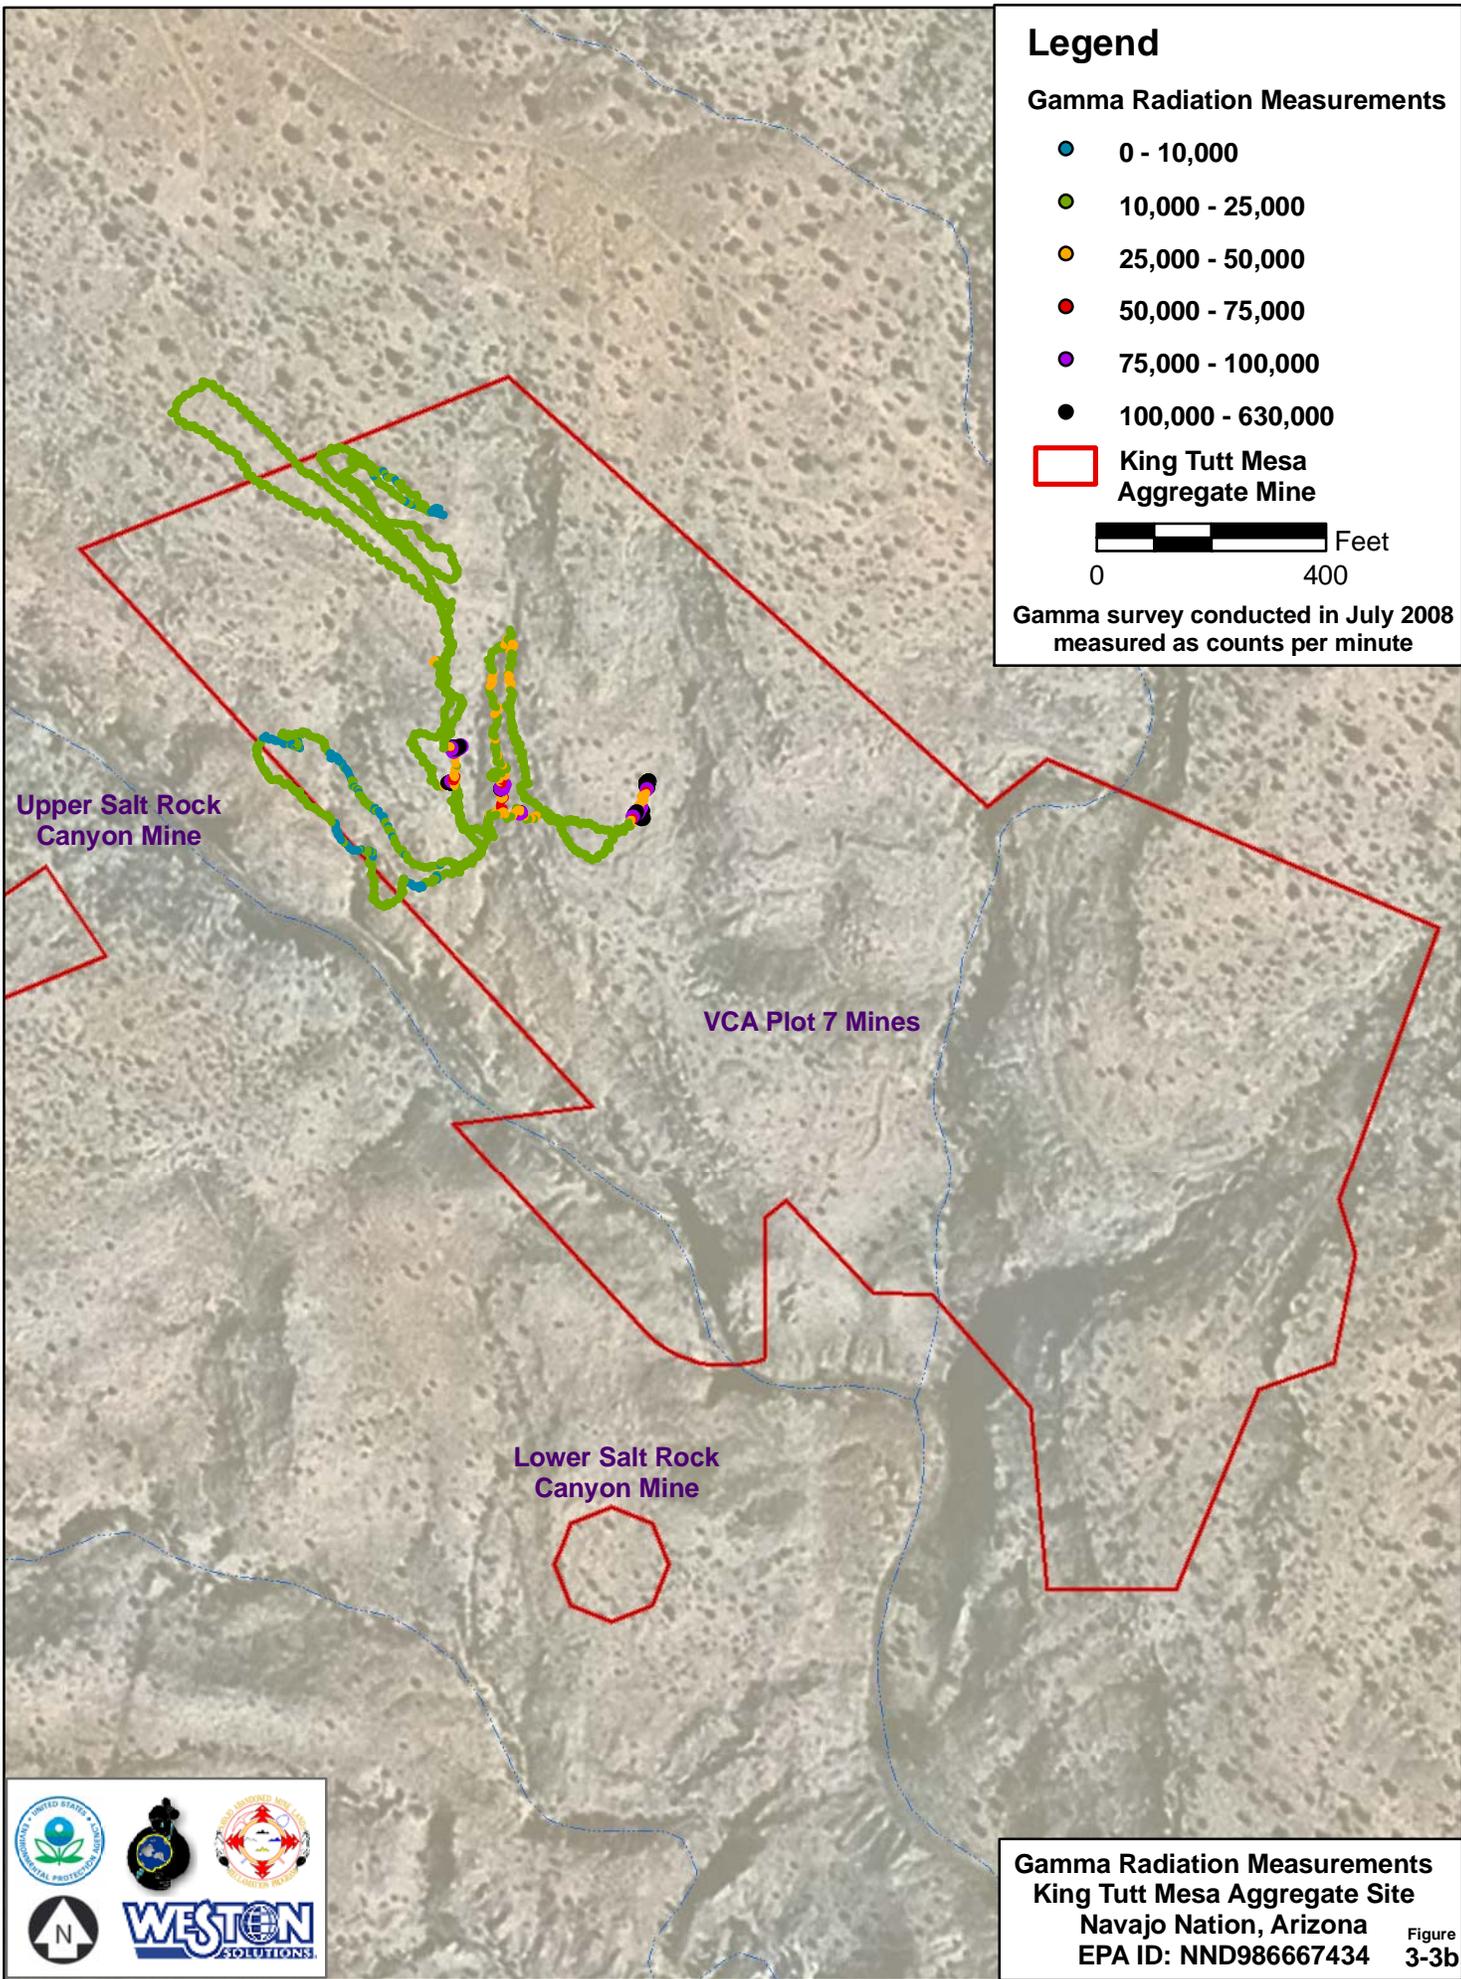
Gamma Radiation Measurements
King Tutt Mesa Aggregate Site
Navajo Nation, Arizona
EPA ID: NND986667434
Figure 3-3b

Gamma survey conducted in July 2008
measured as counts per minute

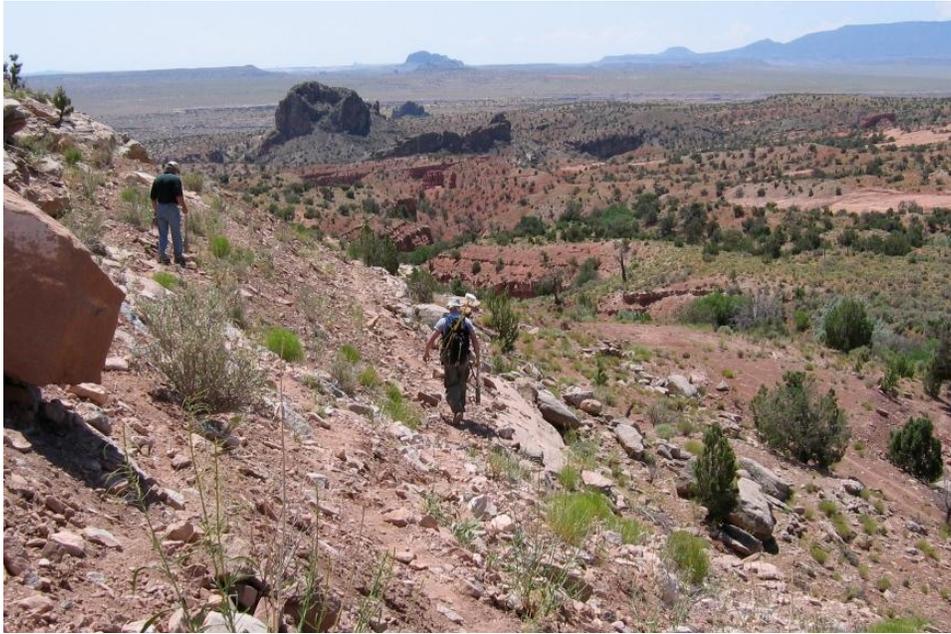
Photo 1: WESTON collecting gamma radiation measurements along a steep slope of the Oak Springs Mine.

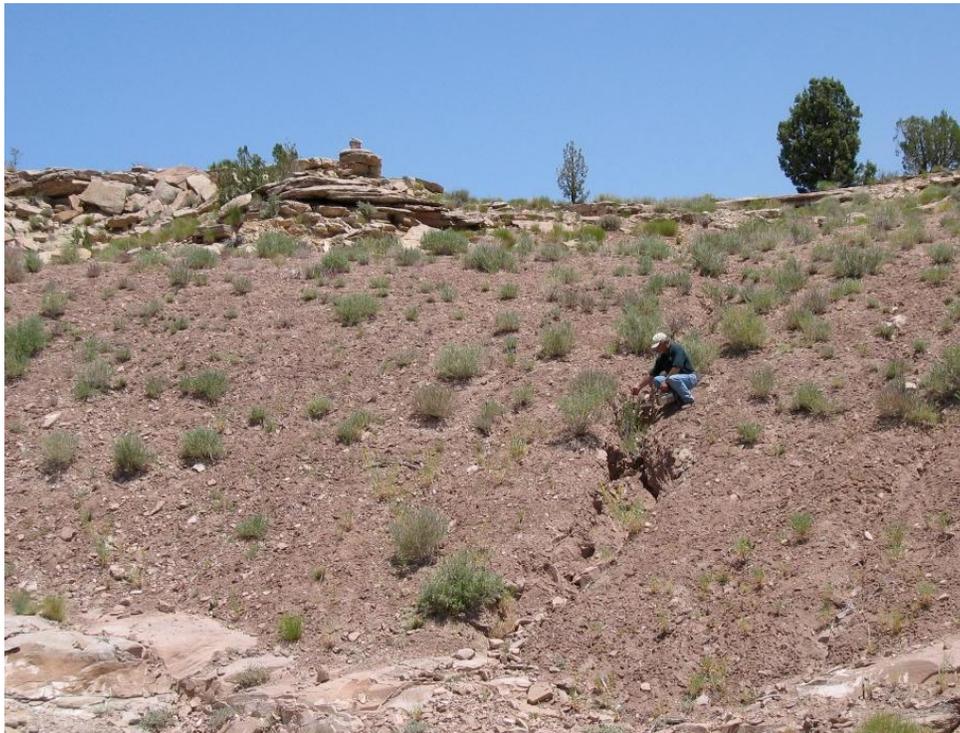
Photo 2: WESTON detected gamma measurements in excess of 100,000 cpm in an eroded section of the cap at the VCA Plot 7 Mines.

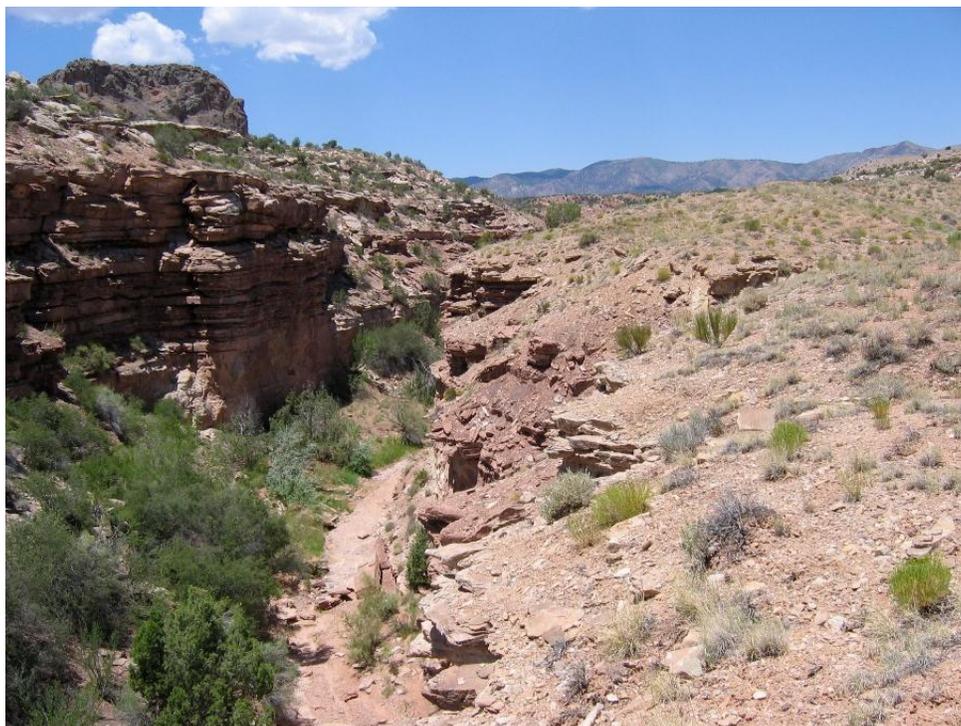
Photo 3: View of the Oak Spring Wash adjacent to the VCA Plot 7 Mines.

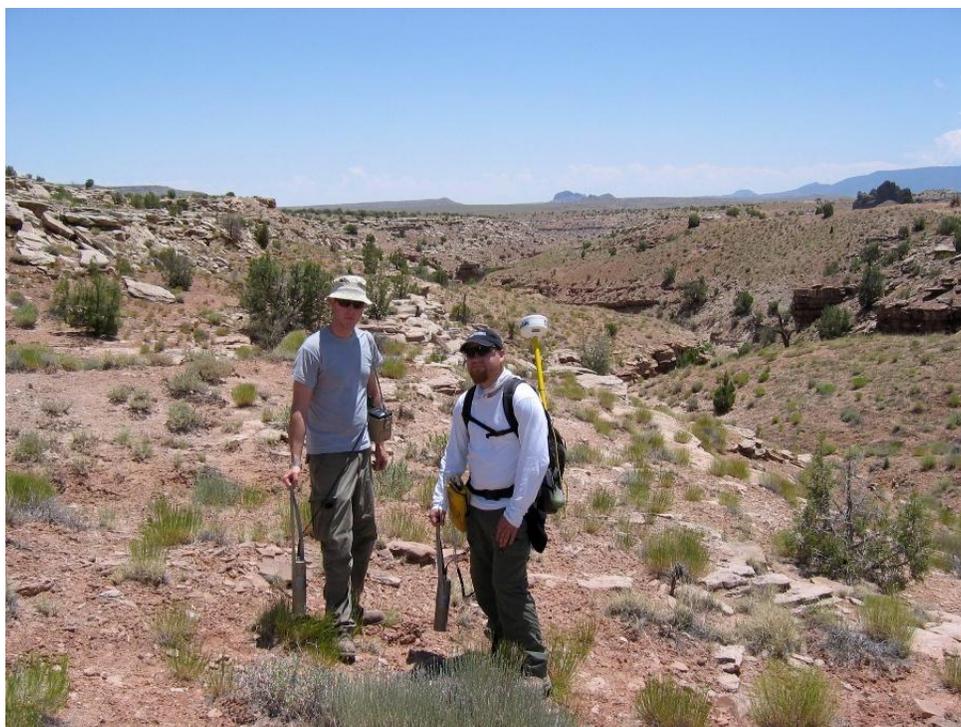
Photo 4: WESTON used a combination sodium-iodide scintillation detector and a GPS unit (right). A stand-alone scintillation detector also was used (left).

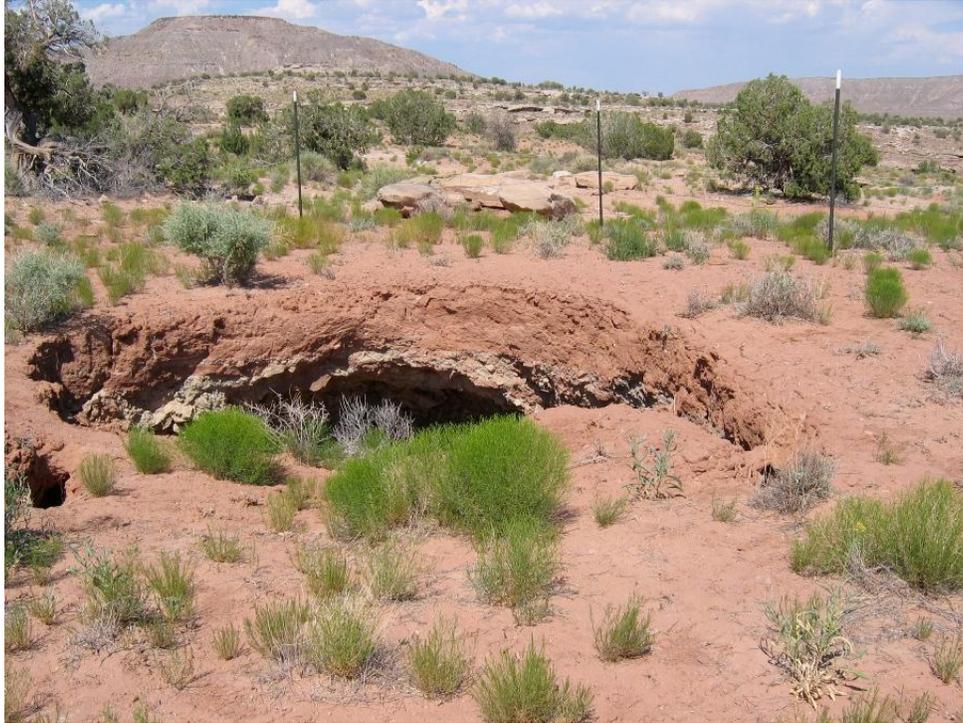
Photo 5: A section of the cap at NA-0806 has subsided. The NAMLRP has identified the area and surrounded it with a fence.

During the site visit, WESTON did not encounter any barriers to the mines aside from the fenced area around the subsidence at NA-0806. However, due to the rugged and remote terrain, access to all of the mine sites was via dirt roads with high clearance vehicles. WESTON identified one residence located the northwest of the Oak Springs Mine. Agricultural fields near this residence were observed. WESTON did not observe any residences, schools, or daycare facilities within 200 feet of the mine sites.

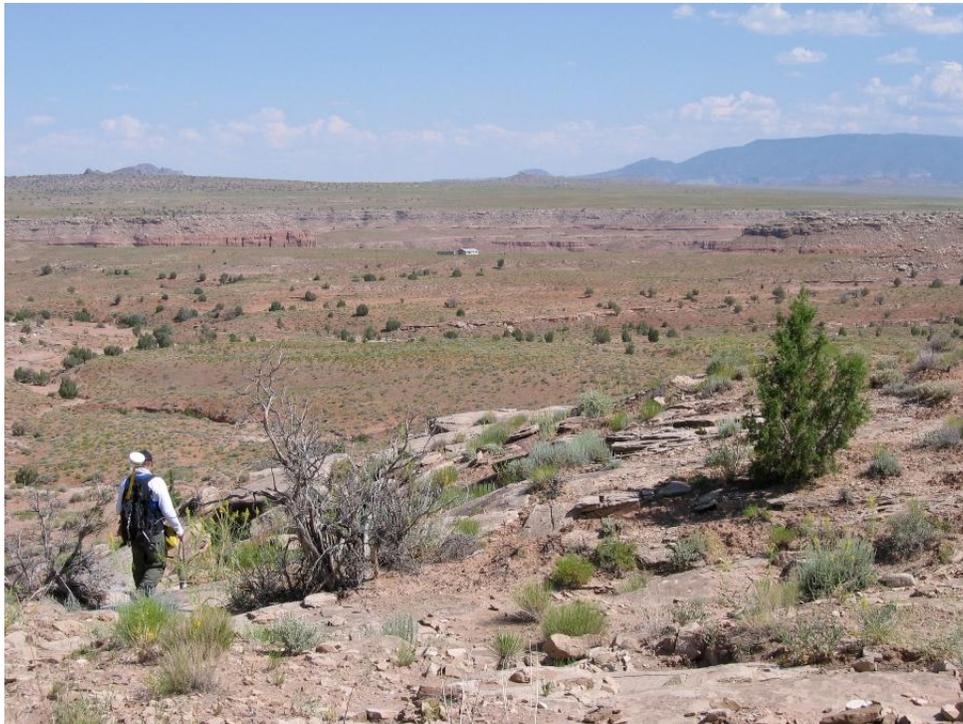
Photo 6: WESTON detected elevated gamma radiation measurements in a natural drainage channel (left) that extends from the northeast corner of Nelson Point Mine.

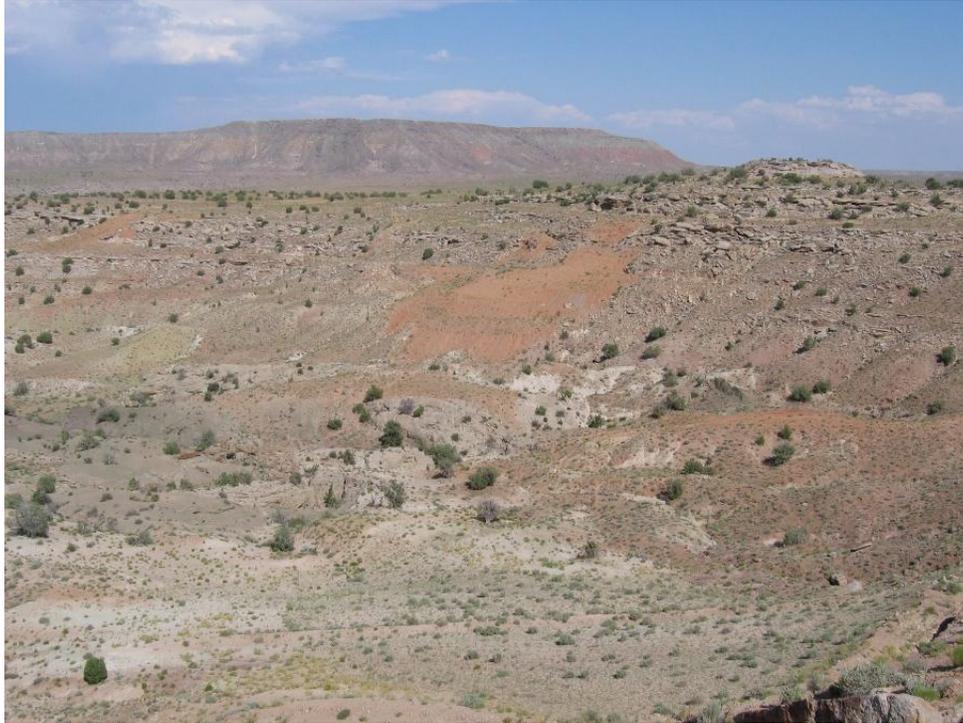
Photo 7: View of the reclamation cap at the Shadyside No. 1 Mine from the Lookout Point Mine. The darker red soil in the center of the photo is the cap.

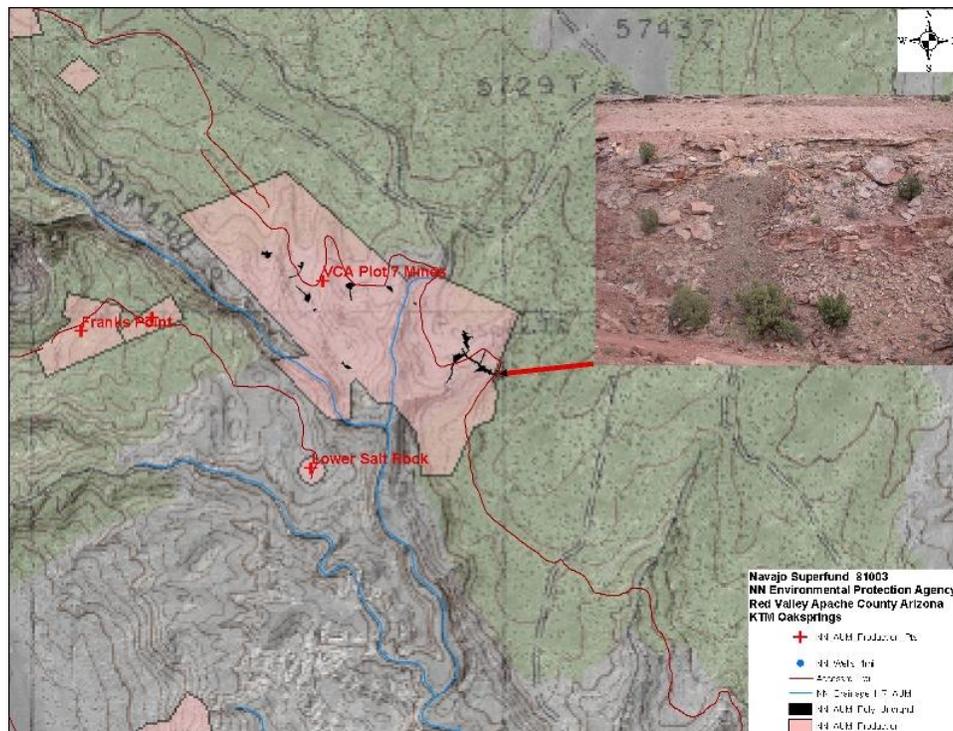
Photo 18: Location of the mine waste at the VCA Plot 7 Mine.
