**UNITED STATES ENVIRONMENTAL PROTECTION AGENCY**

**STATEMENT OF BASIS**

**FORMER CARBOLINE COMPANY**

**April 2017**

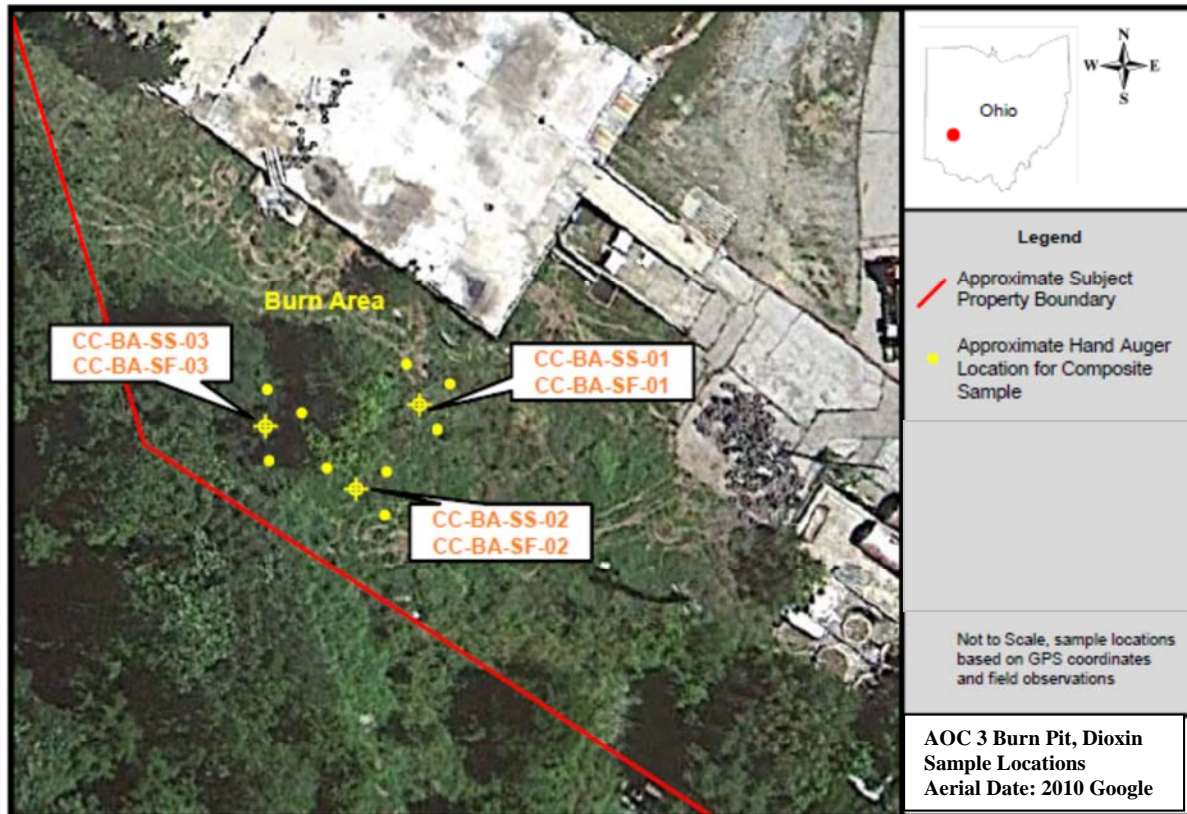
**Attachment D**  
**Sample Location Map 2**

**Booze Allen Hamilton**  
**Field Sampling, September 14, 2013**  
**Carboline Company**  
**125 Fairgrounds Road, Xenia, Ohio**

On September 14, 2013, EPA's contractor Booze Allen Hamilton re-sampled four locations in AOC 3, the Burn Pit Area, for dioxin and furans. When PCBs burn, dioxins and furans can be produced during combustion. Four surface samples collected at 0-1 foot depth and two subsurface soils collected at two to three feet depth in the burn area showed concentrations of PCB's were above residential and industrial EPA's RSL for soils (See Attachment D).
