U.S. ENVIRONMENTAL PROTECTION AGENCY

# Gold King Mine Release: Inspector General Response to Congressional Requests

Report No. 17-P-0250

June 12, 2017

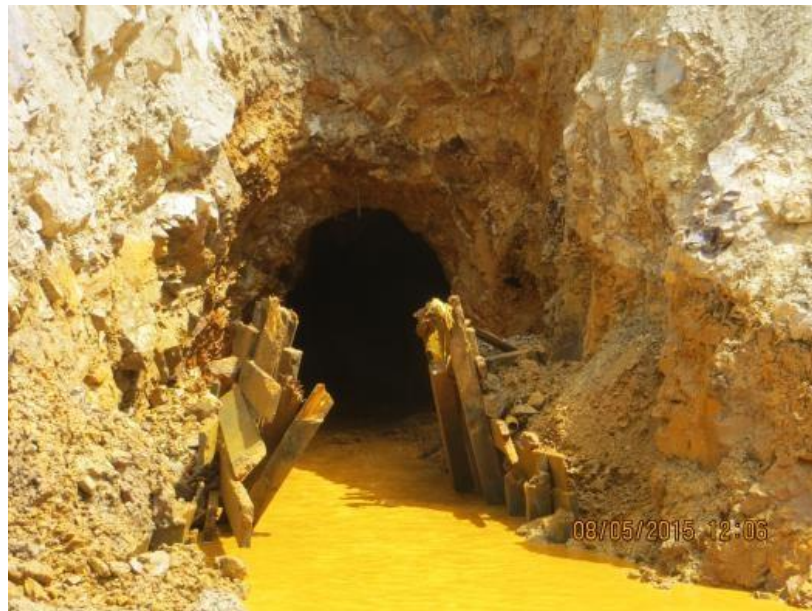
**Cover photo:** An image of the Gold King Mine site after the release of mine water on August 5, 2015. (EPA photo)

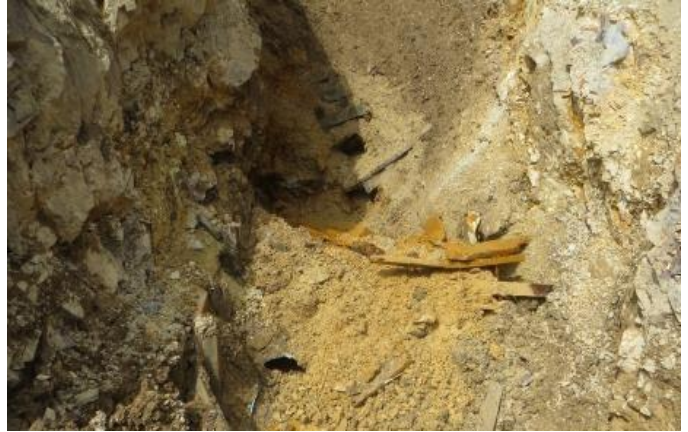
Pictures taken at the end of the workday on August 4, 2015, show that the excavation activities had exposed collapsed timbers and material filled in around those timbers.

Exposed, collapsed timbers and material filled in and around the timbers at the Gold King Mine portal on the afternoon of August 4, 2015. (EPA photo)

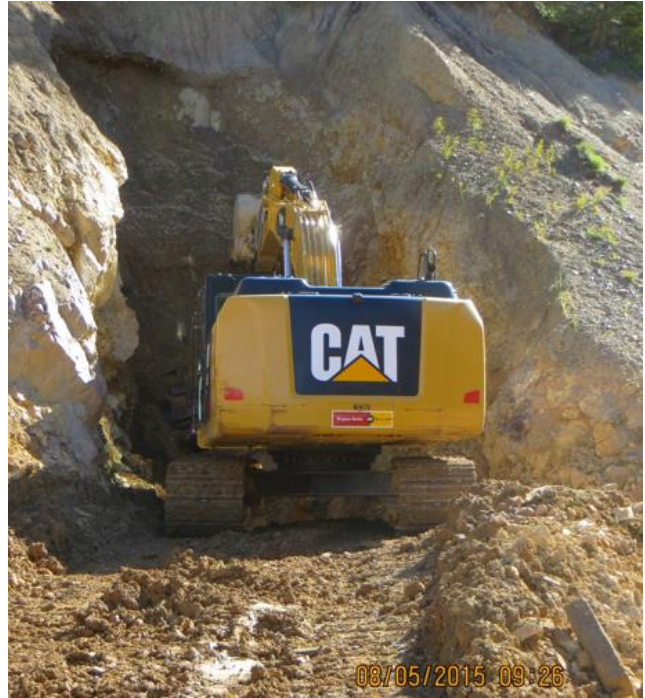
- The OSC would direct the excavator operator to remove a “little” material and stop.
- The OSC and others would then examine the area from which the material was removed.
- After the examination, the OSC would direct the excavator to remove a little more material.
- This process was repeated approximately 12 times over a 2- to 3-hour period.
- The excavator operator piled the material removed from above the adit in front of the excavator.
- When excavation ceased, a loader was used to remove the excavated material.

Photo of excavation activities on August 5, 2015. Image was taken about 1.5 hours before the release. (EPA photo)

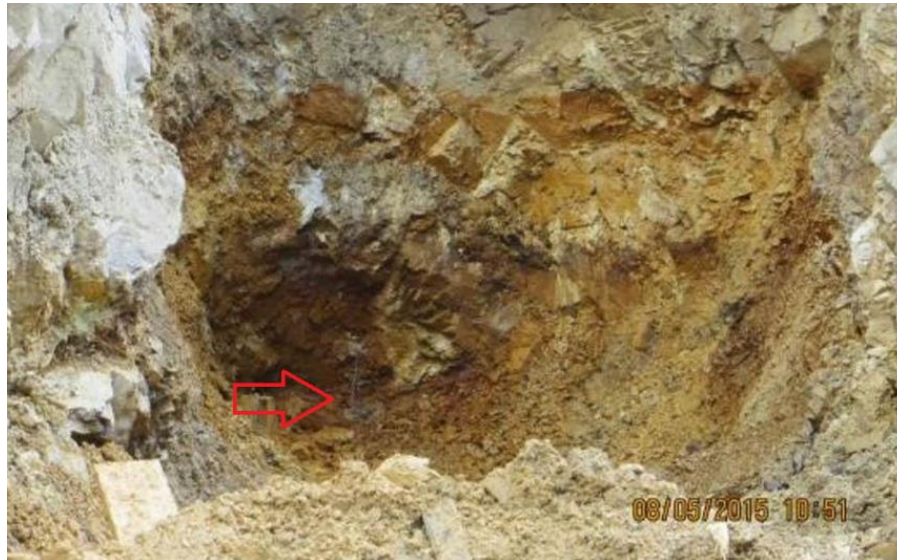
According to the START contractor and the photographs he took on August 5, 2015, the initial leak was evident at 10:51 a.m. The response manager said it was “way above where anyone expected.” The OSC and the response manager said,

and the photos show, the leak started out clear and small, and within minutes turned red or orange and increased in volume.

The initial spurt of water from the Gold King Mine is barely visible in this photo taken at 10:51 a.m. on August 5, 2015. The OIG added the red arrow. (EPA photo)

Although the OSC on-site did not intend to open the mine that day, due to a misjudgment about the height of the adit, the OSC on-site reported inadvertently excavating down to within a foot or two of the top of the adit portal, which initiated an internal erosion failure that caused the release. This is consistent with the Bureau of Reclamation conclusion. In its October 2015 review, the bureau concluded that excavation-induced failure triggered internal erosion and resulted in the uncontrolled release.

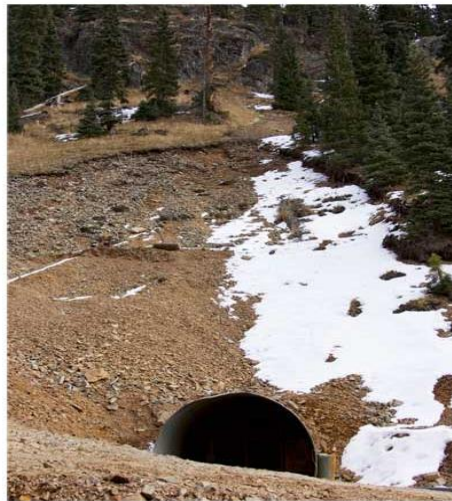
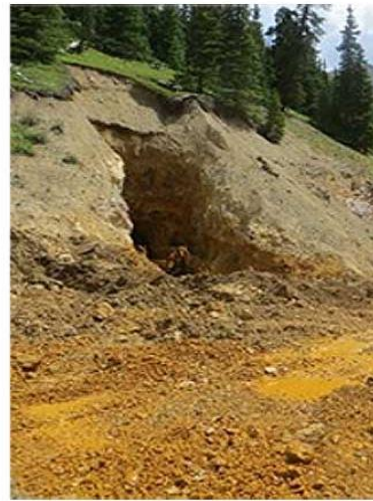
**Slope above Red & Bonita**

The lead OSC had drilled a monitoring well into the nearby Red and Bonita Mine approximately 5 years earlier. At the Red and Bonita Mine, the road loops back over the hillside on top of the portal. This allowed the EPA to get a drilling rig safely positioned above the portal. However, the Gold King Mine portal is located on a steeper and more unstable mountainside than the Red and Bonita Mine portal. In addition, no road crosses above the adit that would have provided stable drilling locations. These conditions at Gold King Mine meant that any drilling attempt from above would have been more costly, required more time, and been more uncertain to achieve success in comparison with what was done at the Red and Bonita Mine.

Side-by-side comparison of Red & Bonita and Gold King mine slopes. (EPA photo)
