# **Second Five-Year Review Report Hudson River PCBs Superfund Site**

## **APPENDIX 7 CAPPING EVALUATION**

Prepared by:  
Louis Berger US, Inc.

May 2017

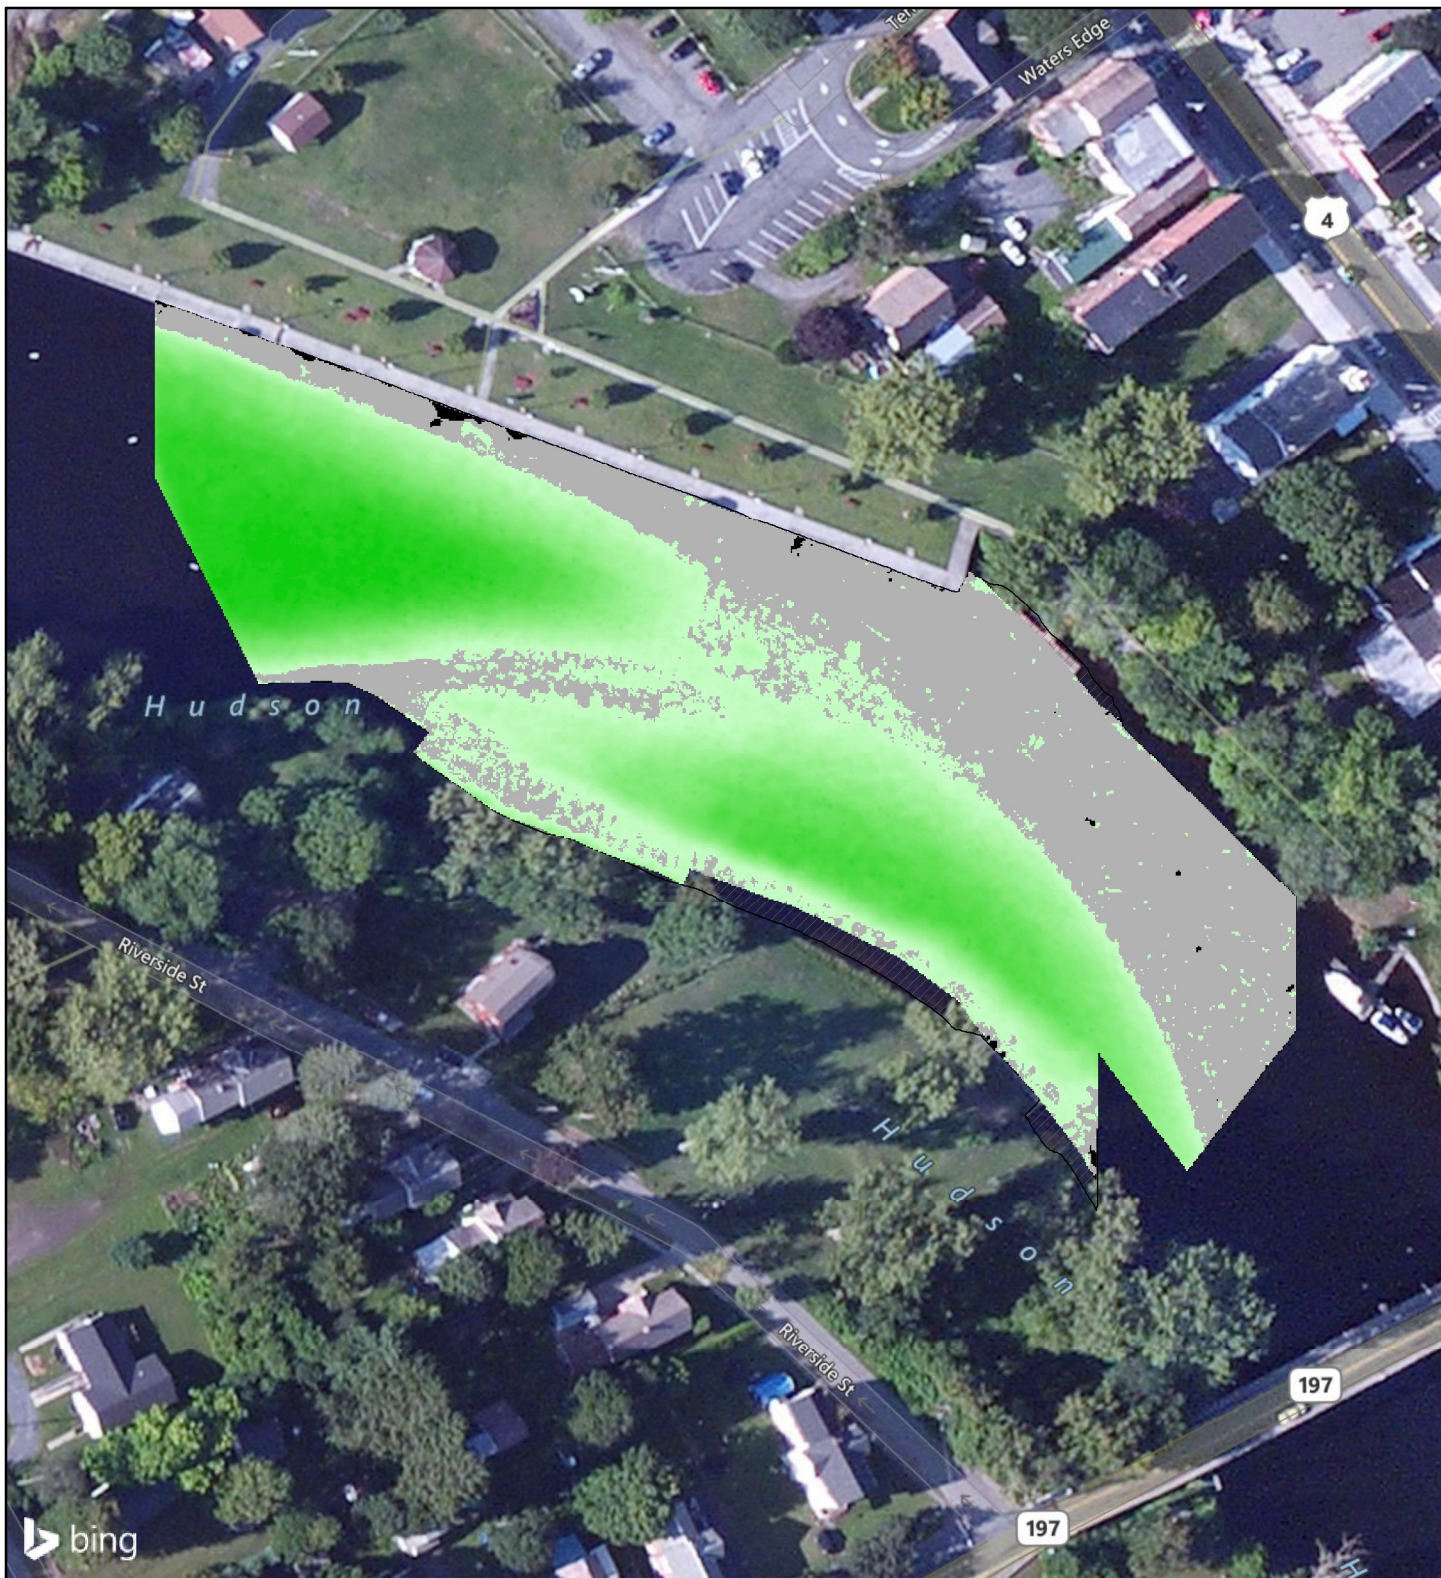
**Figure A7-1a. CU-1  
Bathymetric Comparison  
2009 Cap Reference Survey  
vs.  
2011 High Flow Survey**

Total area capped: 3.31 acres  
Area capped with >3" deposition: 64%  
Area capped with >3" erosion: <1%

**No Measurable Loss in CU-1**

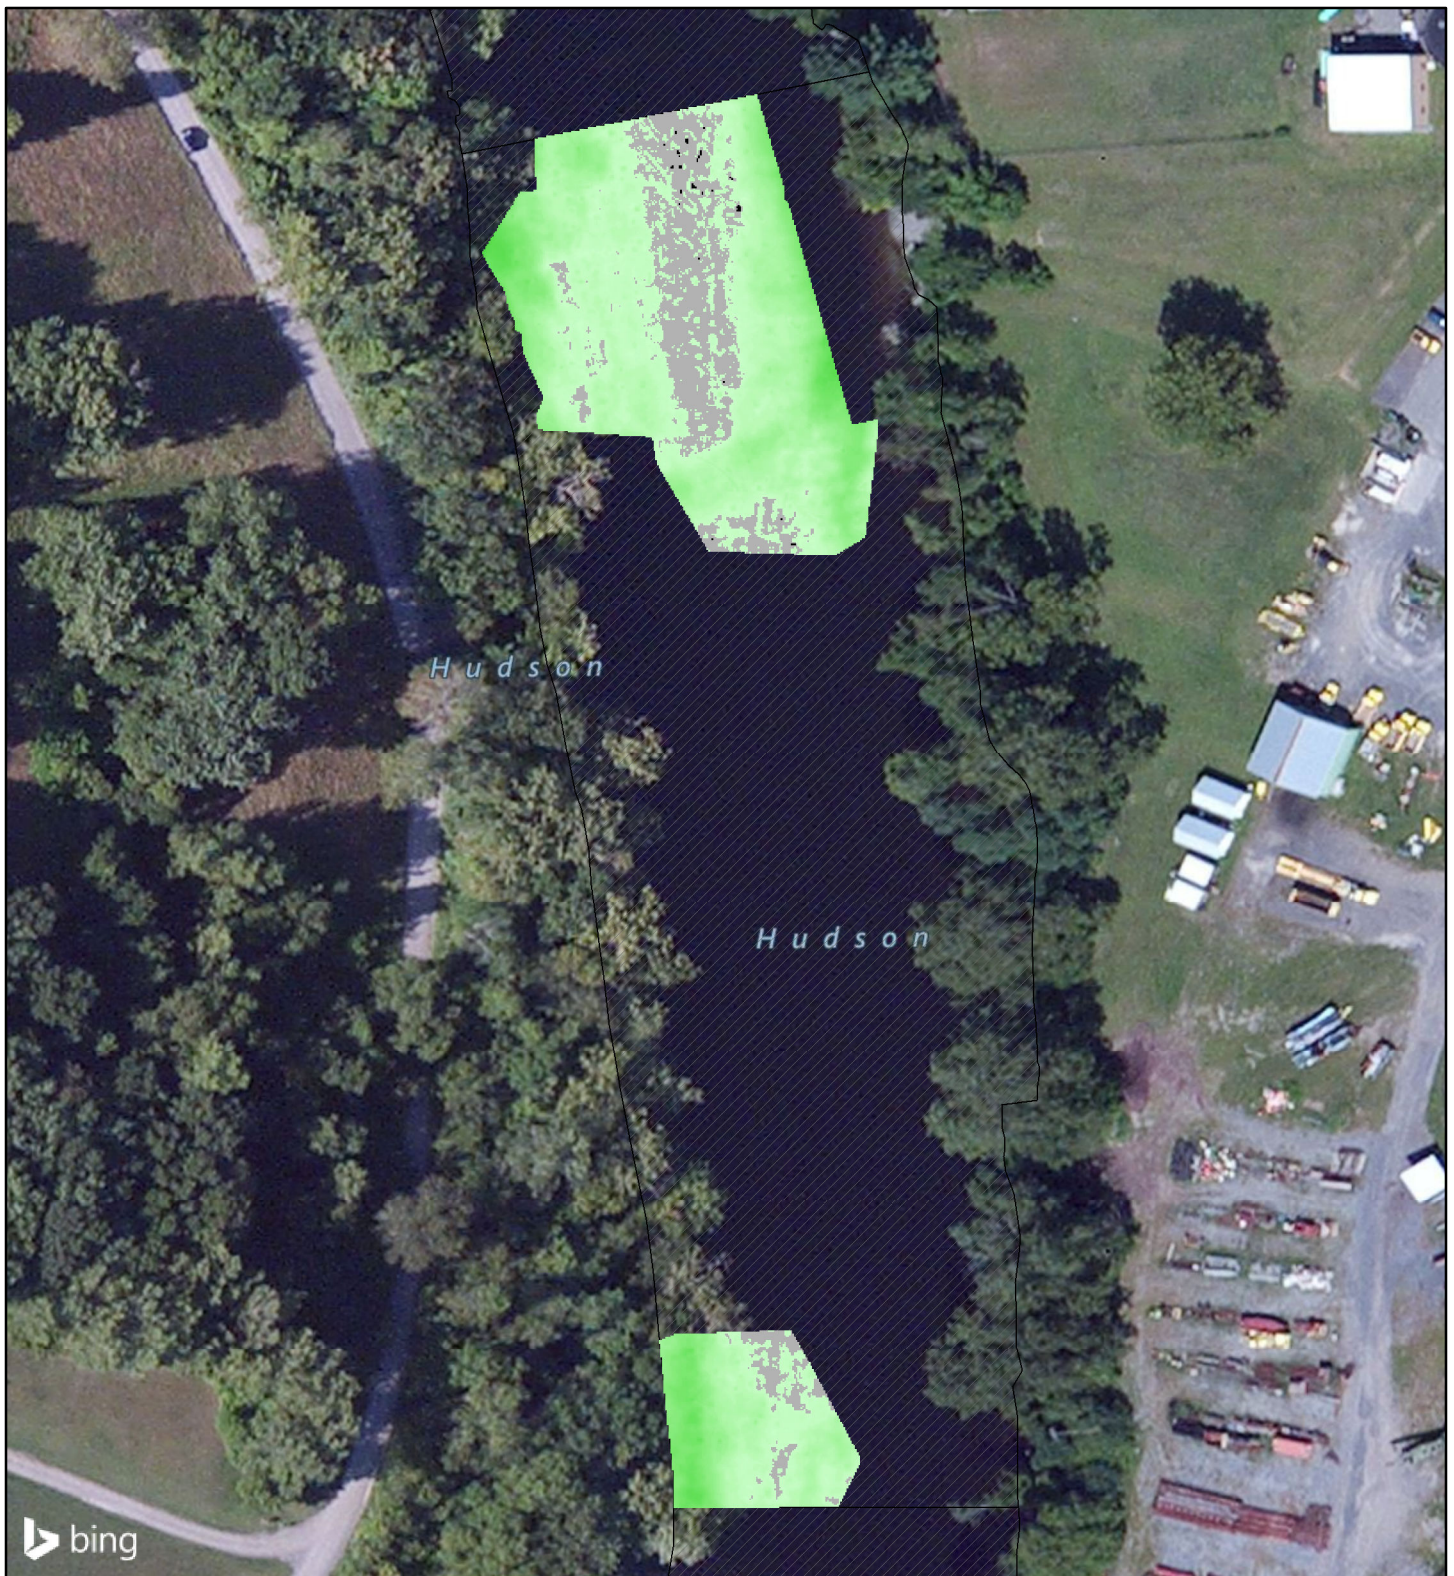
**Figure A7-1c. CU-3  
Bathymetric Comparison  
2009 Cap Reference Survey  
vs.  
2011 High Flow Survey**

Total area capped: 1.22 acres  
Area capped with >3" deposition: 83%  
Area capped with >3" erosion: <1%

**No Measurable Loss in CU-3**
