Core Methane Emission Control Strategies

- Pneumatic device retrofit
- Pneumatic device replacement
- Flashing emission controls
- Inspection with IR camera
- Ongoing evaluation of new technology

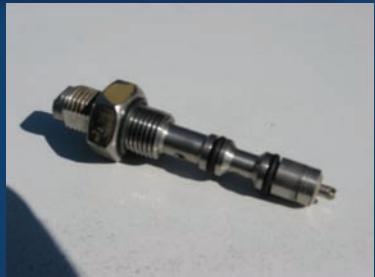
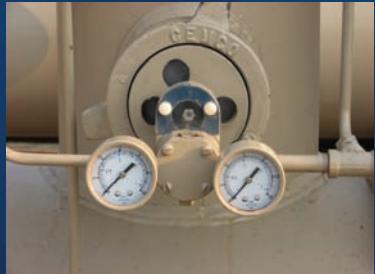
Pneumatic Retrofits

- **Retrofitted 548 Mizer style valves installed**

- Recovers approximately 77 MMscf methane per year
 - Three-month payout

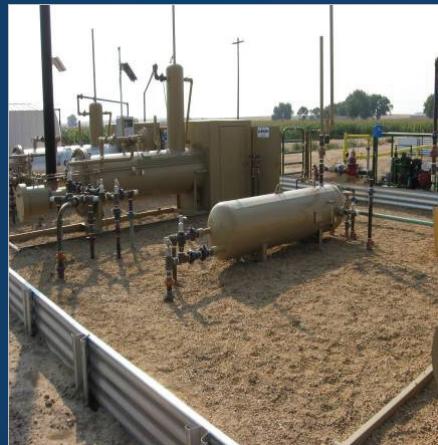
Process Modifications to Reduce Flash Emissions

In 2006 piloted the use of a secondary flash vessel.

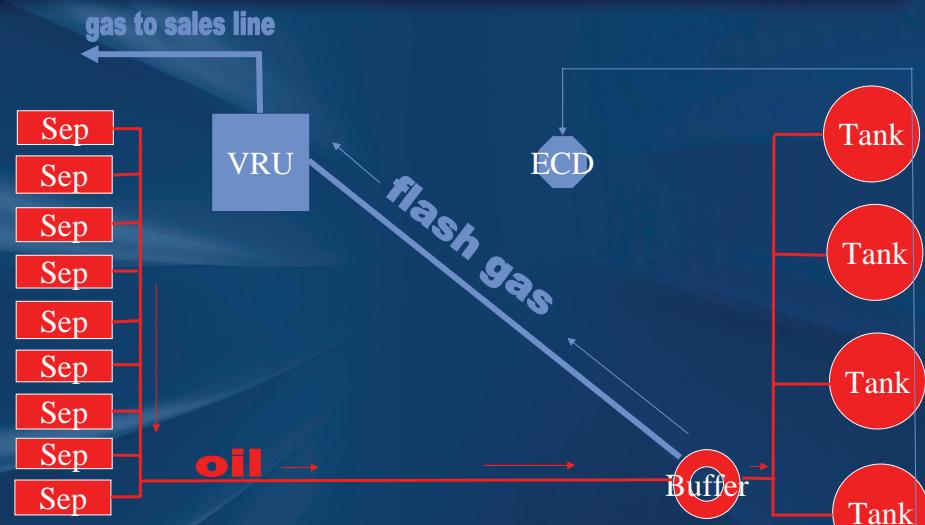
Flash Vessel

In 2007, modified the design to a larger buffer tank.

- Reduces methane emissions
- Reduces products of combustion to atmosphere
- Increased safety due to lower pressure seen at tank
- Gas from buffer tank is compressed back into sales line
- This vessel also eliminates O₂ intrusion

- Average of 1-2 MCF for every 10 bbls oil
- Price of buffer tank \$7,700
- 40~50 bbl location = 4 Mcf a day
- Pay out on buffer tank is 1 year

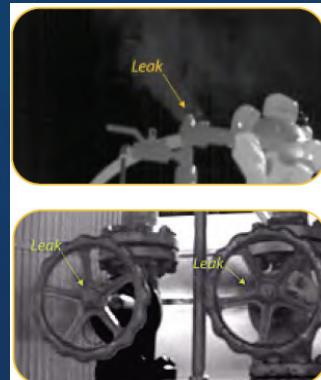
Implemented IR camera inspections in summer 2007

- Two cameras in E&P service
- One camera in midstream service

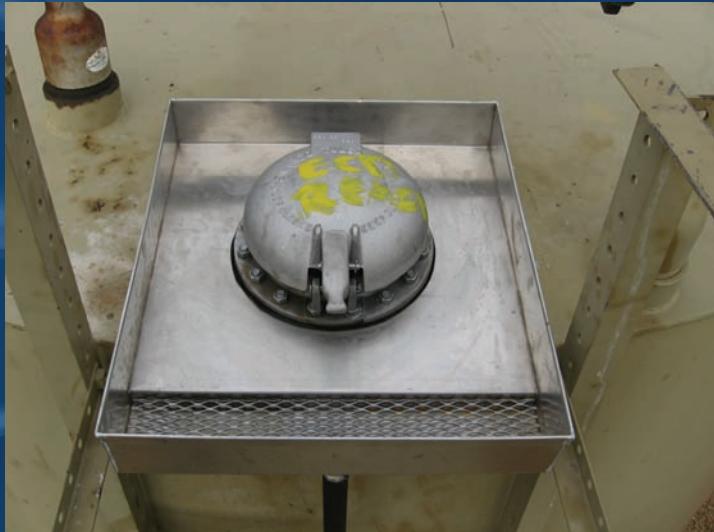
IR Camera Inspections – DJ Basin

- Initial findings led to the formation of maintenance teams to incorporate the use of the IR camera and facilitate repairs.
- Goal was to inspect every separator, tank and wellhead in the Wattenberg Field.
- Developed simple recordkeeping and maintenance log to facilitate data trending in the future.
- Most significant finding:
 - Thief hatch seals

Based on the IR camera findings, Anadarko began a gasket material replacement and longevity program for Enardo and Jayco thief hatches.

- Original equipment was outfitted with Buna-N gaskets
- Retrofitted with Viton
- Now evaluating Fluorosilicone rubber gaskets
