UNITED STATES ENVIRONMENTAL PROTECTION AGENCY
REGION 5

77 West Jackson Boulevard
Chicago, Illinois 60604

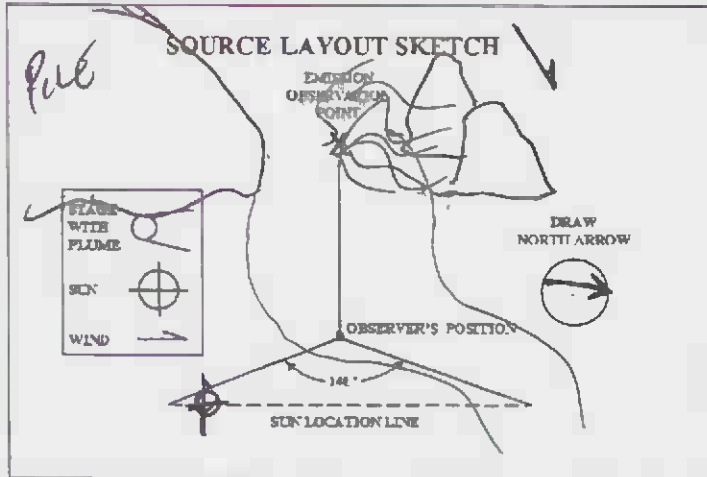
Additional Information EPA reqs for fugitives from roadways (212.109 IL SIP)
