TVA Kingston Site Case Study

Revitalization of the Wetlands, Embayments and Emory River

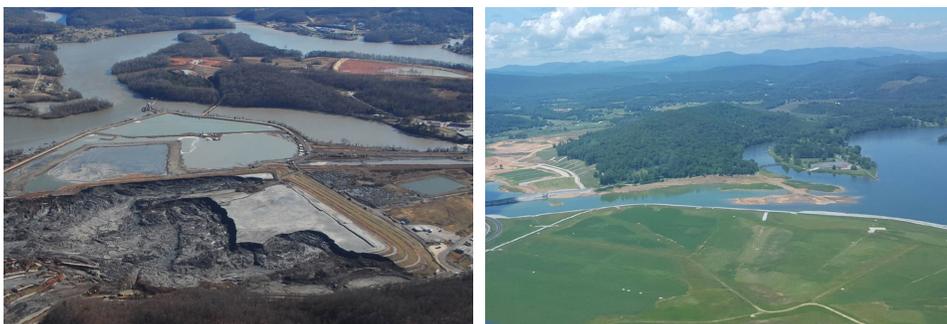
Figure 1. Aerial view of the coal ash spill in 2008 (left). Capped landfill and recreation area at the site in 2015 (right). (Source: EPA)

Today, less than a decade later, the site is home to a 240-acre capped landfill, Roane County’s Swan Pond Recreation Area and Lakeshore Park, see Figure 1. Natural areas at the site provide an interconnected ecosystem that supports diverse wildlife habitat and recreation opportunities.

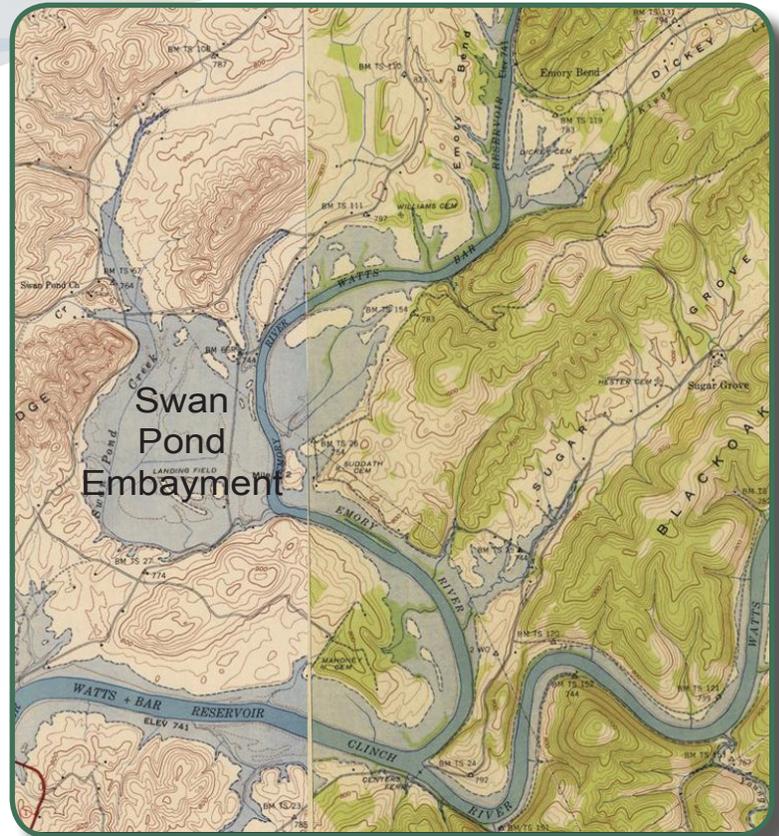
Figure 2. Topography of the area in 1941, before TVA began discharging waste into Swan Pond Embayment. (Source: U.S. Geological Survey)

The site is located at the headwaters of Watts Bar Reservoir near the confluence of the Clinch and Emory Rivers in Harriman, Roane County, Tennessee, see Figure 2. The TVA Kingston Fossil Plant generates about 10 billion kilowatt-hours of electricity per year, enough to supply more than 670,000 homes in the Tennessee Valley.

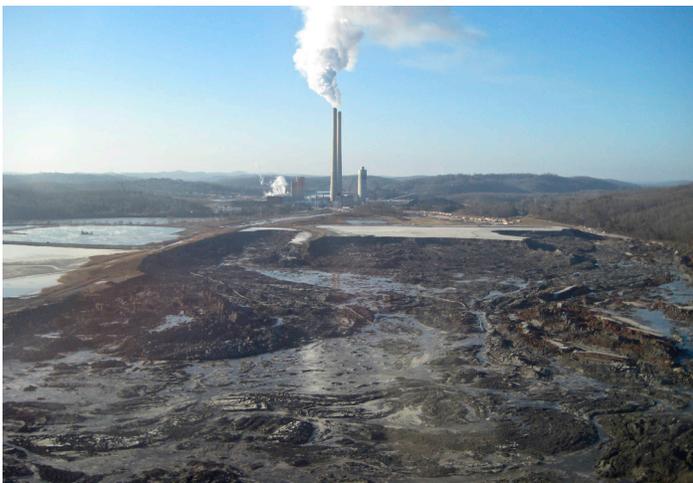
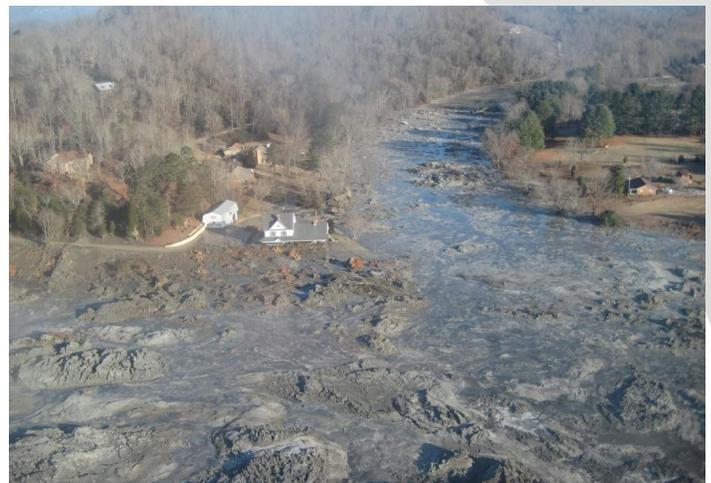
Figure 3. Remaining ash in cell where the breach occurred in 2008 (left). Flow of ash into the Emory River from the breach (right). (Source: EPA)

TVA, state and local emergency management agencies helped nearby residents affected by the release and took actions to reduce further contamination, see Figure 3.

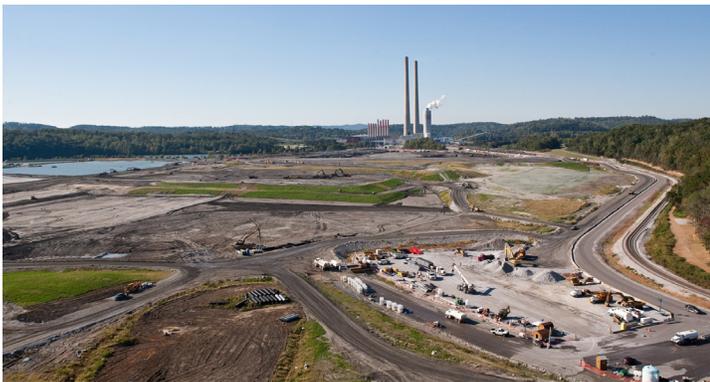
Figure 5. Dredging during cleanup. (Source: EPA)

Phase 2 involved mechanical excavation of about 2.3 million cubic yards of ash in the north and middle Swan Pond Embayments (see Figures 4 and 5). Recovered ash was dried to optimum moisture content, spread into thin lifts and compacted on site in a 240-acre disposal cell. The disposal cell was re-engineered with a 12-mile subsurface stabilization slurry wall. It is the largest slurry wall in the United States. Most Phase 2 activities were finished by December 2014.

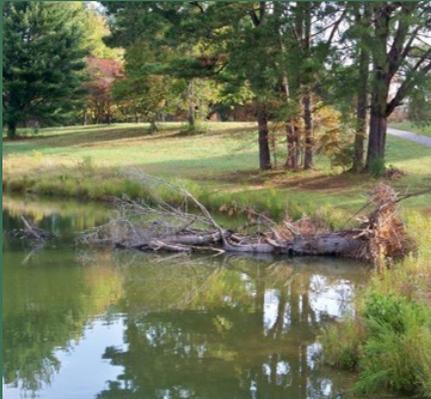
Fish Attractors

Provide preferred fish habitat.

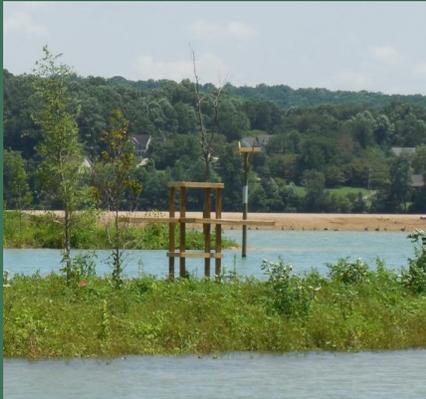
Bird Attractors

Provide optimum osprey and heron nesting areas.

- Installation of osprey and heron platforms in strategic locations throughout relevant habitat to fulfill the need for nesting habitat and encourage use of the sufficient feeding opportunities in area streams and rivers.

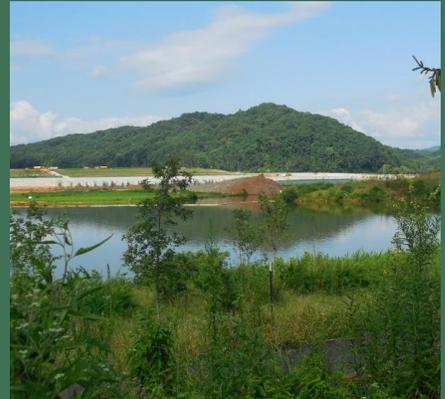
Riparian Zone Plantings

Reduce nutrient runoff and provide shade and habitat for creatures living on land and in water.

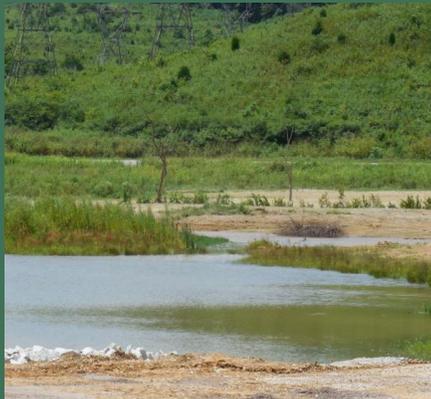
Wetlands

Control water flow, help prevent flooding and provide wildlife habitat.

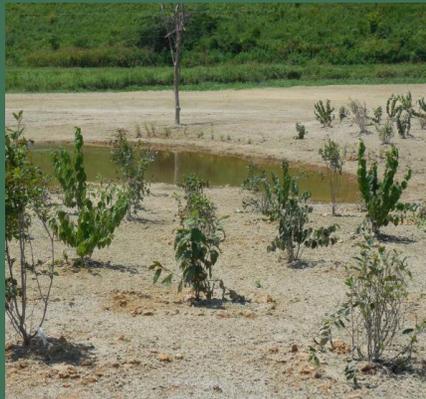
Vernal Pools

Provide areas for amphibians to live and breed.

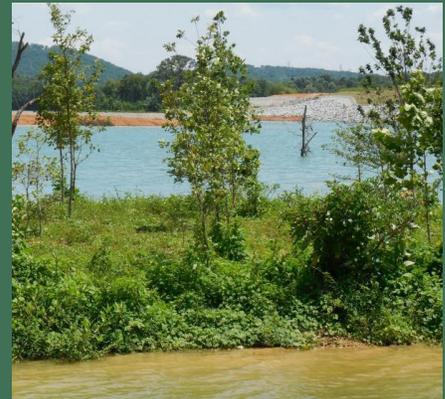
Reforestation

Reduces erosion, provides valuable habitat and reduces nutrient runoff.

- Planting of nearly 7,000 trees across 15 acres, using over 40 tree types. Planting hardwood trees and understory shrubs promotes natural successional growth of hardwood forest.
