Rainier Commons Work Plan

Exterior Paint Removal & Limited Scope for Follow-up on Interior Surfaces

**Dated March 25, 2013
Revised July 25, 2013**

Rainier Commons Exterior Walls Abatement Project

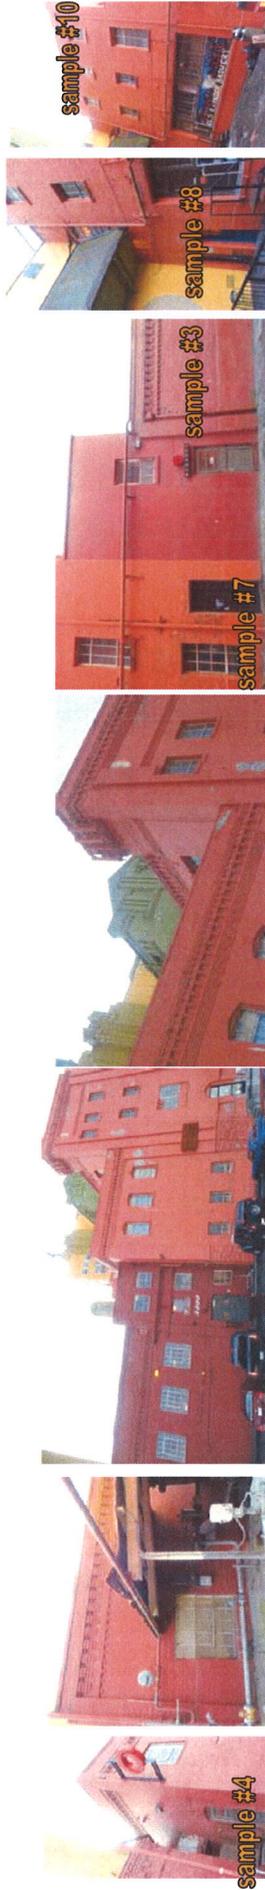
North elevation-bldg 12

West elevation
bldg 12, 23, 11, 10,

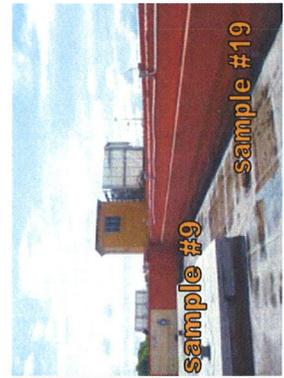
West parapet wall, bldg 9

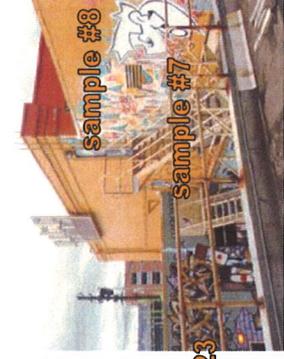
South/East elevation wall, bldg 8

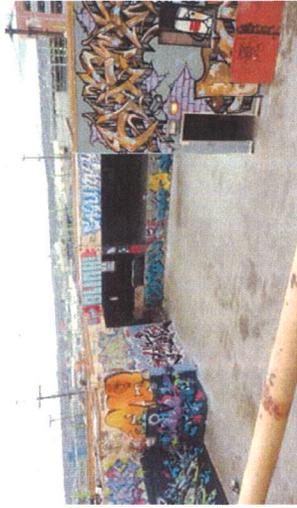
Inside North & East elevation, bldg 8/14/15/18

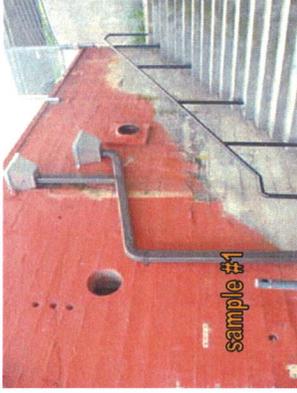
Outside South elevation, bldg 18

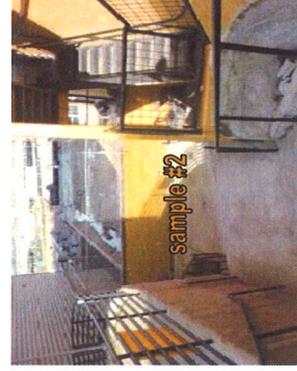
Outside East elevation, bldg 18
