CORRECTIVE MEASURE IMPLEMENTATION REPORT

Duwamish Sediment Other Area and Southwest Bank

Boeing Plant 2

Seattle/Tukwila, Washington

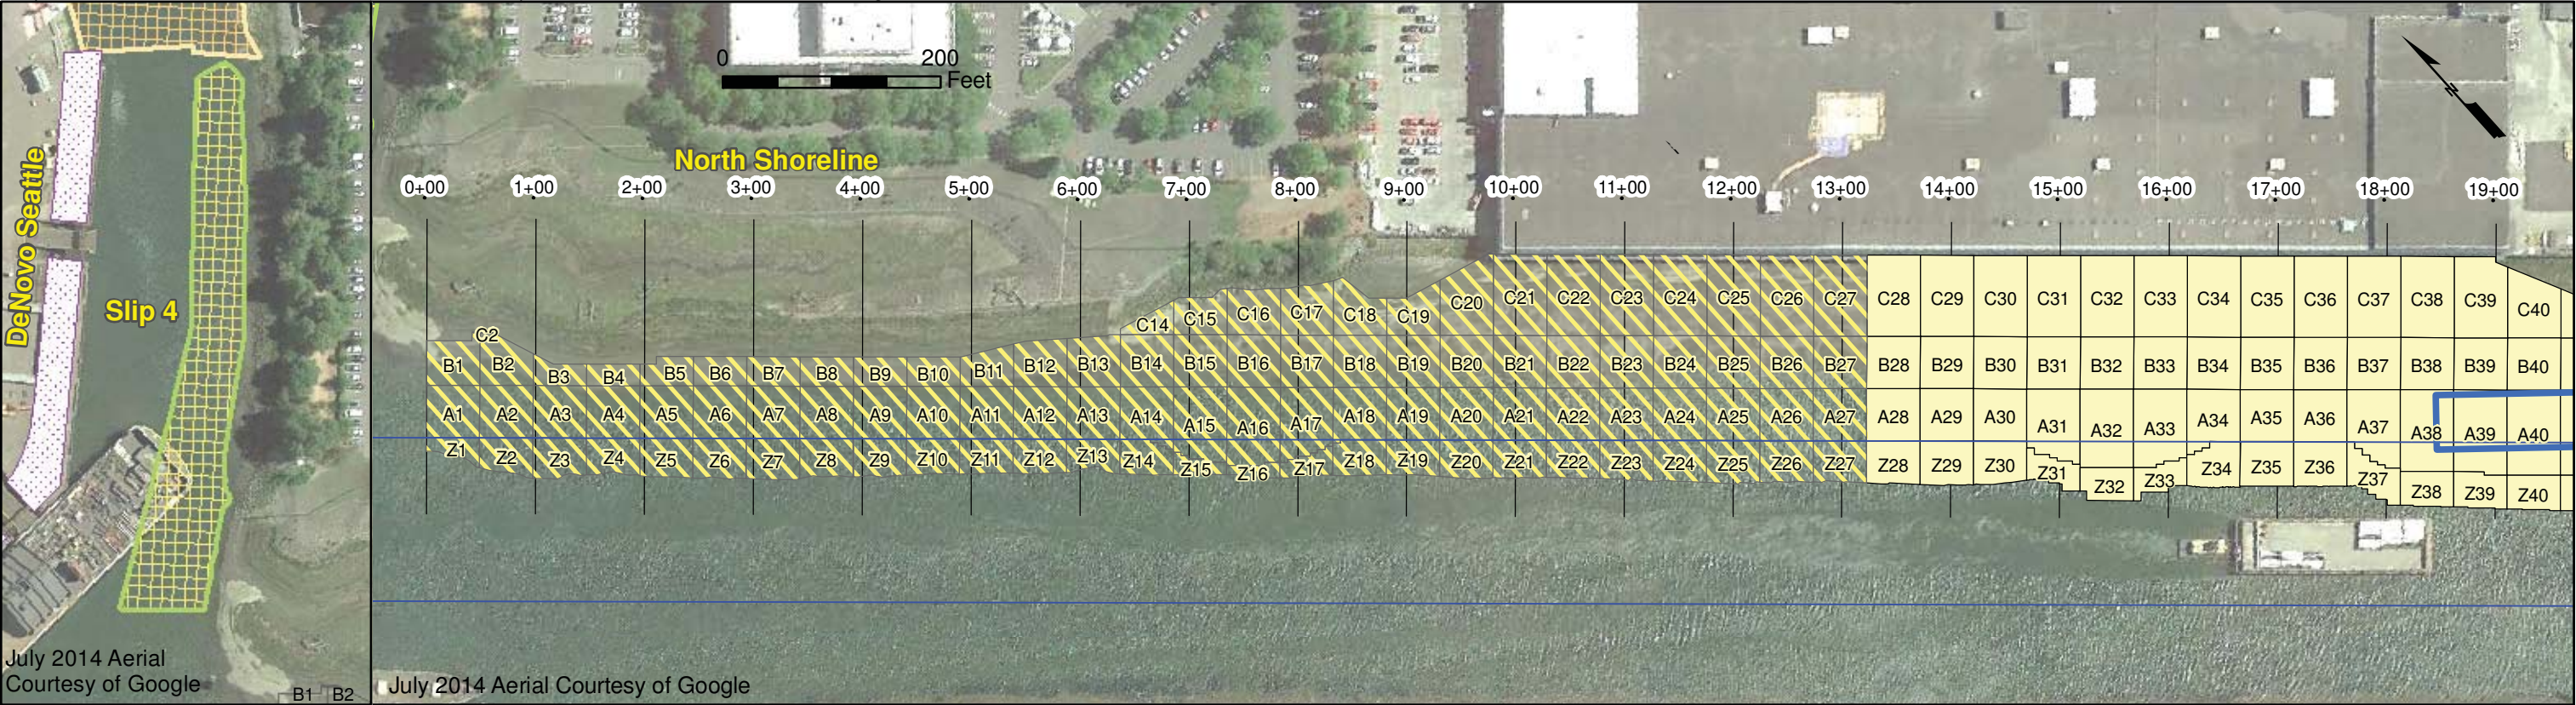
Construction Season 3 Work Areas

- Slip 4 Dredge and Final Backfill Area
- DSOA Dredge and Final Backfill Area
- DSOA Final Backfill Area
- Hydraulic Dredging Conducted (limited area)

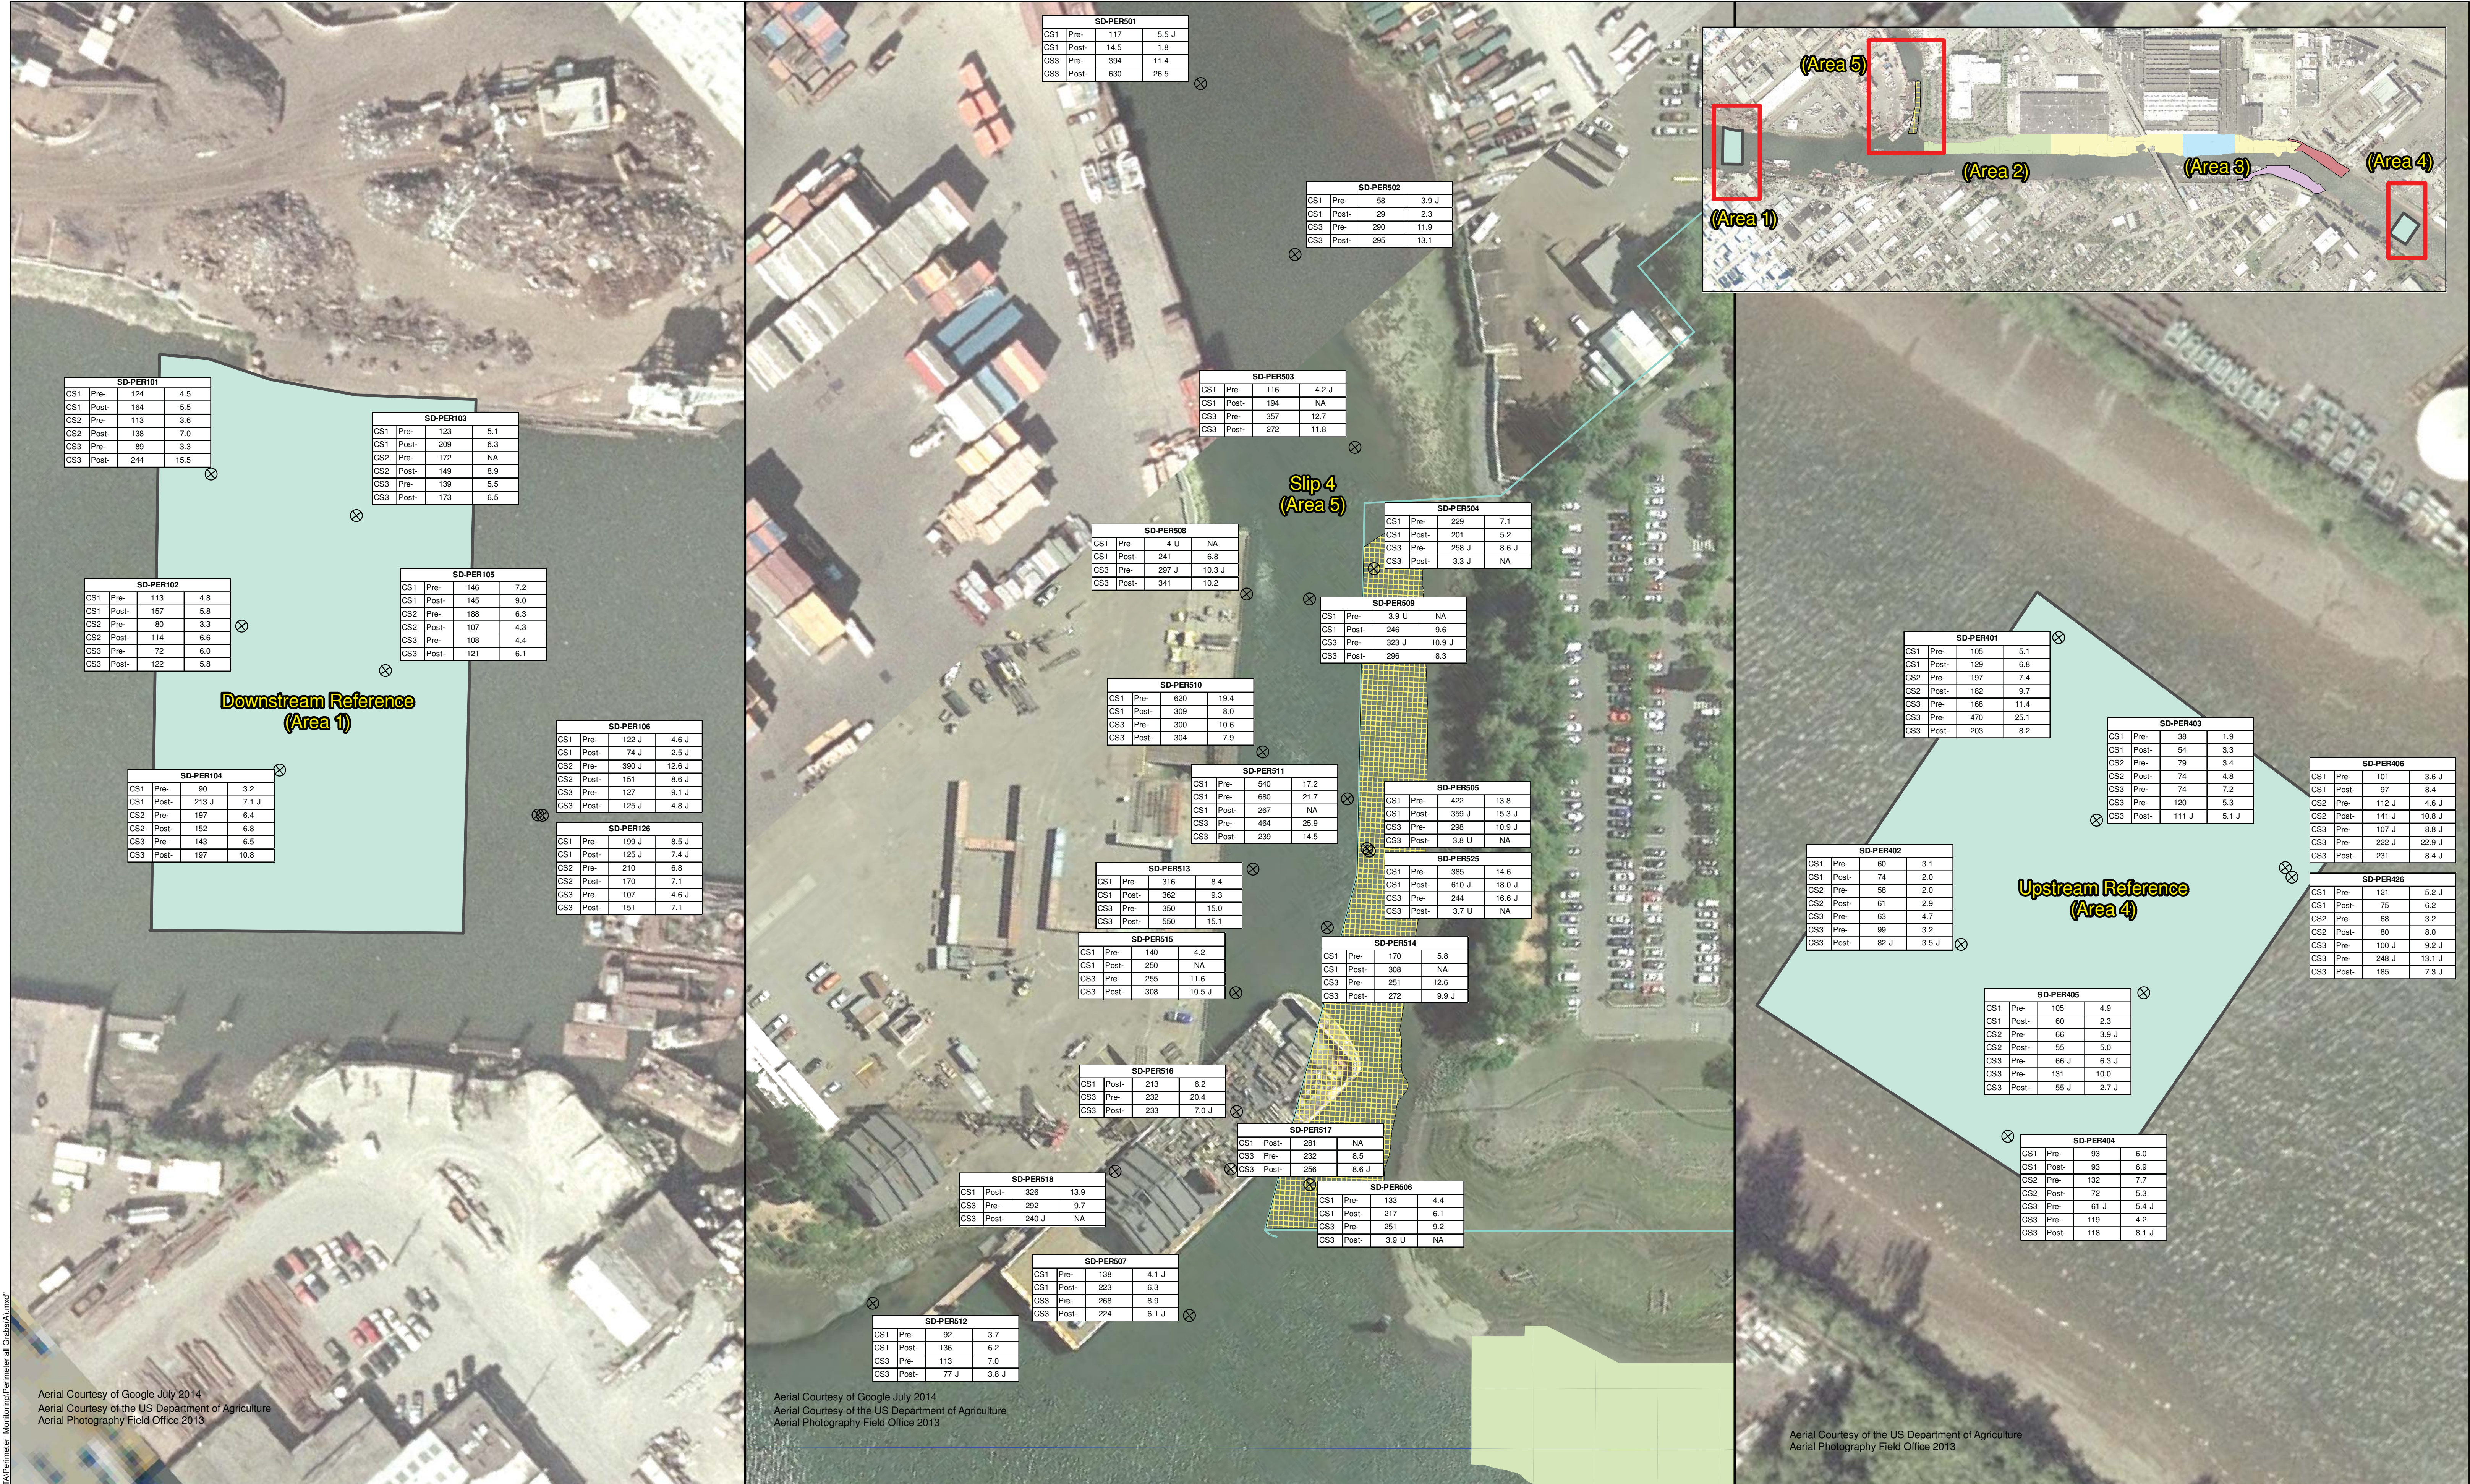
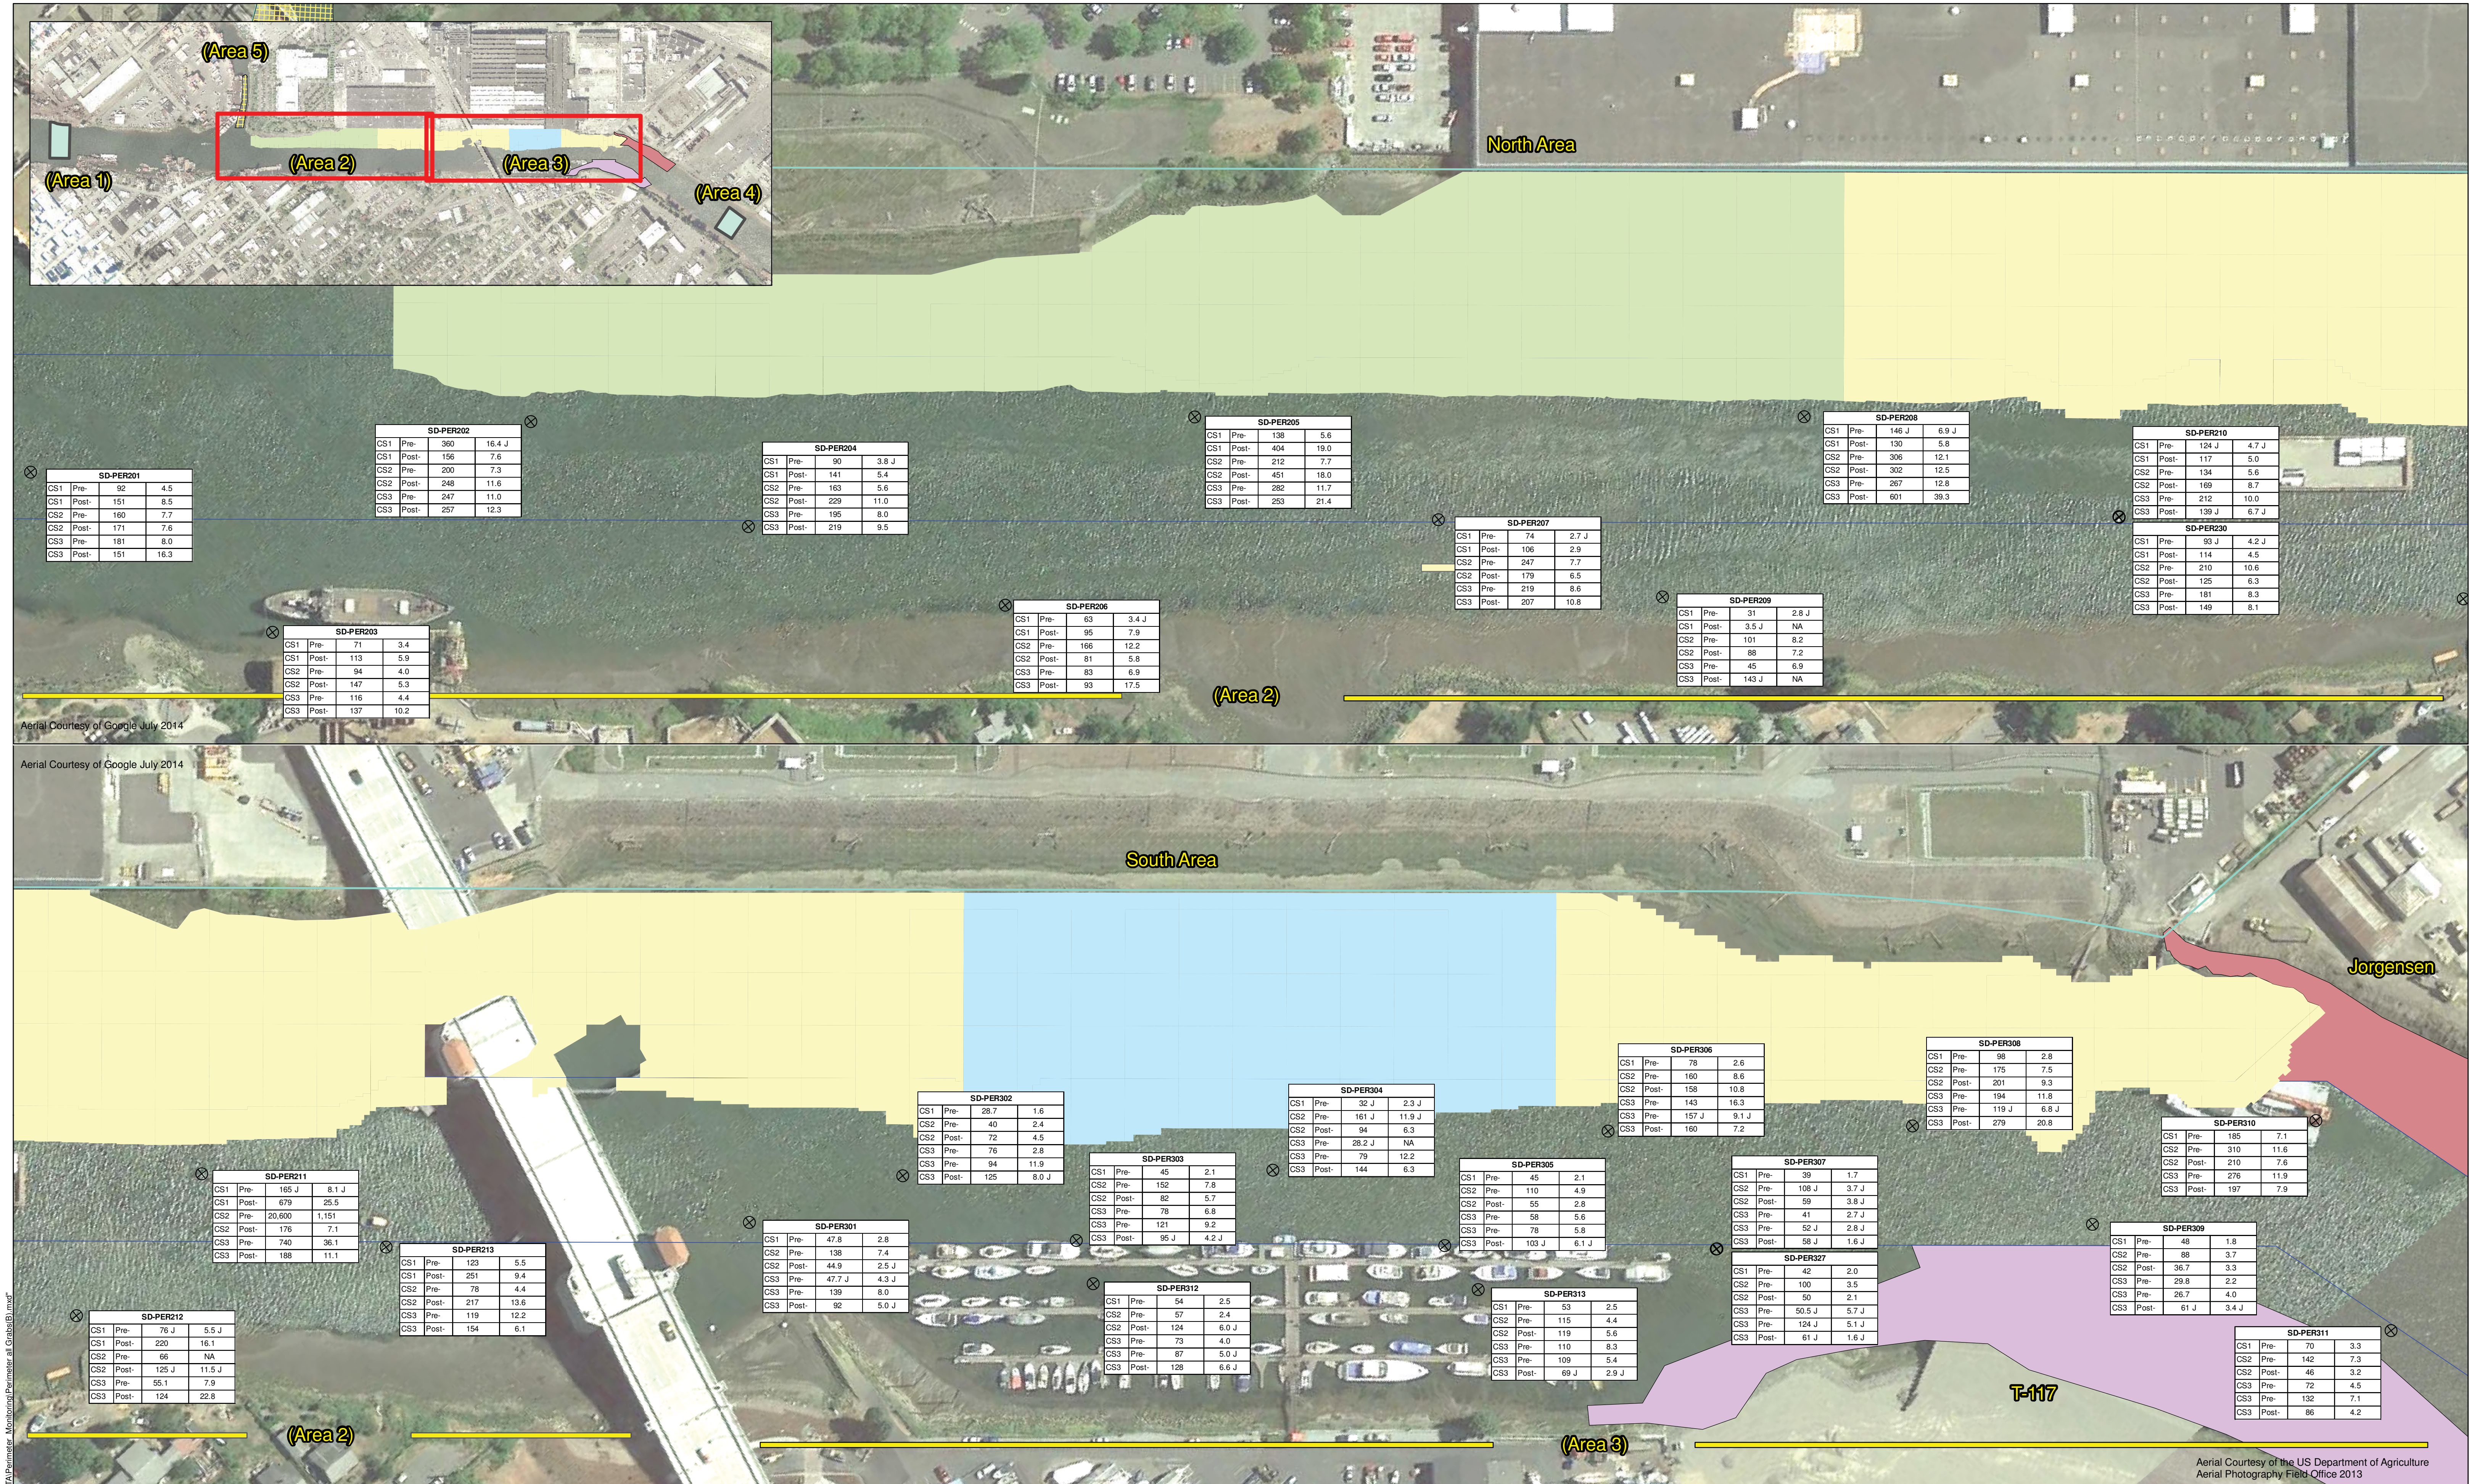
Figure 7b

RESULTS OF PERIMETER MONITORING
PRE- AND POST-CONSTRUCTION CS1 THROUGH CS3
Corrective Measure Implementation Report
Duwamish Sediment Other Area and Southwest
Bank Corrective Measure and Habitat Project,
Boeing Plant 2, Seattle/Tukwila, Washington
