# NONPOINT SOURCE SUCCESS STORY

## Utah

### Partners Work to Reduce Pollutant Loading in Chalk Creek

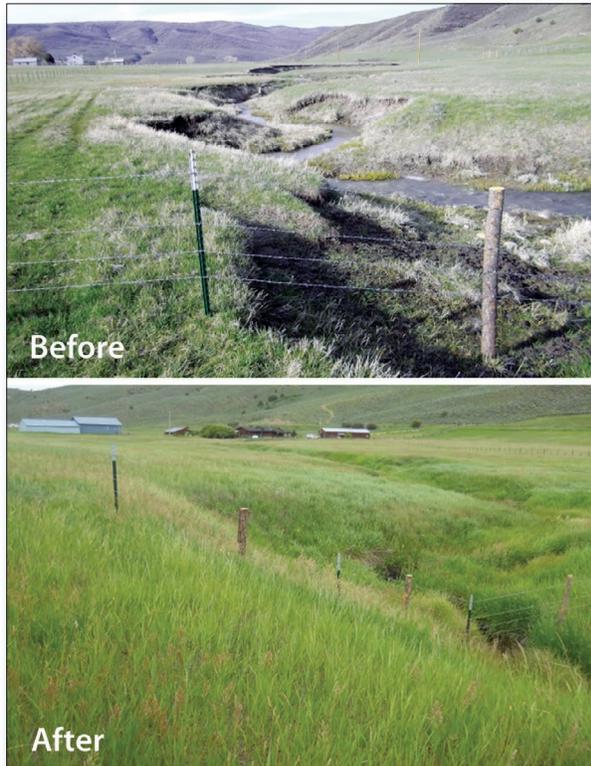
Figure 2. Huff Creek before and after restoration.

In 1990 the Division of Water Quality began funding water quality improvement projects in the Chalk Creek watershed. Implementation has continued through 2017. Since 1990, nearly \$2.5 million in CWA section 319 funding has been spent, resulting in 5.3 miles of stream channel restoration (Figure 2). Grazing management plans have been developed and implemented on over 96,000 acres, which have included reseeding 7,000 acres, adding 2.5 miles of cross fencing, and installing 104 livestock watering facilities, 100 sediment catchment basins and 300 water bars. Other projects included replacing or adding protection on nine bridge sites to reduce erosion, improving 1,200 acres of irrigation, and relocating five animal feeding operations to reduce nutrient loading.
