# PALMERTON ZINC PILE PALMERTON, CARBON COUNTY, PENNSYLVANIA

## Superfund Case Study

### Land Once Barren from Nearby Smelter Becomes Native Prairie

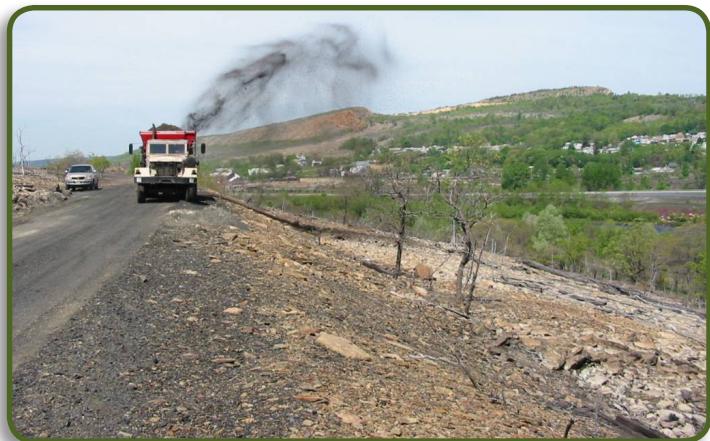
Soil amendments applied using a spreader truck

Full-scale implementation of the revegetation began in 1991. Between 1991 and 1998, approximately 850 acres were revegetated using a spreader truck. The ratio of sludge to ash was 2:1 by volume. The amendment was applied at a rate of approximately 60 dry tons of sludge per acre.

While continuing the revegetation activities, contractors addressed additional challenges using creative methods. Initially, land owned by the responsible parties was revegetated using a spreader truck which required over 60 miles of roads to be constructed. For privately-owned land, a modified agricultural tractor and spreader were used to apply the soil amendment and seed mixture. On

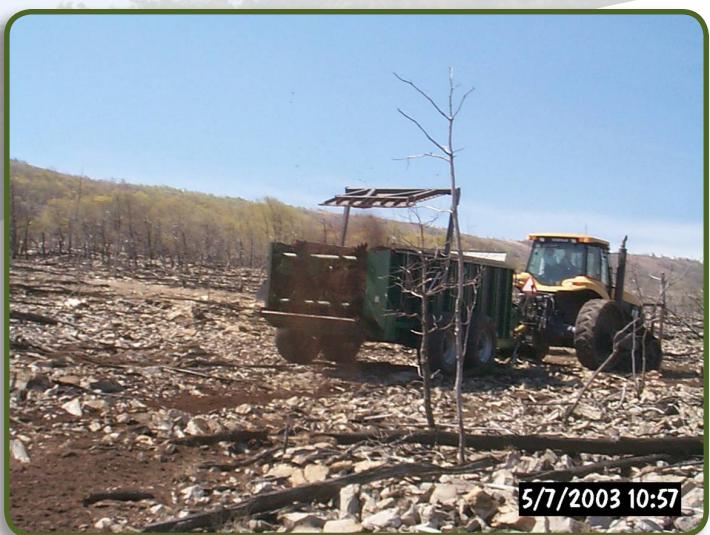
Mushroom compost, fertilizer, lime, and seed mix applied using a tractor/spreader

the Palmerton site continued revegetation activities, but after testing alternatives, replaced the use of sewage sludge in the soil amendment with mushroom compost. In 2005, approximately 40 acres along Stoney Ridge were revegetated using a mixture of mushroom compost, lime, and fertilizer.

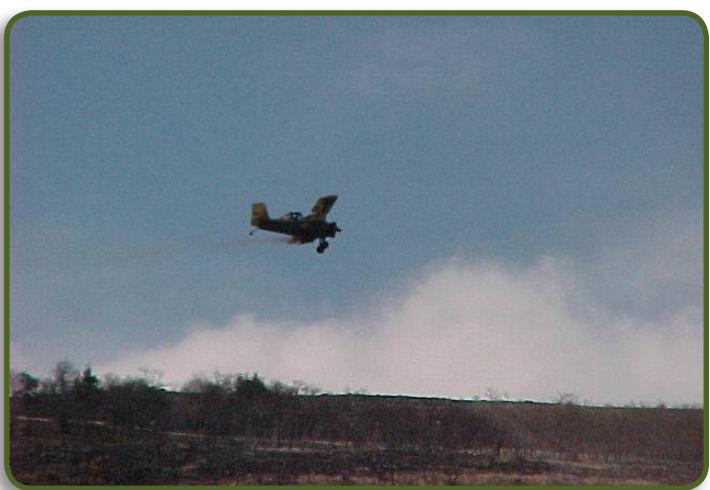
Soil amendment and seed mixture applied using a plane

steep slopes, the seed mixture was applied using a fixed wing crop-duster. This method eliminated the need to build switchback roads throughout the area for truck access to apply the amendments, which saved a considerable amount of money and gave the land a more natural appearance.

4. **Don't discount creative alternatives:** Application methods were modified from land application to aerial application. This less intrusive method eliminated the need for road construction, which significantly decreased costs and resulted in a more natural habitat.

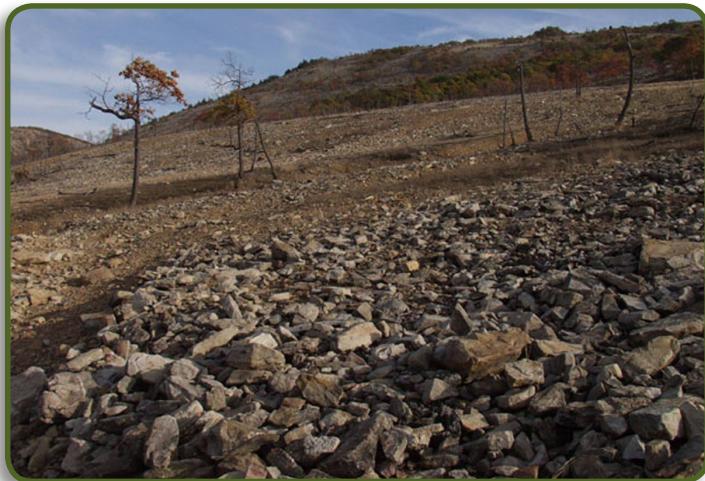
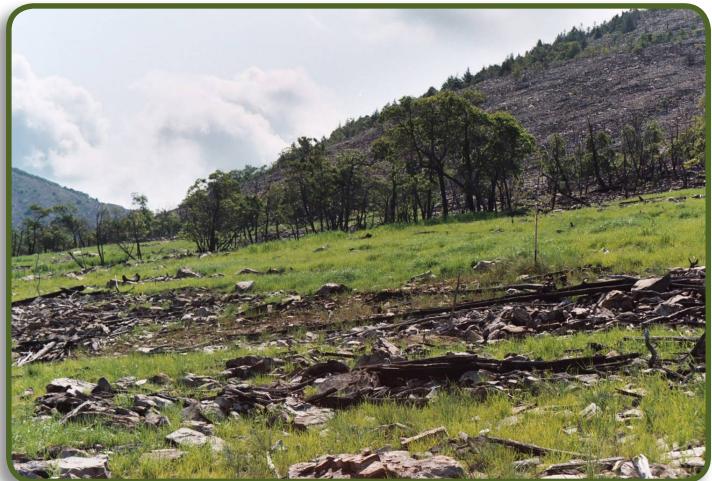
Blue Mountain revitalization in (left) October 2002 and (right) August 2003

The native warm season grasses have become successfully established and have become a thriving prairie habitat for wildlife in the area. Specifically, for over 10 years, the 850 acres reclaimed on Blue Mountain have maintained

more than 70 percent vegetative cover with increasing emergence of volunteer tree species.

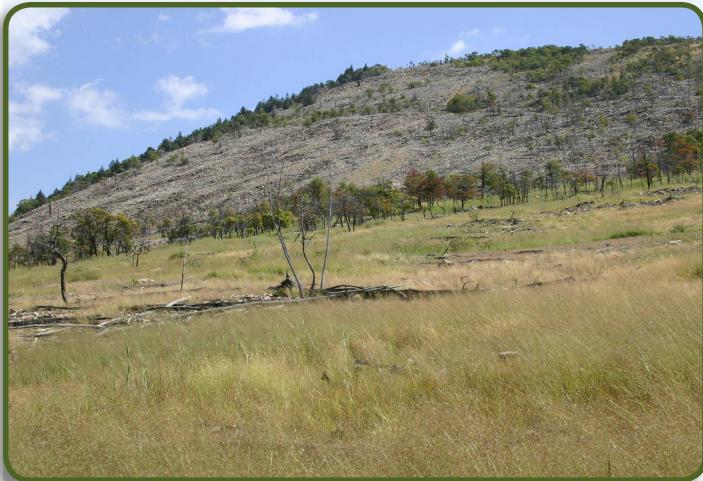
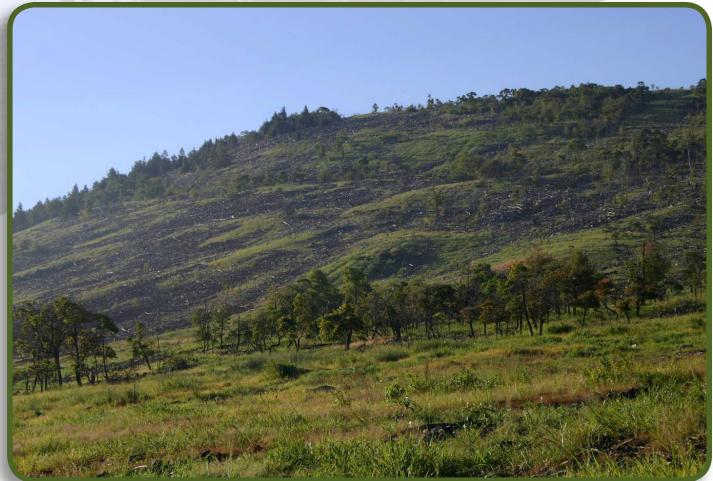
Blue Mountain revitalization in (left) September 2004 and (right) August 2006
