Long-Term Stewardship Assessment Report

Hawkins Point Hazardous Waste Landfill

Assessment Date: March 27, 2018

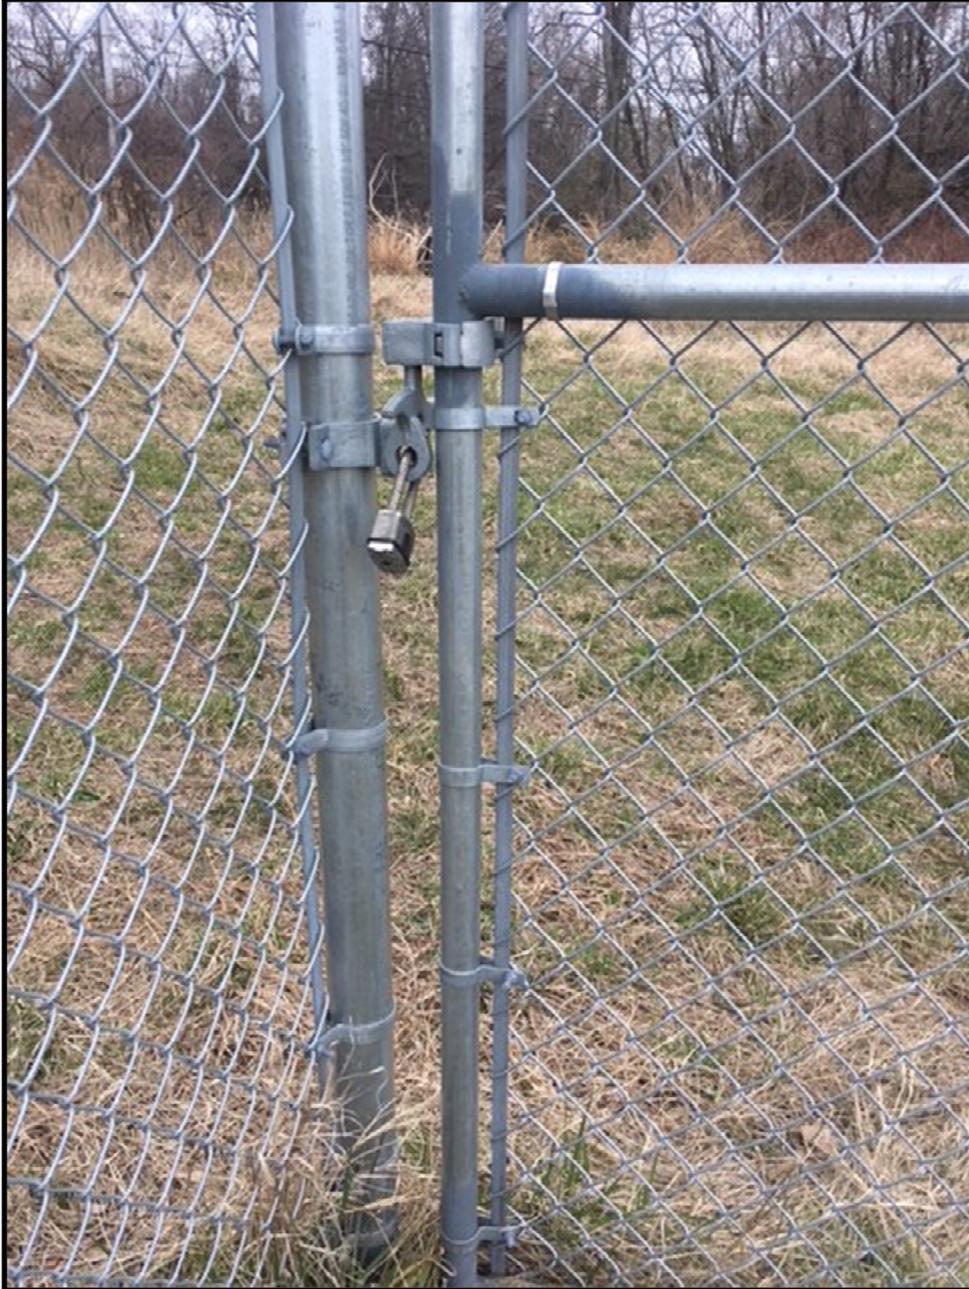
Picture 1: New Padlock on Security Fence

Conclusions and Recommendations: It was recommended to place a new padlock on the North side of the security fence. MES followed up with a picture of the new lock and fence via email on March 27th, 2018. No other EC/IC deficiencies were identified. EPA has determined that the remedy institutional and engineering controls have been fully implemented.

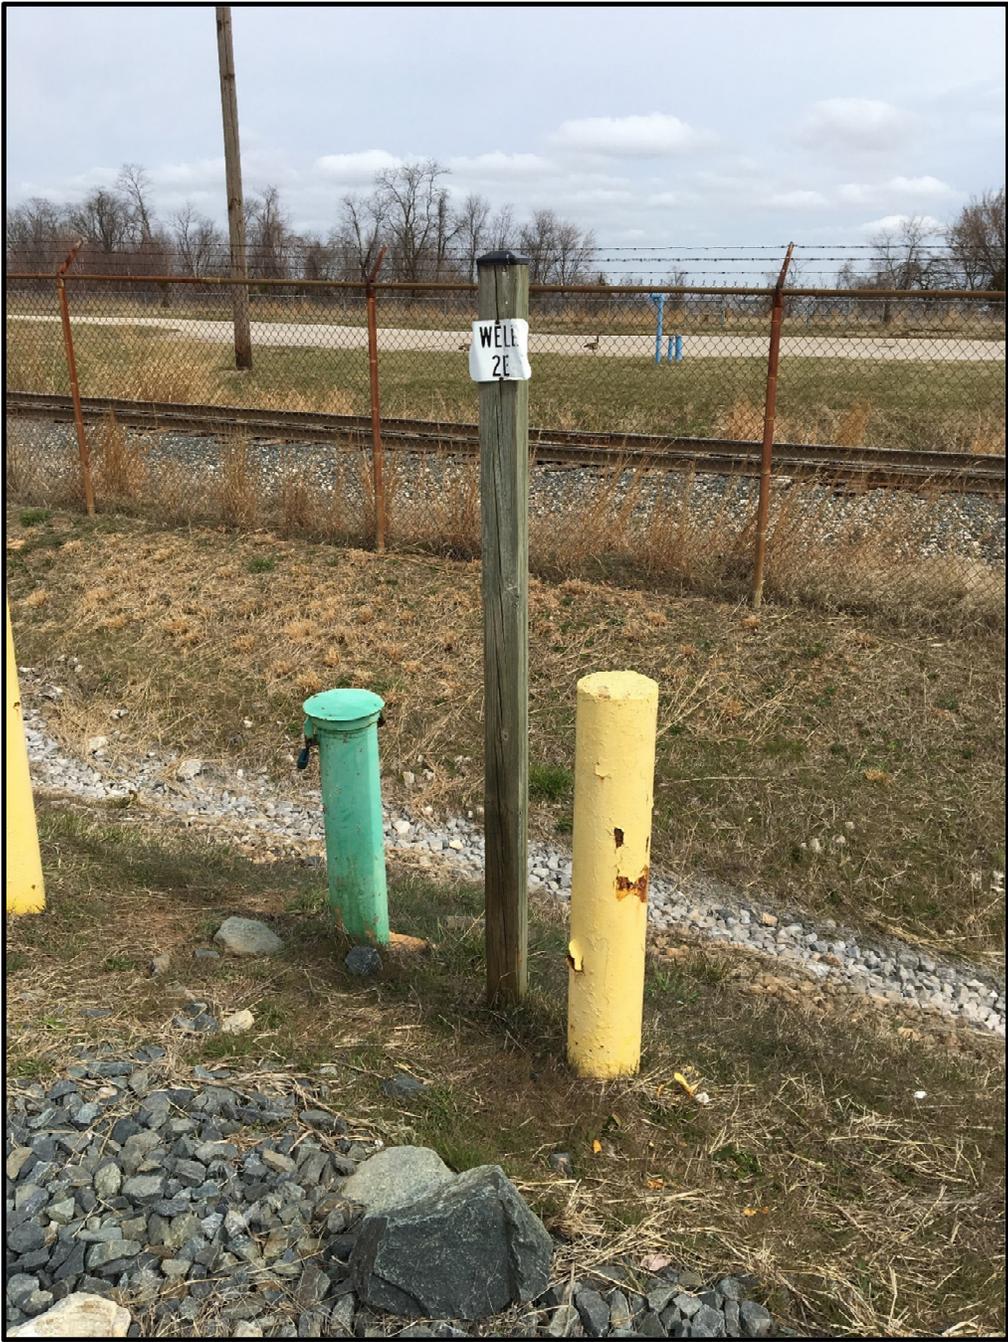
Picture 2: Monitoring Well 2E

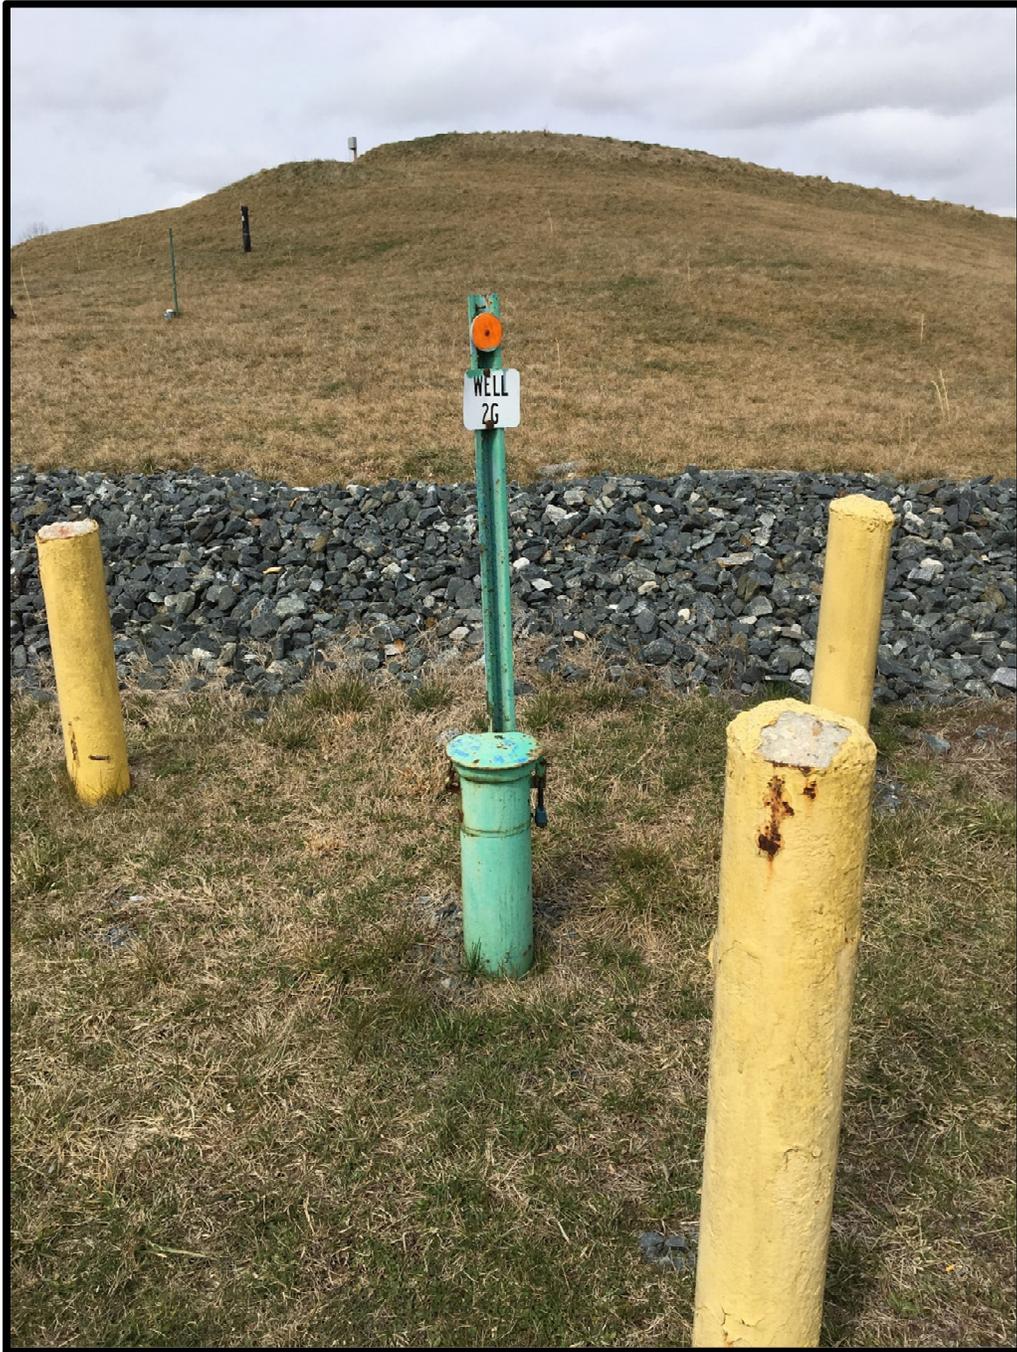
Picture 3: Monitoring Well 2G

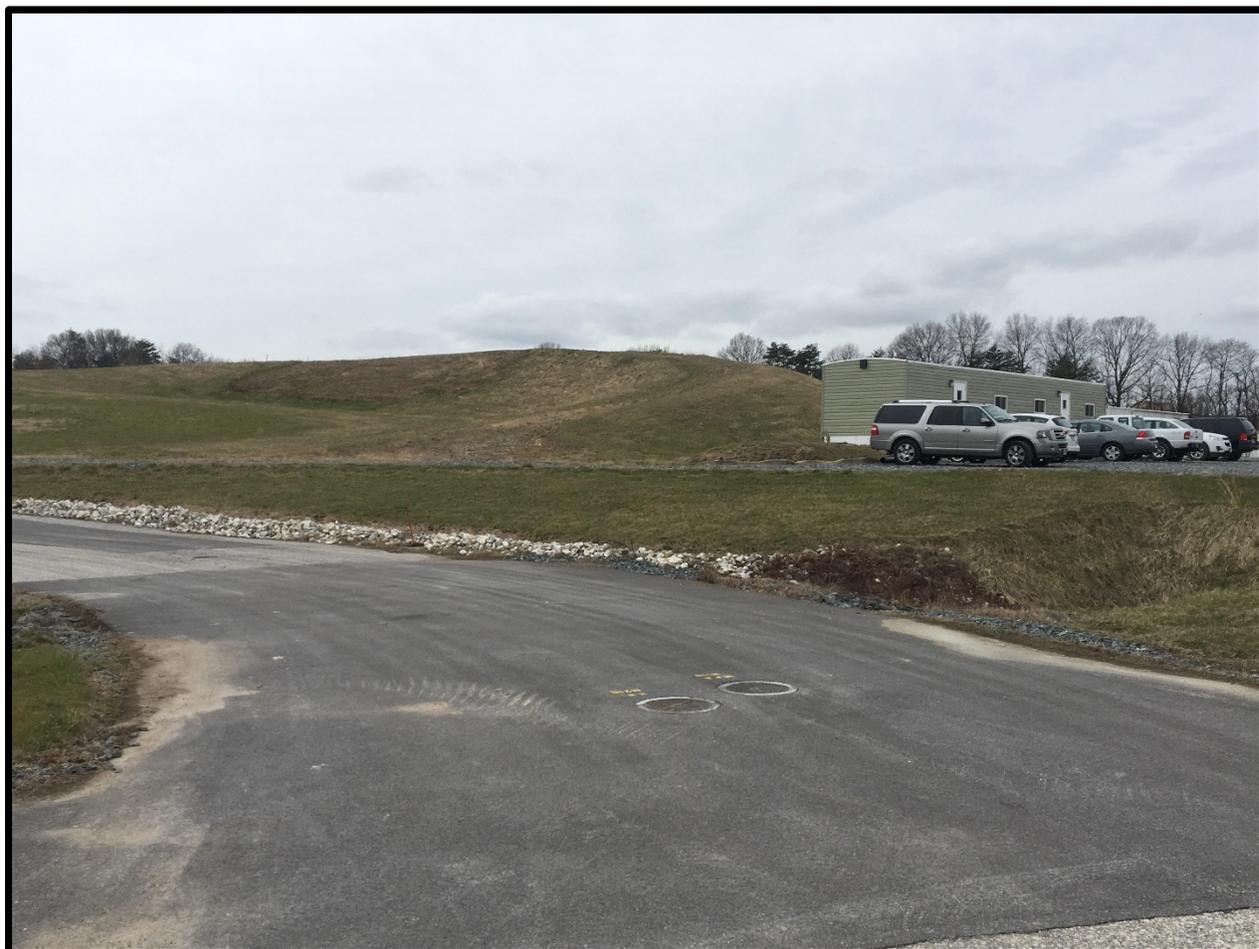
Landfill A Cover: From 1975 to 1979, Areas 2 and 3 (Landfill A) received COPR which was disposed of in three clay-lined cells until its closure in 1980. Landfill A has a vegetative cover and swales which discharge overland surface water flow to Thomas Cove. MES has maintained the integrity and effectiveness of the vegetative cover by mowing regularly. No plants with deeply penetrating root systems or erosion of the cover were observed. Surface water collection swales were also in good condition with no signs of ponding.

Picture 4: Landfill A Area

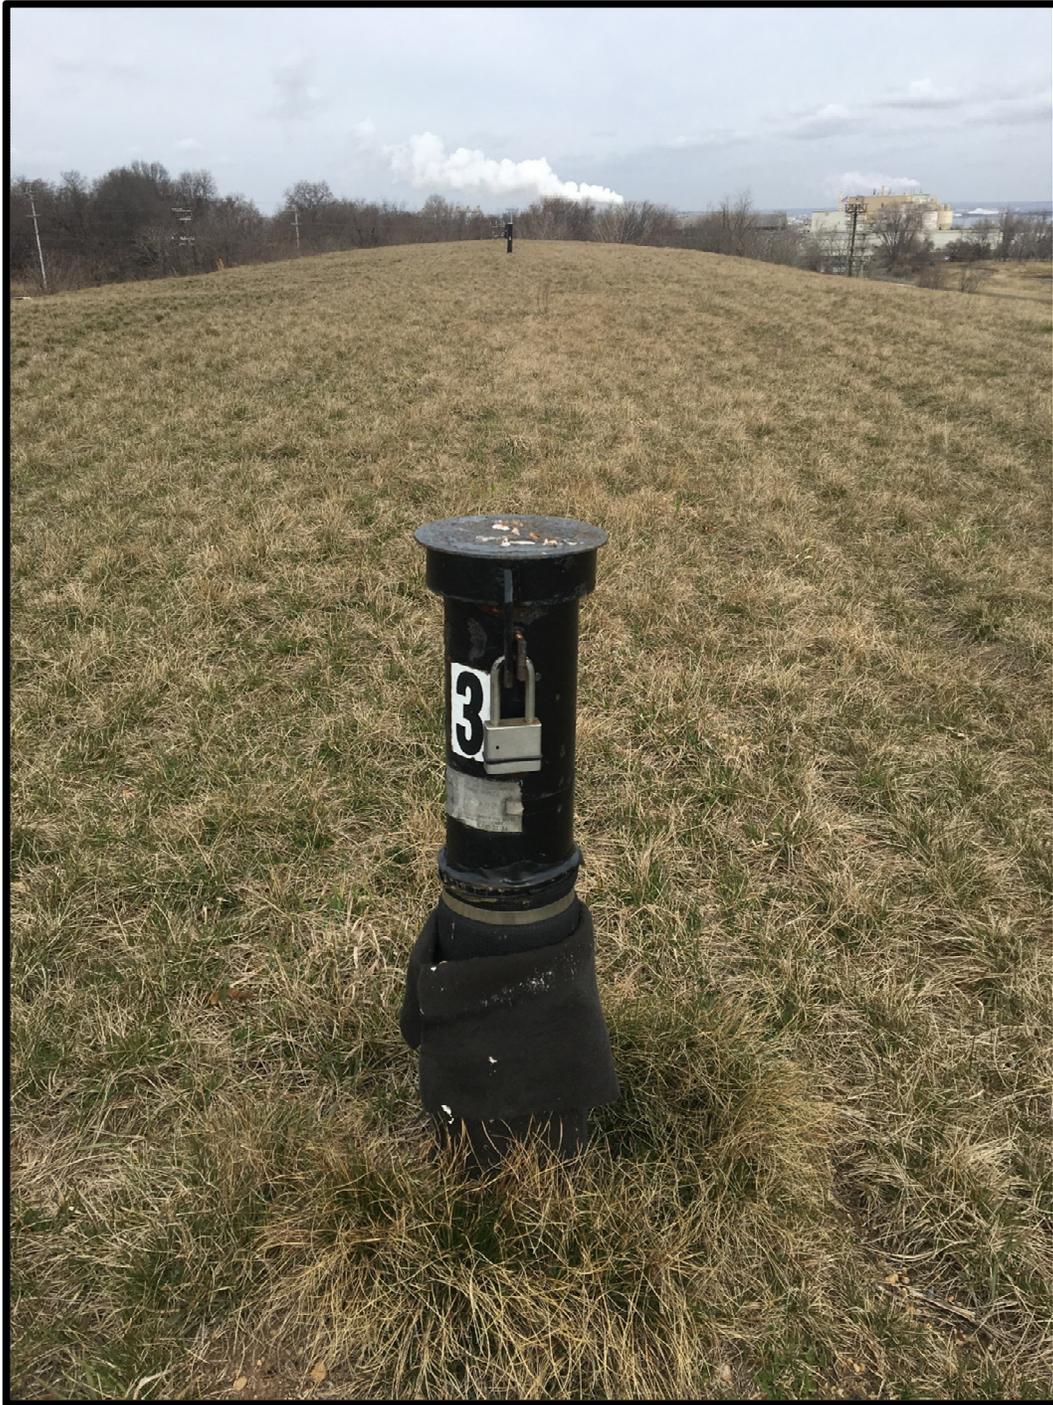
Landfill B Cover: Area 5 (Landfill B), comprised of 10 waste cells, was used for the disposal of approximately 451,450 tons of COPR and demolition debris from the former AlliedSignal, Inc. facility until 1993. MES completed closure activities on May 20, 1994. In August 2015, the existing vegetative cover was replaced with a new geosynthetic cover. As a result, the amount of leachate collected at Landfill B has been significantly reduced. MES has maintained the integrity and effectiveness of the geosynthetic cover. Swales were also in good condition. There were no plants with deeply penetrating root systems or erosion of the cover observed. Surface collection water swales were in good condition. Also, landfill piezometers wells were well maintained.

Picture 5: Top of Landfill B with Piezometer Well

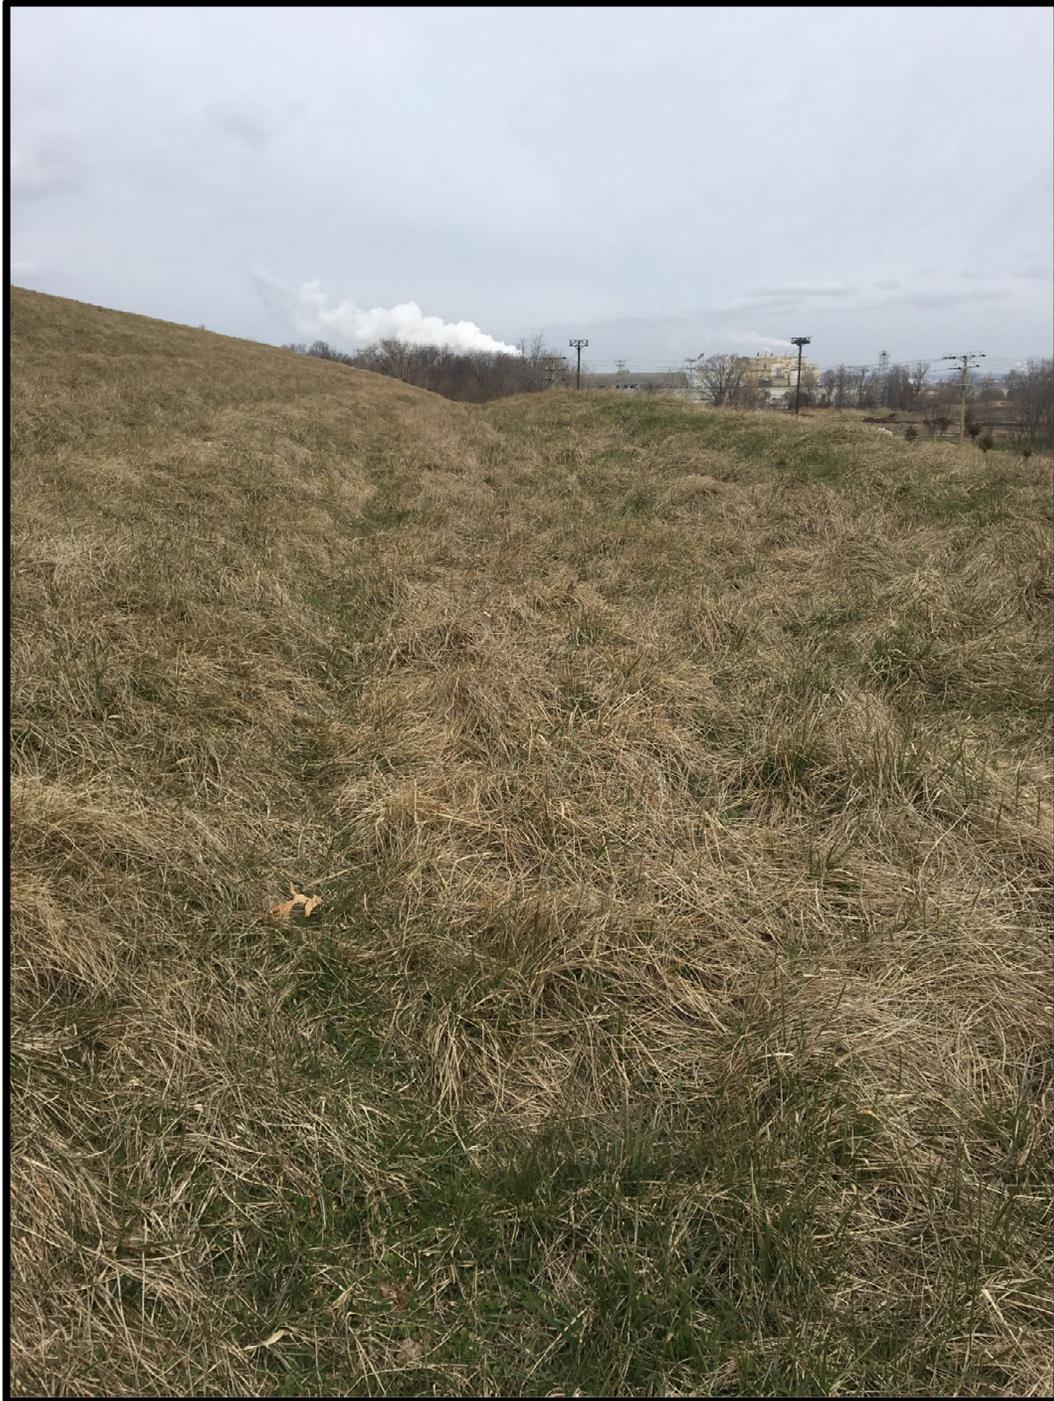
Picture 6: Landfill B East Side Swale
