APPENDIX A

EXPERIMENT-LEVEL REPORTS

Experiment-Specific Reports for Interior Window Replacement #1

Job: Interior window replacement (Low level interior)
City: Pittsburgh
Housing Unit: H16
Experiment #: 41
Interior Phase: Plastic Coverings/Rule Cleaning (Phase I)
Date of work: November 15, 2006

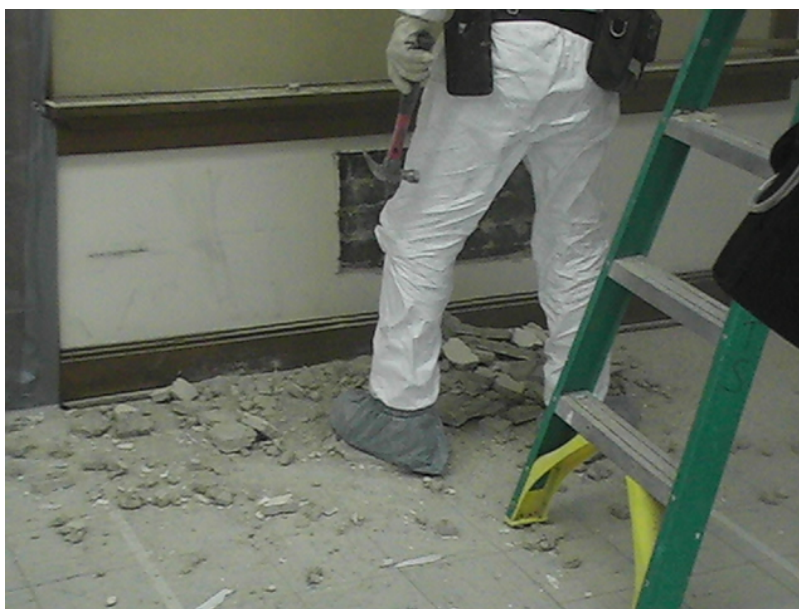
Since the support behind the plaster was masonry, only the plaster was removed during the work, resulting in a cut-out approximately one inch deep. The holes were taped up during the cleaning stage to avoid further contamination by falling debris. An off-duty Columbus police officer was present.

Figure A-1. Wall cut out at school

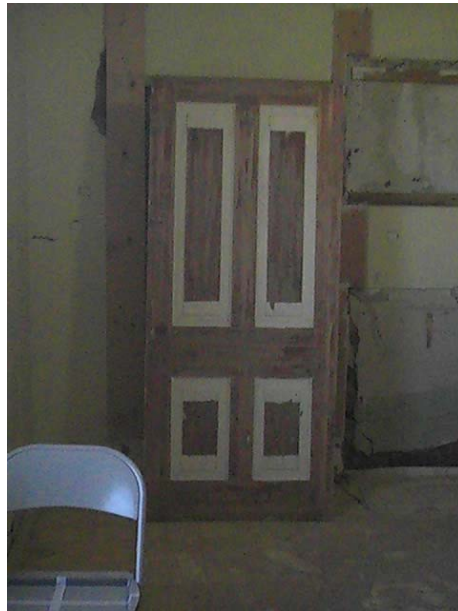
Approximately two linear inches of paint along all inside edges of the door panels (four per door) could not be removed, due to the size and configuration of the planer. Although door planing was classified as a medium level interior job, the process generated tremendous amounts of dust, which settled on all visible surfaces of the Work Room. An off-duty Columbus police officer was present.

Figure A-2. Door with paint removed

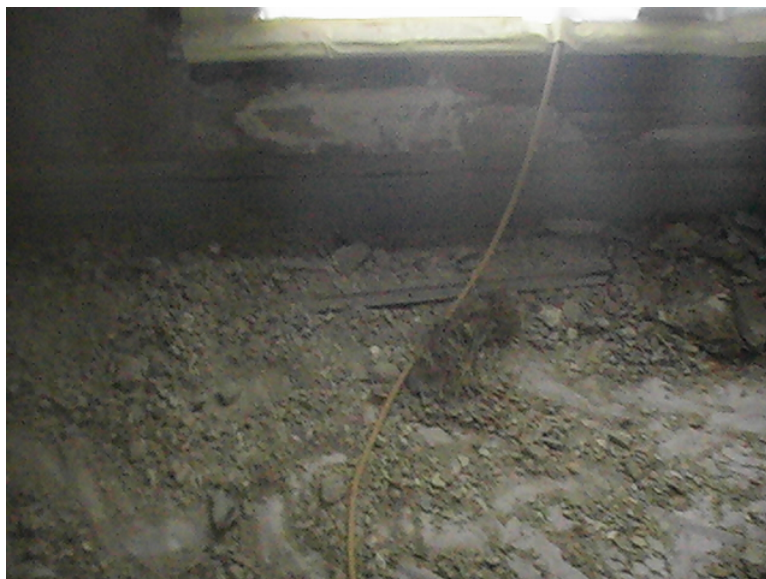
The job presented challenges as the workers attempted to scrape all paint off the wall, which took a long time and resulted in the wall crumbling in places. The workers also thought the plaster wall might contain asbestos. As a result, a plaster sample was obtained and quickly analyzed by a laboratory. When no asbestos was found in the sample, work resumed. Because

Figure A-3. Work room floor following removal of paint

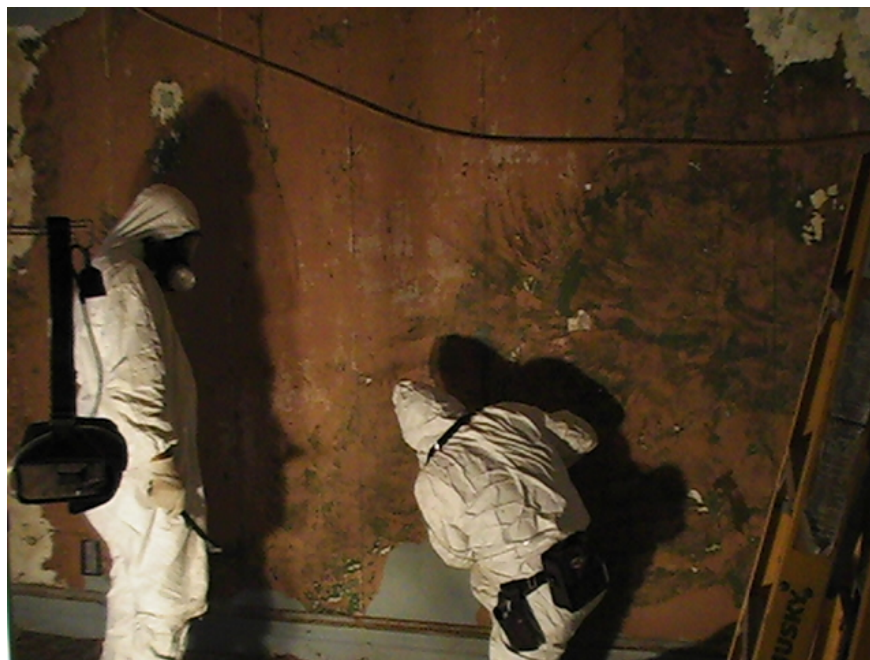
Paint was removed from one wall of a second floor room. Using dry scraping tools, deteriorated paint was removed in preparation for repainting, but not all paint was removed down to the plaster, if intact.

Figure A-4. Dry scraping paint from wall

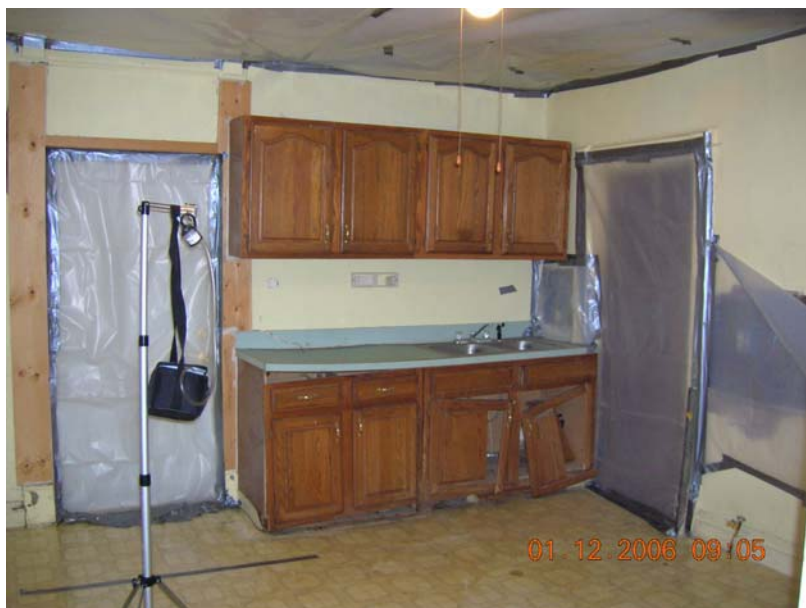
The job included the removal of a counter top, sink and cabinets from a first floor kitchen.

Figure A-5. Kitchen cabinets prior to removal

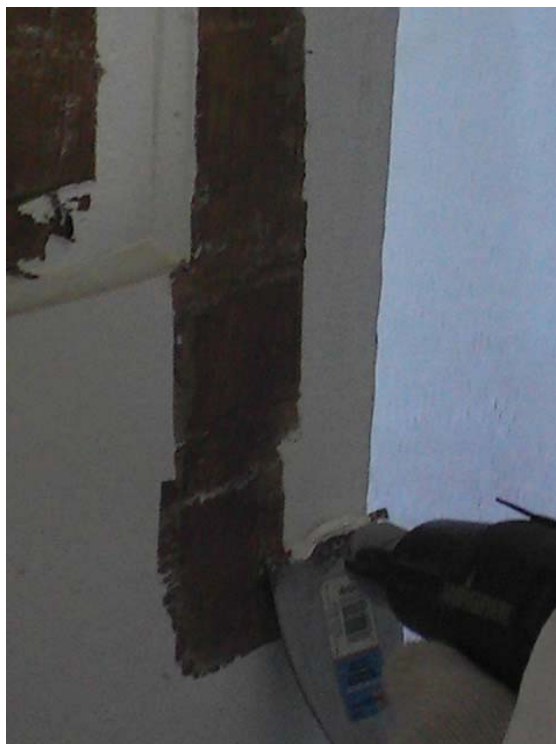
Approximately 53 ft² of paint was removed from the baseboards, window trim, fireplace, and door trim of a second floor bedroom using two heat guns operating at temperatures above 1100°F.

Figure A-6. Using chisel to remove heated paint from door

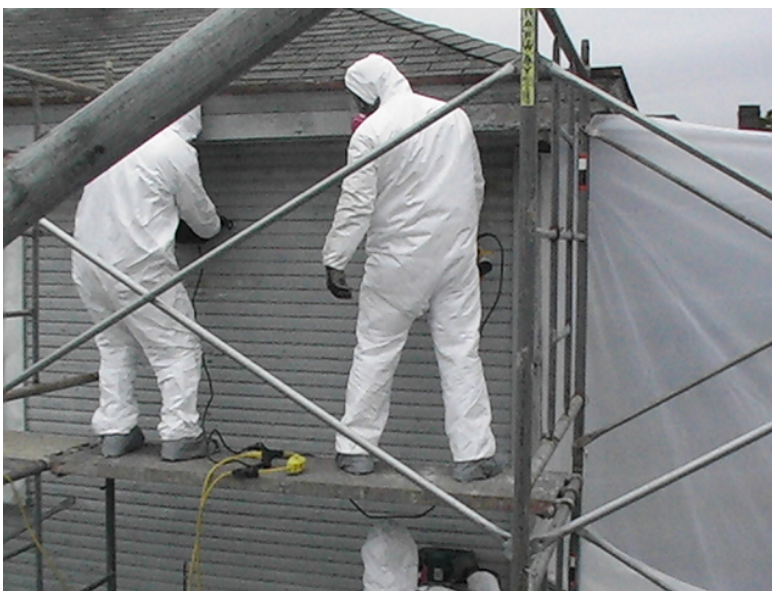
The workers removed deteriorated paint from 100 ft² on a 2-story section of wall at a single family home using power grinders that used metal disks rather than sandpaper. The north wall that they removed paint from was about 20 feet high. The scraping generated a large amount of paint chips and dust throughout the entire containment zone. It took approximately 2 hours to complete the paint removal.

Figure A-7. Power grinding paint from 2nd story wall

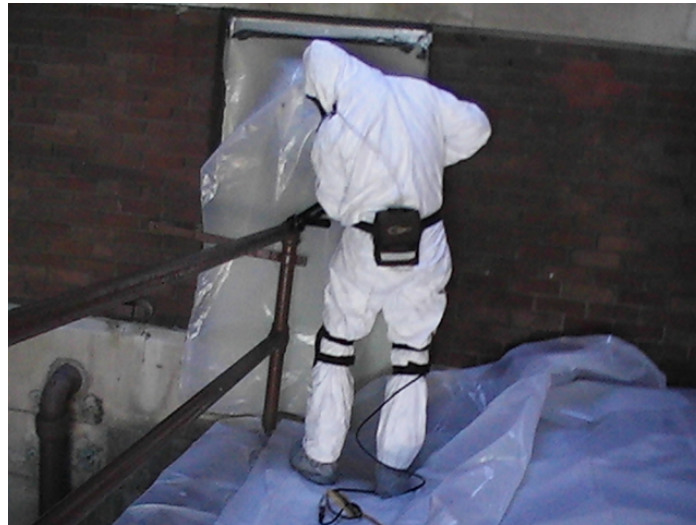
The workers removed deteriorated paint from a metal railing outside a school using a needle gun tool. The railing, located in a courtyard surrounded on three sides by 3-story brick walls, extended about 20 feet from the wall opposite the opening. The railing is set in concrete raised about 1 foot off the ground. One side of the raised concrete was a drop to a set of stairs and a patio about six feet below the base of the railing. The paint removal work took approximately 4 hours to complete.

Figure A-8. Removing paint from railing

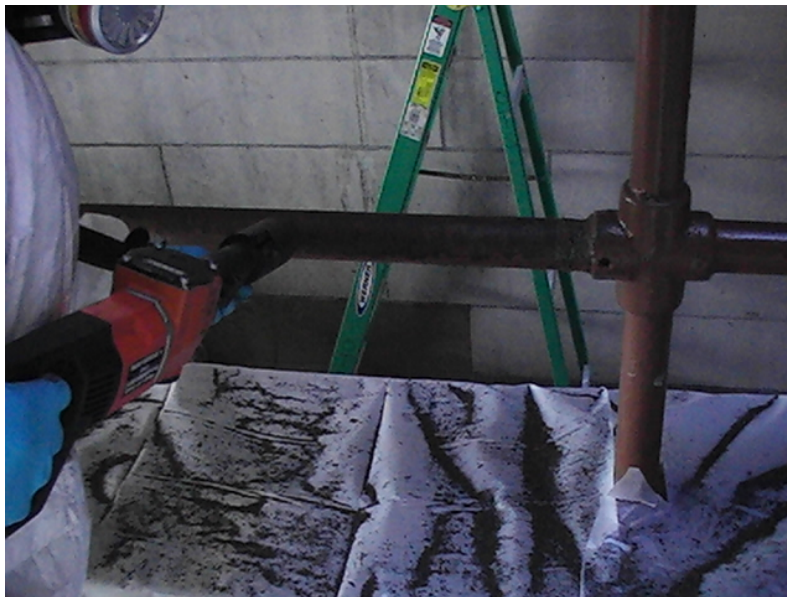
Figure A-9. Close-up of railing paint removal

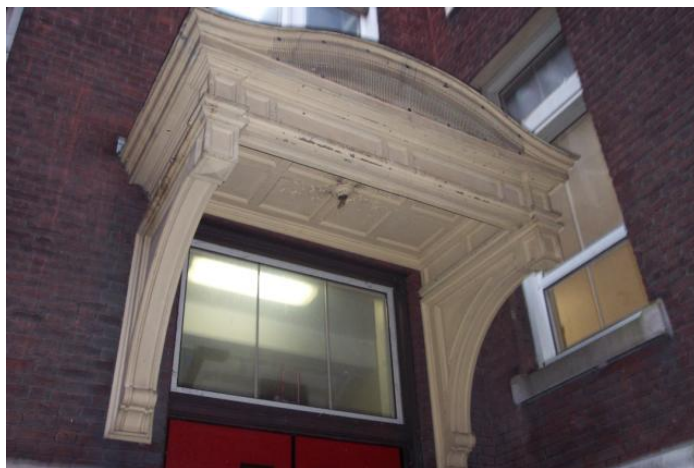
Two workers removed paint from an exterior awning above a doorway outside a school using heat guns above 1100 degrees Fahrenheit. The awning is located in the same courtyard as the other two exterior jobs at the school that is surrounded on three sides by 3-story brick walls. The awning extends about 4 feet from the wall above the doorway. Paint was removed from trim, the ceiling, and the ornate painted supports. Work was halted after approximately five hours of paint removal work even though only about 30 ft² of surface area was worked on.

Figure A-10. Awning prior to work

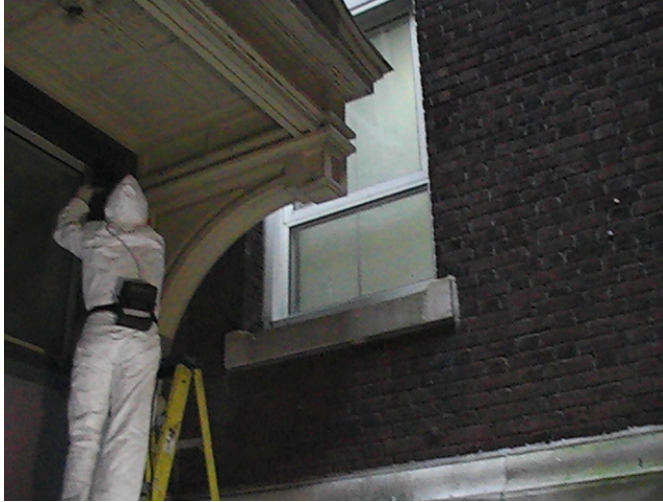
Figure A-11. Removing paint from awning using heat gun

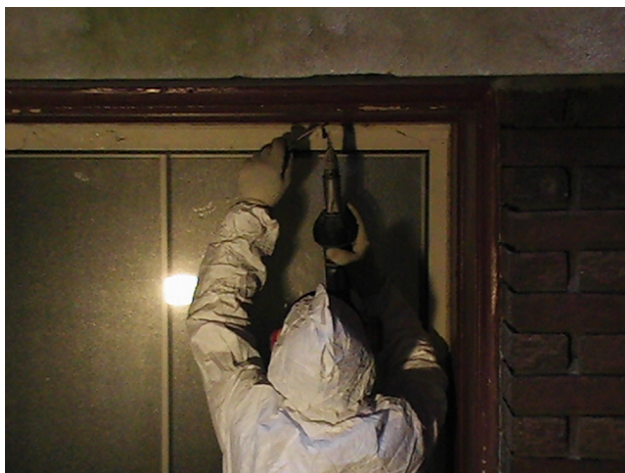
The workers removed paint from all flat surfaces on an exterior door and door casing using heat guns operated at about 1000 degrees Fahrenheit. The door, which opens into the ground level of a closed school, was located at the bottom of a set of stairs. Small areas of paint remained door panels and curved sections of door casing. It took approximately 1 hour and 20 minutes to set up the containment area and 4 hours to complete the paint removal.

Figure A-12. Removing paint from door trim using heat gun

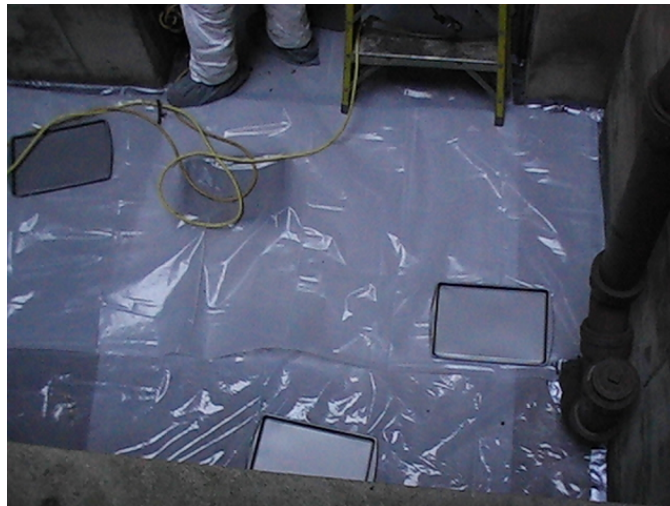
Sample Type	Dust Tray Lead Levels (µg/ft ²)			
	Sample 1	Sample 2	Sample 3	Average
Top Rule Plastic (1-5 ft from door)	130,674,045*	1,133,090*	2,538,052*	44,411,623.2
Under Rule Plastic (2-5 ft from door)	63,283.5	1,840.0	238.6	21,787.4
Outside Rule Plastic (7-8 ft from door)	2,692,069*	26,586.6	16,234.7	911,630.1

Figure A-13. Dust collection trays outside door paint removal job
