Long-Term Stewardship Assessment Report

Cytec Aerospace Materials, Inc.

EPA ID #: MDD003075942

Assessment Date: June 20, 2018

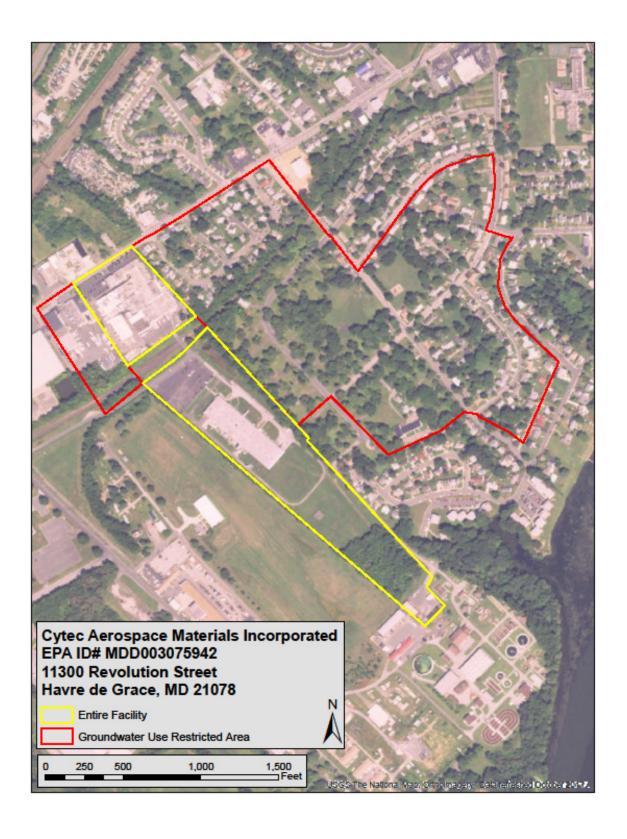
Figure 1: Aerial Map of Cytec Aerospace Materials Incorporated

Permit: The modified Corrective Active Permit is the method for requiring operation of the groundwater pump and treatment system, as a condition of the Statement of Basis and FDRTC. The following ICs apply to the entire Facility, shown on Figure 1:

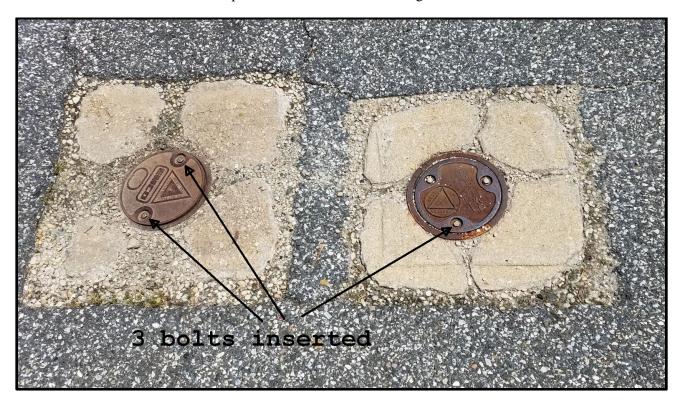
Picture 1: Replacement Bolts on Monitoring Well Covers

<u>Conclusions and Recommendations:</u> No EC/IC deficiencies were identified. EPA recommended to replace three (3) missing bolts from two groundwater monitoring well covers. Cytec followed-up and confirmed replacement bolts were installed. EPA has determined that the remedy institutional and engineering controls have been fully implemented.

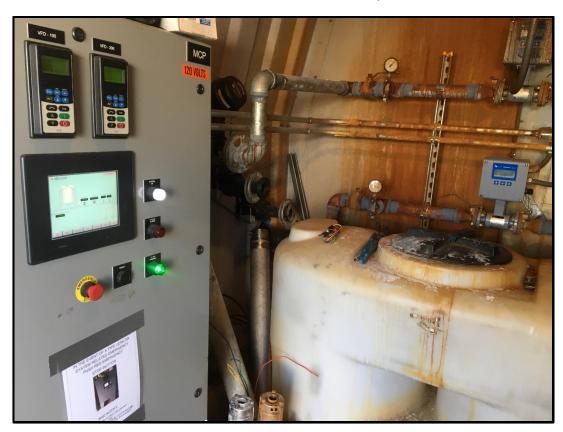
Groundwater Extraction System: In 2001, a groundwater extraction system was installed as an interim measure to control off-site migration of dissolved-phase chlorinated volatile organic compound (VOC) impacts in the immediate and deep overburden groundwater aquifers at the northeastern Property boundary by extracting from former monitoring well MW-10D. In 2014, the system was expanded to include the installation of two additional extraction wells, EW-1 and EW-2, to increase hydraulic control and further reduce the migration of impacted groundwater beyond the Property boundary. Groundwater is currently pumped from each of three extraction wells (EW-1, EW-2 and MW-10D) at specific rates and directly discharged to the POTW. Pumping rates are adjusted to optimize hydraulic control of impacted groundwater, while adhering to the discharge limit requirements of the POTW. The system has operated continuously at a combined rate of approximately 9 to 11 gallons per minute with infrequent, short duration shutdowns for maintenance purposes.

Picture 2: Groundwater Extraction System

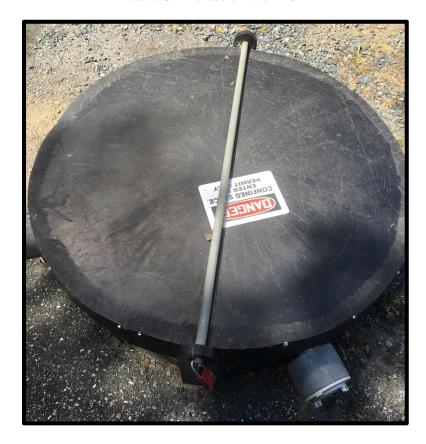
Picture 3: Extraction Well 10-D
