NONPOINT SOURCE SUCCESS STORY

West Virginia

Tuscarora Creek Relocation and Restoration Improves Biodiversity

EPA 841-F-19-001K
March 2019

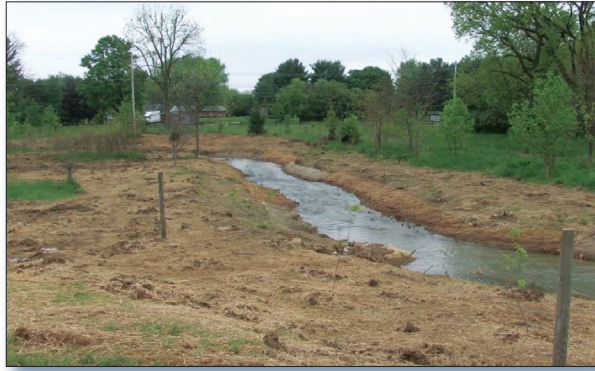
Figure 2. The new stream channel diverts water around a small concrete dam, now buried.

Using CWA section 319 funds, the Canaan Valley Institute (CVI) designed a stream restoration project that adjusted the stream's path to avoid the dam while also approaching the road culvert at a better angle (Figures 2 and 3). The new design added shallow riffles, deep pools, and vegetative bank stabilization to improve the benthic habitat for organisms as well. The project restored 448 feet of natural channel and established 1.5 acres of trees and shrubs. CVI obtained

a grant from National Fish and Wildlife Foundation to implement the dam removal portion of the project. In 2016 a portion of the spillway was removed, the remaining portion of the dam was abandoned and buried in place, and the stream was rerouted to flow around the abandoned dam site.

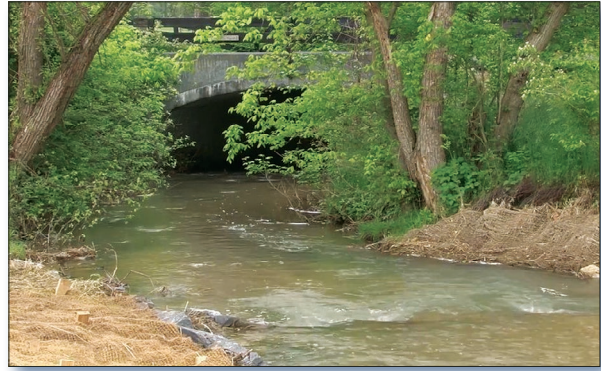
Figure 3. The stream channel was configured to allow water to flow more directly into the culvert.

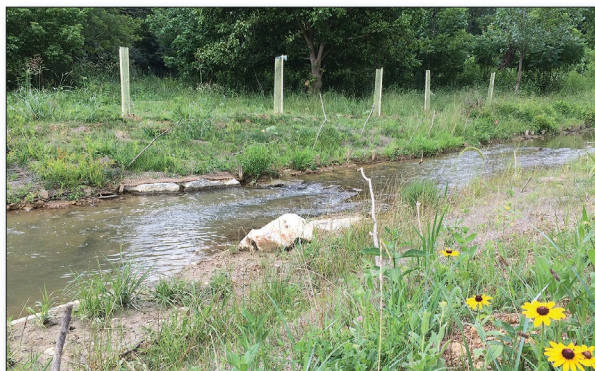
Figure 4. Upper portion of the restored reach.

Native plants in the new riparian buffer along the restored areas flourished quickly after project completion, stabilizing the area (Figures 4 and 5). In September 2017 (one year after the project was completed), DEP collected benthic macroinvertebrates with dip nets from several riffles along the project reach and found that the IBI score has significantly improved. The IBI score recorded on April 23, 2013 (before project implementation) was 31.5 (“poor” integrity). The IBI score recorded on September 12, 2017 (after project implementation), was 57.4 (“marginal” integrity)—a 58 percent increase.

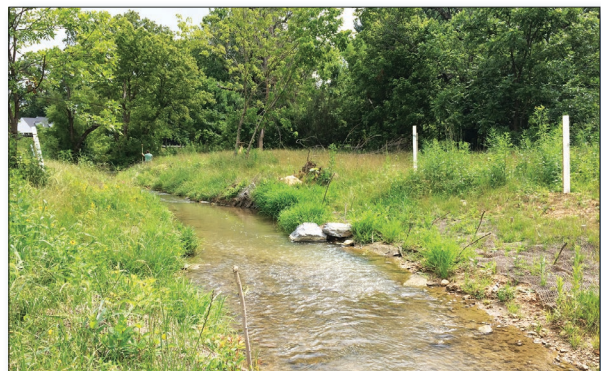
Figure 5. Lower portion of the restored reach.
