**REMEDIAL ACTION CONTRACT 2 FOR  
REMEDIAL, ENFORCEMENT OVERSIGHT, AND  
NON-TIME CRITICAL REMOVAL ACTIVITIES  
IN REGION 5**

**REMEDIAL ACTION REPORT**

**OTTAWA RIVER  
LUCAS COUNTY, OHIO**

Work Assignment No:	146-RARA-1520
Contract No:	EP-S5-06-02
Date Submitted:	September 2011
Prepared by:	SulTRAC
SulTRAC Project Manager:	Jack Brunner
Telephone No:	(312) 201-7788
EPA Work Assignment Manager:	Scott Cieniawski
Telephone No:	(312) 353-9184

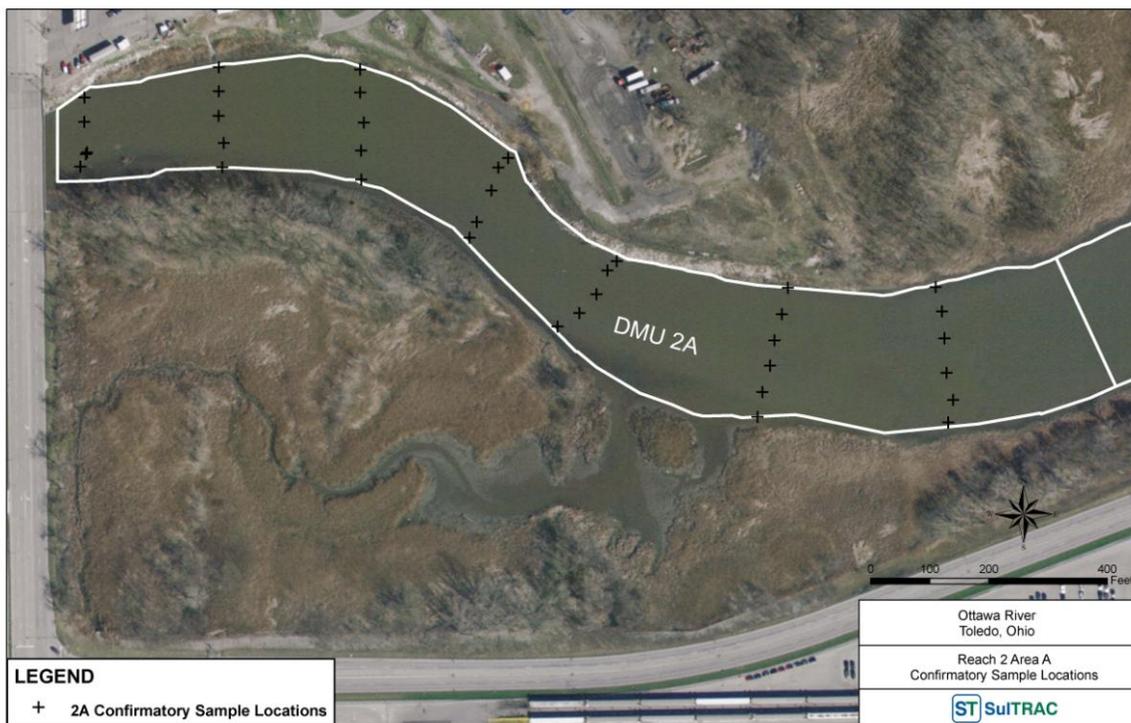
**Figure 3-1. Example Confirmatory Sediment Sample Location Grid**

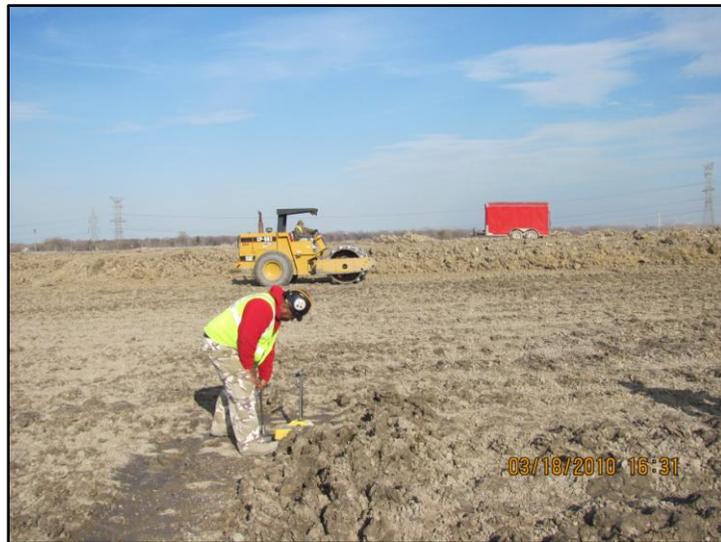
MSG performed construction quality assurance (CQA) testing to ensure the membrane subbase was constructed according to project specifications. MBC surveyed the construction area, and MSG reviewed the survey data to ensure establishment and maintenance of proper lines and grades for the dewatering pad construction. MBC placed the soil material in 8-inch-maximum loose lifts, graded the lifts, and compacted each lift. Project specifications required testing at a minimum frequency of 5 tests/lift/acre. Actual testing frequency was 5.2 tests per lift per acre. Testing results presented in Appendix G of the Construction Quality Assurance Report by MSG (MSG 2010a) indicate achievement throughout the subbase area of project specifications of compaction to at least 85% of the maximum dry density, as determined by the Modified Proctor, test method ASTM D 1557. If a field test indicated the compaction criterion had not been met, MBC re-worked the area and MSG retested it. All areas initially failing to meet the minimum compaction criterion subsequently met the compaction criterion after having been reworked.

**Photo 3-1. Earthwork and Compaction Testing at Non-TSCA Dewatering Pad**

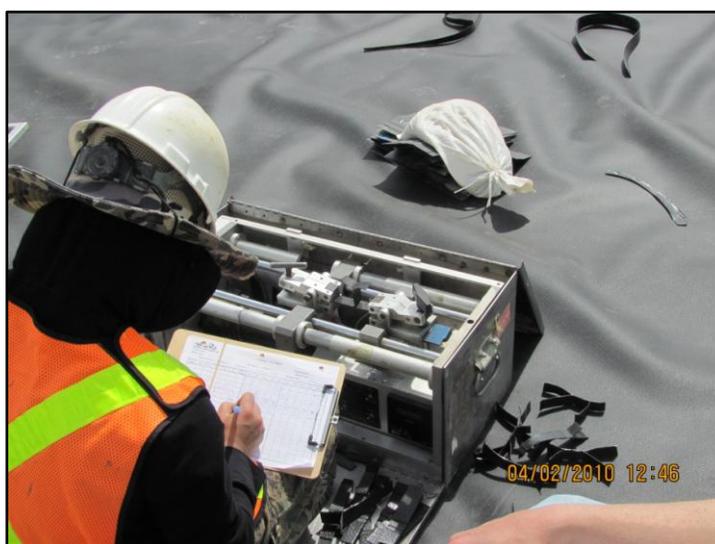
Destructive testing occurred at representative fusion seam locations at a frequency of approximately one test per 690 feet of seam for the non-TSCA dewatering pad, and approximately one test per 813 feet of seam for the TSCA dewatering pad—exceeding the project specifications of one test per 1000 feet of seam. Destructive seam testing is utilized to ensure seam quality during the LLDPE geomembrane layer installation for the dewatering pads. No deficiencies were detected during destructive seam testing.

**Photo 3-2. Destructive QC Testing of Geomembrane at Non-TSCA Dewatering Pad**

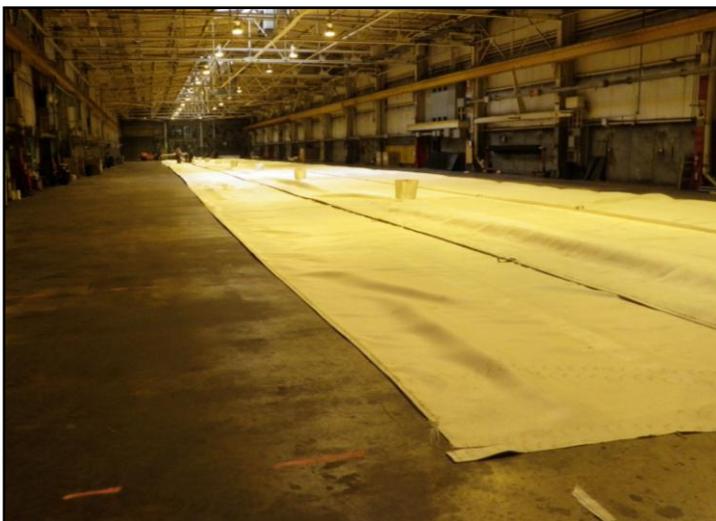
Photo 3-3. Construction of Geotextile Tube

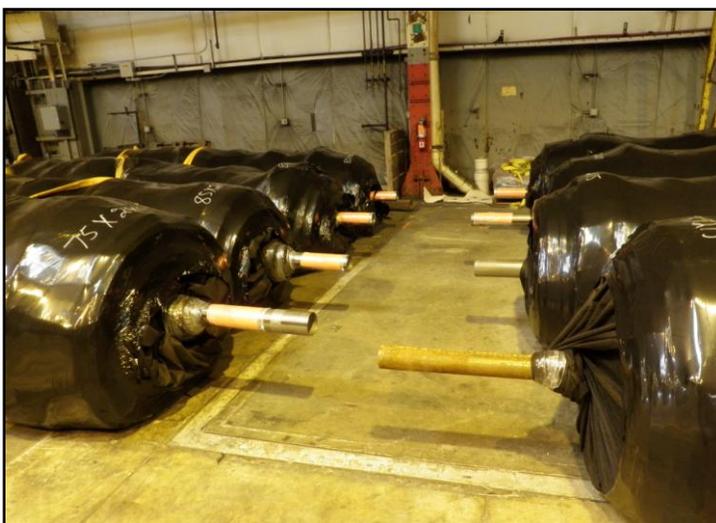
Photo 3-4. Geotextile Tubes Ready to be Shipped to Site

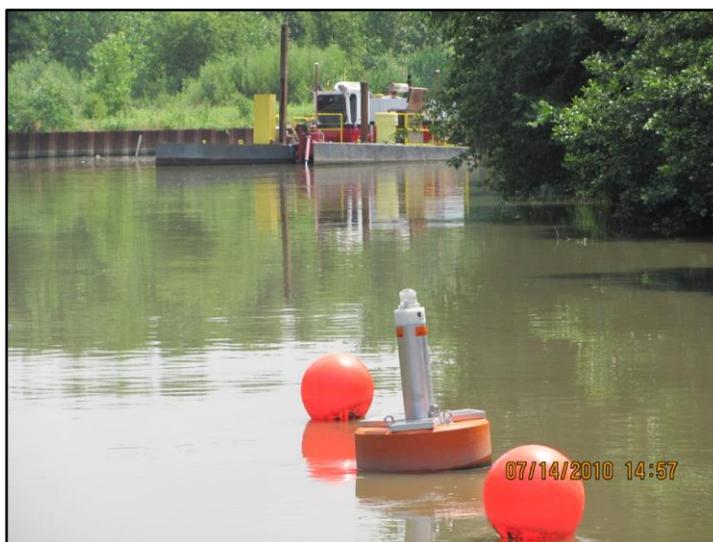
**Photo 3-5. Turbidity Monitoring Station**

turbidity trends and evaluate situations as necessary. Monitoring stations were cleaned and calibrated approximately every 10 days; however, more frequent cleaning was required in the summer months when warm water temperatures and stagnant conditions caused significant biological growth on the buoys and sensors.

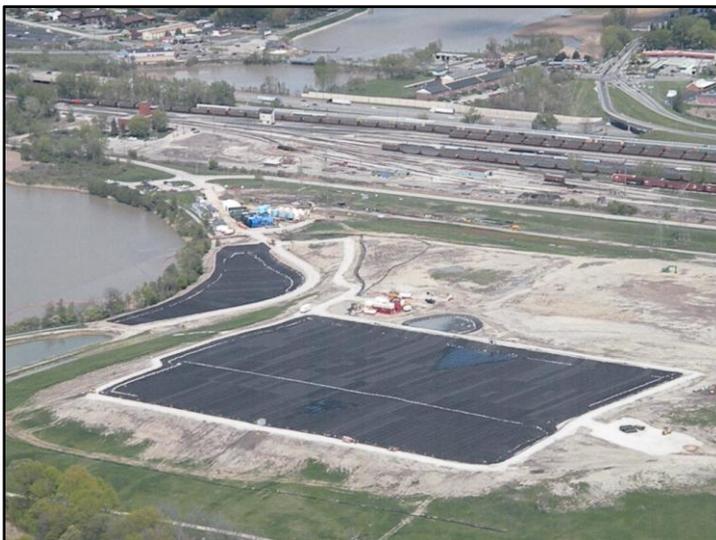
**4-1. Completed Non-TSCA and TSCA Dewatering Pads**

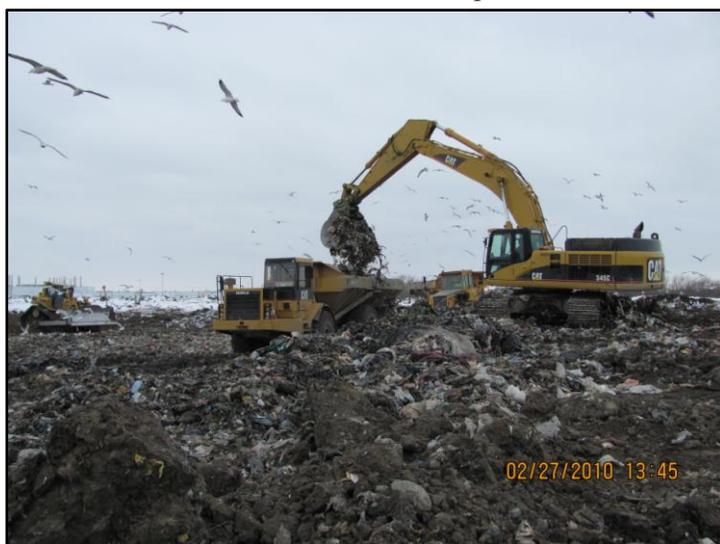
Construction of the 10-acre (TSCA) and 2-acre (non-TSCA) dewatering pads began in February 2010 and proceeded in the following manner. The first step was for MBC to strip the existing 12 inches of intermediate cover soils from the municipal waste in the non-TSCA cell and relocate it on site at the HRLF. MBC removed and relocated municipal waste in order to bring the non-TSCA pad to grade. The intermediate cover soil was then re-used to cover the relocated municipal waste. To address the cases of less than 12-inch cover on the municipal waste, MBC used approximately 6,500 CY of on-site soil to

**Photo 4-2. Municipal Waste Relocation at Non-TSCA Dewatering Pad**

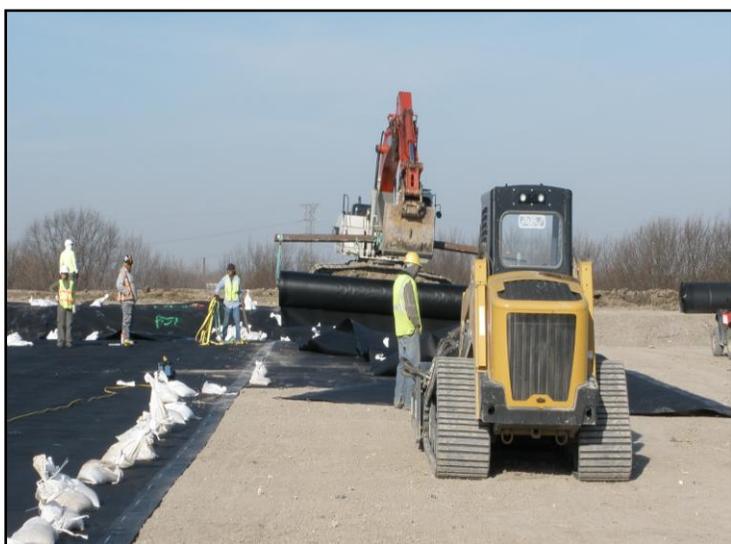
with a spreader bar attachment which remained stationary on the top of the slopes, and a 4-wheeler which pulled the geomembrane into place. Final positioning of the panels was done by hand and included overlapping the panels a minimum of 4 inches to allow for seaming. Photo 4-3 shows the LLDPE line being pulled into place in the non-TSCA dewatering pad.

**Photo 4-3. LLDPE Liner Installation in Non-TSCA Dewatering Pad**

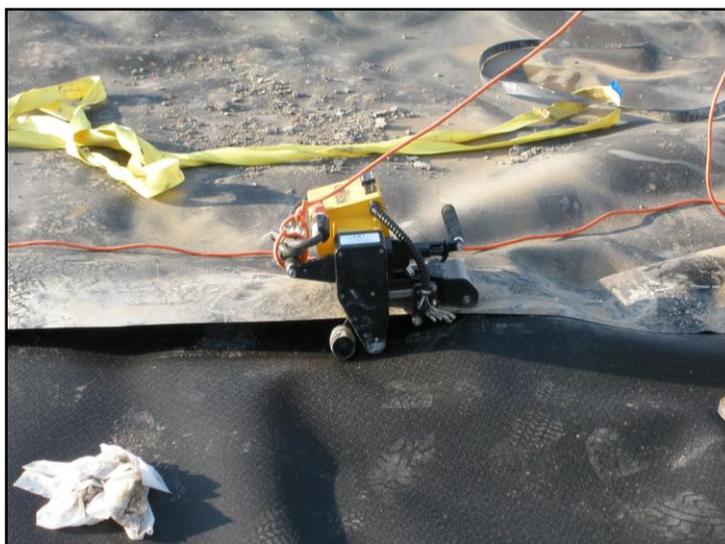
Installation of the LLDPE barrier layer during construction of the dewatering pad involved field welding using specialized welding equipment including a hot wedge welder and an extrusion welder. The hot dual wedge welder was primarily used for long geomembrane panel-to-panel welding and large repair areas, as it is best suited for relatively straight-line seaming (see Photo 4-4). For that reason, the majority of field seams were produced by the hot wedge welder. Typically, the extrusion welder was used for small repairs (patches), mild surface damage repairs, repairs to deficient hot wedge seams, and in restrictive locations. As mentioned in Section 3.2, during LLDPE geomembrane installation, CQC conducted destructive and non-destructive testing of the geomembrane and its seams.

**Photo 4-4. Hot Dual Wedge Welding of LLDPE Liner Panels**

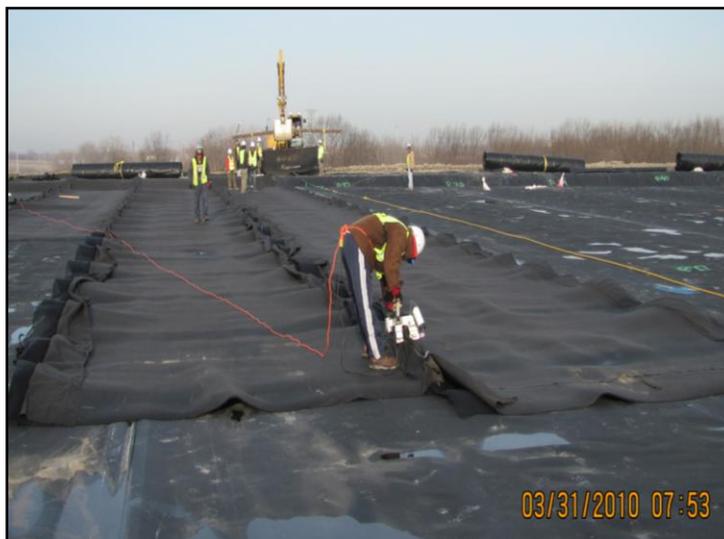
A geocomposite drainage layer was installed over the 40 mil LLDPE liner to assist with drainage in the dewatering pads (see Photo 4-5). The geocomposite layer was deployed in the same manner as the geomembrane. The geocomposite was positioned with a minimum of 4-inch overlap. The overlaps were joined by tying the geonet structure with cable ties. Plastic ties were used at 5-foot intervals in the direction of the roll

length and at 2-foot intervals across the end of the panel to tie the drainage net panels. The geotextile flaps of the adjacent panels were sewn together. Adjoining geocomposite rolls (end to end) across the roll width were shingled down in the direction of the slope, with the geonet portion of the top overlapping the geonet portion of the bottom geocomposite a minimum of 12 inches across the roll width.

**Photo 4-5. Sewing Geocomposite Layer**

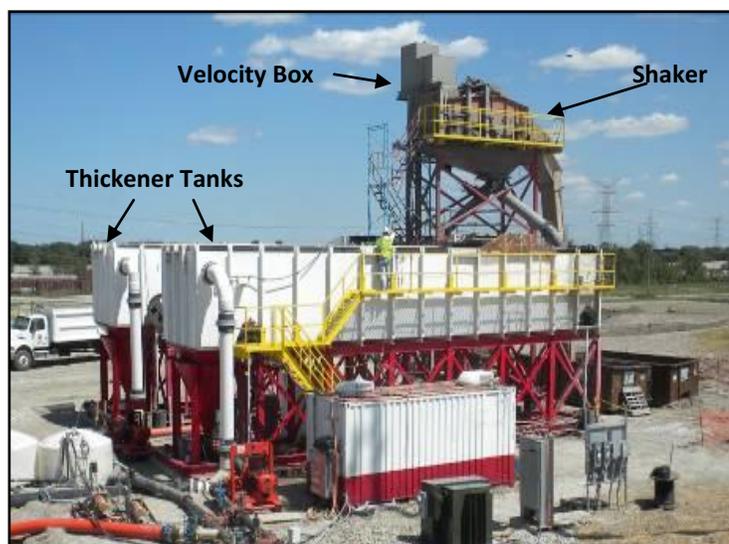
The non-TSCA dredge slurry was pumped to the velocity box above the shaker screen, where material 2 inches in size or greater was stripped off, allowing the slurry to be routed into one of the two thickener units. The material stripped prior to the thickener units fell into roll-off dumpsters, which were emptied at HRLF. The clear water removed from the thickeners using a weir system was routed directly to the WTP, while the thickened sediment slurry settled toward the bottom, where it was routed to the non-TSCA dewatering pad. Photo 4-6 shows the setup of the shaker and thickeners at HRLF.

Photo 4-6. Thickeners and Shaker

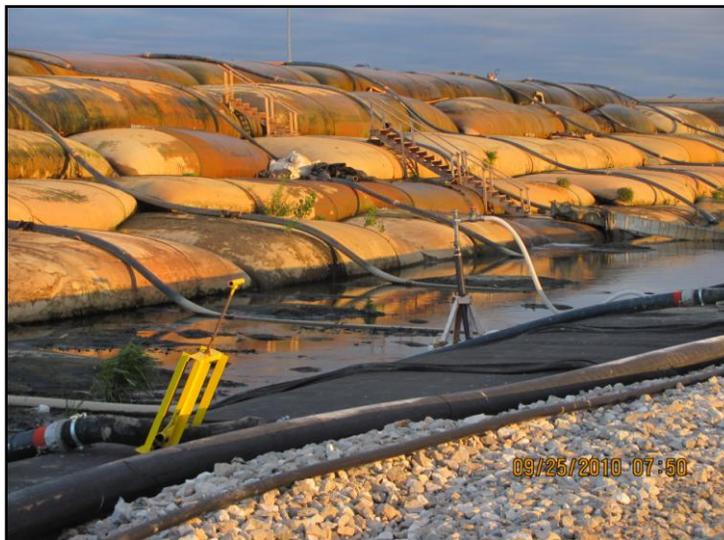
**Photo 4-7. Geotubes Stacked Five High in Non-TSCA Pad**

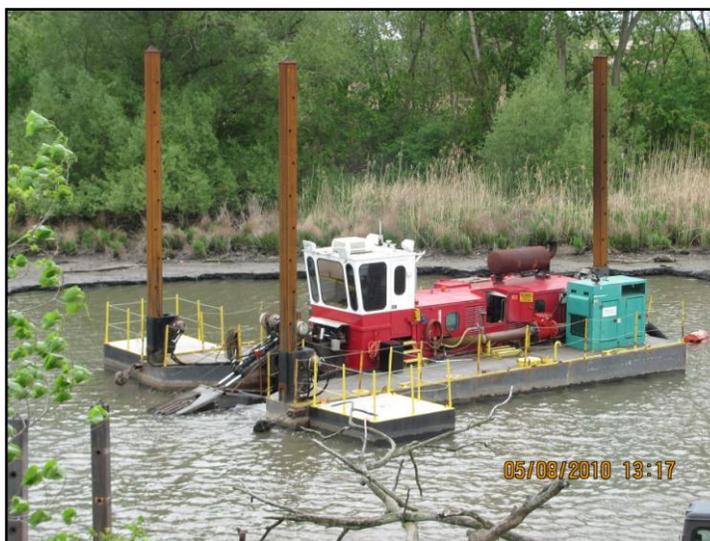
**Photo 4-8. 10-inch Swinging-Ladder Hydraulic Dredge Michael**

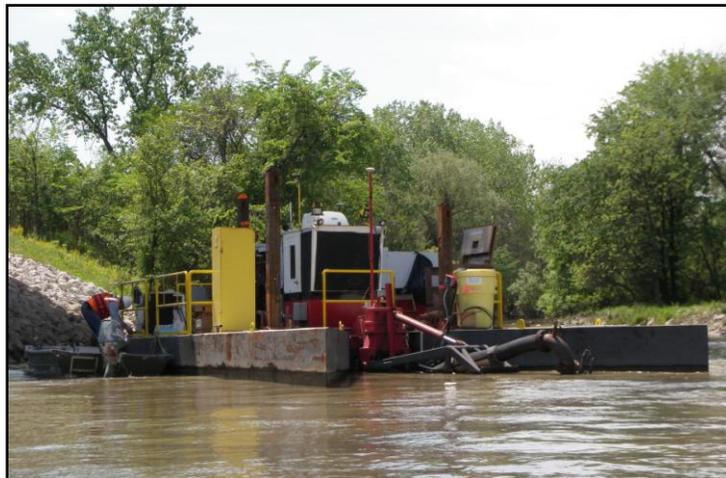
shows the dredge Fox River, a typical 8-inch dredge, on the Ottawa River. The Block Island was used to complete non-TSCA operations in Reach 2 DMUs 2C through 2G and TSCA area 2A. Only two dredges could operate at one time due to flow restrictions from the WTP. The Block Island was utilized when the Michael or Fox River was down because of mechanical issues or while awaiting confirmatory sampling results. Once operations were completed in Reach 2, the Block Island was used as a booster for the other two 8-inch dredges completing Reach 3.

**Photo 4-9. 8-inch Swinging-Ladder Hydraulic Dredge Fox River**

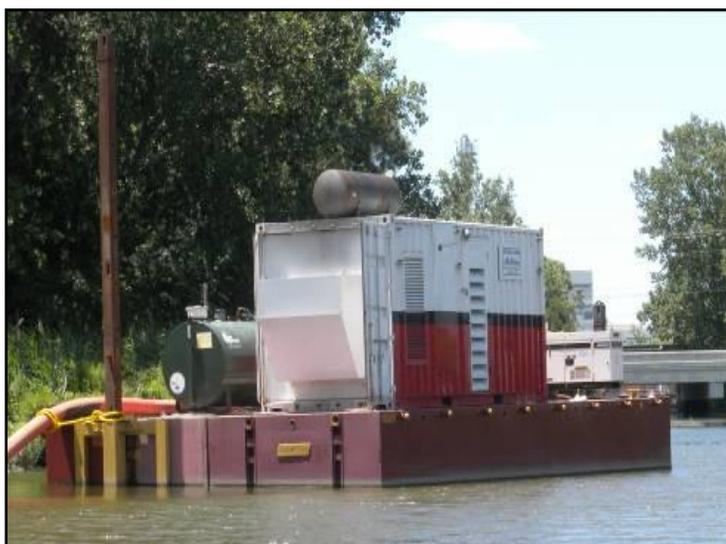
Because of the distance along which the sediment was pumped, five booster pumps were needed to transport the sediment to the HRLF bag field. Boosters #1, #3, and #4 were staged on land, and the Boosters #2 and #5 were barge-mounted, 8-inch booster pumps. Booster #2 was staged adjacent to the Enchanted Forest property in DMU 2A, while Booster #5 was staged in Reach 4 near DMU 4X. All booster barges were held in place by two spuds. Photo 4-10 shows Booster #2 staged in DMU 2A.

**Photo 4-10. JFB Booster Barge – Mounted Booster #2**

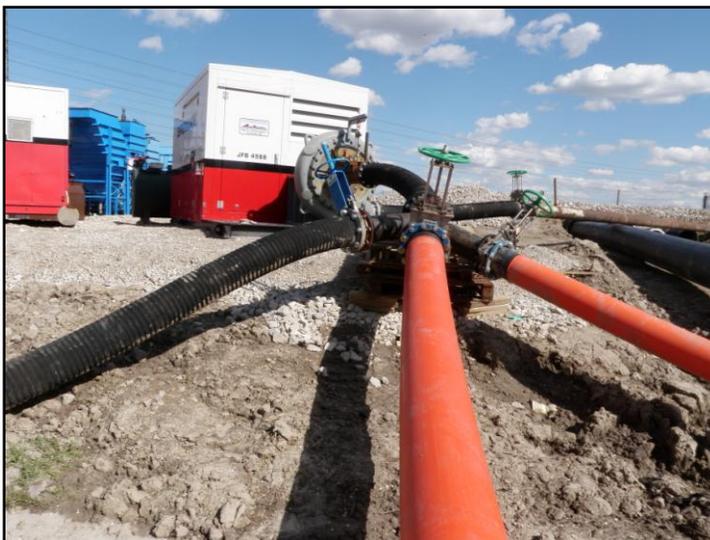
JFB staged Boosters #1, #3, and #4 on land along the Ottawa River. Booster #1 was a 10-inch pump staged near the WTP at the HRLF site, and was common to both the 8-inch and 10-inch lines via a Y-connection located just before the pump intake. This pump transported slurry from the edge of the river bank at HRLF through 1,000 feet of 10-inch, double-wall HDPE pipeline to a velocity box above the shaker screen, resulting in a discharge elevation of over 60 feet above the booster intake. Photo 4-3 shows Booster #1 located at the HRLF.

Photo 4-3. Y Connection at 10-inch Booster – Booster #1

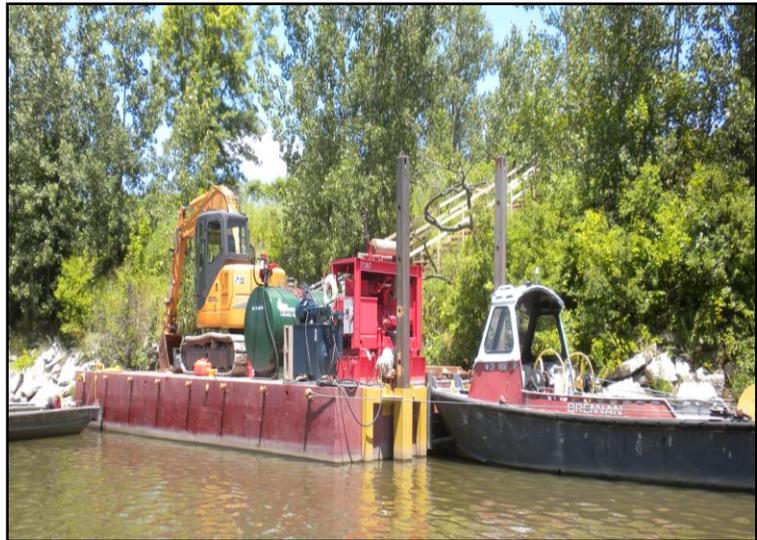
**Photo 4-12. Jet Boat Docked at Reach 2 Marine Plant near Enchanted Forest**

Enchanted Forest, this plant was used as a docking point for the Jon boats and a refueling station. This plant was also used to repair pipeline kinks in DMU 2B. Photo 4-12 shows both the jet boat and the marine plant docked at Enchanted Forest staging area.

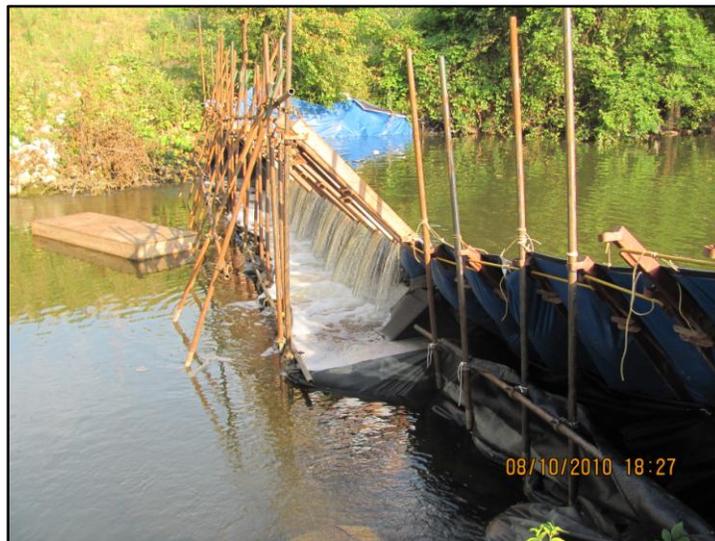
Portadam mobilized heavier components and placed the dam at a new location upstream of the West Central Avenue Bridge. The heavier components were placed on a more granular stretch of the river that was slightly deeper. The temporary dam was successful in raising the water to operable levels for the time period needed to dredge DMUs 4X and 4Y. Photo 4-13 shows the temporary dam in place.

**Photo 4-13. Temporary Dam Structure in Reach 4**

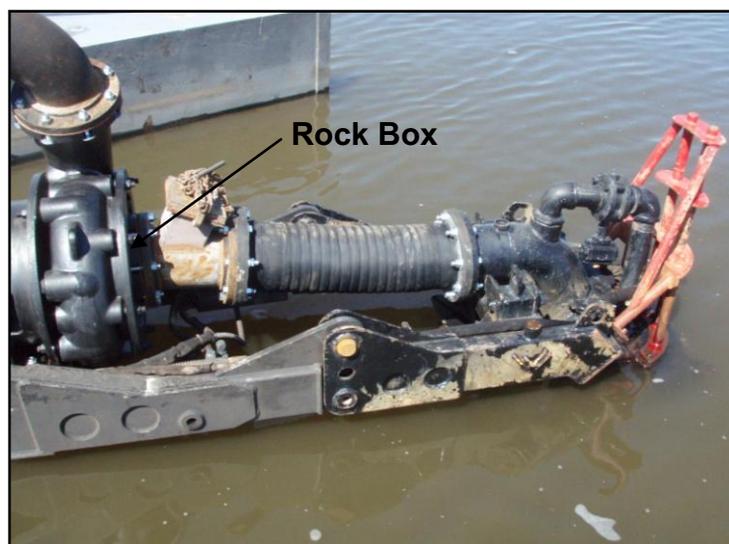
During dredge operations, smaller debris such as lumber, tires, strapping, cable, and chain accumulated in the pump impeller vanes. This accumulation decreased pumping efficiency dramatically, and posed possible mechanical damage to the pump and the pump drive system. To address this issue, a cleanout or “rock box” was located on the intake of the dredge and booster pumps to allow access into the impeller vanes in order to remove the debris. All debris was placed directly into a heavy-duty plastic garbage bag for removal and disposal at HRLF. Photo 4-14 depicts the dredge pump rock box.

**Photo 4-14. Dredge Pump Rock Box**

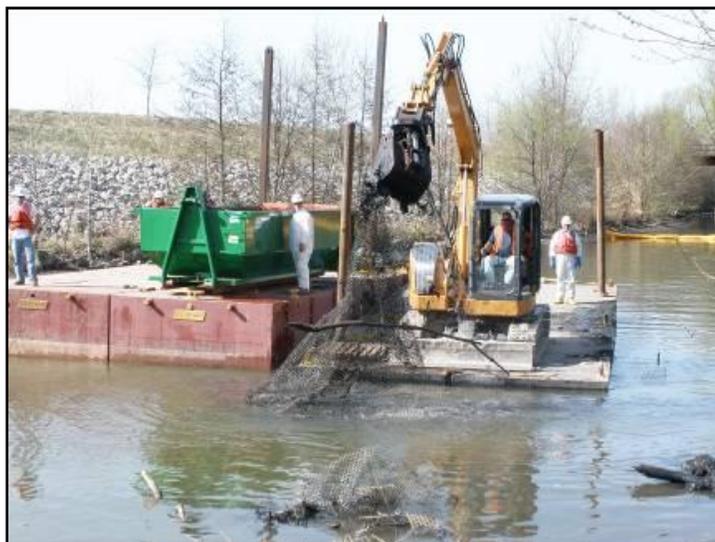
Geo-grid was first removed from the non-TSCA areas and placed in a sealed 20 CY roll-off dumpster staged on a barge near the marine plant removing the material. Once the roll-off was full, it was off-loaded and hauled to HRLF for disposal. The geo-grid in TSCA areas was removed and placed in a 20 CY roll-off dumpster provided by The Environmental Quality Company (EQ), and was transported by EQ to its TSCA-permitted Wayne Disposal, Inc. (WDI), facility located at 49350 North I-94 Service Drive, Belleville, MI. in Wayne, MI. Photo 4-15 shows the excavator removing geo-grid from the Ottawa River.

**Photo 4-15. Geo-grid Removal from Ottawa River in Reach 3**

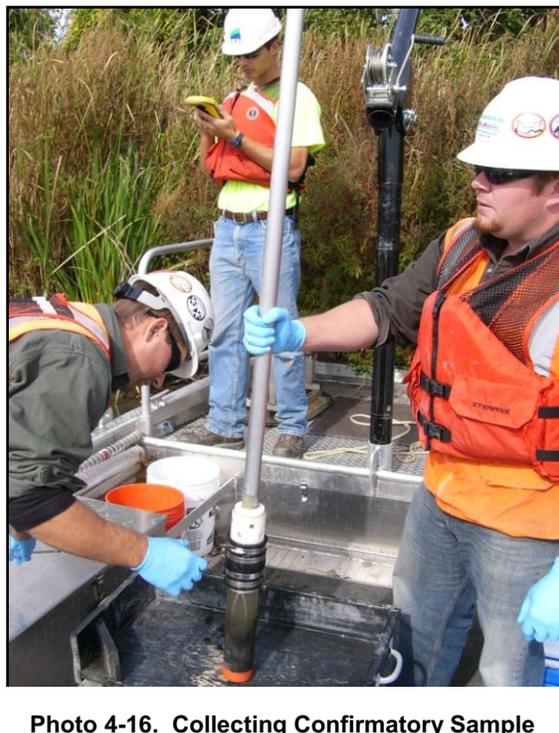
Post-dredge TSCA samples were collected from the top 4 inches of sediment within TSCA DMUs. This sampling occurred at pre-determined sample locations specified by CRA and listed in Appendix E of the Dredge Monitoring Plan (CRA 2010). Samples were capped and labeled, and given to a SulTRAC representative on the boat for storage in a cooler prior to processing the sample on land. NRT and SulTRAC field staff processed all sediment samples on land, and SulTRAC submitted samples for PCB analysis to confirm that average residual PCB sediment concentrations were less than 25 ppm, with no individual sample containing over 40 ppm PCBs. See Section 3.1.1 for additional information regarding the evaluation of confirmatory sampling results. Post-dredge samples collected in TSCA areas were analyzed for PCBs only, and the results appear in Table 4-6.

**Photo 4-16. Collecting Confirmatory Sample**

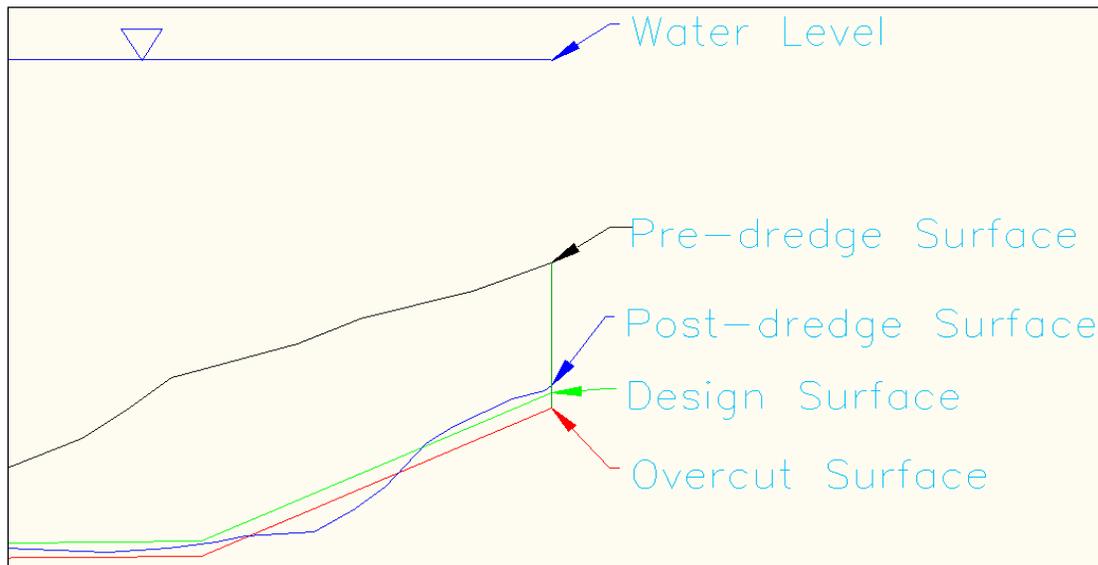
**Figure 4-1. Example Cross Section**

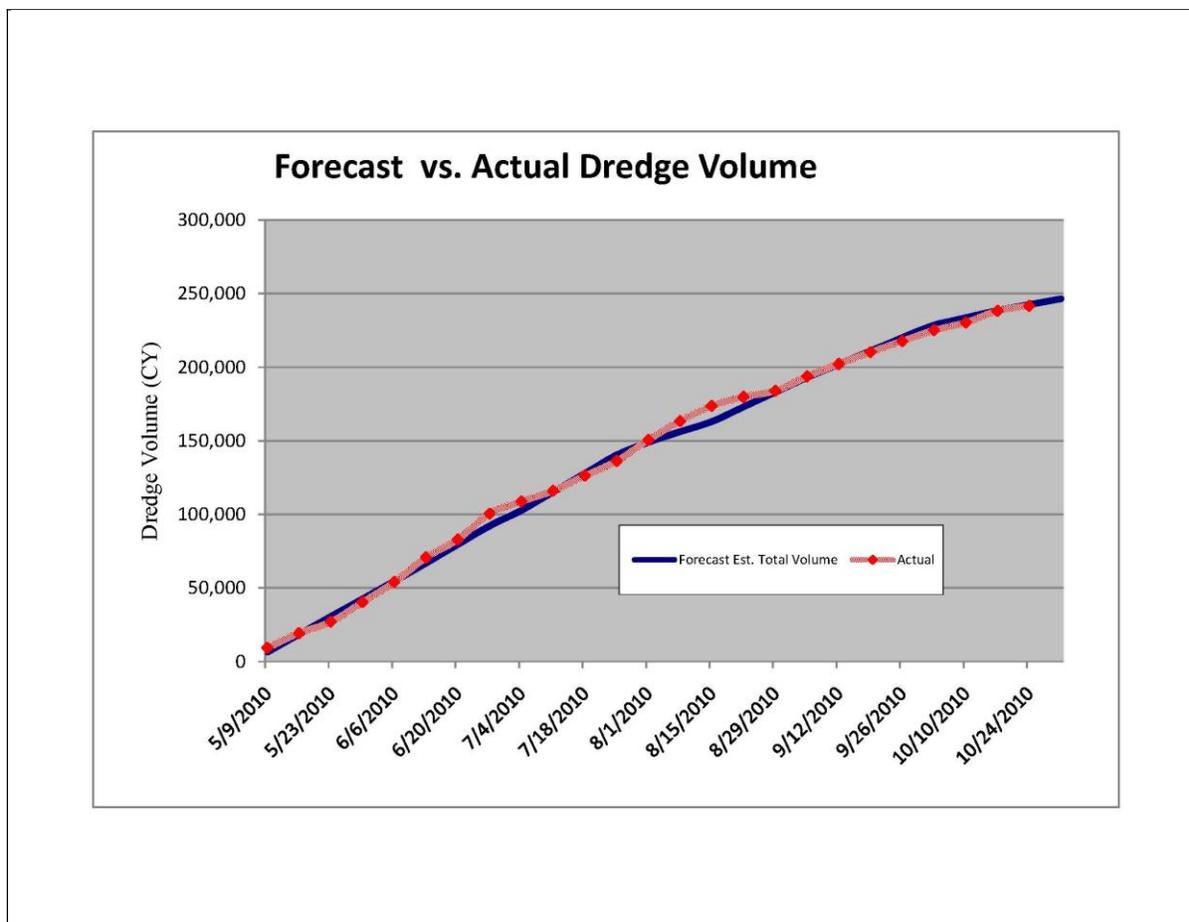
**Figure 4-2. Actual Volume Dredged Versus Forecasted Volume**

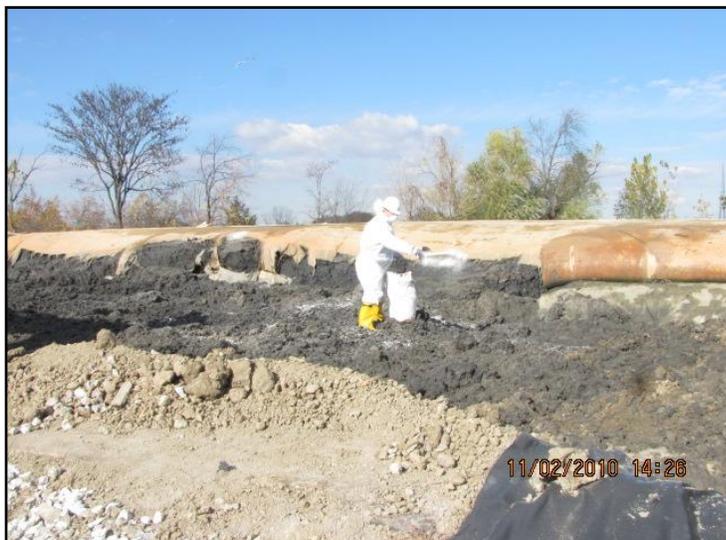
To address this problem, it was initially decided to add SAP in order to absorb free water and make the material suitable for disposal. SAP was selected as a drying additive because it is not a bulking material, does not cause an exothermic reaction, and poses fewer dust concerns than other additives. Based on initial estimates, a 0.25% mixture of SAP (approximately 44 tons) would be applied by hand to treat the estimated 15,000 tons of TSCA material. Photo 4-18 shows the material encountered when the initial geotubes were opened, as well as the application of SAP.

However, as load out continued and additional geotubes were opened at other areas of the dewatering pad, the material encountered was much wetter than initially anticipated (see Photo 4-19). Improper drainage in the TSCA pad further compounded the problem. To improve the drainage, a channel was created along the north edge of the pad, but wet material treated with 0.25% SAP still did not meet PFT requirements for landfill disposal.

**Photo 4-18. Application of SAP**

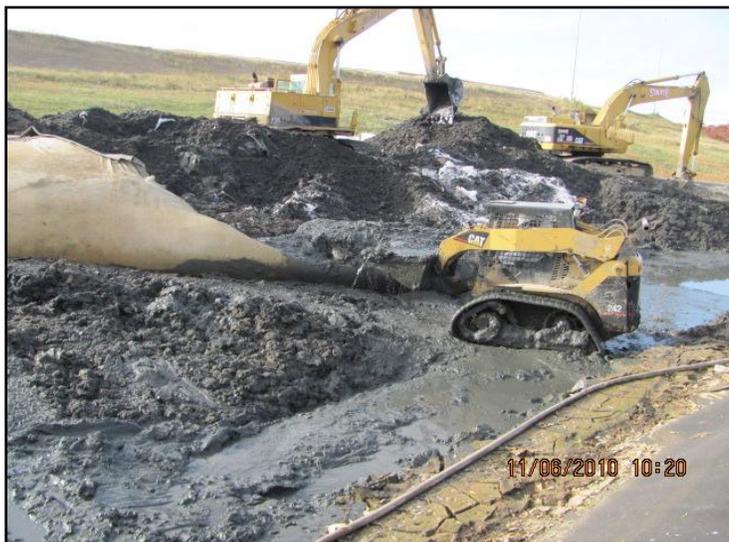
**Photo 4-19. Wet TSCA Material**

Increasing the SAP dosage to meet PFT rendered the material unfit to meet landfill material strength requirements. It was determined that SAP was not cost-effective and did not improve the sediment sufficiently at an application rate that was acceptable to the project team or the landfill.

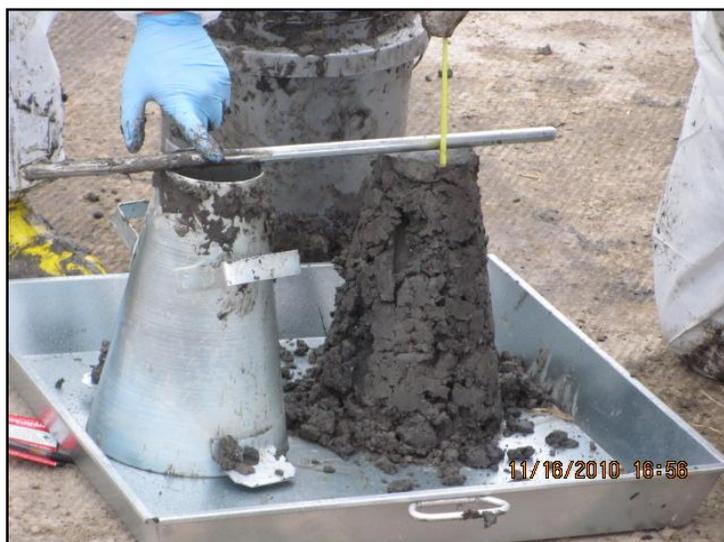
Because the EQ's landfill's permit specified different strength criteria for cohesive and non-cohesive materials, a soil classification study was also performed on the material. The results showed that the material was non-cohesive and therefore was required to pass a 2-inch slump test per the landfill's permit. In order to meet this requirement, the material was mixed with LKD to a near 0 slump (<0.5 inch) at the site. After mixing began, a second round of soil classification tests confirmed that the addition of LKD did not change the material classification as non-cohesive; therefore, the 2-inch slump test would still apply. Photo 4-20 shows the TSCA material passing the slump test on site.

**Photo 4-20. 2-Inch Slump Test of TSCA Material**

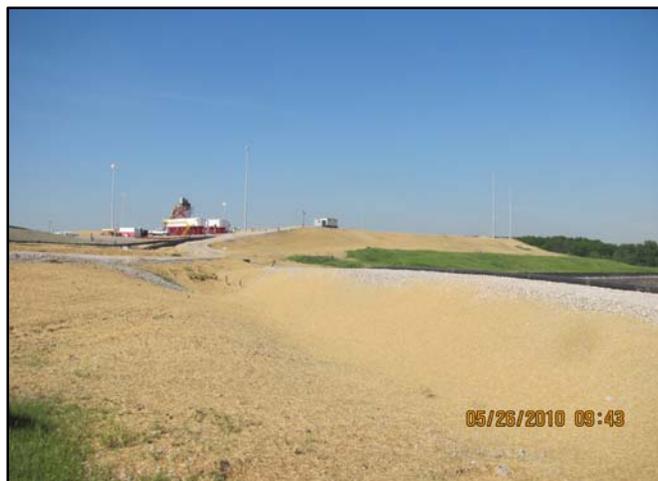
After MBC had constructed access roads, TSCA dewatering pads, and non-TSCA dewatering pads, and had conducted all other required contract work at HRLF, MBC restored approximately 8 acres of interim turf (see Photo 4-21). Hydroseeding equipment was used to spread grass seed, fertilizer, and straw mulch on all disturbed areas during May 2010. All materials used for the restoration met contract specifications. Additional restoration on the TSCA dewatering pad area is discussed further in Section 4.6.3. ORG was responsible for other restoration at HRLF.

Photo 4-21. Interim Turf Restoration at HRLF

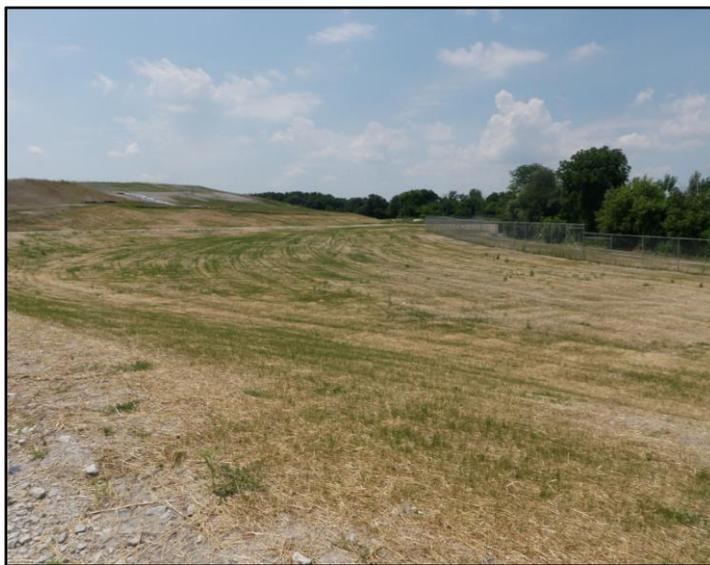
The inspection participants agreed that no additional work by SulTRAC or its subcontractors would be required (SulTRAC 2011c).

**Photo 5-1. Restored TSCA Dewatering Pad Area During Final RA Inspection**
