# NONPOINT SOURCE SUCCESS STORY

## District of Columbia Stream Restoration and Trash Removal Efforts Improve Nash Run

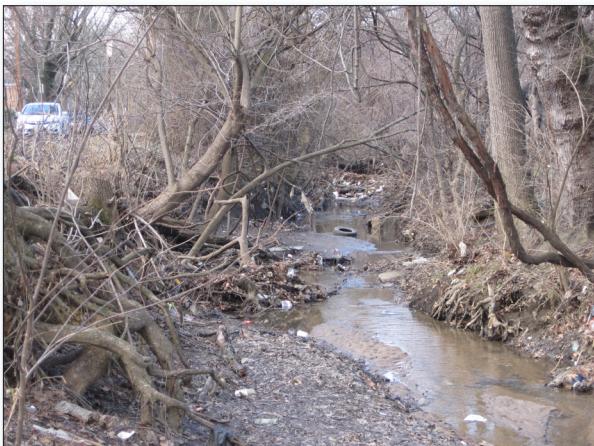
Figure 1. Nash Run mid-stream in 2010 (before restoration).

The Nash Run Stream Restoration Project restored 1,400 feet of urban stream, turning a degraded stream into both a community and environmental asset. DOEE excavated over 9,000 cubic yards of soil along the stream corridor and created a floodplain bench that is 55 feet wide along the stream (Figures 1 and 2). The floodplain bench is one acre in size on both sides of the stream and is planted with over 1,000 native grasses and herbaceous plants. It serves as a grassy wetland complex adjacent to the stream and allows the stream to spread out in storm events, thus dissipating energy and reducing the stream's erosive forces. Designs for the project began in 2011 and were completed in 2015.

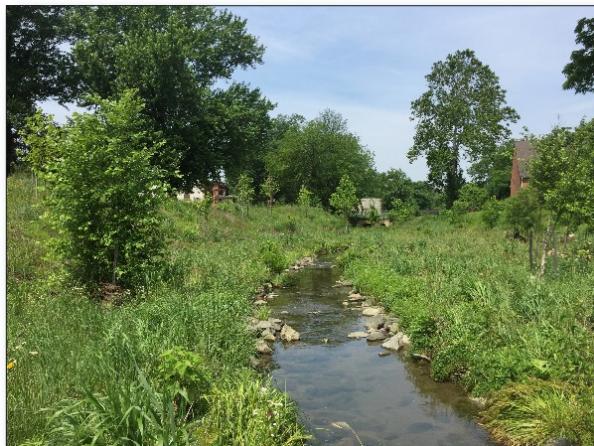
Figure 2. Nash Run mid-stream in 2018 (after restoration).
