NONPOINT SOURCE SUCCESS STORY

Implementing Conservation Practices Reduced Polluted Runoff and Restored the Biological Integrity of Fannegusha Creek

EPA 841-F-19-001VV
December 2019

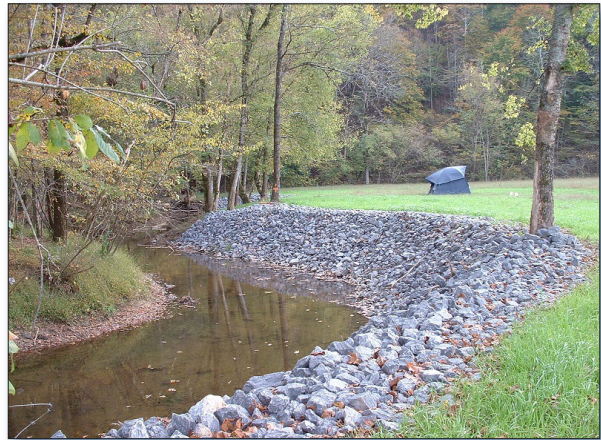
Figure 2. Grade stabilization structures were used to prevent erosion of streambanks.

| BMP type installed | Amount installed |
|---|---|
| Grade stabilization structure | 24 |

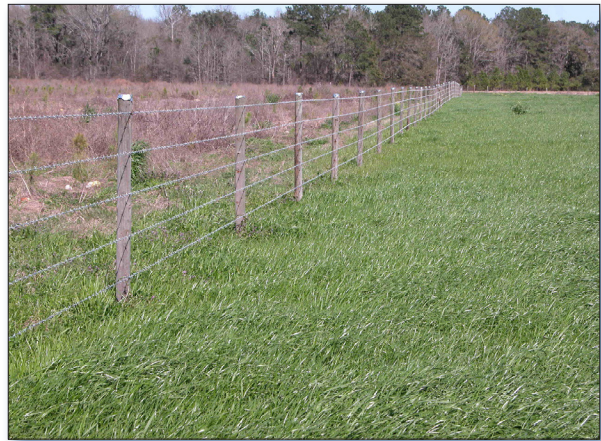
Figure 3. Fencing was used to provide a barrier to control livestock and manage sensitive riparian areas.

| BMP type installed | Amount installed |
|---|---|
| Fence | 82,439 ft |
