NONPOINT SOURCE SUCCESS STORY

Pennsylvania

Treatment of Mine Drainage Improves Hubler Run

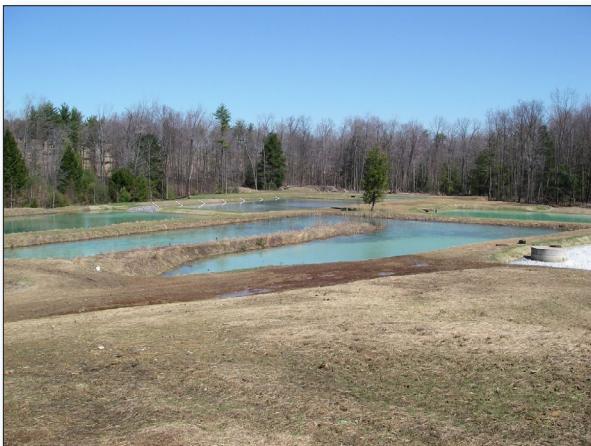
Figure 2. A passive treatment system installed at one of the four priority sites.

The Emigh Run/Lakeside Watershed Association received a CWA section 319 grant in 2004 to assess the watershed. Using TMDL assessment data, project partners developed a watershed implementation plan for Hubler Run, which was approved in 2007. More than six AMD seeps were identified and sampled, and four priority areas were listed in the watershed implementation plan. Passive treatment systems composed of anoxic limestone drains and limestone leach beds have been constructed to address each of the four priority areas (Figures 2 and 3).

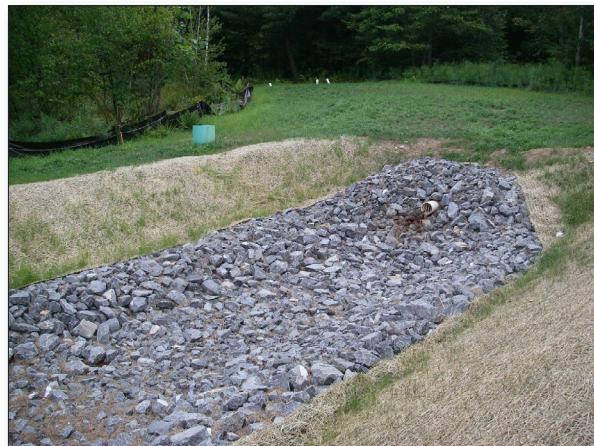
Figure 3. A buried anoxic limestone drain empties into a limestone channel.
