UNITED STATES ENVIRONMENTAL PROTECTION AGENCY
REGION 5
77 W JACKSON BLVD.
CHICAGO, IL 60604

I. HEADING

SUBJECT: Oil Pollution Act 1990 Removal Project Plan
Cline Avenue Ditch Oil Sheen Site (E11513), Gary, Indiana

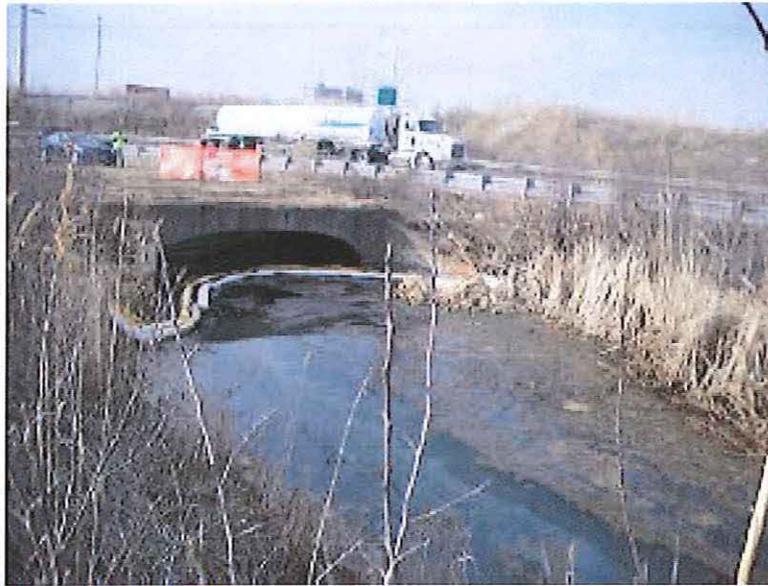
Site: Cline Avenue Ditch Oil Sheen
Photograph No.: 1
Direction: Southwest
Subject: Sheen in ditch along Cline Avenue

Oil is continuously releasing to a ditch on the property at multiple points from the eastern wall and possibly from the sediment, along Cline Avenue in Gary, Indiana. A sheen is visible for approximately 500 ft, at which point it enters an underground culvert (see Attachment 2 photos) that discharges into the Grand Calumet River. The sheen is visible in the Grand Calumet River at the culvert outfall which is approximately one half mile downstream from the point of entry into the ditch. The Grand Calumet flows into Lake Michigan approximately five miles from the ditch outfall discharge point.

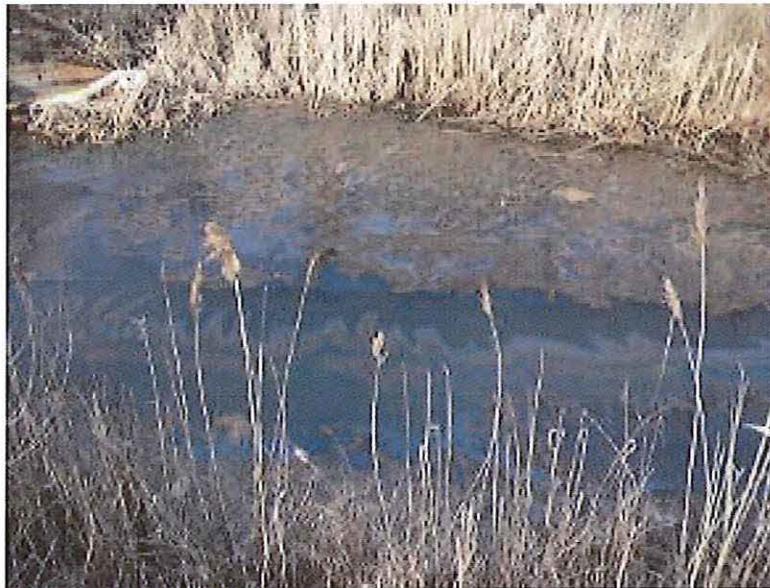
Site: Cline Avenue Ditch Oil Sheen
Photograph No.: 2
Direction: Down
Subject: Sheen in ditch along Cline Avenue

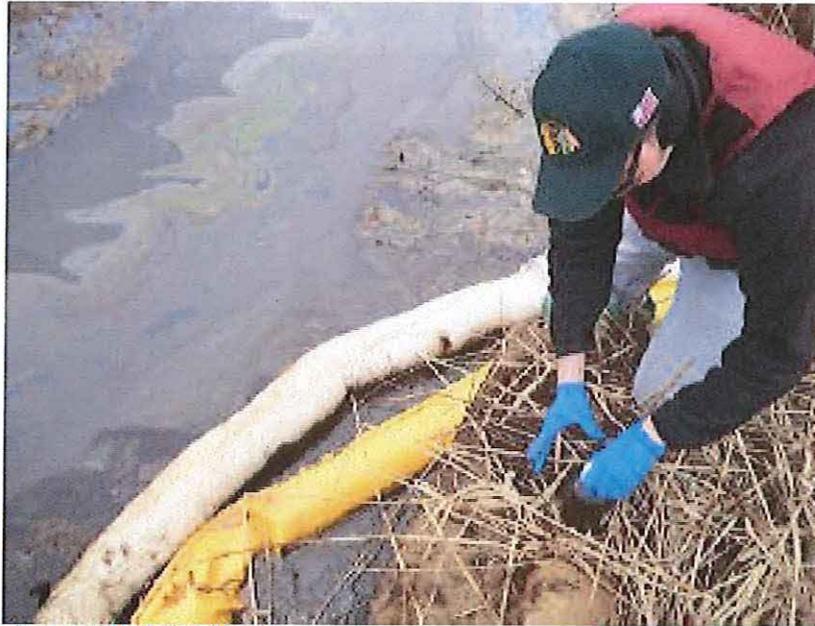
Photograph No.: 3

Subject: Collection of sample of stained soil next to the ditch

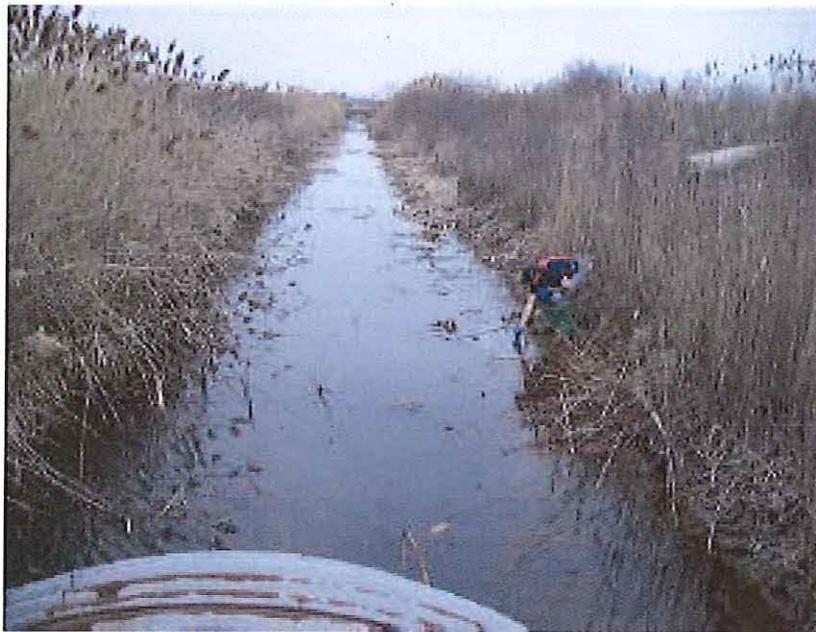
Photograph No.: 4

Subject: Collection of surface water/sheen sample from the ditch

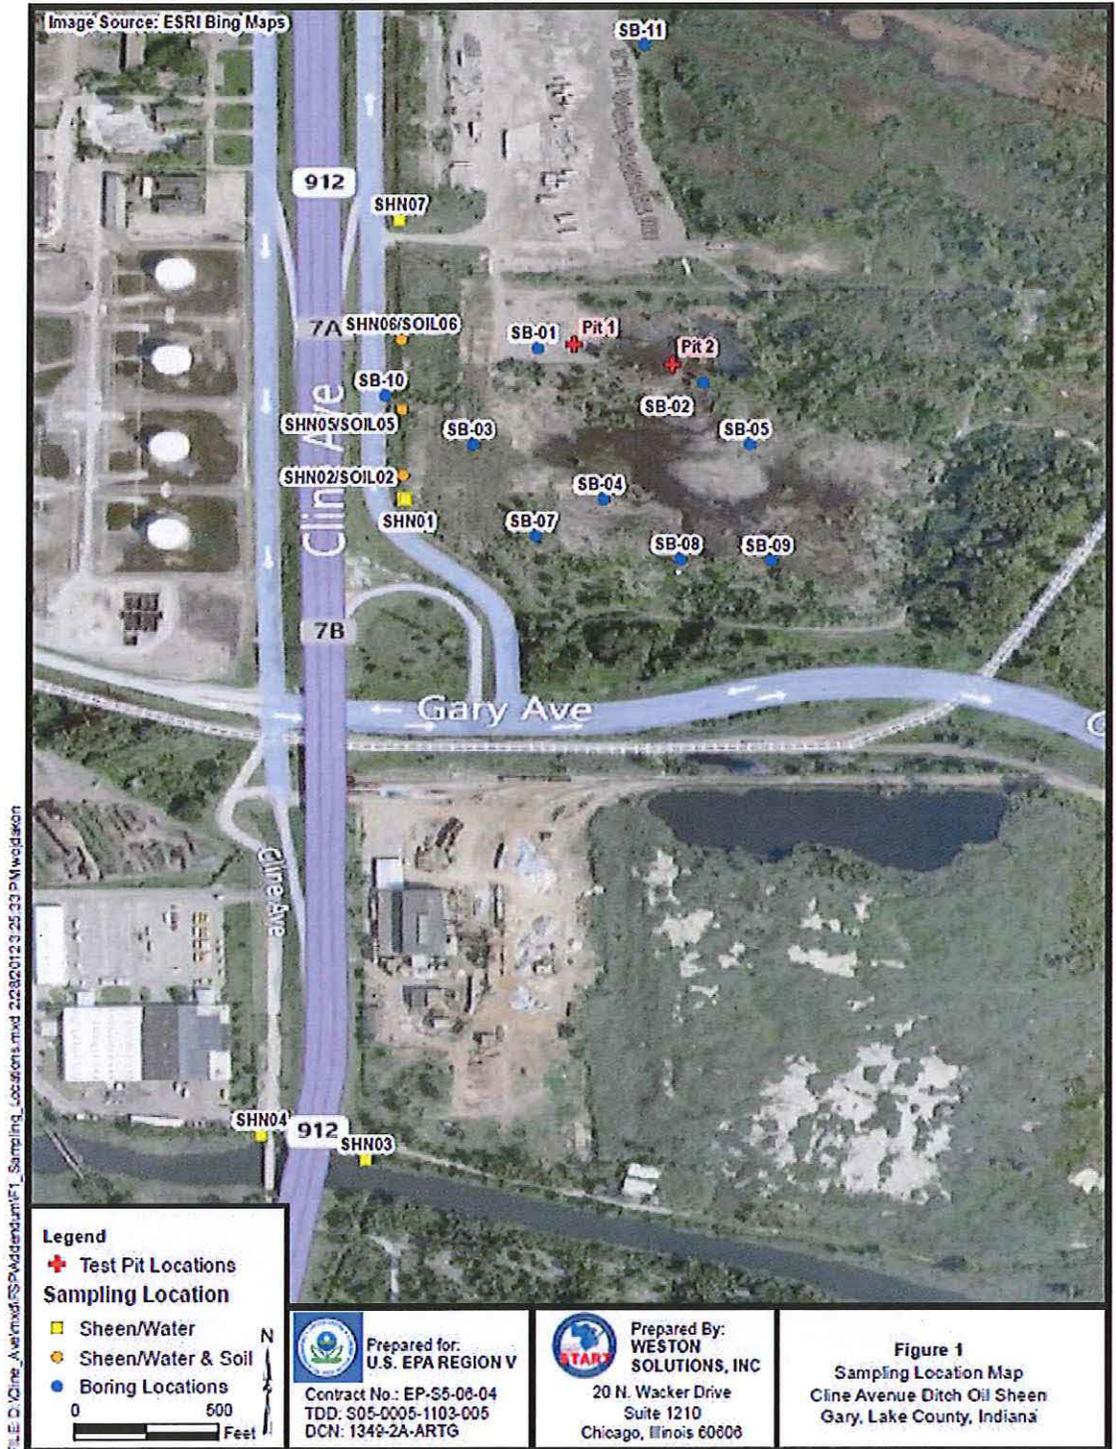
SAMPLING LOCATIONS

On April 1, 2011, EPA, ERRS, and Superfund Technical Assessment and Response Team (START) contractor, Weston, mobilized to the Site to conduct sampling activities. A total of seven sheen samples (SHN01 through SHN07) and 3 soil samples (SOIL02, SOIL05, and SOIL06) were collected in and along the ditch (see attachment 3). The sheen and soil samples were submitted to the U.S. Coast Guard (USCG) Marine Safety Laboratory (MSL) for fingerprinting (forensic oil) analysis (see attachment 4a and 4b). In addition, the soil samples were submitted to STAT Analysis Corporation (STAT) for analyses of total petroleum hydrocarbons (TPH) as gasoline range organic (GRO), diesel range organic (DRO), and extended range organic (ERO).

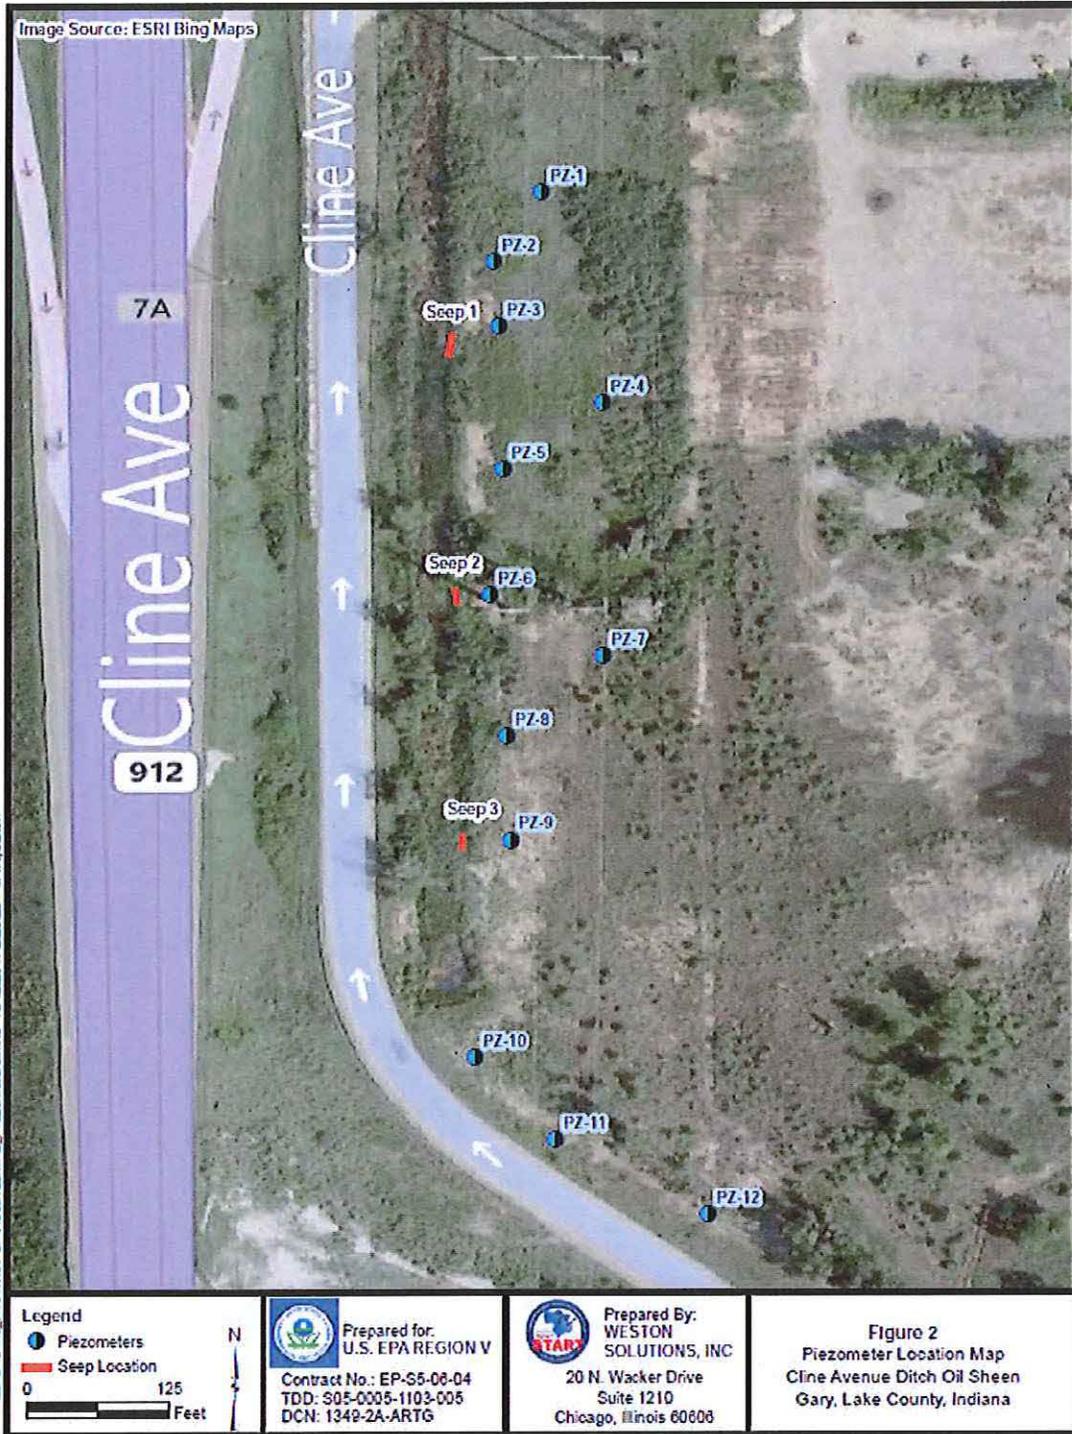
PIEZOMETER LOCATIONS

On September 27, 28, and 29, 2011, EPA and START mobilized to the site to install 12 piezometer wells next to the ditch (see attachment 5). These wells were installed adjacent to the ditch to determine oil location and thickness. The wells were surveyed and groundwater levels measured to determine the flow direction to the ditch. Using an Oil/Water Interface Probe, START has measured the depth of water and the depth of oil at each piezometer well finding oil layers greater than four feet thick (see attachment 6).
