# NONPOINT SOURCE SUCCESS STORY

## New Jersey

### Riparian Restoration and Watershed Stewardship Improve Water Quality in Bear Brook

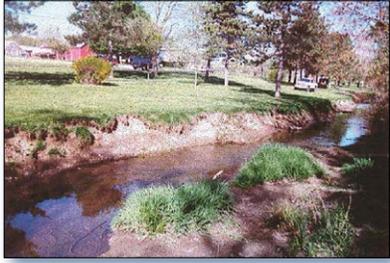
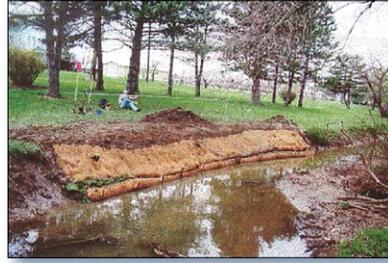
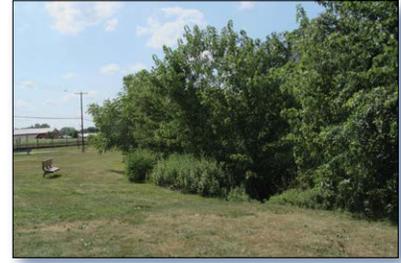
Figure 2. In 2001, partners addressed an eroding, incised section of Bear Brook in East Windsor Township's Anker Park (as seen on left, March 2001) by implementing bioengineering and revegetation riparian restoration techniques (as seen in the middle, May 2001). By July 2014 (as seen on right), Bear Brook had a healthy, well-established riparian buffer that provides shade and protects against erosion.

In 1998 the SMWA received a CWA section 319 grant to restore the 12-mile segment of Bear Brook in East Windsor Township's Anker Park. Streambanks in this segment were stabilized and planted using bioengineering techniques and native vegetation (Figure 2). In total, the projects resulted in the restoration of approximately 1,500 linear feet of stream bank, the addition of 1,000 square feet of lake shore plantings and the reforestation of 10.4 acres of land. Although this project was completed in May 2001, it typically takes at least 5 years to become fully established. Because the 2002 impairment was based on data from 1997–2001, it would not reflect the benefits of this work. The increased tree canopy shading the stream contributed to a reduction in stream temperature, and placement of groundcover plants helped reduce sediment loading to the stream during storms.
