# NONPOINT SOURCE PROGRAM SUCCESS STORY

## Vermont

### Ski Resort Improves Stormwater Management and Restores North Branch Ball Mountain Brook Tributary

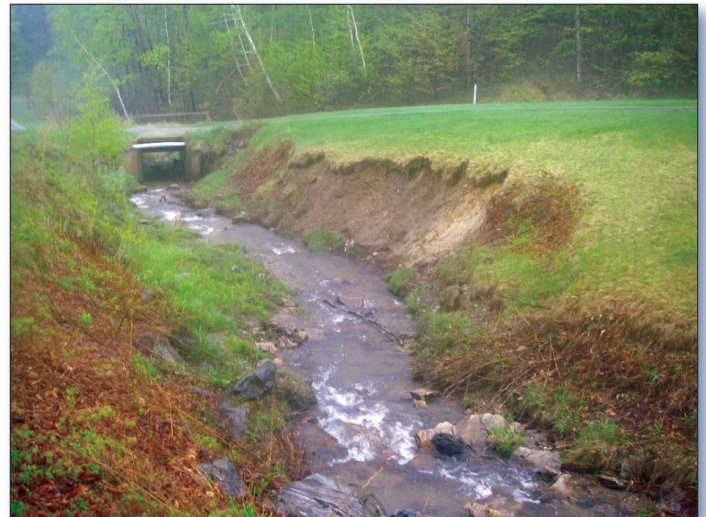
Figure 1. Before restoration, urban runoff contributed to stream habitat impairment in Vermont's North Branch Ball Mountain Brook Tributary #1. The right bank visible in this 2007 photograph was one of the areas observed to be directly contributing sediment to Tributary #1 through erosion processes.

had low EPT values, macroinvertebrate density and low EPT/richness. This impaired biological condition was caused by excessive sediment from urban runoff degrading stream habitat (Figure 1). Habitat evaluation revealed a high substrate embeddedness. As a result, VTDEC placed Tributary #1 (0.5 miles long, segment VT11-15.01) on its CWA section 303(d) list of impaired waters in 1998 for sediment impairment. In 2002 VTDEC completed a sediment total maximum daily load that outlined the load reductions necessary to attain water quality standards in the impaired segment.

Stratton developed a comprehensive water quality remediation plan (the Stratton Water Quality Remediation Plan, or SWQRP) in 1999 to comply with Vermont's land development law (Act 250), which regulates expansions and new developments involving more than 10 acres, in order to mitigate water quality problems arising from additional development. The development of the plan was a collaborative effort involving the Vermont Agency of Natural Resources (VTANR), the Vermont Natural Resource Council (VNRC) and the Stratton Area Citizens Committee (SACC). Riparian restoration projects implemented as part of the plan included stream corridor enhancements on the golf course, the creation of no-mow zones, and additional stream buffer plantings. Stormwater treatment projects included infrastructure upgrades to the parking lots and catch basins, culvert replacements and better placement of plowed snow during the winter months in the Stratton Village area. Other smaller-scale projects such as ditch re-grading were also implemented. On-mountain stormwater improvement projects included water bar installations and repairs, sediment basin installations, and seeding and revegetation of previously exposed bare earth.
