### Site Update – November 2020

#### Electro Plating Services Site, Madison Heights, Michigan

#### **OSC** Tricia Edwards

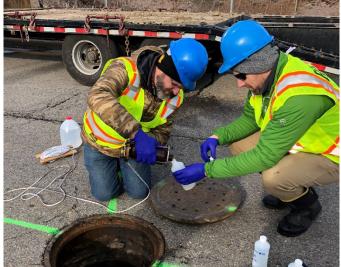
### **Embankment Sump**

- I-696 Barrier Wall

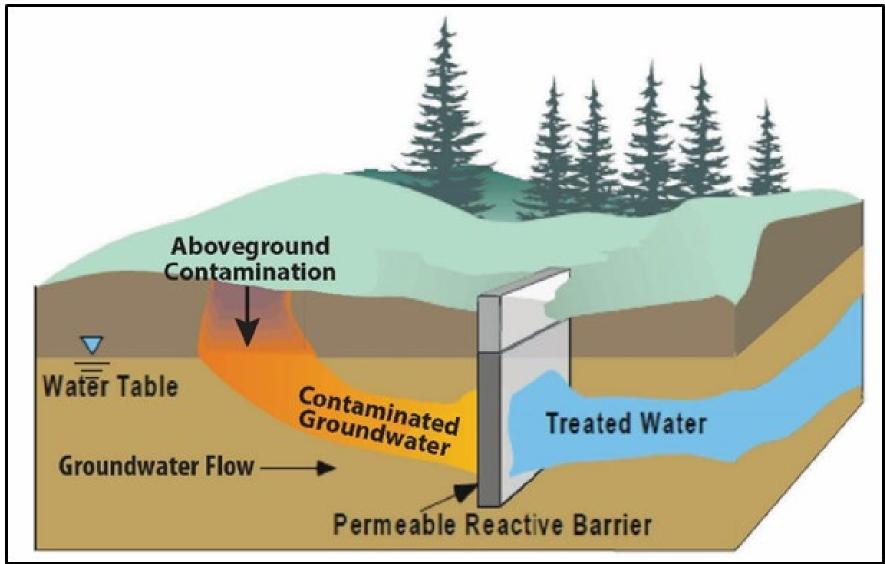
### **Conceptual Example Design**

Permeable Reactive Barrier

- A permeable reactive barrier (PRB) is an In-Situ treatment zone established within a contaminated groundwater unit through the application of reactive products.
- The reactive materials interact with the plume of contaminants as it passively migrates through the PRB, removing or degrading contaminants with treated groundwater migrating out of the PRB.
- The primary removal mechanisms include:

(1) sorption and precipitation,

- (2) chemical reaction, and
- (3) biological oxidation or reduction, depending on the target contaminants.

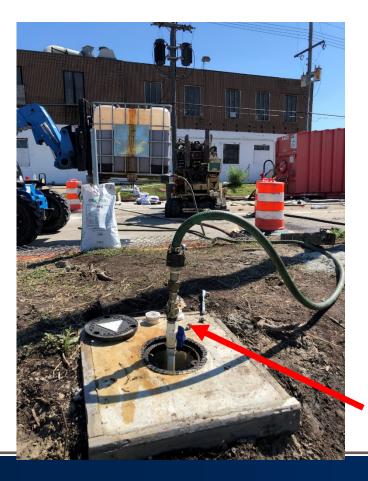
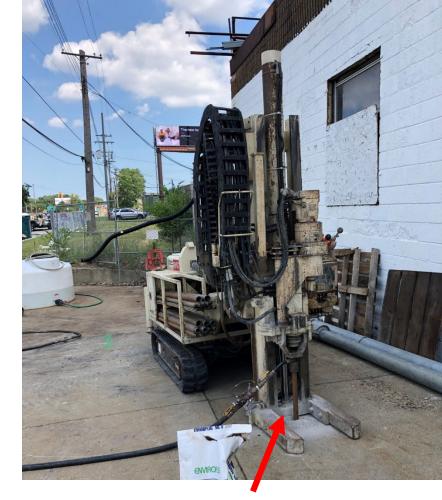
### **Pilot Study**

- 11 On-site Injection Points
- 3 Downgradient Soluble Reagent Injection Wells

Injection of the treatment reagents under pressure (on-site) Gravity fed soluble reagents into permanent injection wells along the embankment

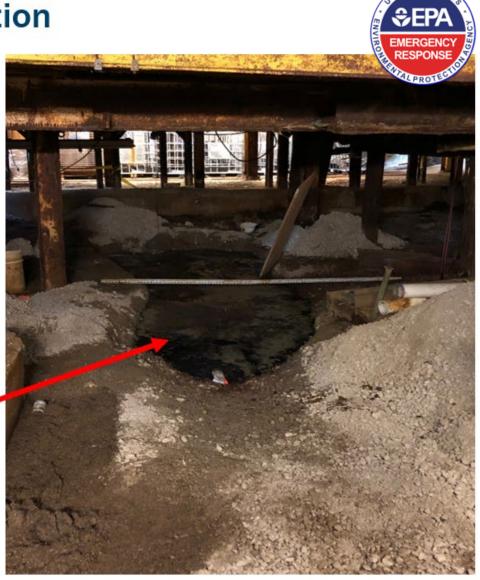
### **Pilot Study - Sump Application**

- Soluble Reagent
  - 38 lbs ELS Microemulsion
  - 3.6 kg Ferrous Sulfate
  - 470 gal water

Dark color is an indication of reducing, anaerobic conditions

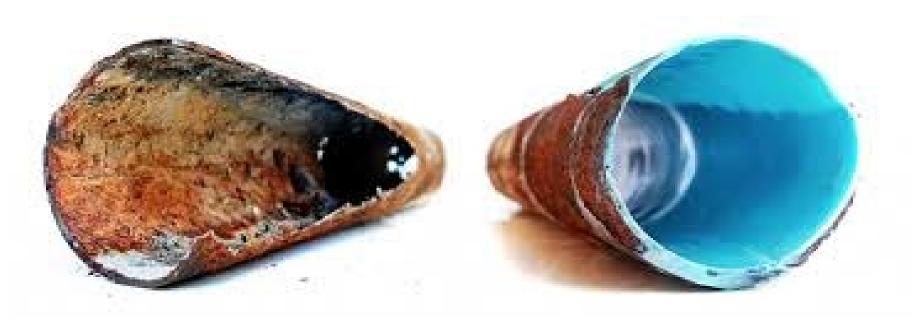
- Lining of Sanitary & Storm Sewers Cured In Place Pipe
  - Repair damaged underground wastewater and stormwater sewer pipes without excavation
  - Repair 1 manhole

## MADISON HEIGHTS 10 MILE 1659 -> 1658 Circular 121mch Vitrified Clay Pip

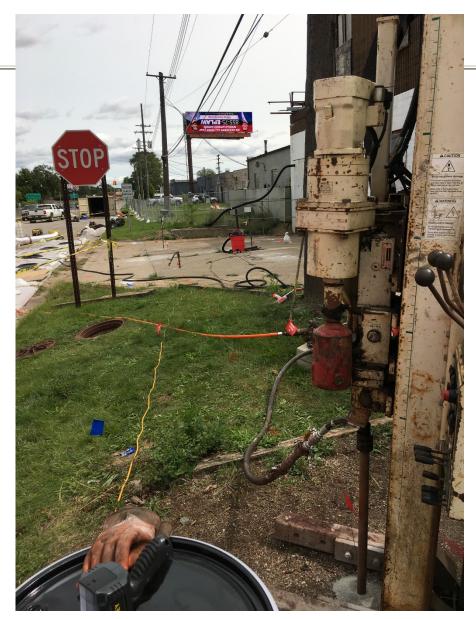
### **On-Site PRB**

- 61 Injection Points
- 5 9 feet bgs
- 19.6 gal reagent per foot
  - 31 lbs EHC Plus
  - 125 Ibs Metafix I-3
  - 13.4 gal water
- 150 200 psi; typ. 175 psi
- 1.4 3.9 gpm; typ. 2.5 gpm
- Totals
  - EHC Plus 9,500 lbs
  - Metafix 38,100 lbs

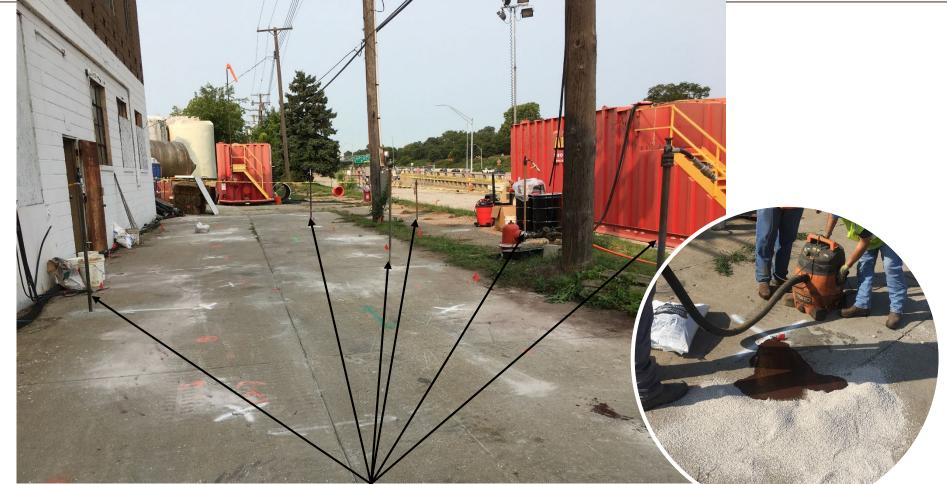
## **On-Site PRB**

Completed injections spaced apart to avoid daylighting

Very few, minor occurrences of daylighting

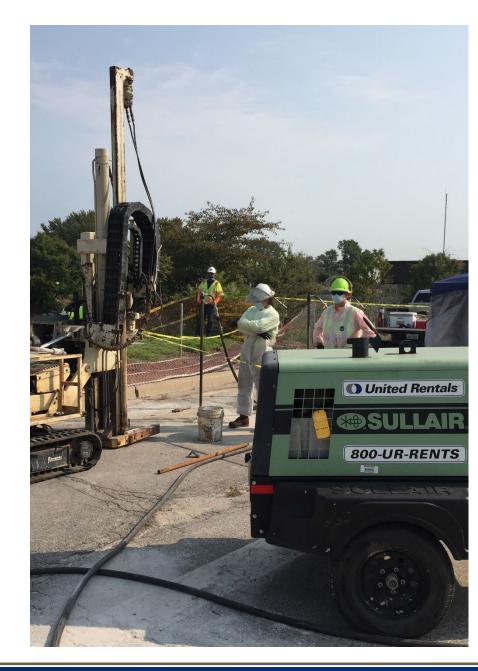
## **Downgradient Slurry PRB**

- 28 Injection Points
- 5 11 feet bgs
- 4.6 gal reagent per foot
  - 12.8 lbs EHC Plus
  - 3.5 gal water
- 170 psi
- 2.3 4.6 gpm; typ. 4.6 gpm
- Total EHC Plus 2,500 lbs

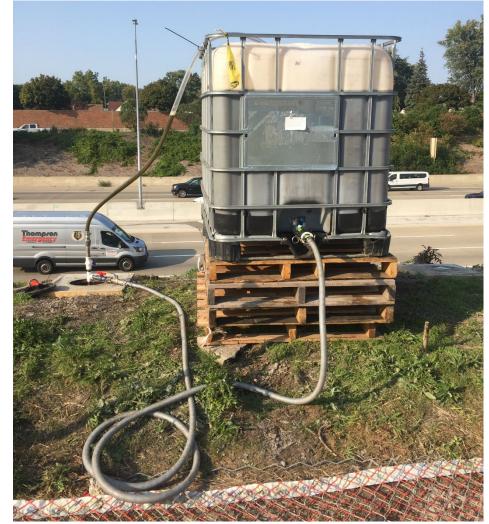
## **Downgradient Soluble PRB**

- 10 New, 2 PT Injection Wells
- Screened 6 16 feet bgs
- Target Reagent per Well
  - 38 lbs ELS Concentrate
  - 96 lbs GeoForm Soluble
  - 209 gal water
  - 225 gal per point
  - 2,250 gal total volume
- Completed Application
  - 3 Exceeded Target Volume – PIP-1, PIP-3, PIP-8
  - 7 Less than Target Volume

Remaining
  - 2 Negligable Volume
     PIP-10, PIP-11
  - 1,460 gal total volume

- 246 Ibs ELS Concentrate
- 622 Ibs GeoForm Soluble

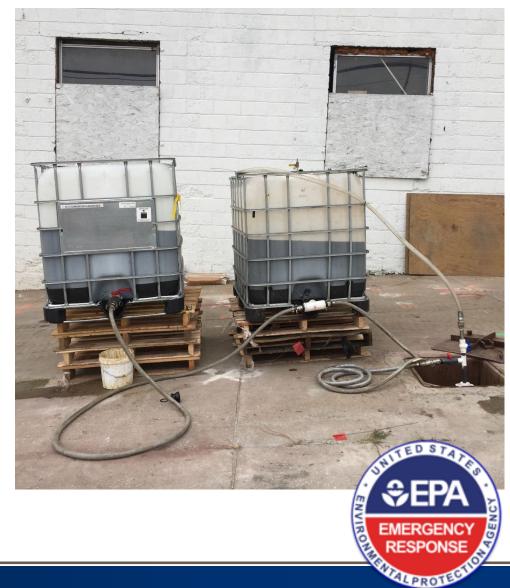
## **RW-01 Soluble Application**

- 10 New Injection Wells
- Screened 6 16 feet bsg
- Target Application
  - 77 Ibs ELS Concentrate
  - 191 lbs GeoForm Soluble
  - 440 gal water
  - 450 gal total volume
- Completed Application
  - 620 gal total volume
  - 106 lbs ELS Concentrate
  - 263 lbs GeoForm Soluble

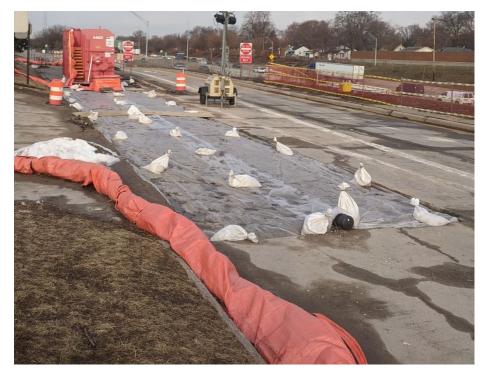
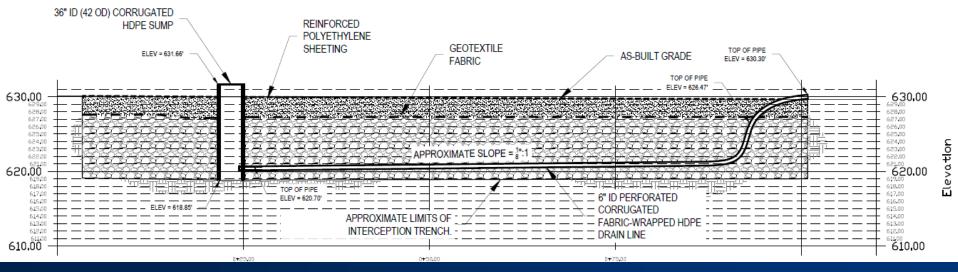
## **Interceptor Trench Soluble Application**

- Excess product from downgradient soluble PRB
- Same reagent blend as PRB and RW-01
- Completed Application
  - 615 gal total volume
  - 105 lbs ELS Concentrate
  - 262 lbs GeoForm Soluble

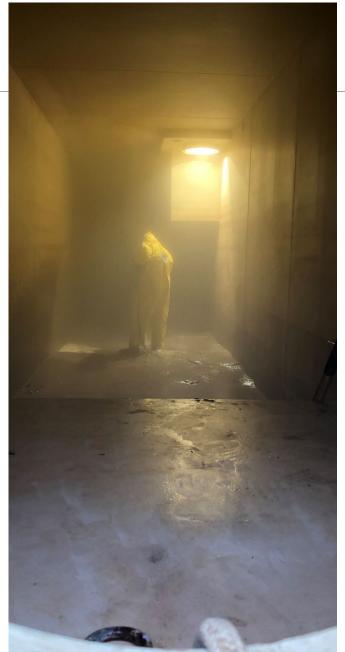
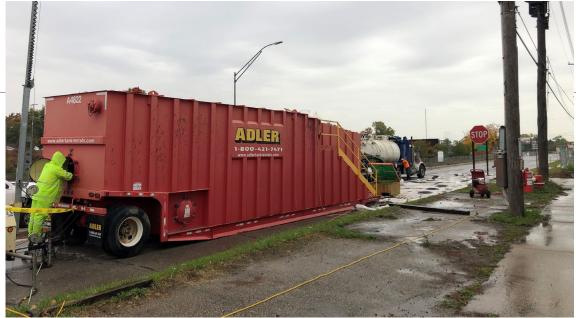
## **Current Conditions**

Volume (Gallons) (10/20)
Total Liquid Currently On-Site	0
Total Liquid Taken Off-Site for Disposal	353,878
- D007/PFOS 293,959-gallons	
- N/H / PFOS 59,919-gallons
