## **Appendix B**

### **Exhibit Log**

**Exhibit 6. Sunol Grade/Route 680 Roadway Rehabilitation Project—outstanding issues had not been corrected through adequate enforcement of the contract conditions as of October 7, 2009, the date of the EPA Audit Team’s site visit.**

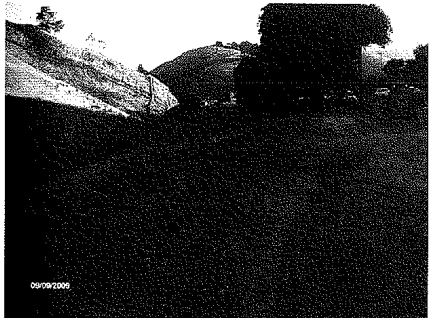
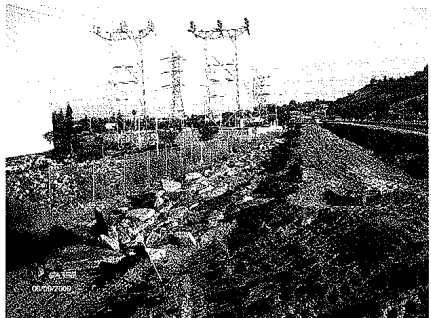
<p>7. AC grindings mixed with granular material spread at this location it should be segregated, removed and hauled away.</p>	<p>8. CTB rubles should be removed and hauled to recycling plant.</p>

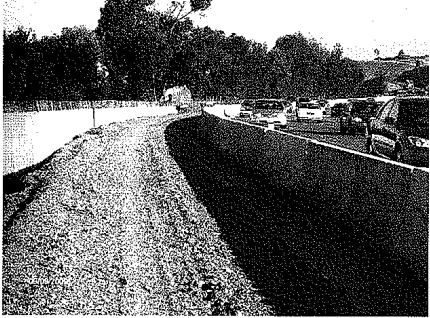
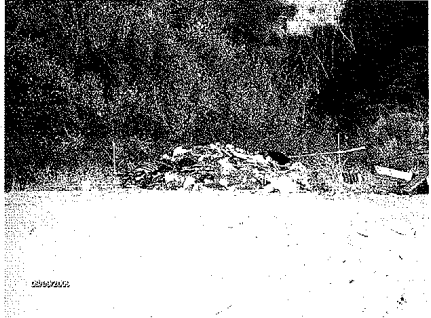
<p>9. Paved section behind the "K" rails should be cleaned prior to rain event.</p>	<p>10. Construction generated waste should periodically be removed and hauled away.</p>

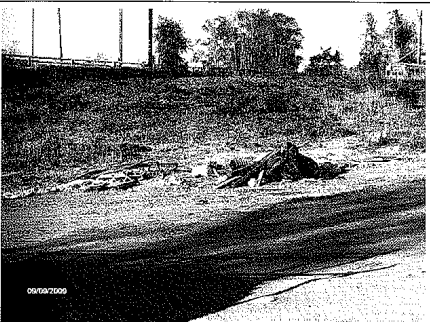
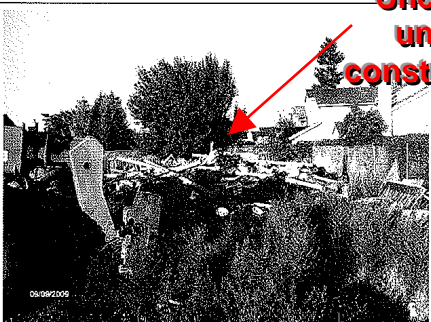
<p>11. Construction generated waste should periodically be removed and hauled away.</p>	<p>12. Construction generated waste should periodically be removed and hauled away.</p>

**Exhibit 7. Sunol Grade/Route 680 Roadway Rehabilitation Project—Photograph 12 above corresponds to the area shown in Appendix E, Site Visit No. 11, Photograph 5 of this audit report.**

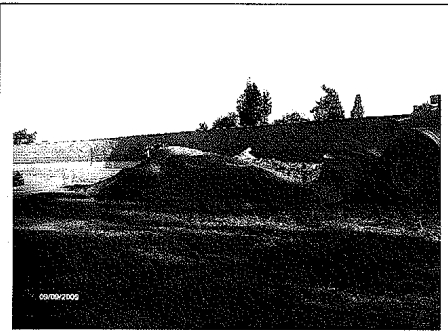
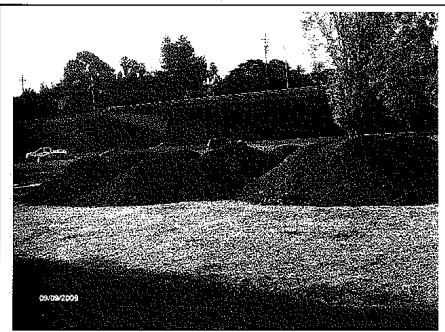
<p>13. AC grindings should be either covered or perimeter control prior to rain.</p>	<p>14. AC grindings should be either covered or perimeter control prior to rain.</p>

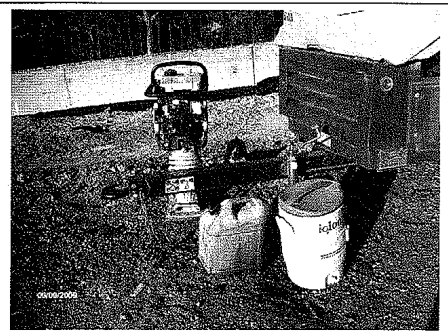
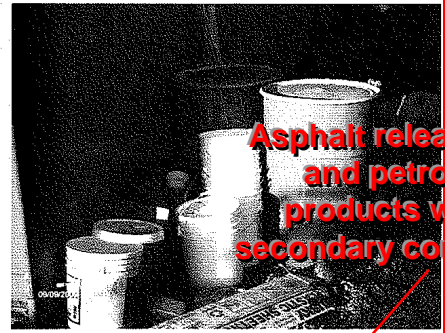
<p>Asphalt release agent and petroleum products without secondary containment</p>
<p>15. Fuel containers should be stored in the back of pick up.</p>	<p>16. Paint buckets curing compound should be stored in the tool shed or secondary container.</p>

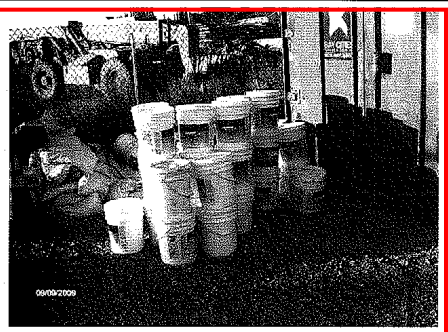
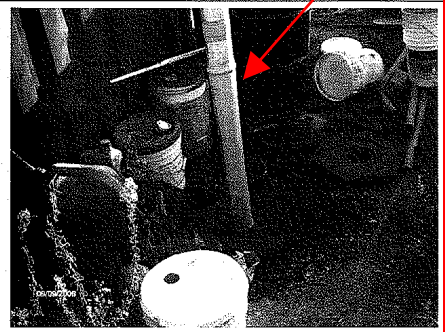
<p>17. Paint buckets should be stored in the tool shed or secondary container.</p>	<p>18. Spilled liquid should be cleaned.</p>

**Exhibit 8. Sunol Grade/Route 680 Roadway Rehabilitation Project—Photograph 18 above corresponds to the same asphalt release agent and petroleum products (lacking secondary containment) shown in Appendix E, Site Visit No. 11, Photographs 6—8 of this audit report.**

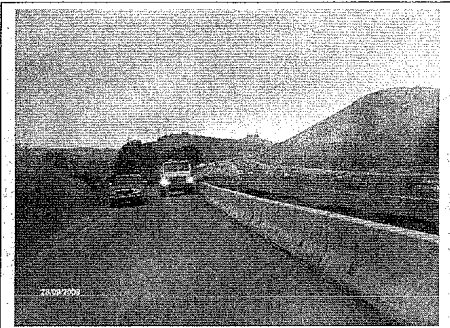
<p>7. Water truck on hand to help keep both dust under control and moisturize the compacting materials</p>	<p>8. Geo textile netting on hand at Vargas Yard.</p>

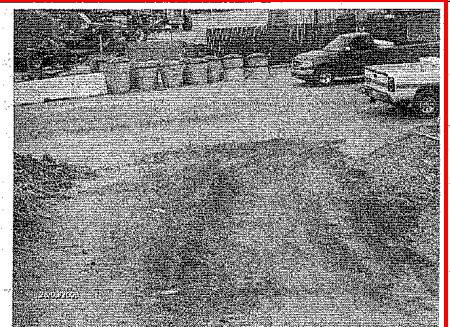
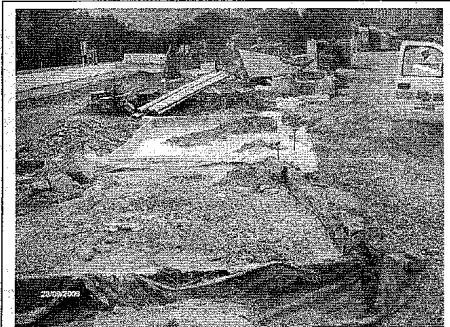
<p>9. It was recommended to install an entrance and exit at this location if it is going to be used as an entrance and exit.</p>	<p>10. Both of these washouts are leaking should be removed and replaced.</p>

**Exhibit 10. Sunol Grade/Route 680 Roadway Rehabilitation Project—Photograph 9 above corresponds to the same construction entrance shown in Appendix E, Site Visit No. 15, Photographs 8—9 of this audit report.**

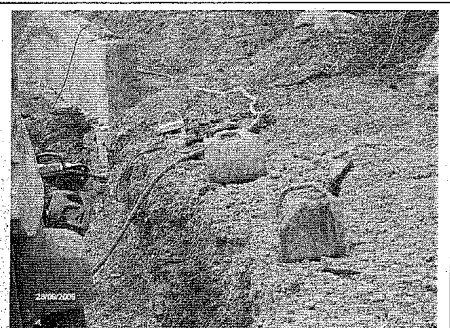
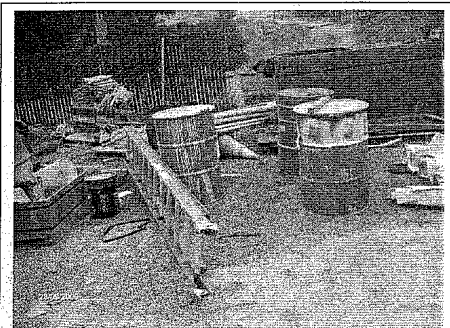
<p>11. Gas containers and pipe soup should be in the back of pick up or secondary container.</p>	<p>12. 5 gallon bucket has oil and two 55 gallons have some curing compound it should be stored in secondary</p>
