# STORM WATER POLLUTION PREVENTION

## PROTECTING WATER QUALITY ON CONSTRUCTION SITES

Tom Keegan, Dry Creek Rancheria

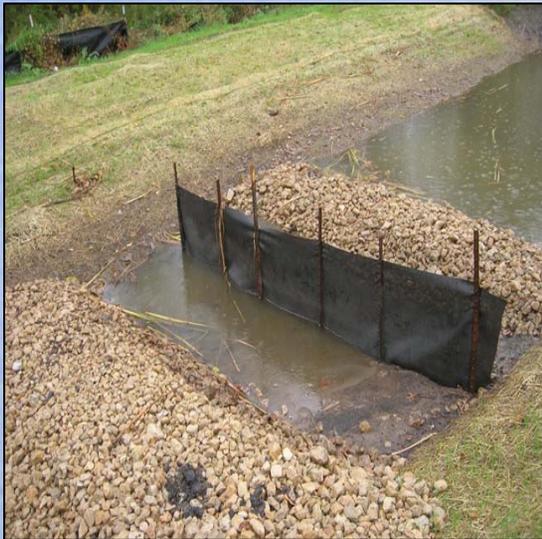
GOOD

80% of BMP failures are from incorrect installation

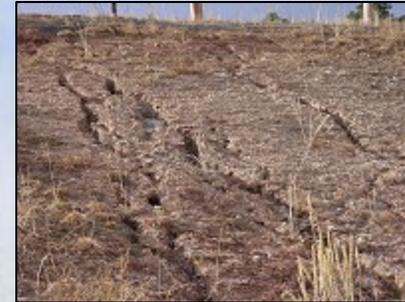
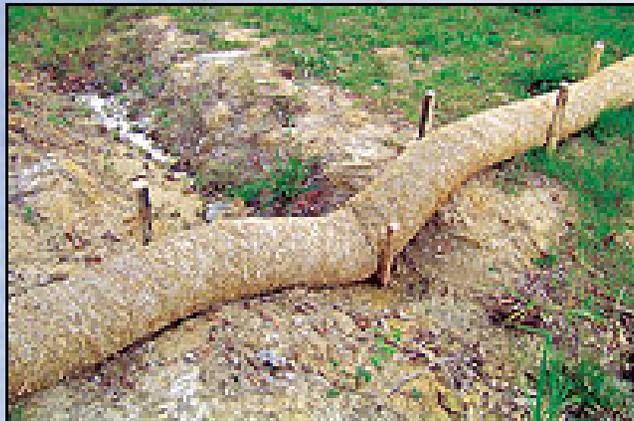
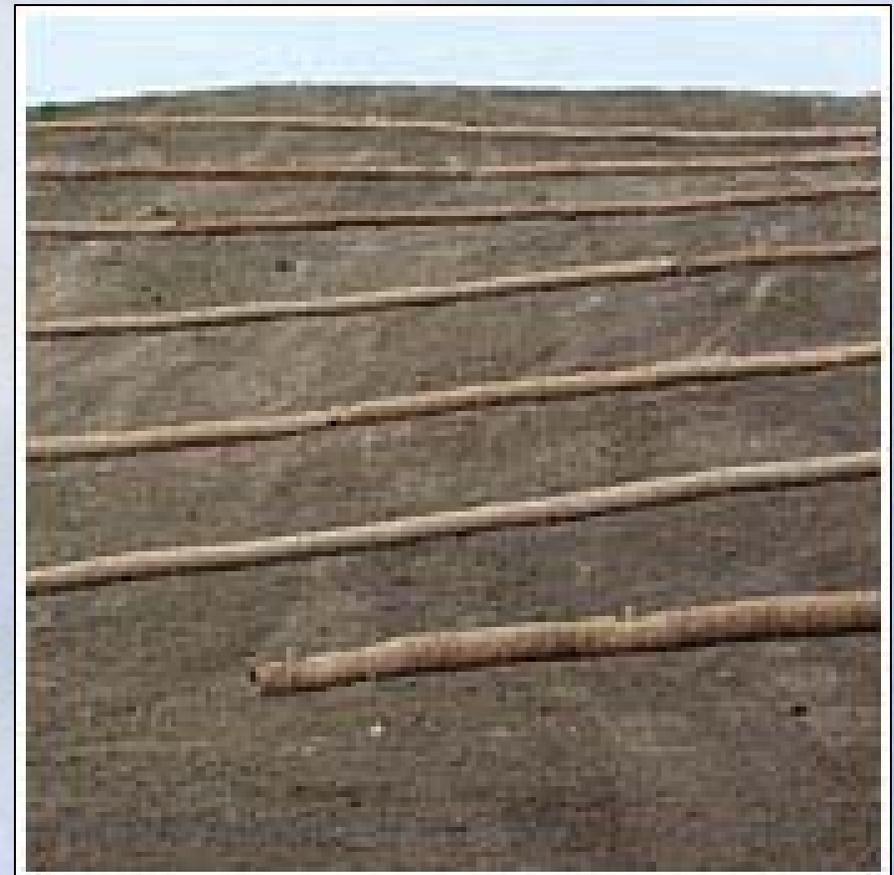
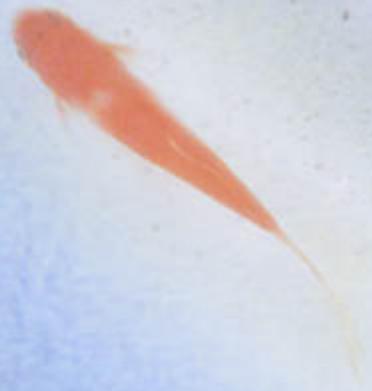
Potential Riling:

Straw Wattles

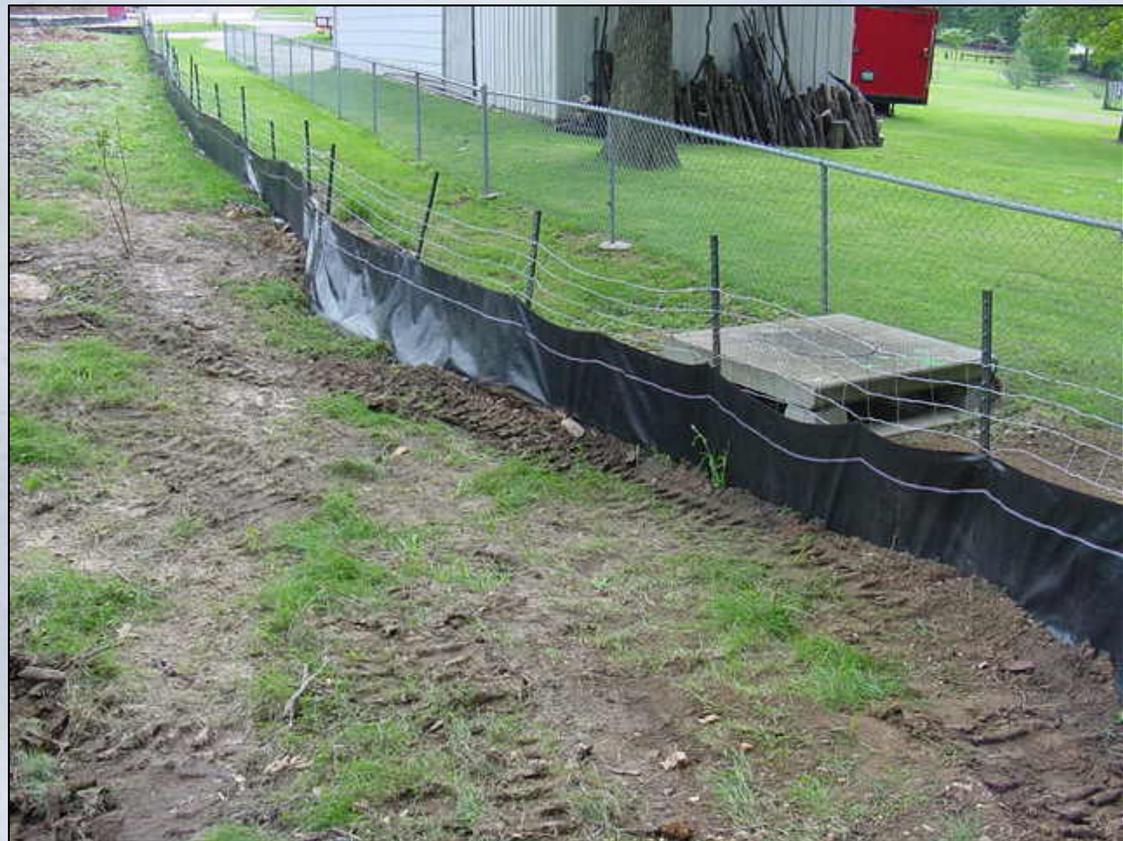
Reinforced Silt Fencing:

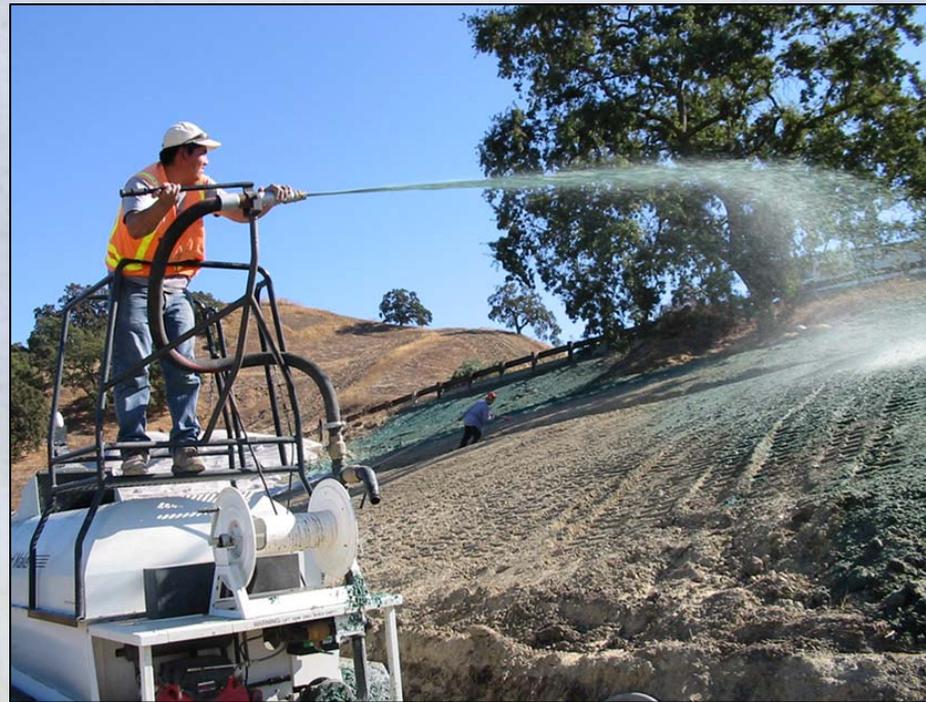
Hydroseed:

Native Seed Mix

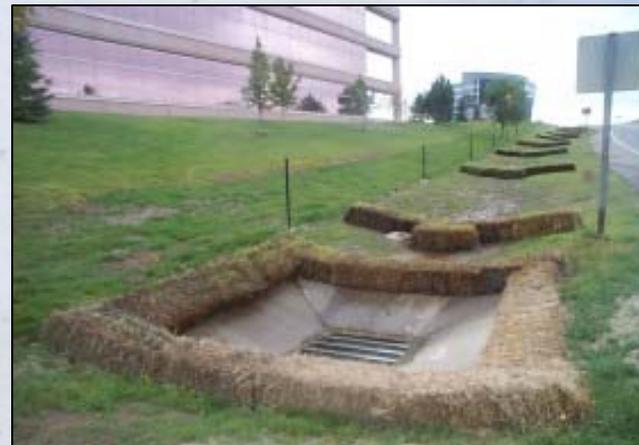
PROTECT STORM DRAINS:

STRAW BAILES

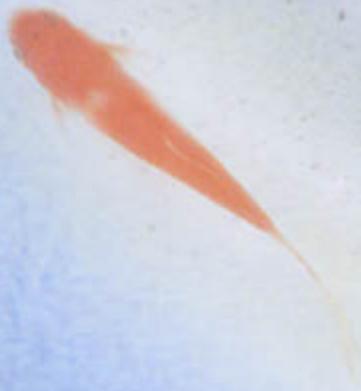
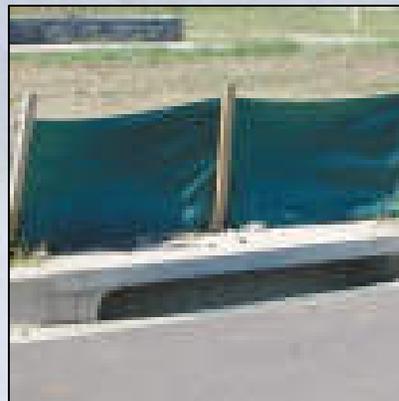
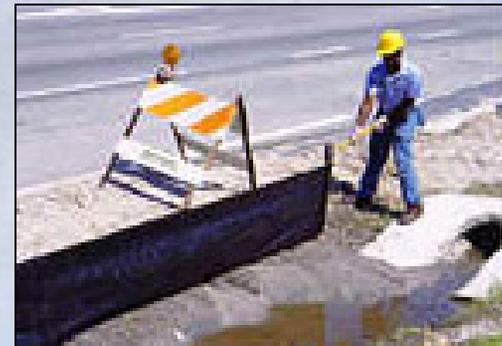
SILT FENCES

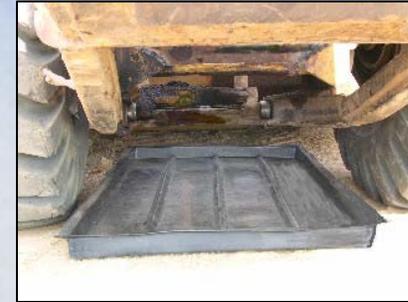
Petroleum:

Secondary Containment

Designated Fill and Repair Location

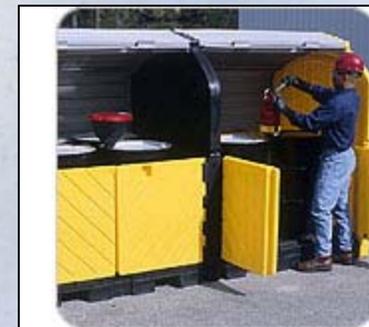
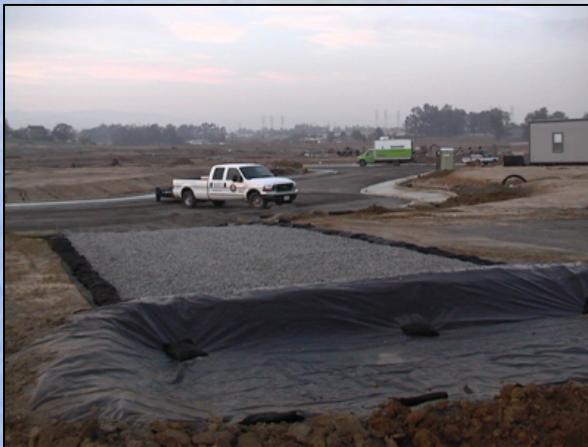
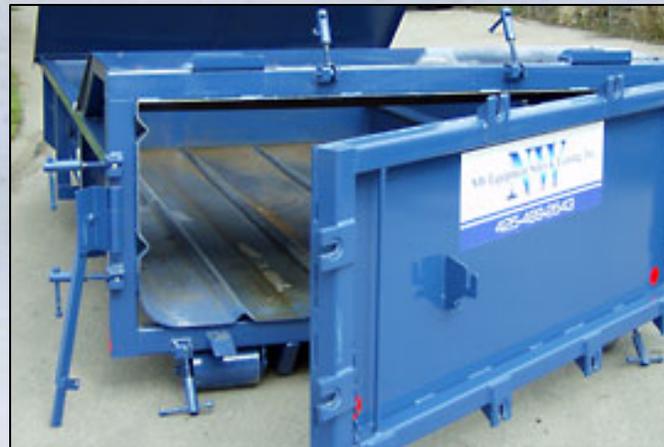
Cement Trucks:

Designated Wash Down Location

Settling Percolation Basin

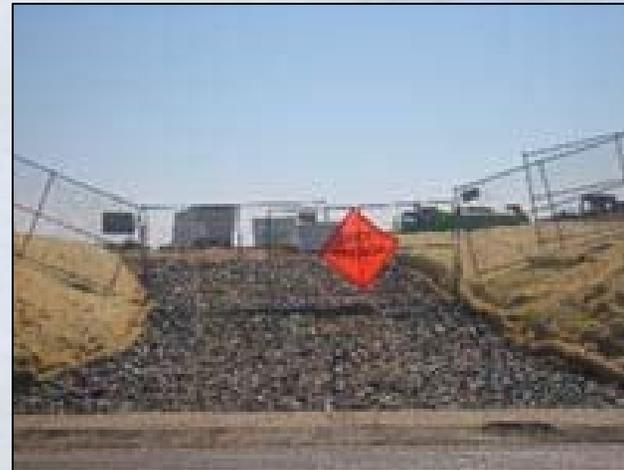
Prevents Tracking onto Roadways

Large Drain Rock

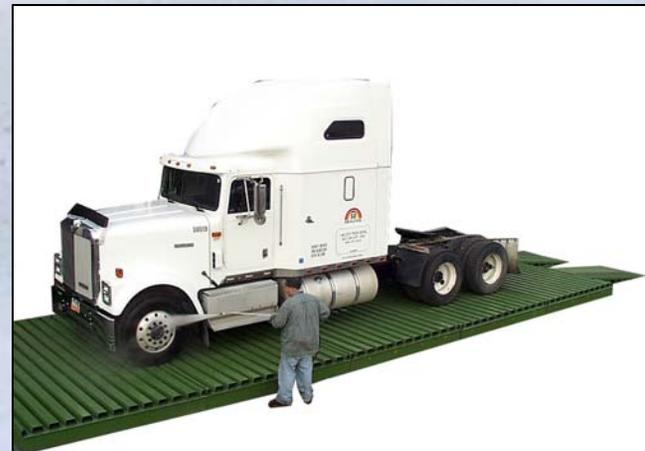
Wash Down Station

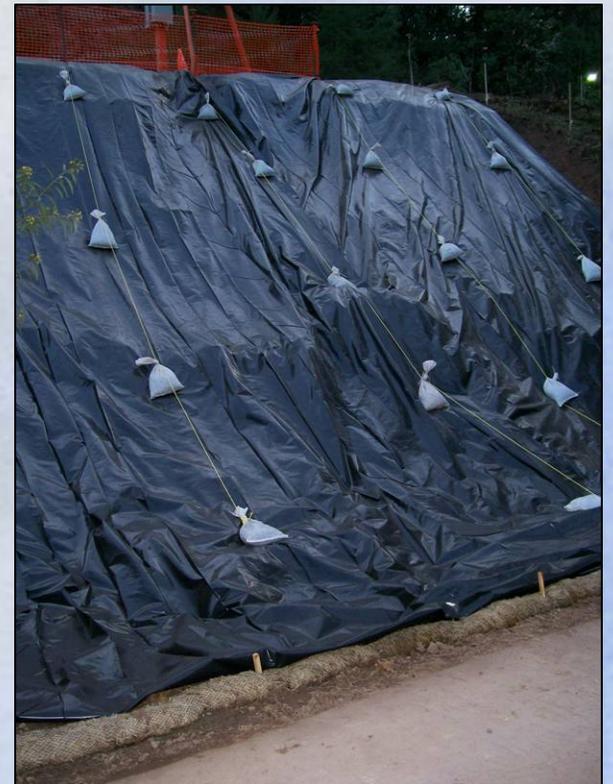
## Plastic Sheathing:

Protects Work In Progress

Must Protect Lower Edge

Keeps Soil Dry

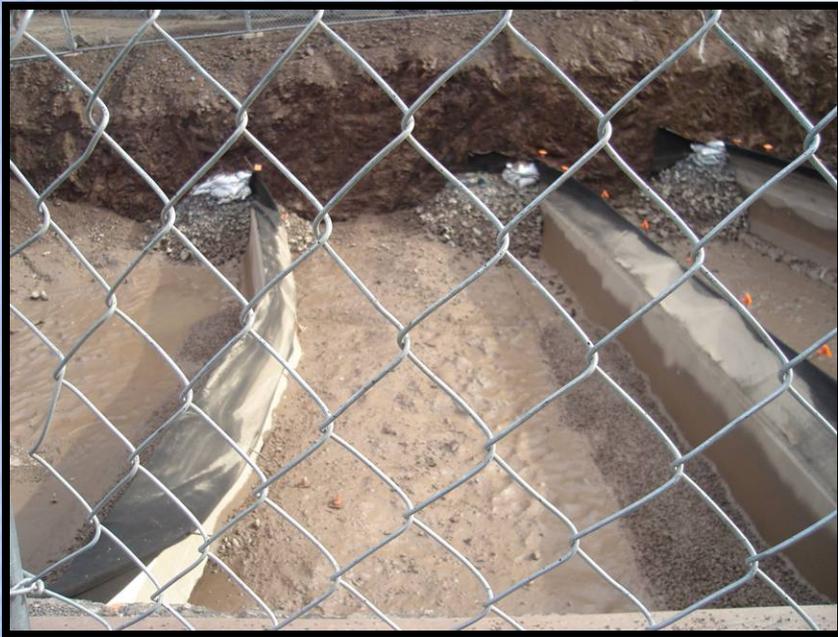
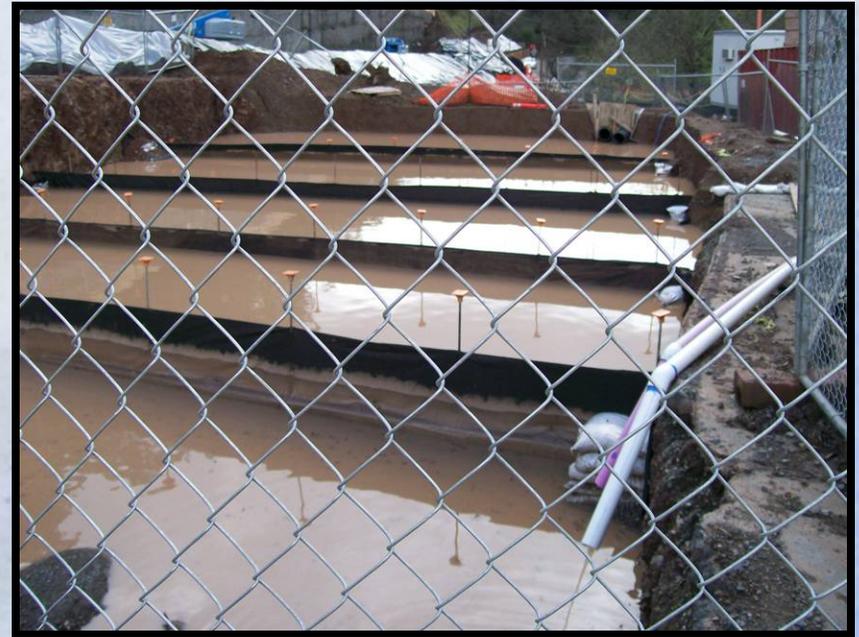
Lower Velocity Causes Sediment to Settle:

Designed for Sediment Loading
