Carmel River Watershed: Water Supply Perspective

**Western States Source Water and
Ground Water Protection Forum**

Tuesday, May 5, 2009

Joseph Oliver, Water Resources Manager

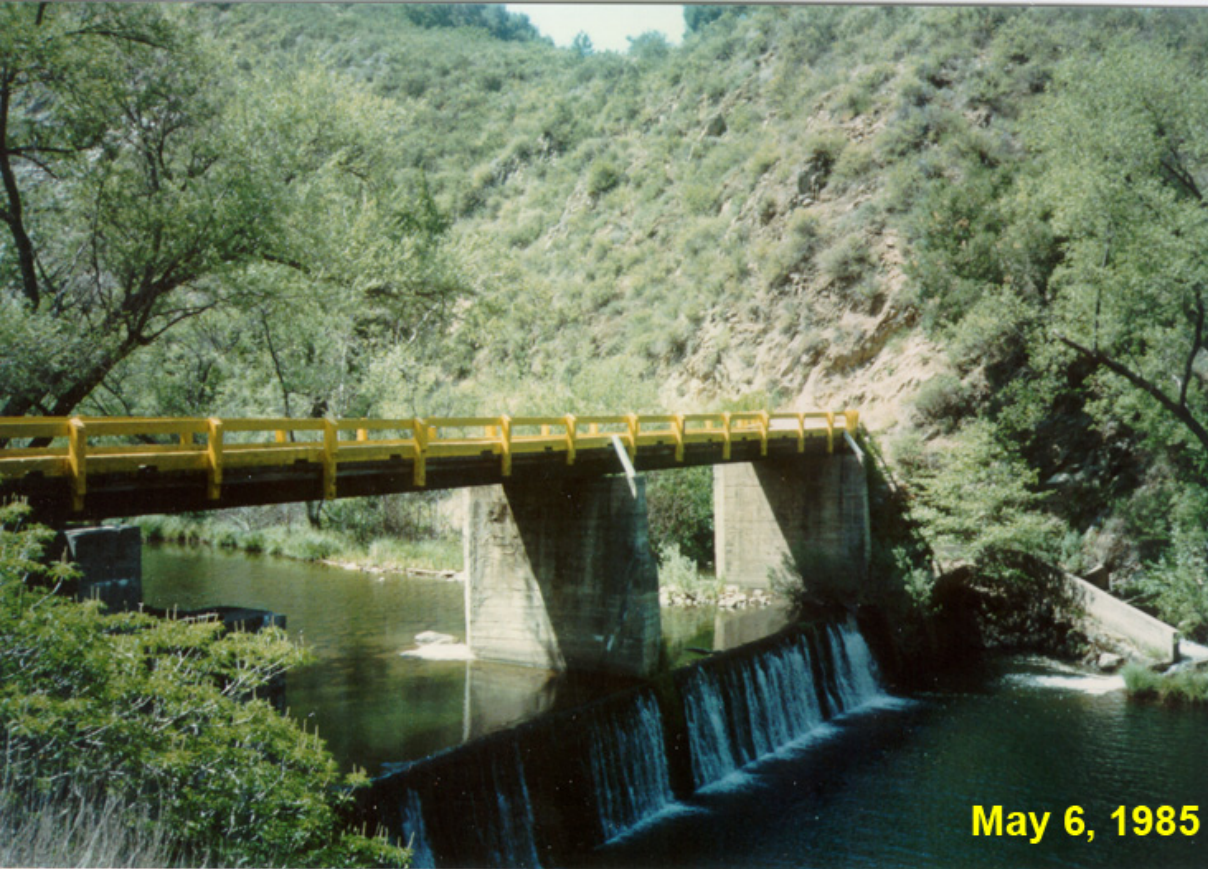
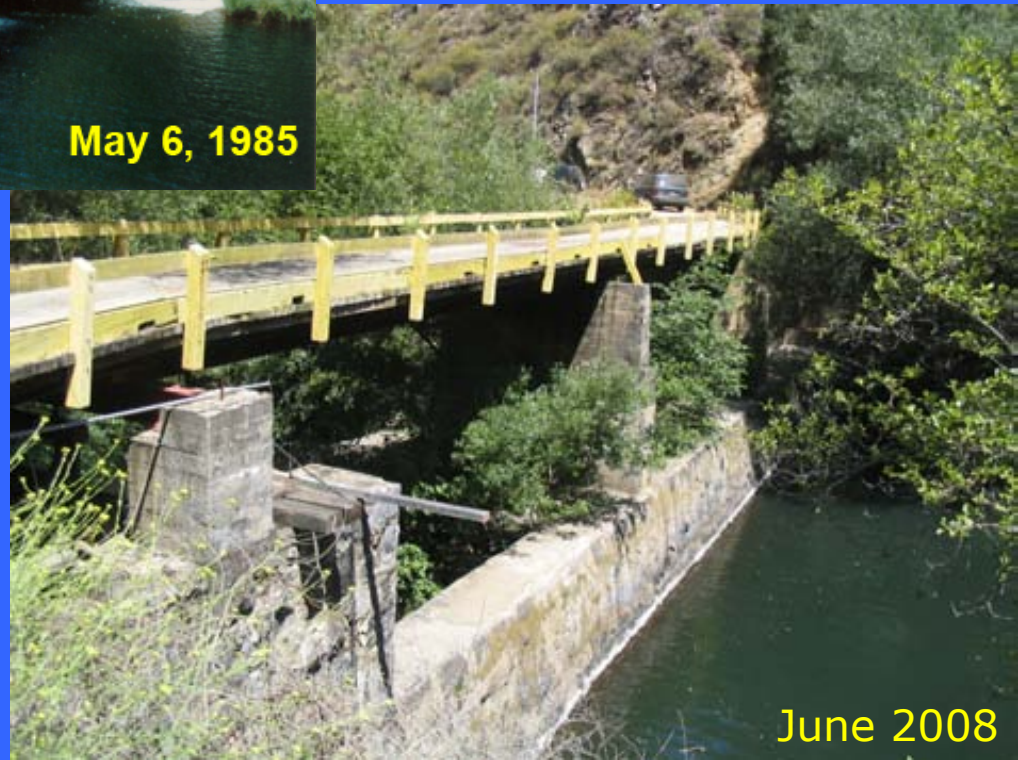
Old Carmel Dam

Constructed circa 1880

- 700 Chinese laborers
- 25 miles of 12-inch iron pipe crossed river in five places
- first Monterey Peninsula municipal water supply

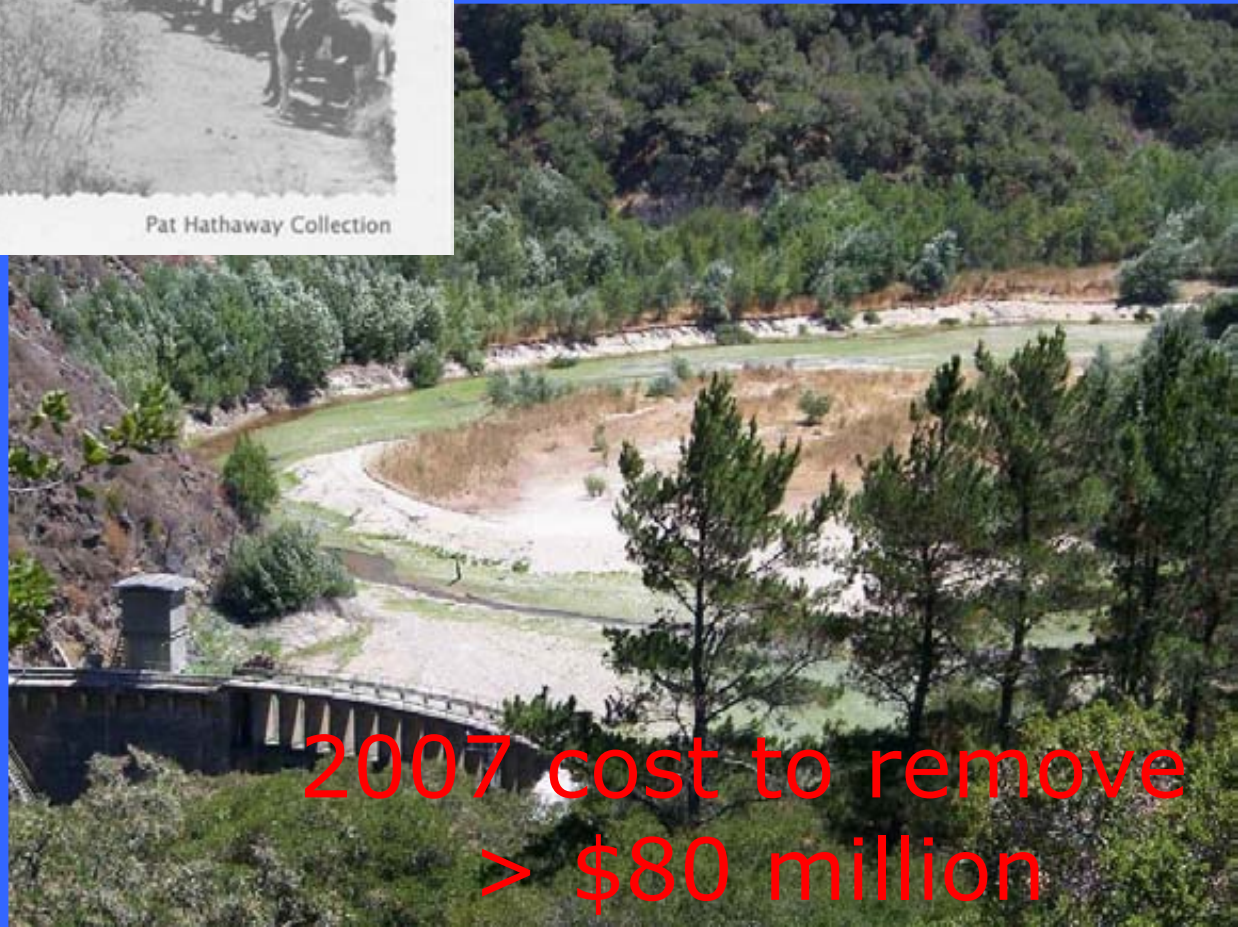
Constructed
in 1921:
\$1-2 million

2007 cost to remove
> \$80 million

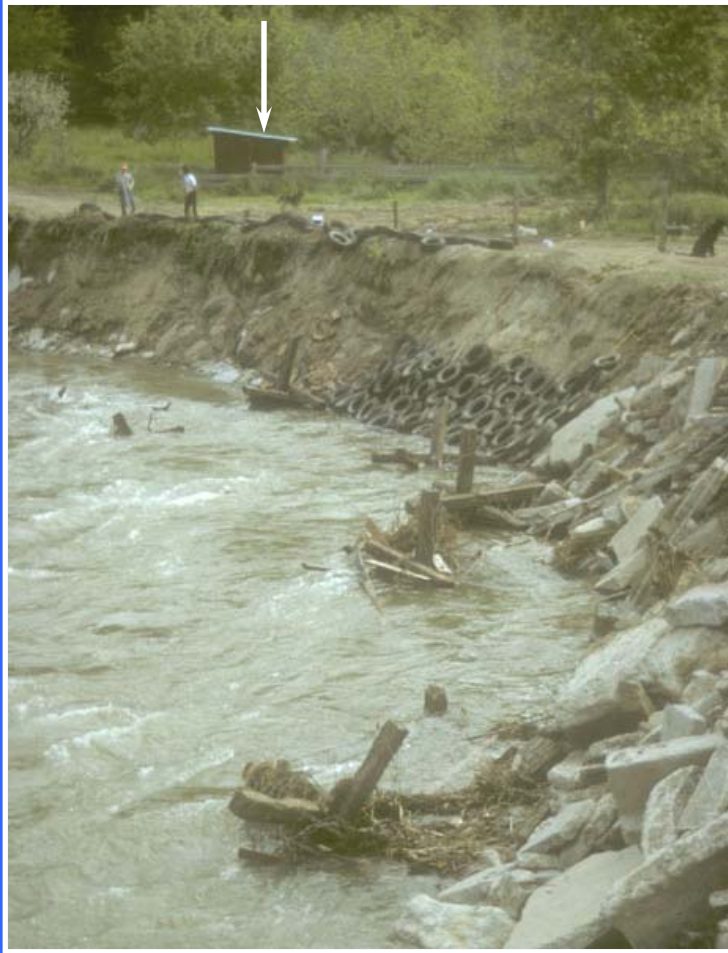
Left - Looking upstream from Schulte Bridge, April 1982. Note tires, wooden jacks, and concrete rubble dumped by the owner on the streambank to slow erosion. A white arrow points to a small brown well pump building at the upper left.

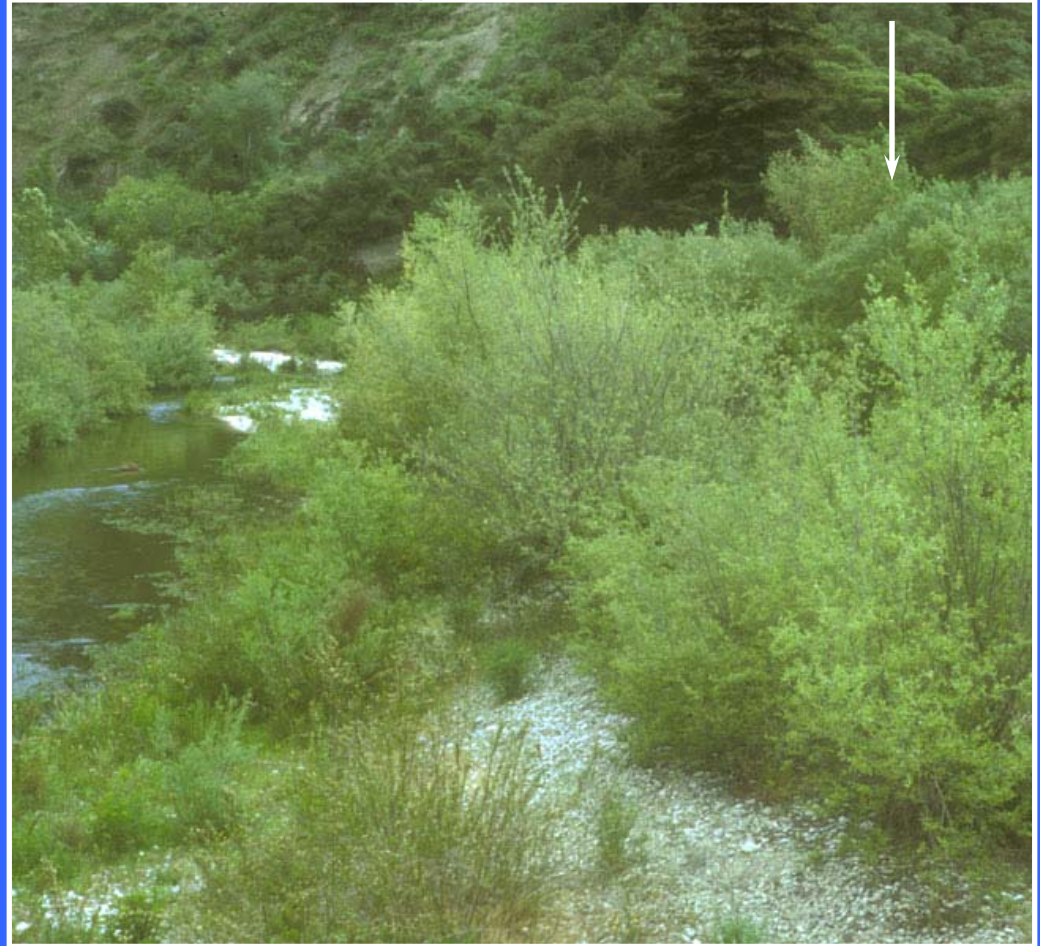
Right - May 2003 - after MPWMD-sponsored restoration work. The arrow shows where the brown well pump building was at the upper left of the 1982 photo. MPWMD continues to maintain and monitor this project area.

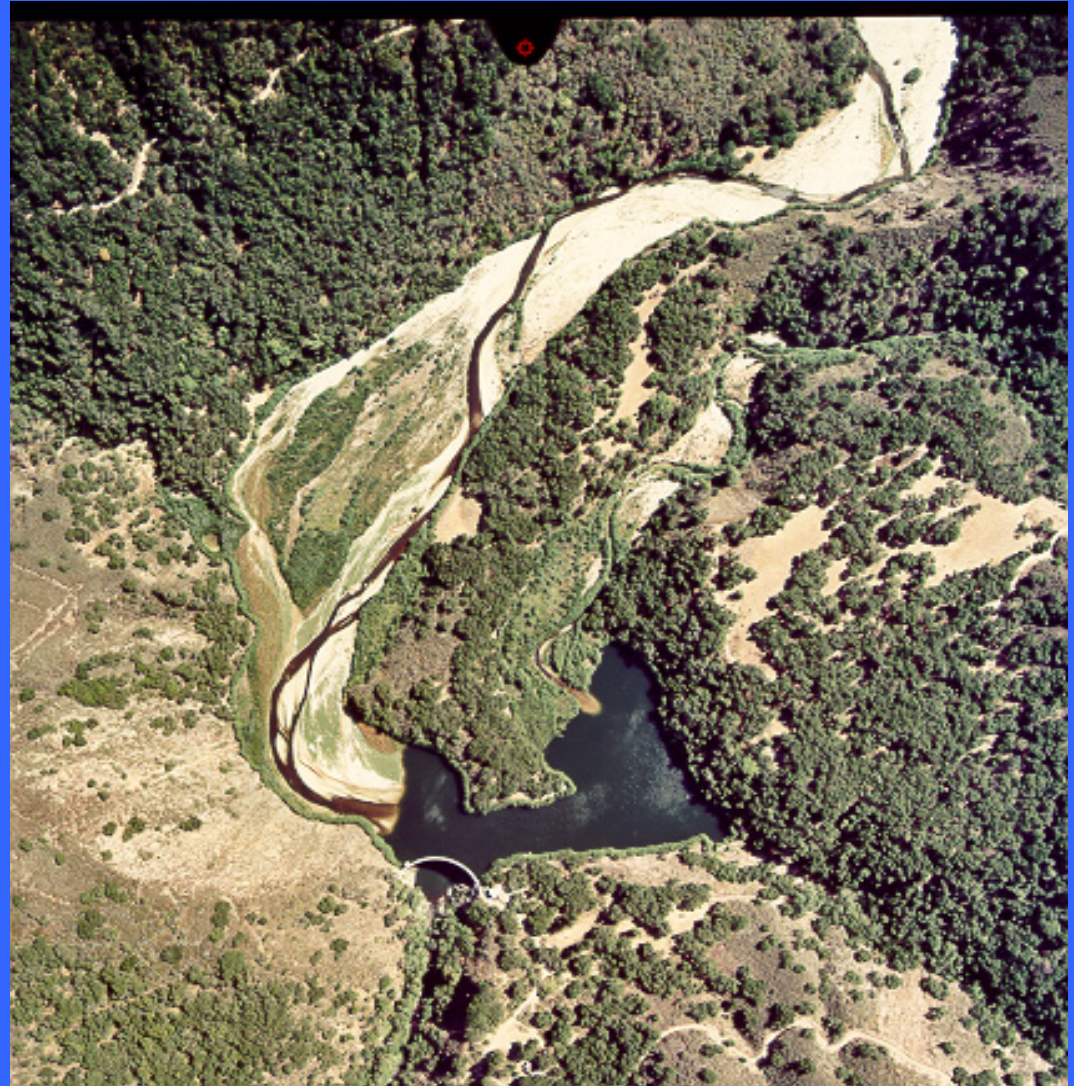
San Clemente Dam and Reservoir

Issue: Reservoir sedimentation and seismic safety

Storage loss

1921: 1,425 acre-feet

2008: < 100 acre-feet

Proposals:

- Strengthen dam
- Remove dam and re-route river
