## *A Guide for School Administrators and Maintenance Personnel*

# **Proper Maintenance, Removal, and Disposal of PCB-Containing Fluorescent Light Ballasts**

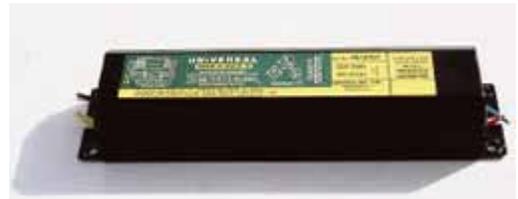
An intact ballast from a typical pre-1979 fluorescent light fixture.

Figure 1 can help you determine whether there may be PCB-containing ballasts in your school. The ballasts are contained within the light fixture (see photos on page 1). Because you may need to remove the fixtures to view the ballasts, select a representative number of ballasts throughout the school to inspect first. Inspection may also be accomplished by removing a portion of the fixture, such as the metal panel covering the ballast. Expand your inspection if you find PCB ballasts. To prevent exposure if leaking ballasts are discovered, wear protective clothing, including chemically resistant gloves, boots, and disposable overalls. Make sure the survey is performed in a well-ventilated area, or provide supplemental ventilation or respiratory protection if necessary to reduce the potential for breathing in fumes. Be sure to keep a record of the areas (e.g., classroom 101) and location of the lights surveyed.

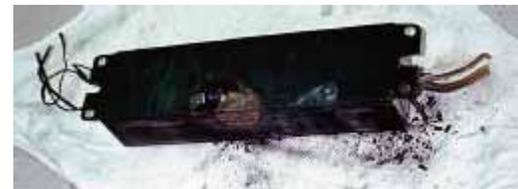
This ballast sparked a fire at a Southern California school in 1999.

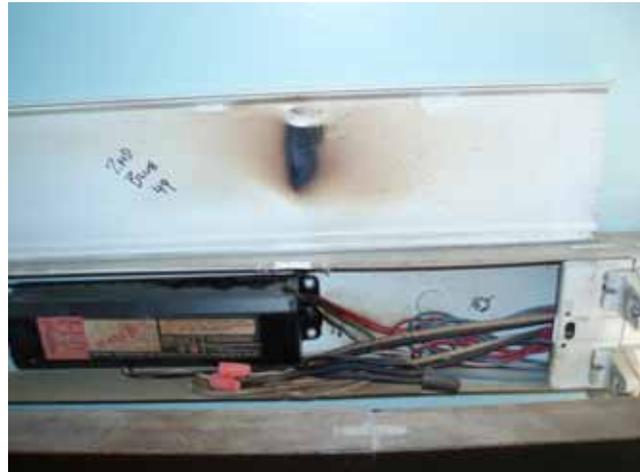
An old ballast that exploded unexpectedly.
