# Refrigerant Management at Giant Eagle

Cliff Timko, P.E.  
Energy Manager

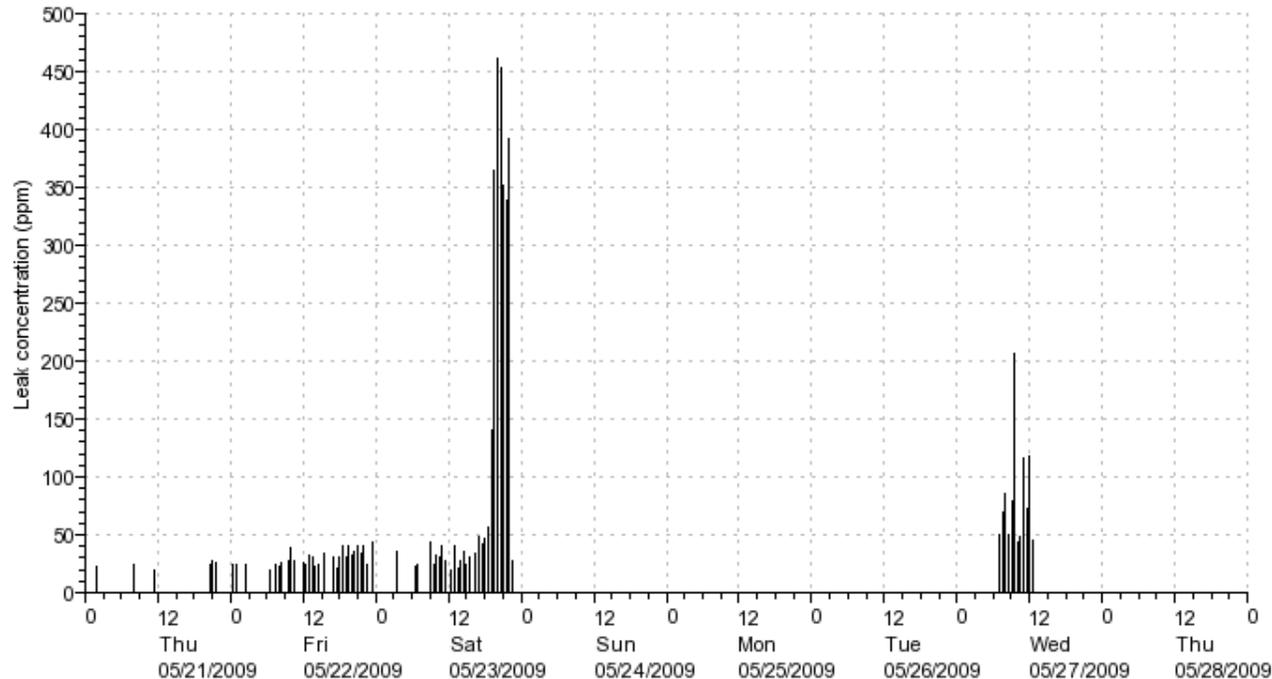
## System Leakage Report

5878 ~ Howe Ave [62,614 sq ft]

From 05/21/2009 to 05/29/2009

Rack C

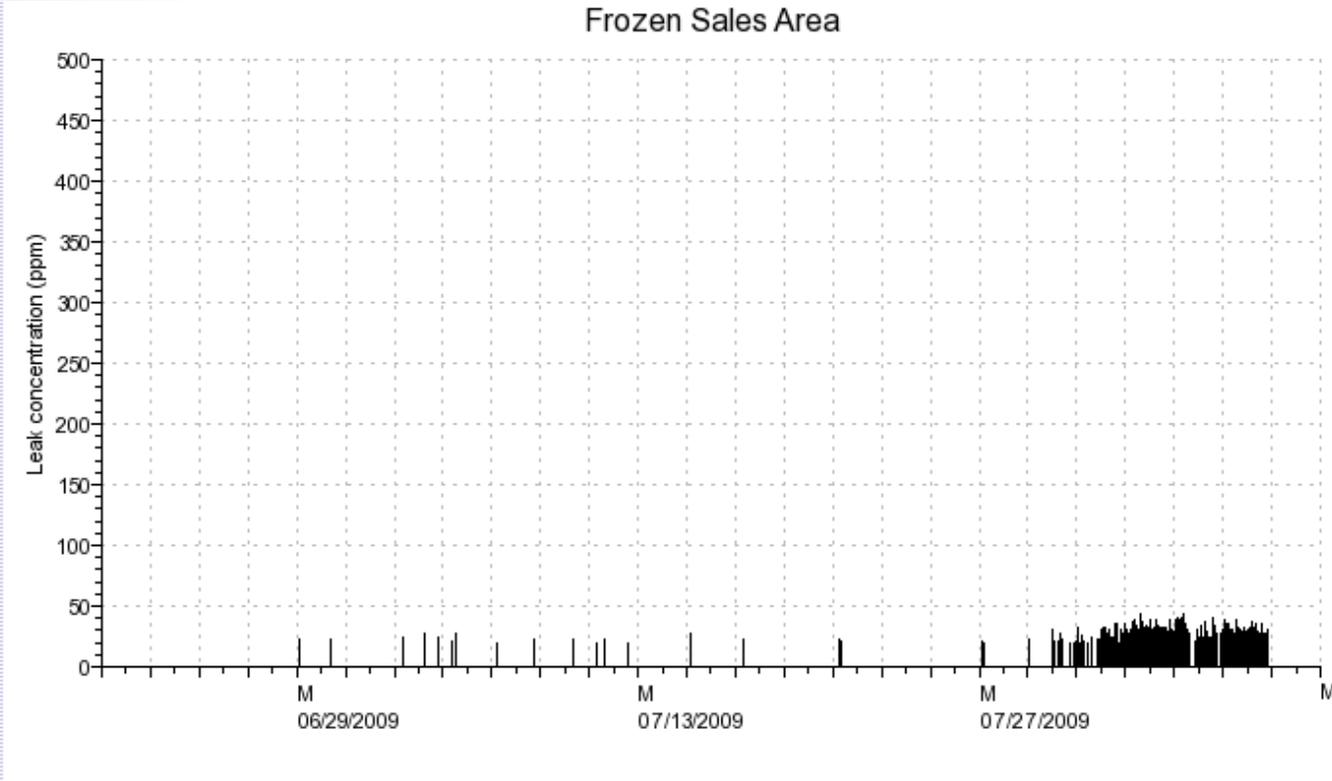
# Graphic View of Monitoring Point

## System Leakage Report

5878 ~ Howe Ave [62,614 sq ft]

From 06/21/2009 to 08/10/2009

Frozen Sales Area

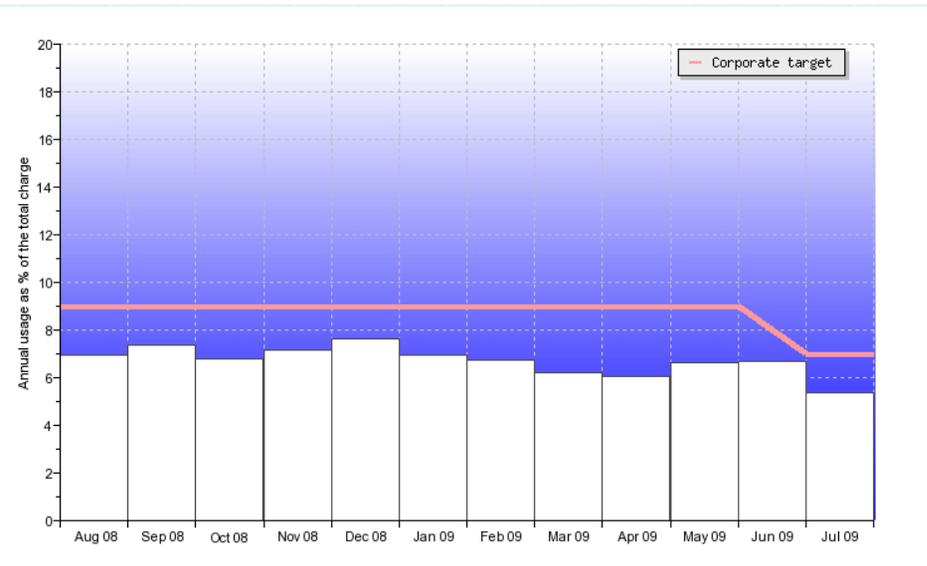
## Contractor A

# KPIs for Service Providers

- You Must Have Targets - All Contractors Are Not Equal

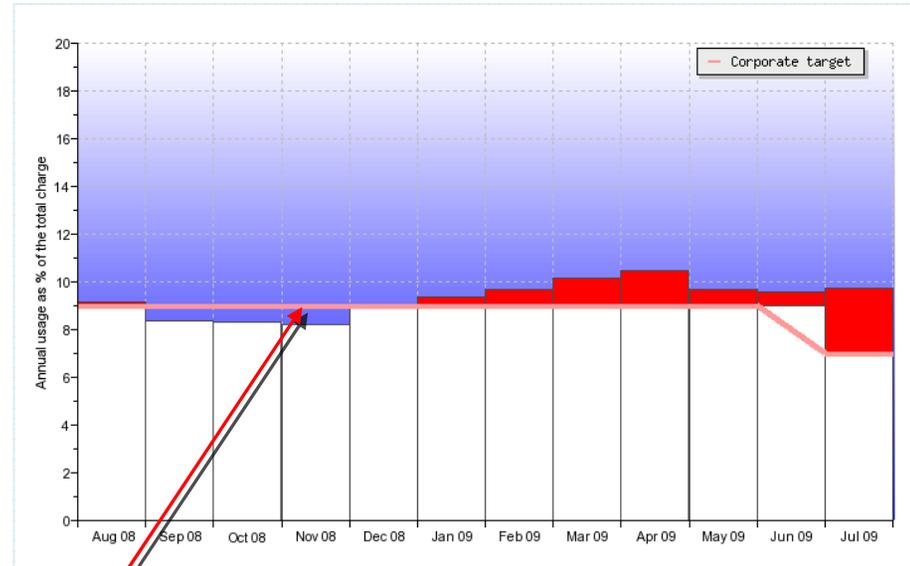
## Contractor B

Corporate Refrigerant  
Usage Target
