## SEWAGE COLLECTION SYSTEM INSPECTION FORM

### Stege Sanitary District

Inspection Date: **March 30 – 31, 2009**

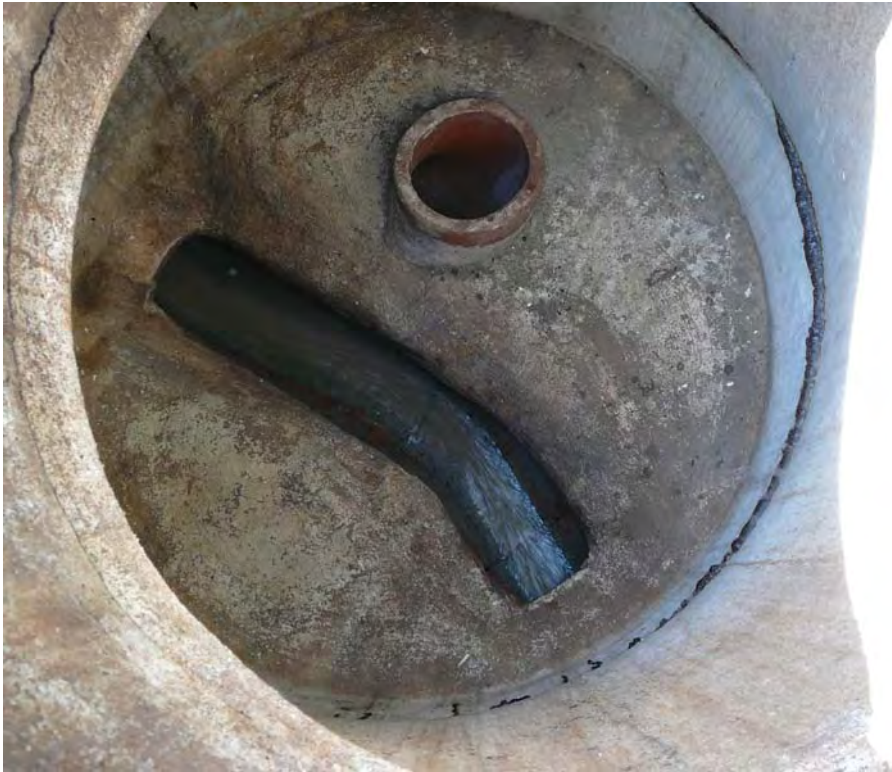
The inspection team also visited capacity spill sites at Stanford & Wellesley (Photos 7 and 8) and Ocean View & Coventry (Photo 9) where spills occurred in 2005. SSD performed work at these locations to prevent further spills. This may not have completely resolved the situation, however. SSD continues to look for ways to address these situations. They smoke tested the Stanford & Wellesley area last fall and found that laterals contribute heavily to I/I in this area. SSD tells the homeowner about the problem but can't make them replace the laterals (outside of a change of ownership). They haven't found many connected roof leaders or sump pumps. They believe that the problem is made worse by holes in the corrugated metal storm drain pipes, which allows storm water to seep into the sanitary sewer.

Photo 7 "Stanford & Wellesley" - Addition of underflow pipe to prevent overflows from this manhole

- Wellesley & Stanford Avenues – believe to be corrected in 2008, increased downstream capacity and added manholes
- 4 Pomona Avenue – replaced downstream line, SSO in 2008 caused by combination of flow and blockage – not really capacity problem

They have done three projects at the Stanford & Wellesley problem area. At the “4 Pomona” SSO location, the model indicates that the site can handle the flow, but it probably doesn’t account for the energy dissipation problem caused by its location at the end of a steep hill.

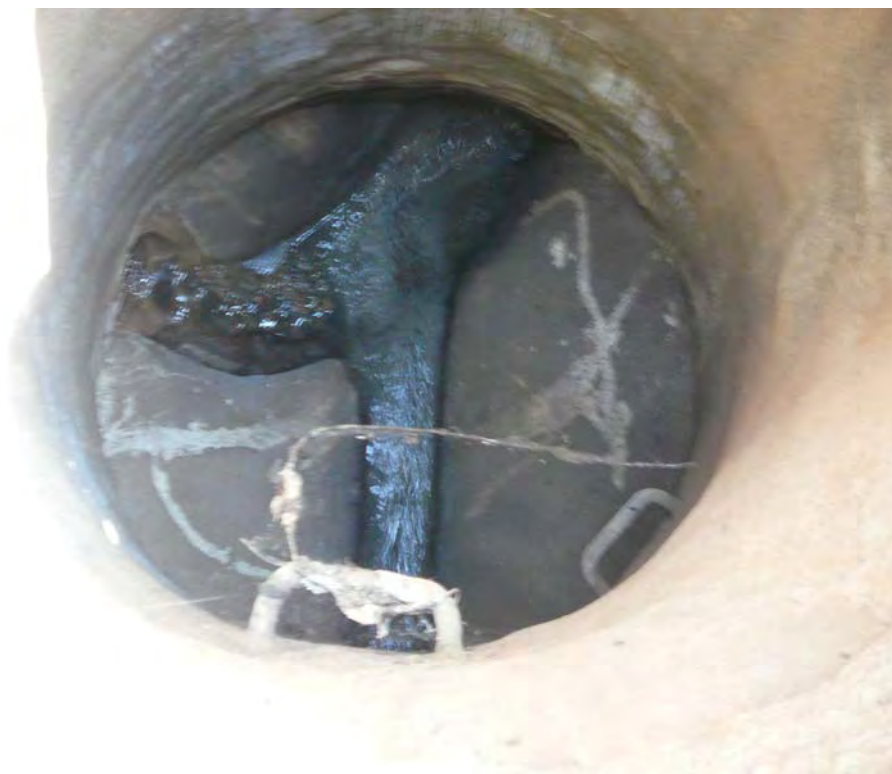
Photo 8 "Stanford & Wellesley" - this is the manhole that now overflows

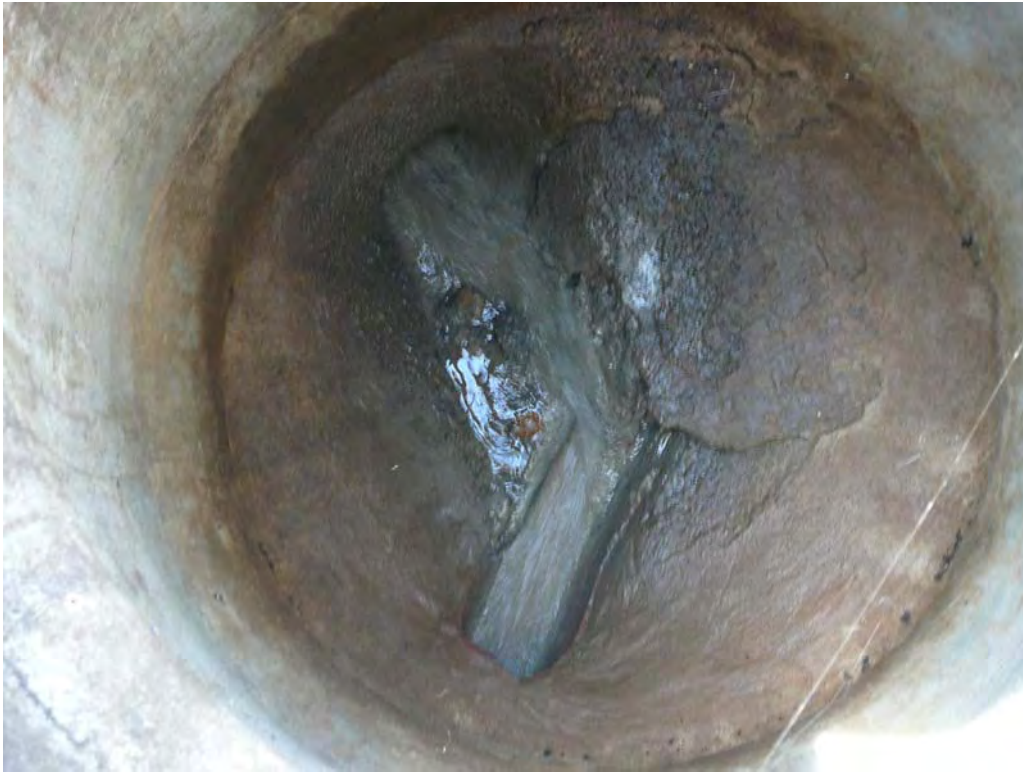
Photo 9 "Ocean View & Coventry" - reduced 90 degree bend in pipe to prevent overflows

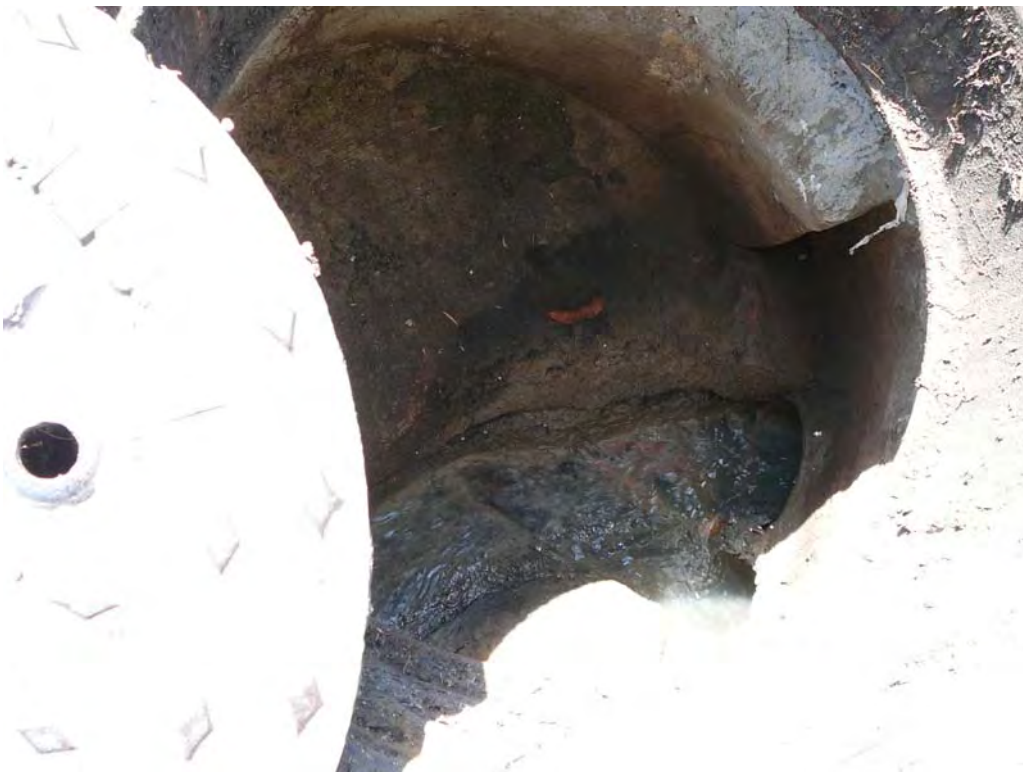
The inspection team visited the “4 Pomona” spill site (see Photo 10). This site also overflowed in 2004 and 2005. The manhole here is only two feet deep. SSD believes the spills occur because of an obstruction, but they have televised the pipes and not found an obstruction. SSD is continuing to investigate.

Photo 10 "4 Pomona" - capacity spill site
