Cleanup Update

Milltown Reservoir Sediments Superfund Site

Issue #77

April 1, 2009

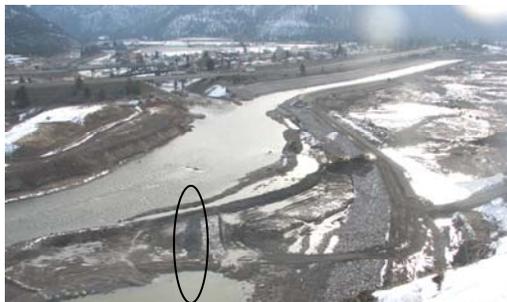
9 am: Pre-breach view of the project area. Oval shows area where coffer dam will be breached.

The spillway coffer dam was breached last Friday, March 27, 2009, one day shy of the year anniversary of the dramatic breach of the Milltown Dam last year (March 28, 2008). Friday's breach lowered the river level about two feet just below the former dam site.

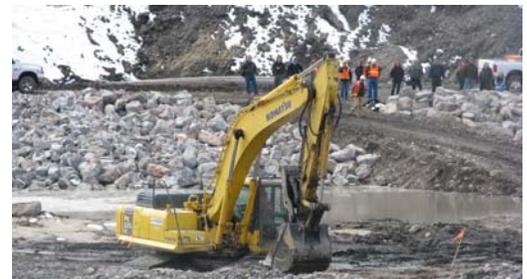
2 pm: Removing material to begin the breach of the spillway coffer dam and divert the Clark Fork and Blackfoot Rivers into the new channel

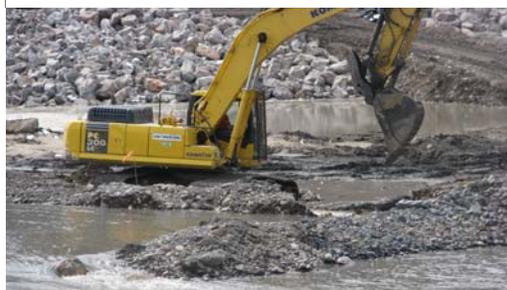
Coffer dam is breached! Clark Fork and Blackfoot Rivers begin to flow into the new channel.

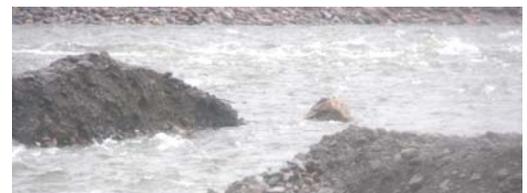
Flow into the new channel increases; By late Friday, about 20% of the river flow was in the new channel (as projected). By Monday, about 70% of the river flow had been diverted into the new river channel at the base of the bluff.

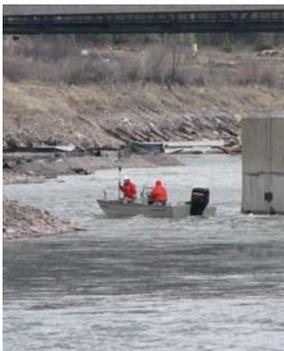
In this photo (left), US Geological Survey staff are shown navigating the Blackfoot River as they set up equipment to measure river velocities during spring flows. EPA is funding this work to evaluate pier scour and estimate the ability of fish to swim upstream (fish passage) on the Blackfoot River during

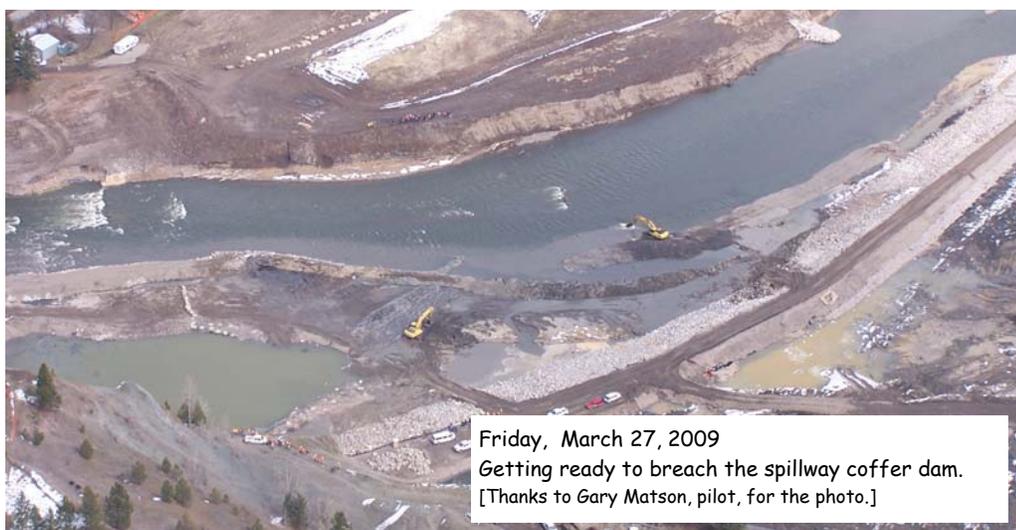
Friday, March 27, 2009
Getting ready to breach the spillway coffer dam.
[Thanks to Gary Matson, pilot, for the photo.]

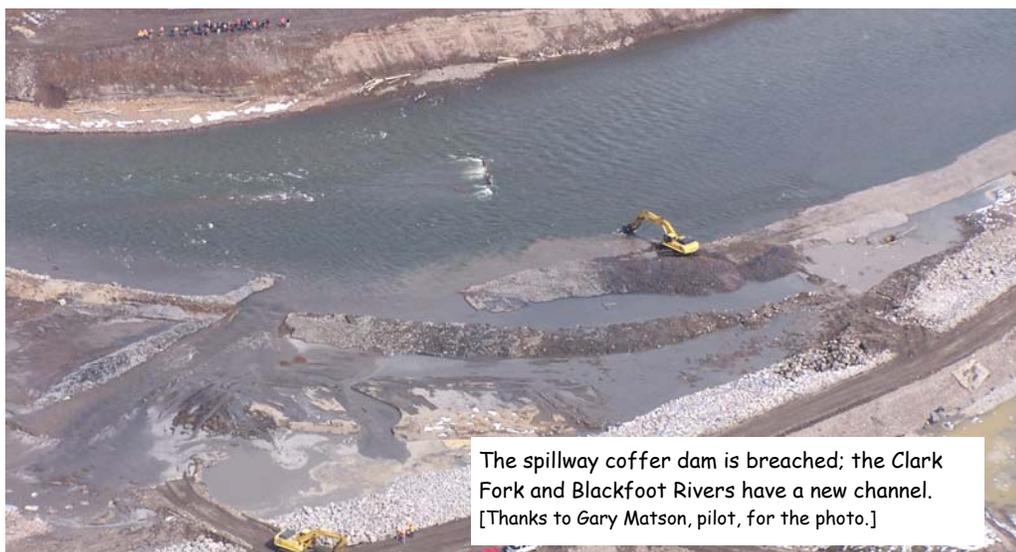
The spillway coffer dam is breached; the Clark Fork and Blackfoot Rivers have a new channel.
[Thanks to Gary Matson, pilot, for the photo.]
