**UNITED STATES ENVIRONMENTAL PROTECTION AGENCY
REGION IX
75 Hawthorne Street
San Francisco, CA 94105**

**WASTE MANAGEMENT DIVISION
RCRA ENFORCEMENT OFFICE**

Purpose:	TSCA Section 6(e), PCB Inspection
Facility:	Veolia Environmental Services
Facility Address:	1704 West 1 st Street Azusa, CA 91702
Mailing Address:	107 South Motor Avenue Azusa, CA 91702
EPA ID Number:	CAD 008 302 903
Date of Investigation:	July 15, 2009
EPA Representatives:	Jim Polek (415) 972-3185 polek.jim@epa.gov Kaoru Morimoto (415) 972-3306 morimoto.kaoru@epa.gov Chris Rollins (415) 947-4166 rollins.christopher@epa.gov
DTSC Representatives:	Tina Roberson-Holefield (818) 717-6579 troberso@dtsc.ca.gov Carolos Ortega (818) 717-6698 cortega@dtsc.ca.gov

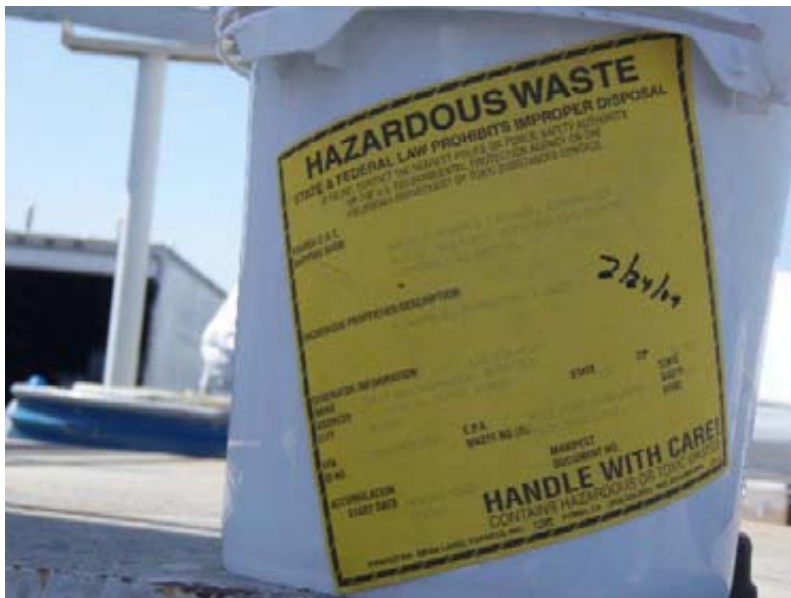
Prior to sampling, the inspectors walked through the facility and inspected the PCB storage shed in the drum storage area, the truck loading area, and the 10-day storage area. Three containers were in the PCB storage shed and two of them were properly labeled. However, a one-gallon poly container had a hazardous waste label indicating it contained PCBs, but it did not have a PCB label (see photo below).

- In the PCB storage shed, a one-gallon poly container had a hazardous waste label indicating it contained PCBs, but it did not have a PCB label.
- In the on-site laboratory, two garbage bags of PPE were ready to be taken out to the PCB shed and one of the bags did not have a PCB label on it.

- On July 16, 2009, the facility emailed a photograph documenting that the one-gallon poly container of PCB waste had been properly labeled.
- During the inspection, the bag of PPE was labeled as PCB waste.

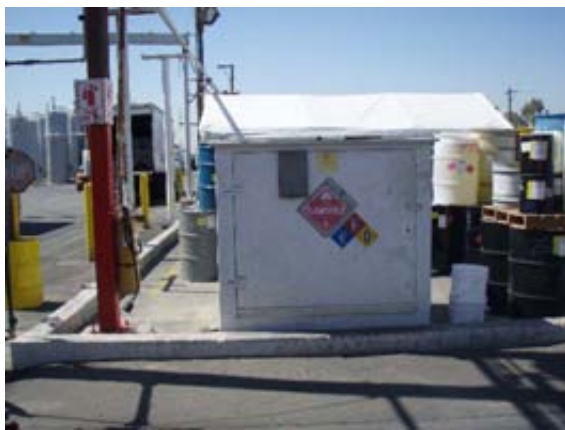
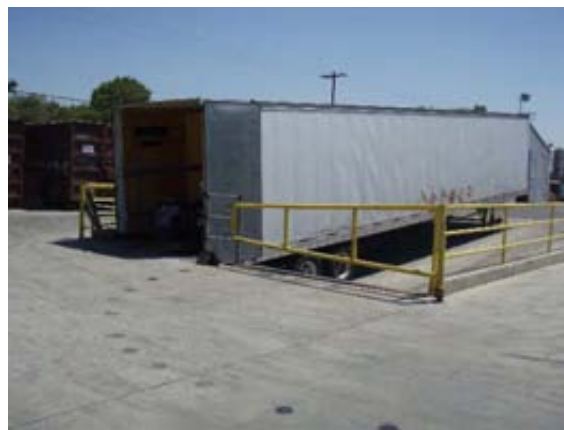
During the facility inspection, the inspectors identified the PCB storage shed and the truck loading area as potential locations for sampling. General photographs of these two areas are shown below, from left to right, respectively.

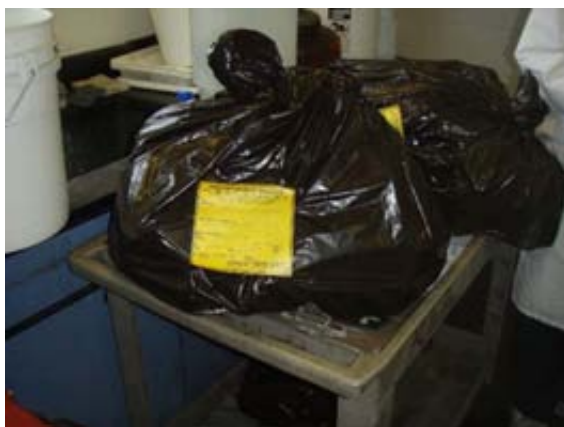
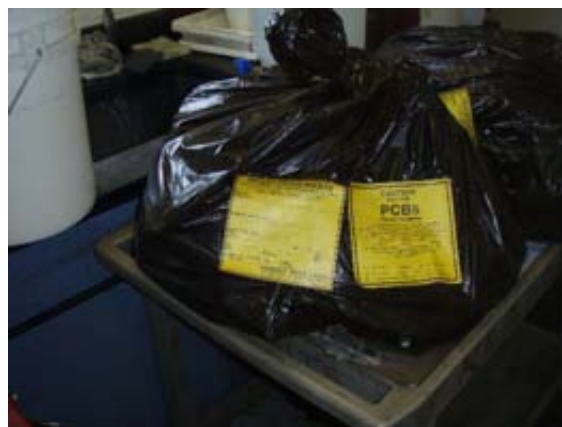
After collecting samples, the inspectors were shown the facility's laboratory and were given an overview of the laboratory's sampling procedures by Dev Maheshwari, the laboratory supervisor. All waste associated with PCB sampling is assumed to be PCB waste. This waste includes personal protective equipment (PPE), acids, solvents, and vials. The laboratory PPE is removed once per week. At the time of the inspection, a cart with two garbage bags of PPE were ready to be taken out to the PCB shed. One of the bags did not have a PCB label on it. The facility corrected this potential violation during the inspection (see before and after photographs below).
