# APPENDIX A

## EXPERIMENT-LEVEL REPORTS

# Experiment-Specific Reports for Interior Window Replacement #1

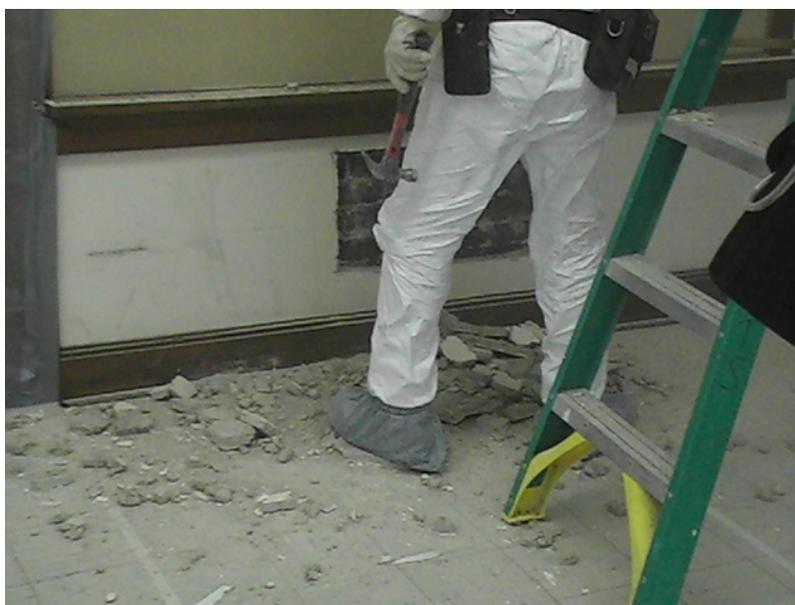
Since the support behind the plaster was masonry, only the plaster was removed during the work, resulting in a cut-out approximately one inch deep. The holes were taped up during the cleaning stage to avoid further contamination by falling debris. An off-duty Columbus police officer was present.

**Figure A-1. Wall cut out at school**

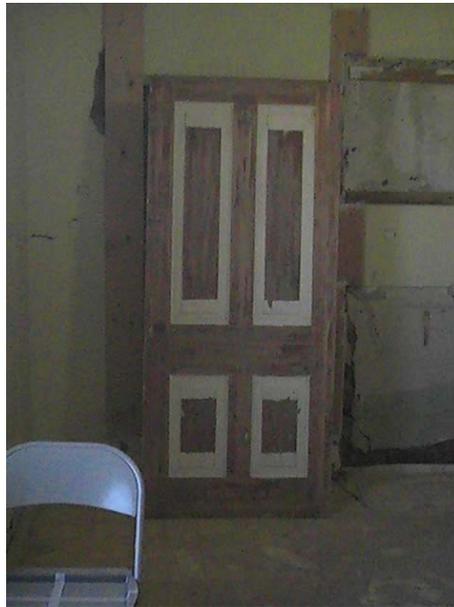
Approximately two linear inches of paint along all inside edges of the door panels (four per door) could not be removed, due to the size and configuration of the planer. Although door planing was classified as a medium level interior job, the process generated tremendous amounts of dust, which settled on all visible surfaces of the Work Room. An off-duty Columbus police officer was present.

**Figure A-2. Door with paint removed**

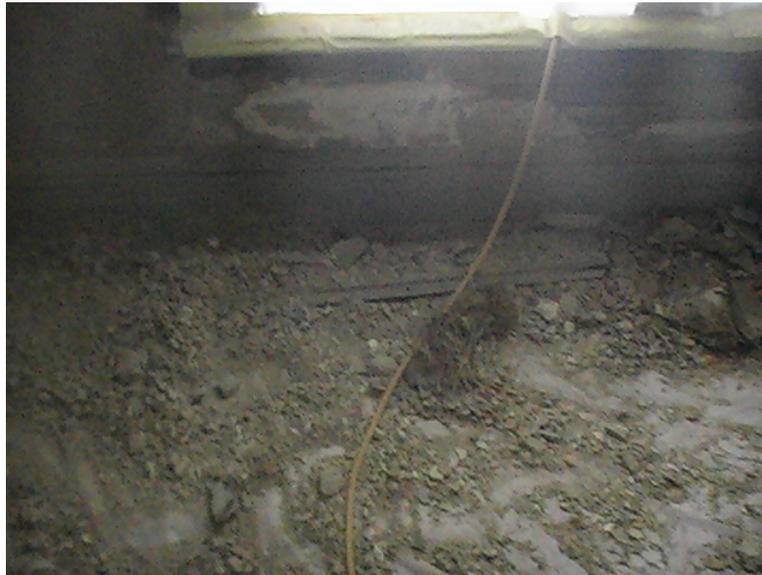
The job presented challenges as the workers attempted to scrape all paint off the wall, which took a long time and resulted in the wall crumbling in places. The workers also thought the plaster wall might contain asbestos. As a result, a plaster sample was obtained and quickly analyzed by a laboratory. When no asbestos was found in the sample, work resumed. Because

**Figure A-3. Work room floor following removal of paint**

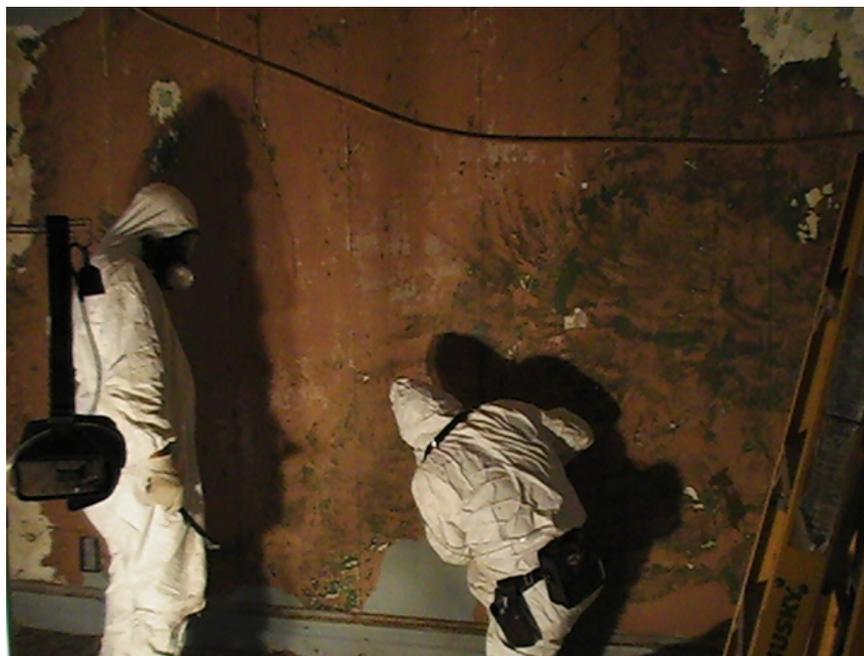
Paint was removed from one wall of a second floor room. Using dry scraping tools, deteriorated paint was removed in preparation for repainting, but not all paint was removed down to the plaster, if intact.

**Figure A-4. Dry scraping paint from wall**

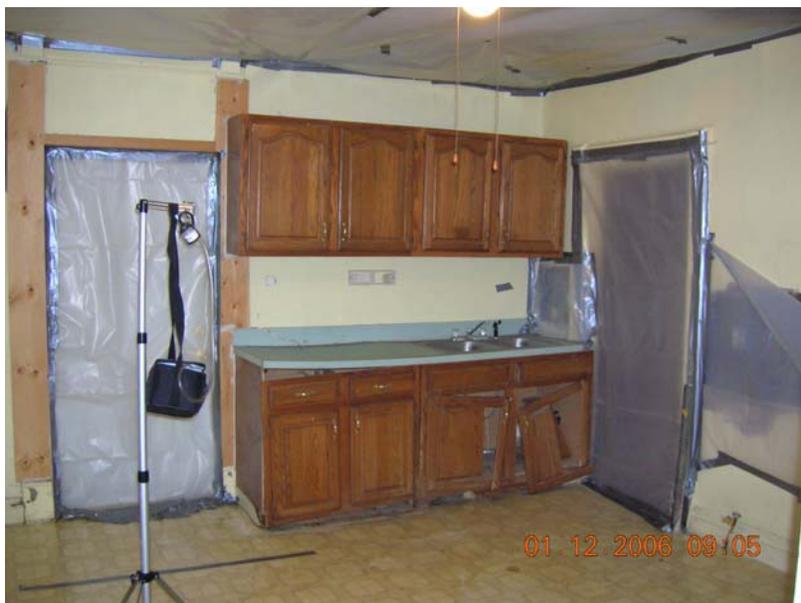
The job included the removal of a counter top, sink and cabinets from a first floor kitchen.

**Figure A-5. Kitchen cabinets prior to removal**

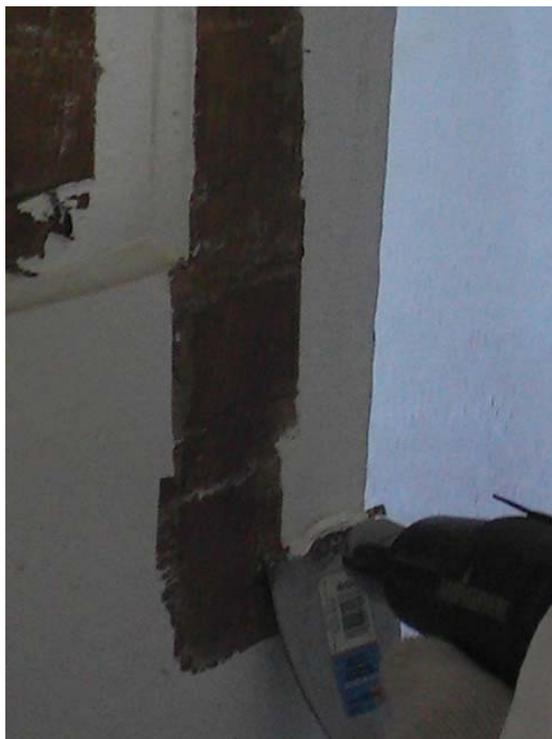
Approximately 53 ft<sup>2</sup> of paint was removed from the baseboards, window trim, fireplace, and door trim of a second floor bedroom using two heat guns operating at temperatures above 1100°F.

Figure A-6. Using chisel to remove heated paint from door

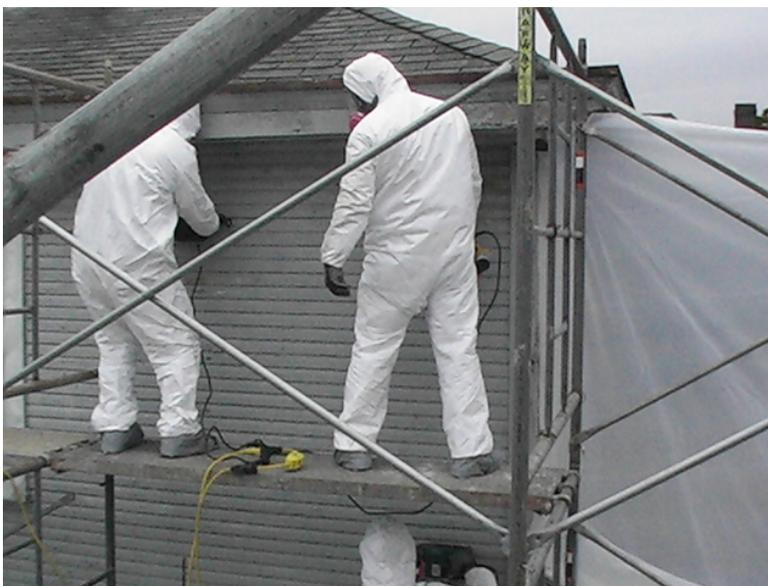
The workers removed deteriorated paint from 100 ft<sup>2</sup> on a 2-story section of wall at a single family home using power grinders that used metal disks rather than sandpaper. The north wall that they removed paint from was about 20 feet high. The scraping generated a large amount of paint chips and dust throughout the entire containment zone. It took approximately 2 hours to complete the paint removal.

**Figure A-7. Power grinding paint from 2<sup>nd</sup> story wall**

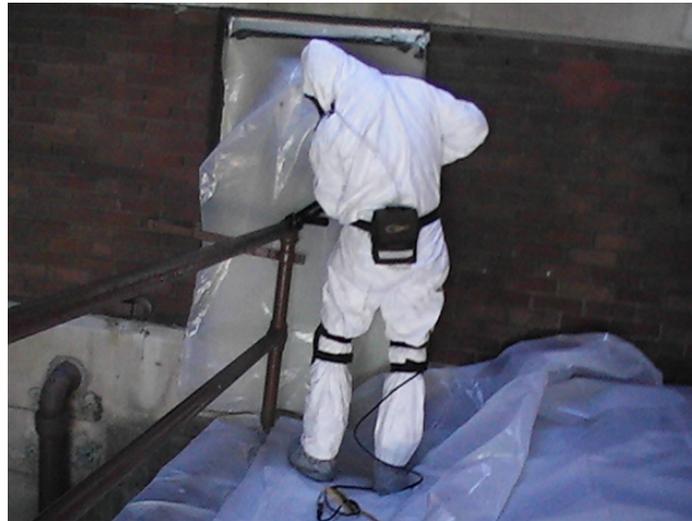
The workers removed deteriorated paint from a metal railing outside a school using a needle gun tool. The railing, located in a courtyard surrounded on three sides by 3-story brick walls, extended about 20 feet from the wall opposite the opening. The railing is set in concrete raised about 1 foot off the ground. One side of the raised concrete was a drop to a set of stairs and a patio about six feet below the base of the railing. The paint removal work took approximately 4 hours to complete.

**Figure A-8. Removing paint from railing**

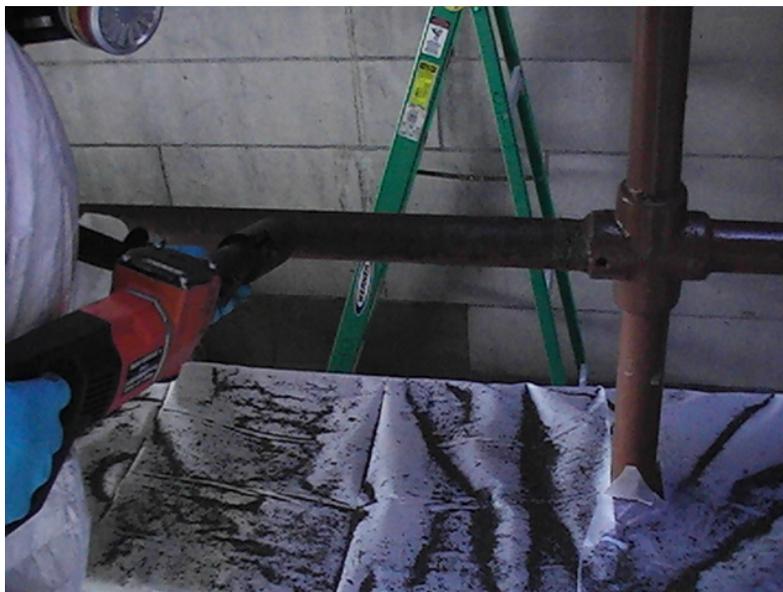
**Figure A-9. Close-up of railing paint removal**

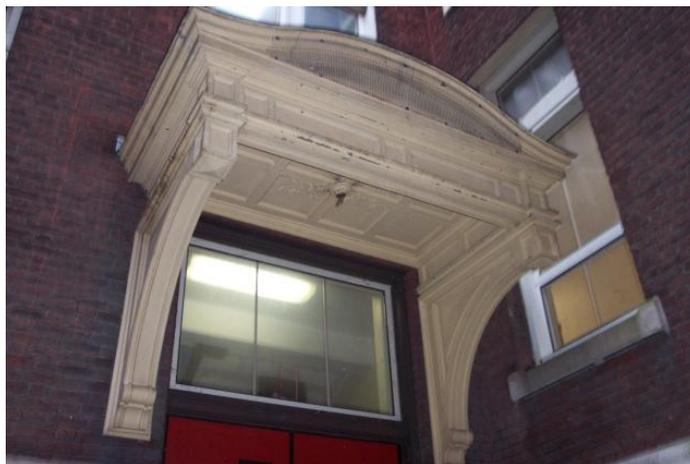
Two workers removed paint from an exterior awning above a doorway outside a school using heat guns above 1100 degrees Fahrenheit. The awning is located in the same courtyard as the other two exterior jobs at the school that is surrounded on three sides by 3-story brick walls. The awning extends about 4 feet from the wall above the doorway. Paint was removed from trim, the ceiling, and the ornate painted supports. Work was halted after approximately five hours of paint removal work even though only about 30 ft<sup>2</sup> of surface area was worked on.

**Figure A-10. Awning prior to work**

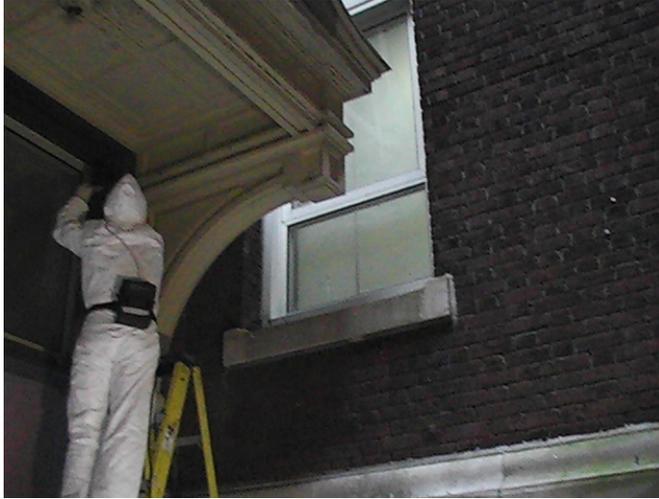
**Figure A-11. Removing paint from awning using heat gun**

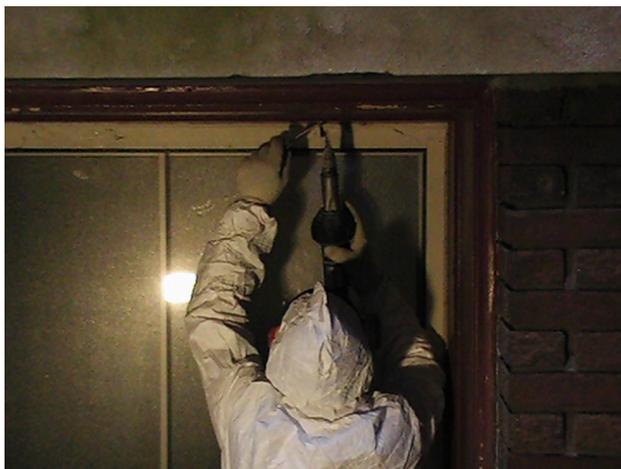
The workers removed paint from all flat surfaces on an exterior door and door casing using heat guns operated at about 1000 degrees Fahrenheit. The door, which opens into the ground level of a closed school, was located at the bottom of a set of stairs. Small areas of paint remained door panels and curved sections of door casing. It took approximately 1 hour and 20 minutes to set up the containment area and 4 hours to complete the paint removal.

**Figure A-12. Removing paint from door trim using heat gun**

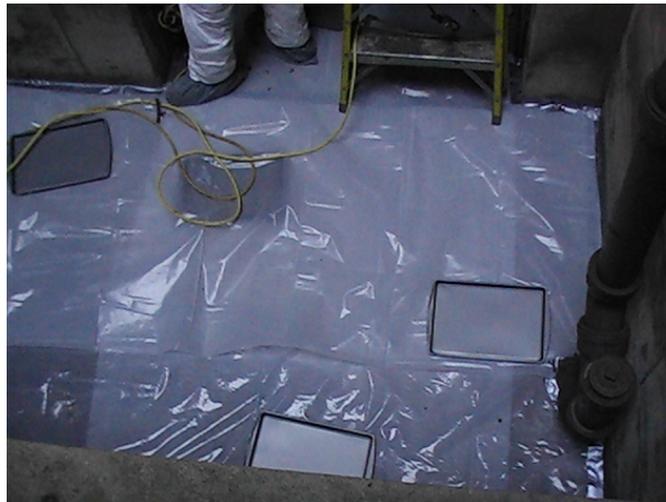
**Figure A-13. Dust collection trays outside door paint removal job**

Sample Type	Dust Tray Lead Levels (µg/ft <sup>2</sup> )			
	Sample 1	Sample 2	Sample 3	Average
Top Rule Plastic (1-5 ft from door)	130,674,045*	1,133,090*	2,538,052*	44,411,623.2
Under Rule Plastic (2-5 ft from door)	63,283.5	1,840.0	238.6	21,787.4
Outside Rule Plastic (7-8 ft from door)	2,692,069*	26,586.6	16,234.7	911,630.1
