2010 INTEGRATED REPORT

CLEAN WATER ACT Sections 303(d), 305(b) and 314

Guam Environmental Protection Agency
P.O. Box 22439 • Barrigada, Guam 96921
Tel: (671) 475-1658 • Fax: (671) 475-8007

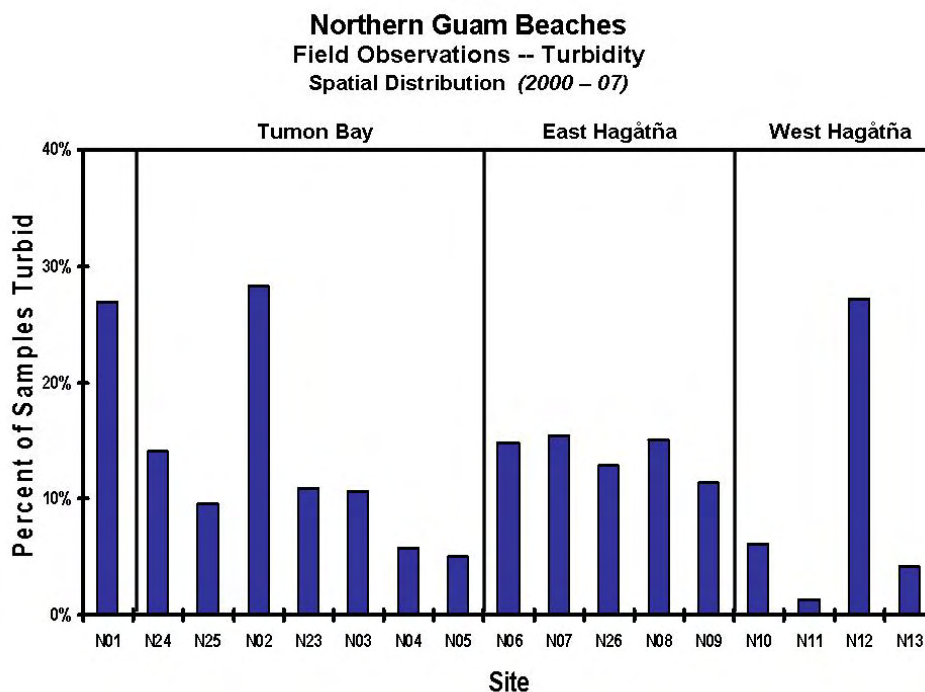
Figure 6-3 provides a spatial summary of the presence or absence of turbidity information reported by Guam EPA staff. This shows the percent of time at a given location where turbidity was present at the time the bacteria sample was collected. As can be seen, there are certain areas where turbidity seemed more prevalent (e.g., N01: Tanguisson Beach, N02: San Vitores Beach, N12: Hagåtña Boat Basin)

Figure 6-3. Spatial analysis of turbidity field observations during bacteria sampling events.

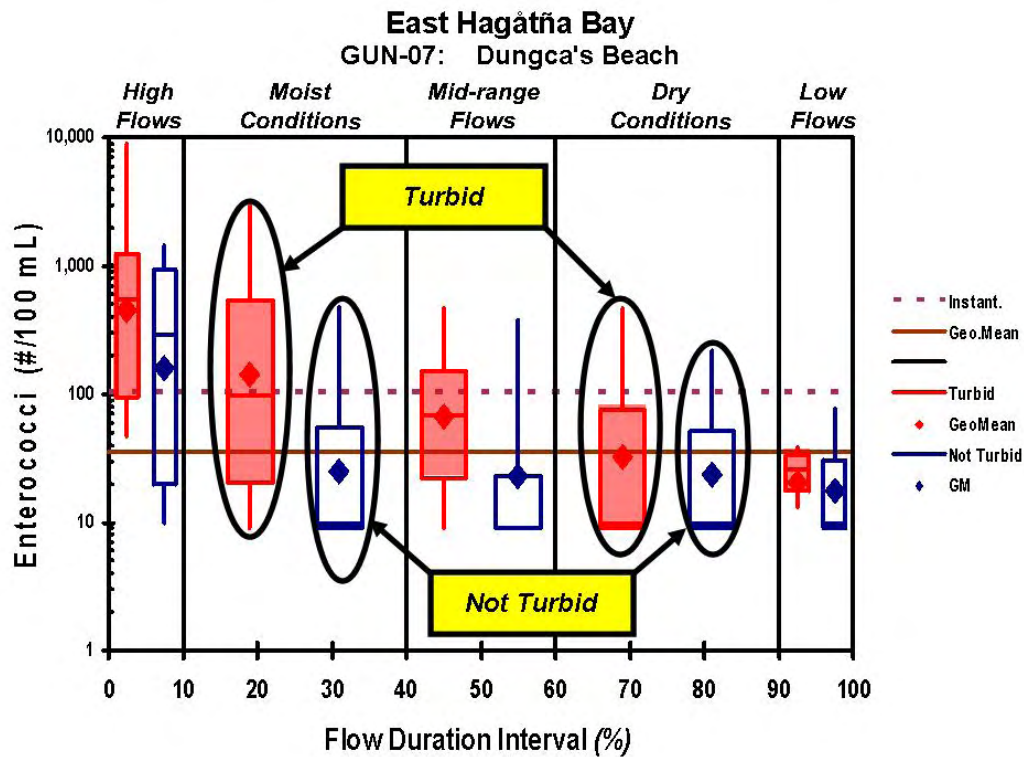
As an example, Figure 6-4 shows the difference between bacteria levels when turbidity was present or absent during sample collection under the various flow conditions. The increased levels when turbidity was present under high, moist, and mid-range flow conditions likely reflects the effect of bacteria transported with fine particles during storm events. However, the effect of bacteria associated with resuspension of bottom sediments should also be considered as a possible source when wind and wave action could affect beach water quality. This potential effect could be examined by evaluating bacteria levels at other sites during similar conditions.

Figure 6-4. Turbid versus non-turbid sample comparison for Dungca's Beach site.
