Slide 1 of 22 – Well Integrity Narrowly Defined as the Prevention of Fluids Migration into Protected Water

Case Study for Well Integrity over a Full Life Cycle

Lloyd H. Hetrick, PE, CSP
Newfield Exploration Company

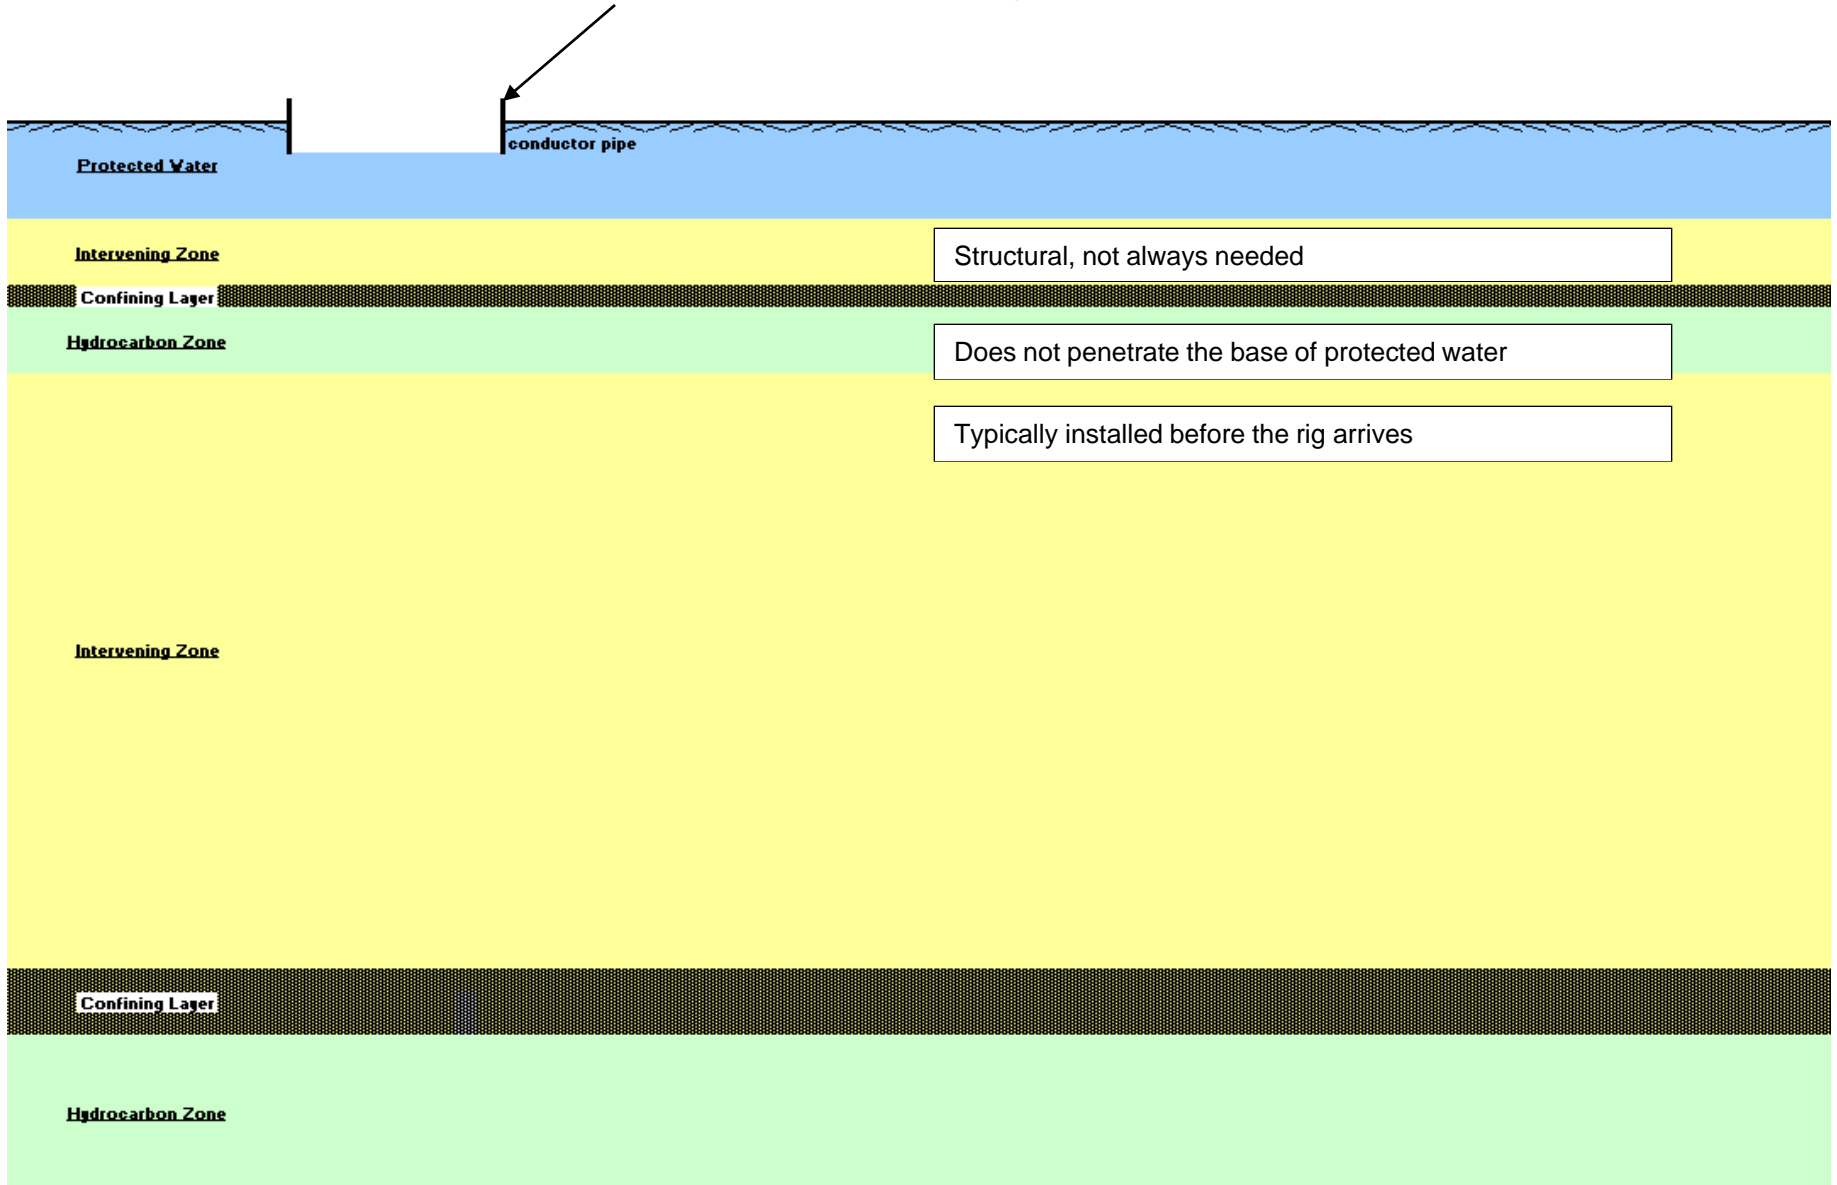
Slide 4 of 22 – Spud well with conductor pipe (driven, augered or drilled) no impact on Protected Water

A typical onshore well is spud with a conductor pipe that is driven, drilled, or augered into the ground by a construction crew or “spud rig” prior to the drilling rig’s arrival. This conductor pipe is a structural component that sometimes is not needed at all. Conductor pipe most often does not reach the top and does not penetrate the base of protected water; therefore it is not involved in protecting USDWs from vertical migration of fluids. Accordingly, failure categories for the conductor pipe will not be discussed.

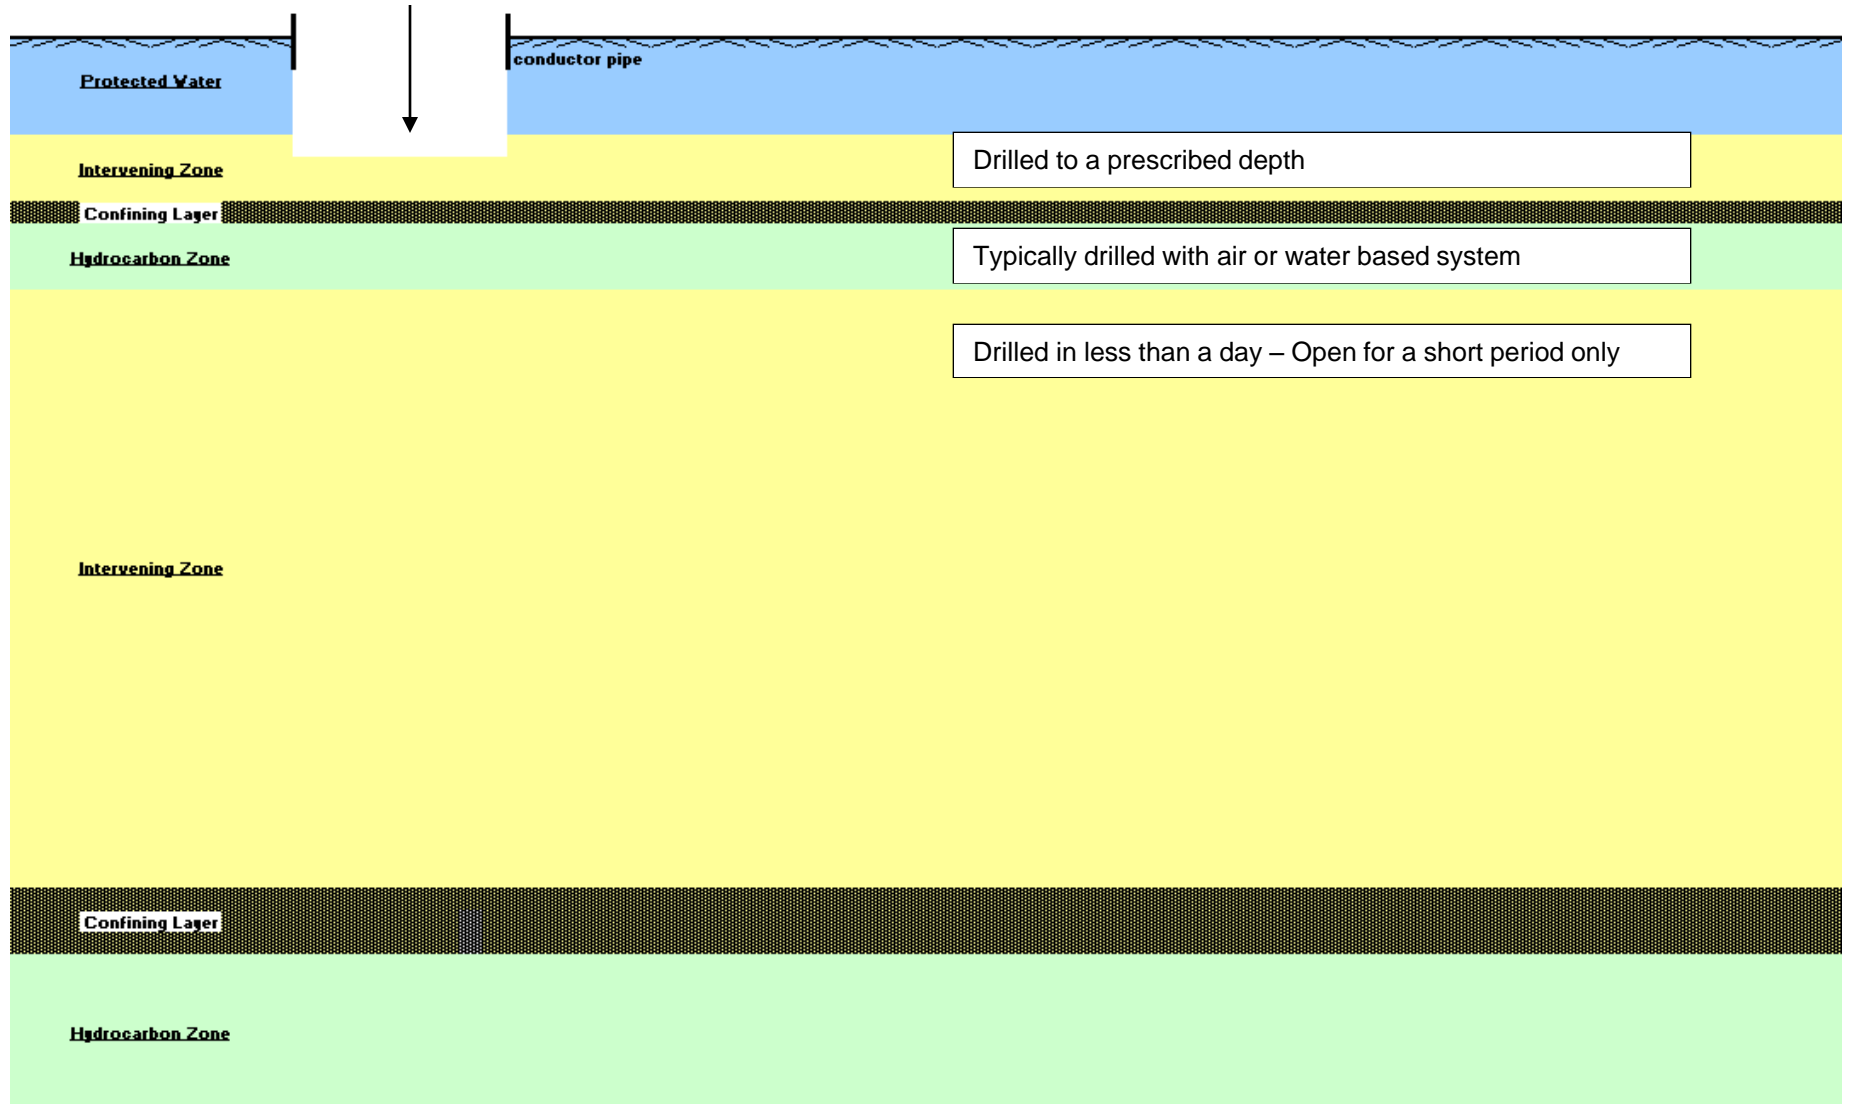
Slide 5 of 22 – Well is drilled to a prescribed depth below Protected Water

The surface hole is drilled to a prescribed depth below the base of protected water. This depth is most often provided by the State Oil and Gas Regulator as in Oklahoma (16), or the State Environmental Protection Regulator as in Texas (17), or not specifically provided other than to protect all USDWs encountered as in Pennsylvania (18). In this latter situation, oil and gas operators typically research a Pennsylvania Groundwater Information System “PaGWIS” database and local water well driller’s records to generate a hydro geological map in order to determine depths of water that need to be protected.

The surface hole is not left open for more than a few hours while being drilled, cased, and then cemented back to surface. Those zones left open during this brief period are all USDWs, so vertical migration of fluids does not present a significant threat during surface hole drilling. The surface hole on our case study well is drilled in a few hours on the first day of the drilling operation.

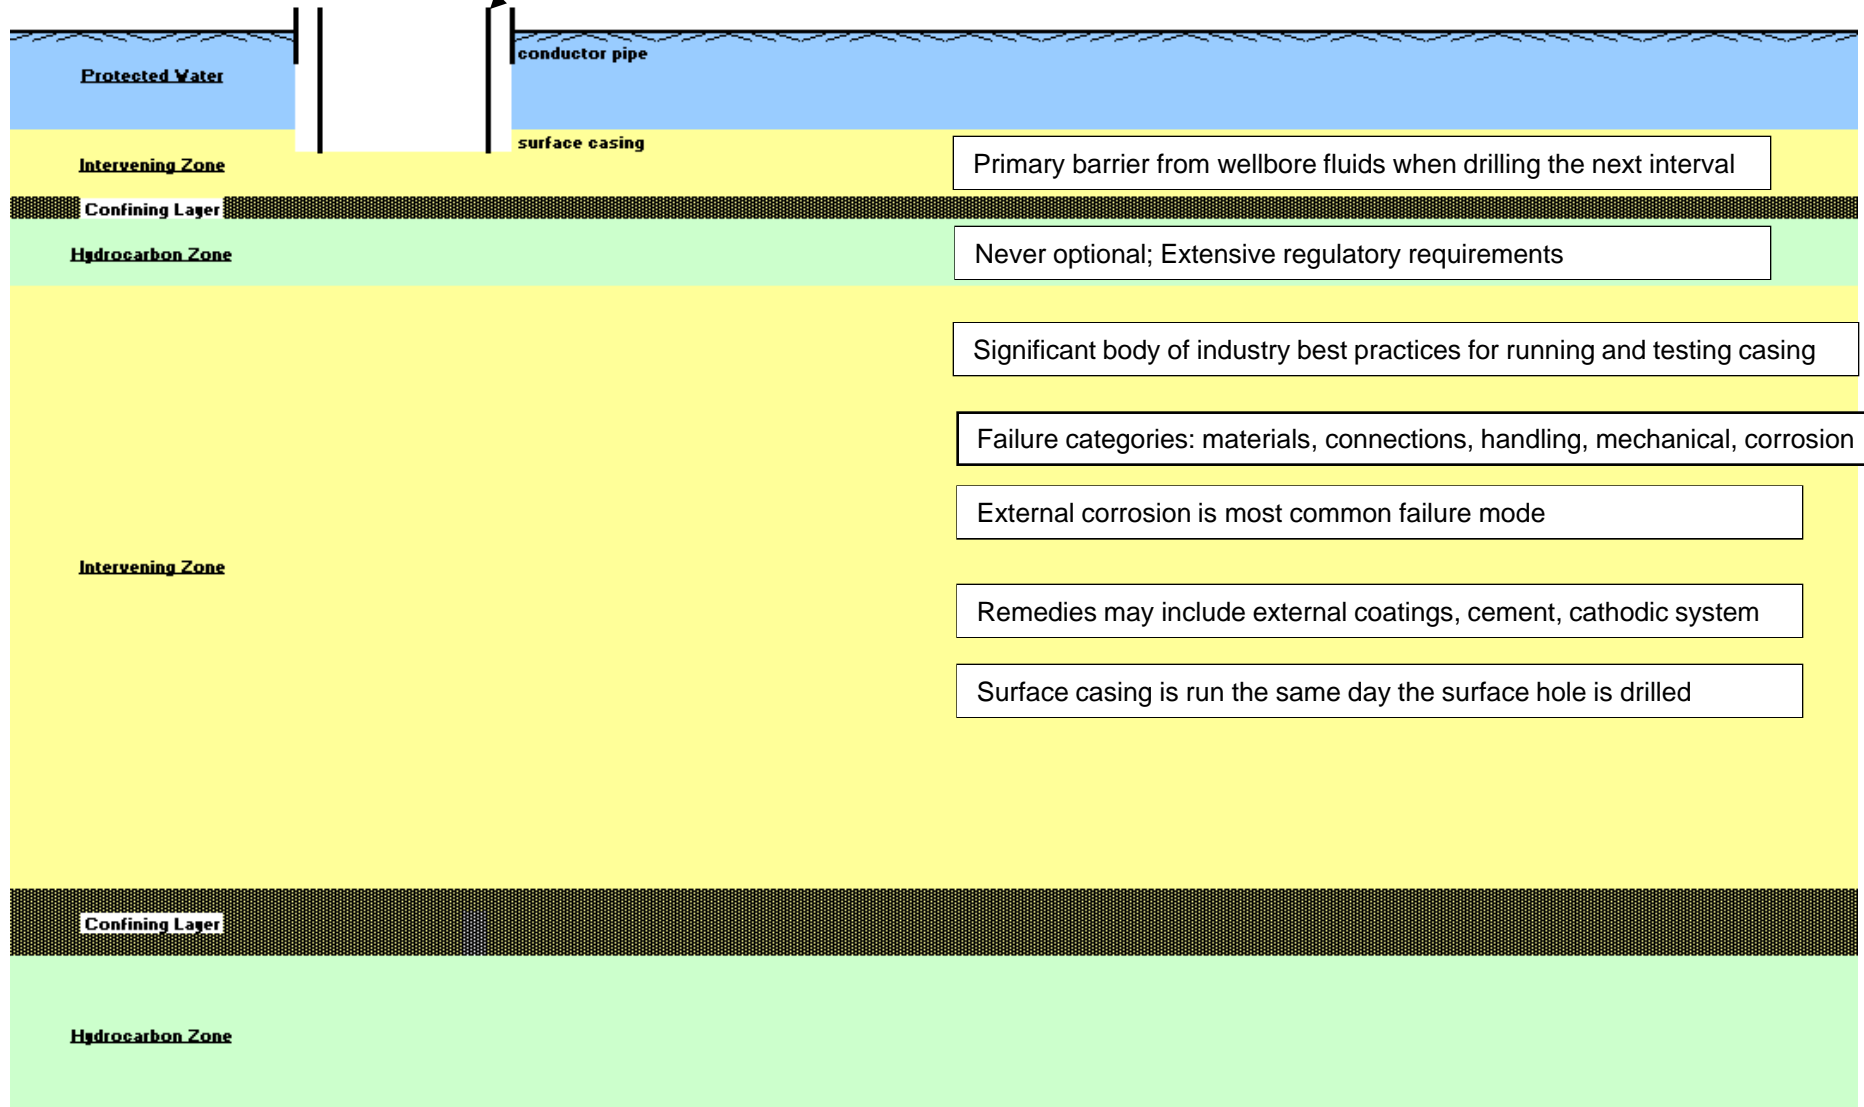
Slide 6 of 22 – Surface casing is run

The surface casing string is the primary barrier to prevent fluids from the wellbore from entering protected water as the well is being drilled to the next casing setting depth. Unlike the conductor pipe, surface casing is always required and is typically specified by regulation to be of “suitable and sufficient” quality (19) or “suitable for all drilling and operating conditions such as tension, burst, collapse” (20). For all casing strings, industry best practices provide extensive guidance on the selection of proper casing size, grade, weight, connections, plus procedures for field handling, inspection, and testing (21) (22) (23) (24) (25) (26) (27). For our case study well, the surface casing is “run” or installed in a few hours during day #1 of the drilling operation.

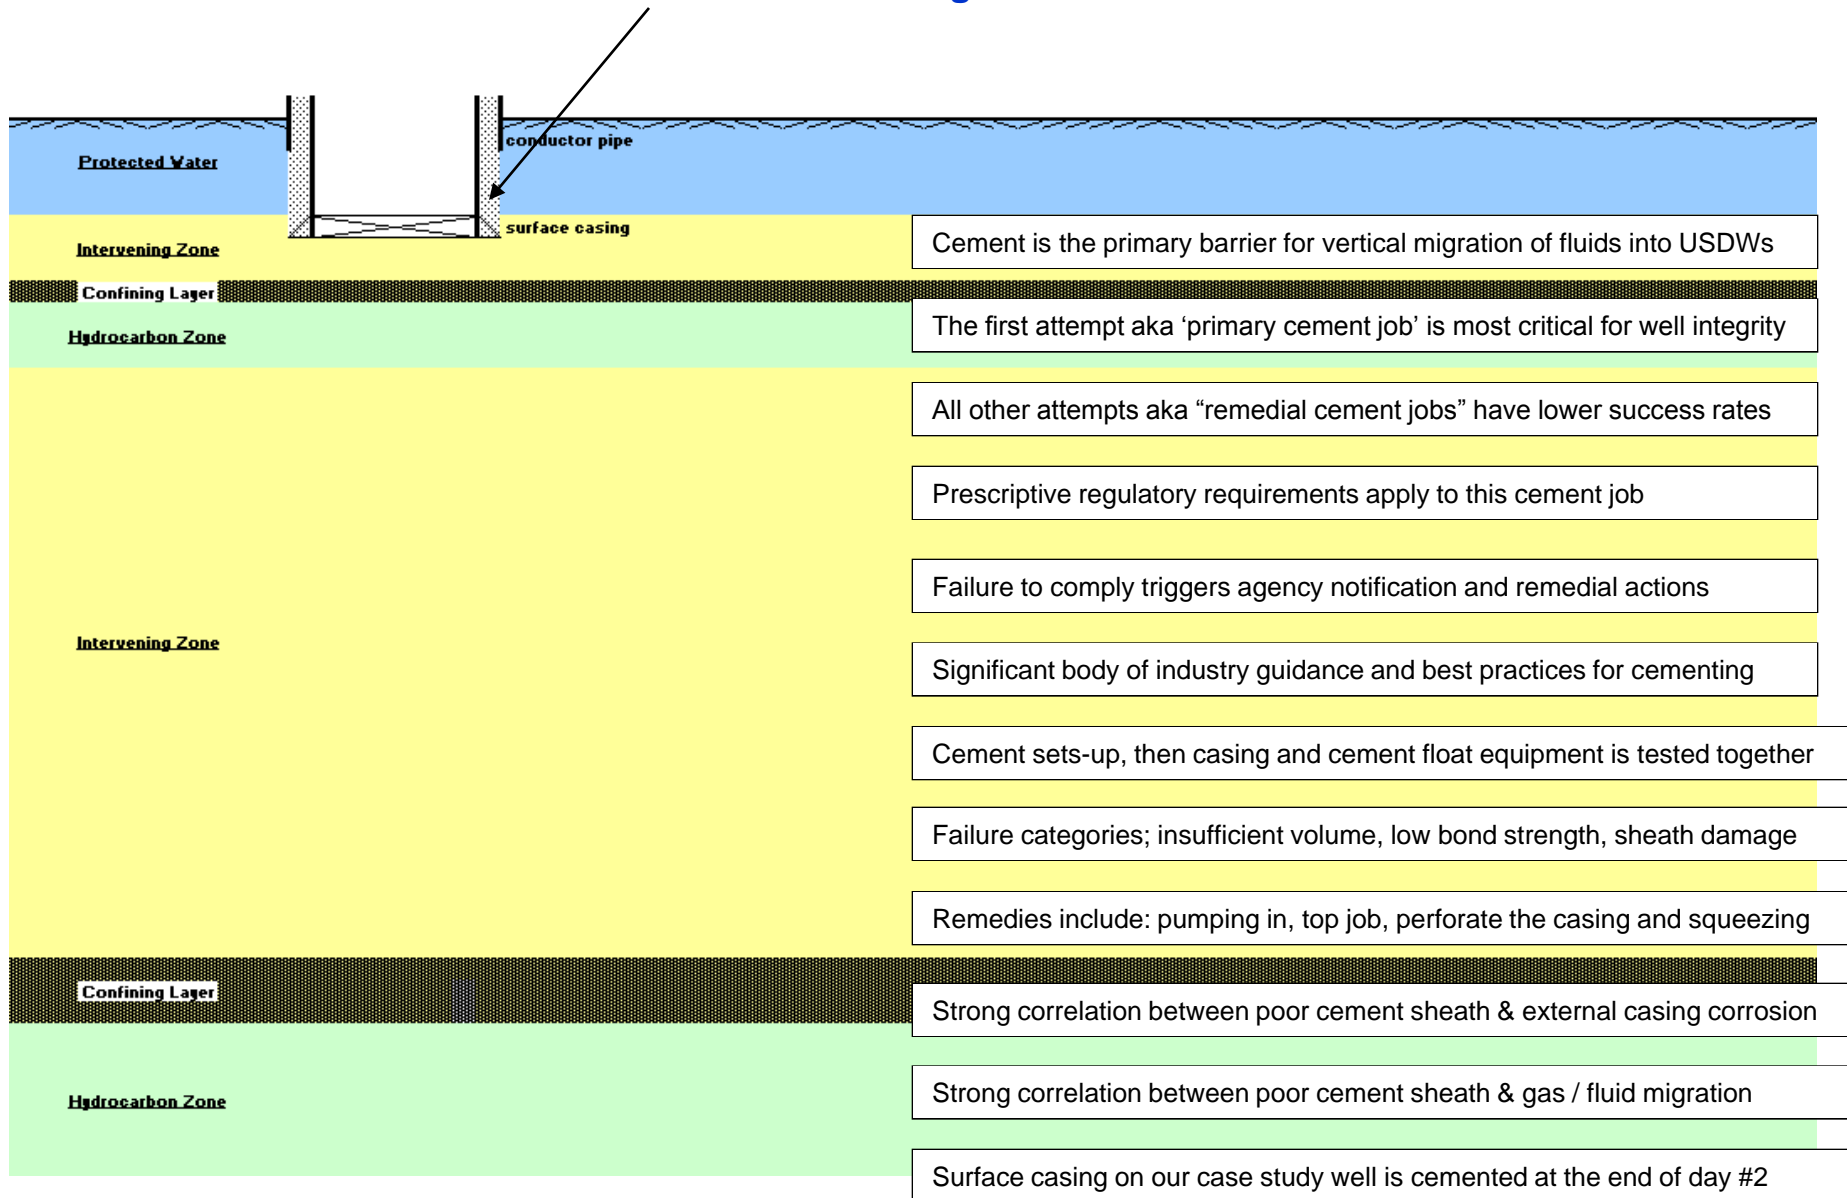
Slide 7 of 22 – Surface casing is cemented and tested

The surface casing string's cement job provides the primary barrier against vertical migration of fluids into protected water for the entire life of the well. In the context of USDW protection, the importance of getting a good primary cement job on the surface casing string cannot be overstated. Remedial cementing options do not provide high success rates for zonal isolation and should be considered only for contingency purposes. Of all regulations for onshore wells, the rules for surface casing cementing contain the most stringent requirements for hole size vs casing size, centralization, cement quality, cement quantity, cement placement techniques, and quality assurance than for any other casing string (29). Failure to properly cement the surface casing string triggers both agency notification and corrective actions (30). The surface casing on our case study well is cemented on day #2 of the drilling operation.

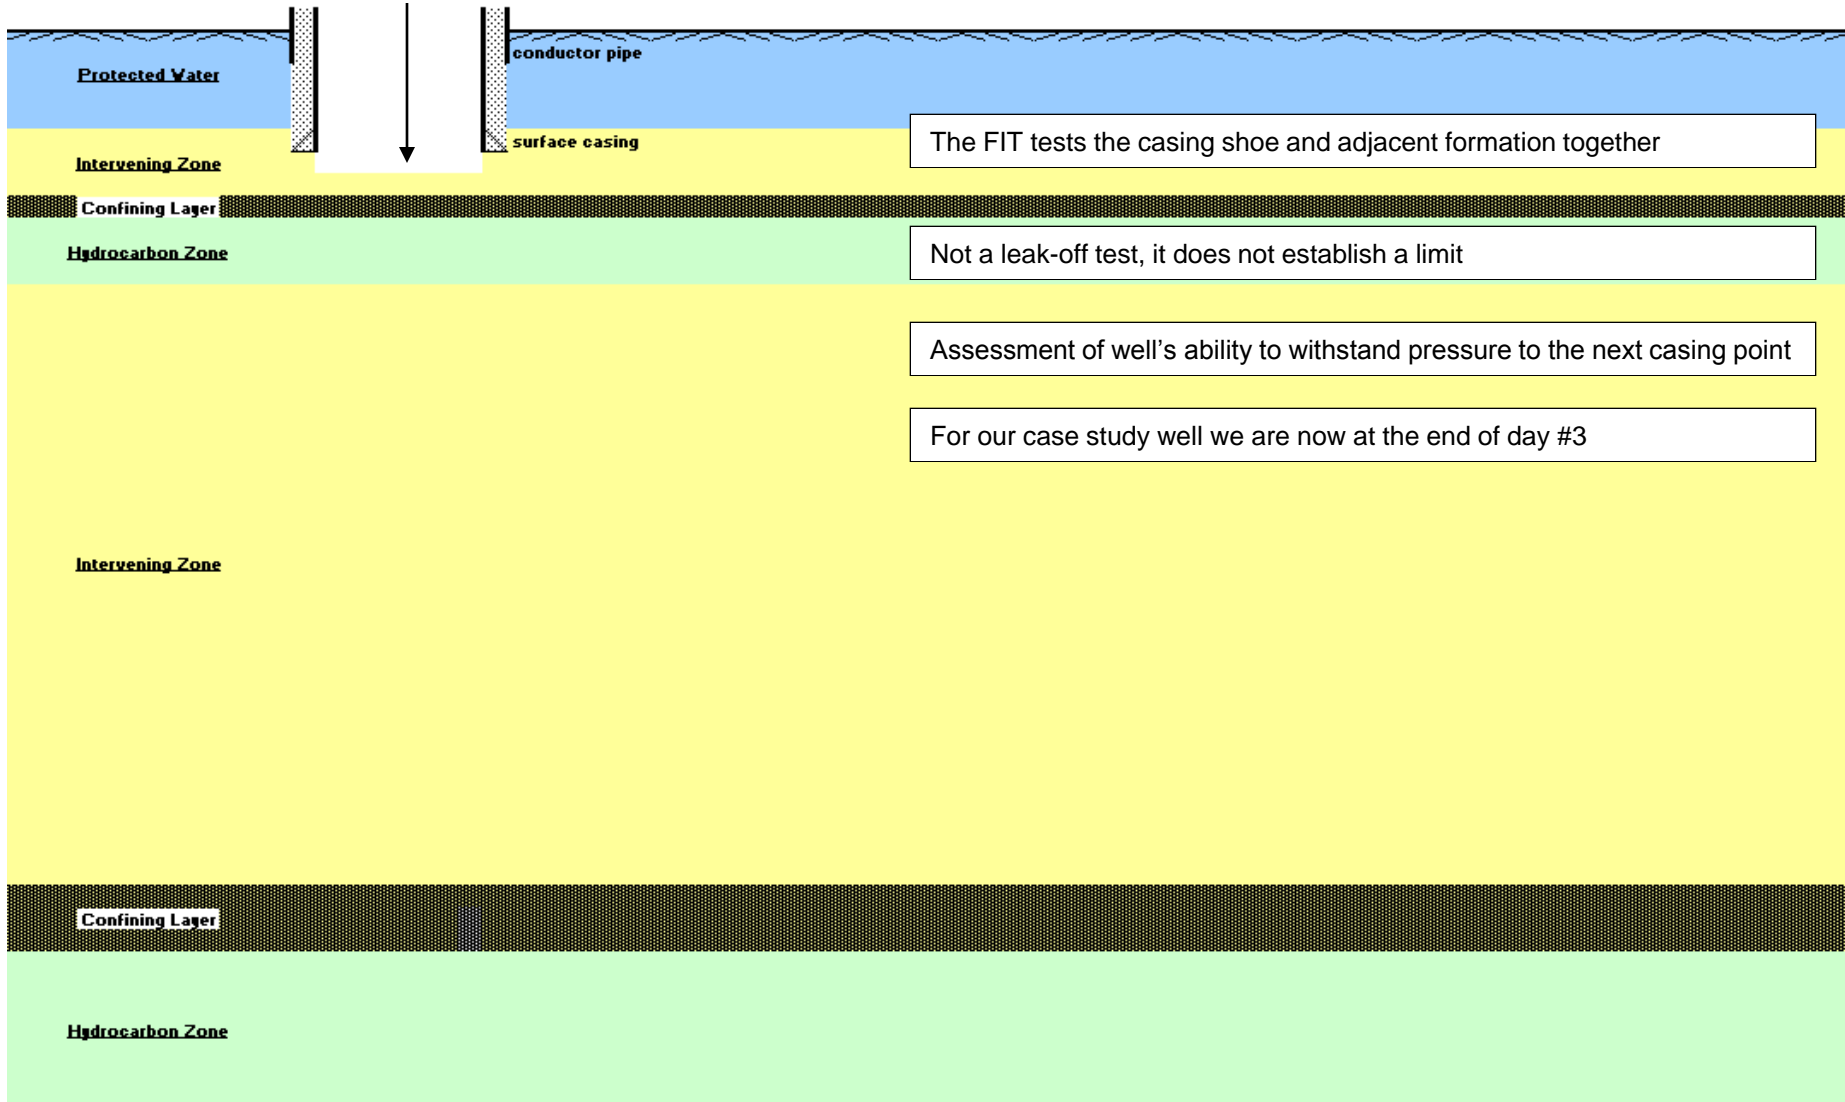
Slide 8 of 22 – Surface casing shoe and formation integrity is tested

The FIT tests the casing shoe and adjacent formation together

Not a leak-off test, it does not establish a limit

Assessment of well's ability to withstand pressure to the next casing point

After the surface casing has been successfully tested, the float collar, float shoe, and approximately 10' of new formation are drilled. Another integrity test is then performed, a Formation Integrity Test or "FIT" which tests both the casing shoe and new formation together. This is not a leak-off test and does not test the limits of the shoe and formation, rather the FIT provides an assessment of the wellbore's ability to withstand additional pressure in case of an influx of fluids and allows for safer drilling to the next casing point (38).

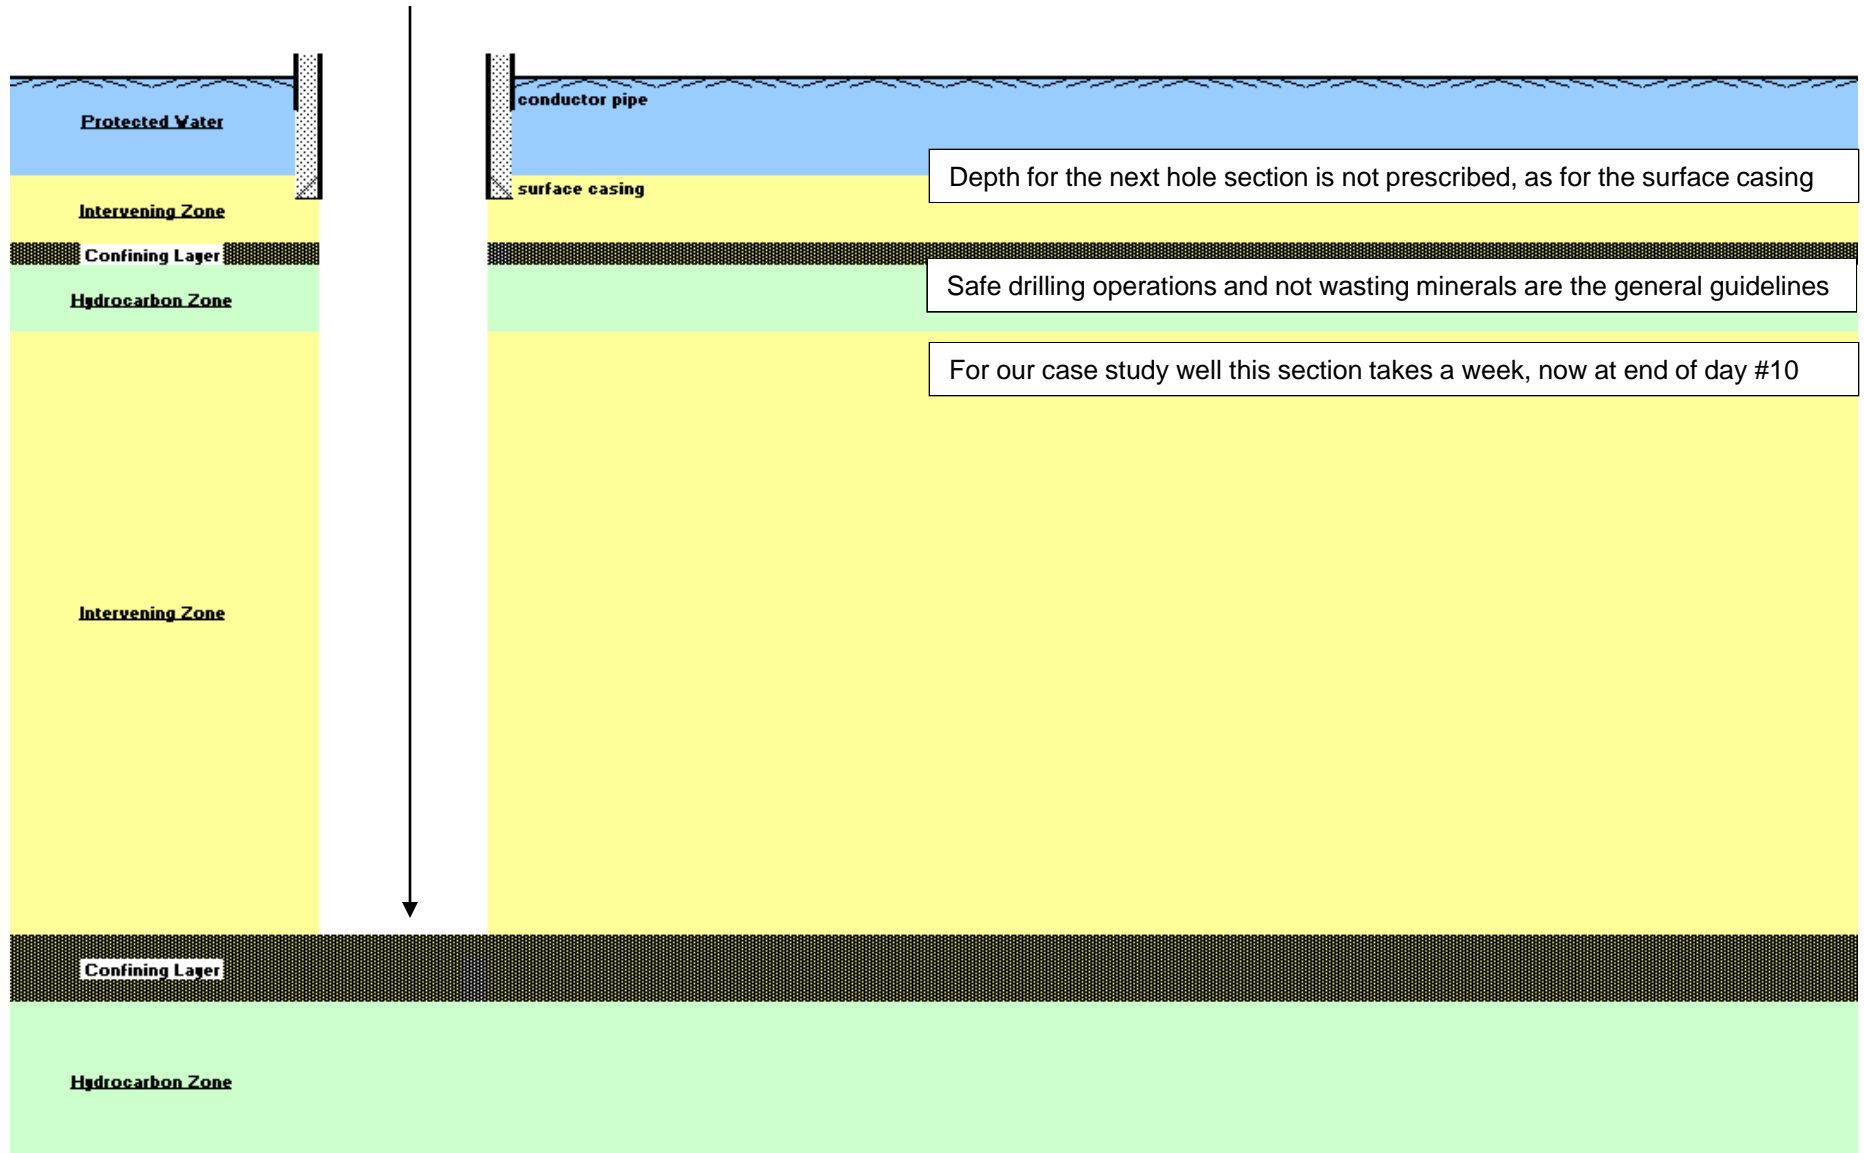
Slide 9 of 22 – Next section of hole is drilled

The next sections of well, which for this case study includes an intermediate and production casing section, are essentially a repeat of the surface casing section described above except that:

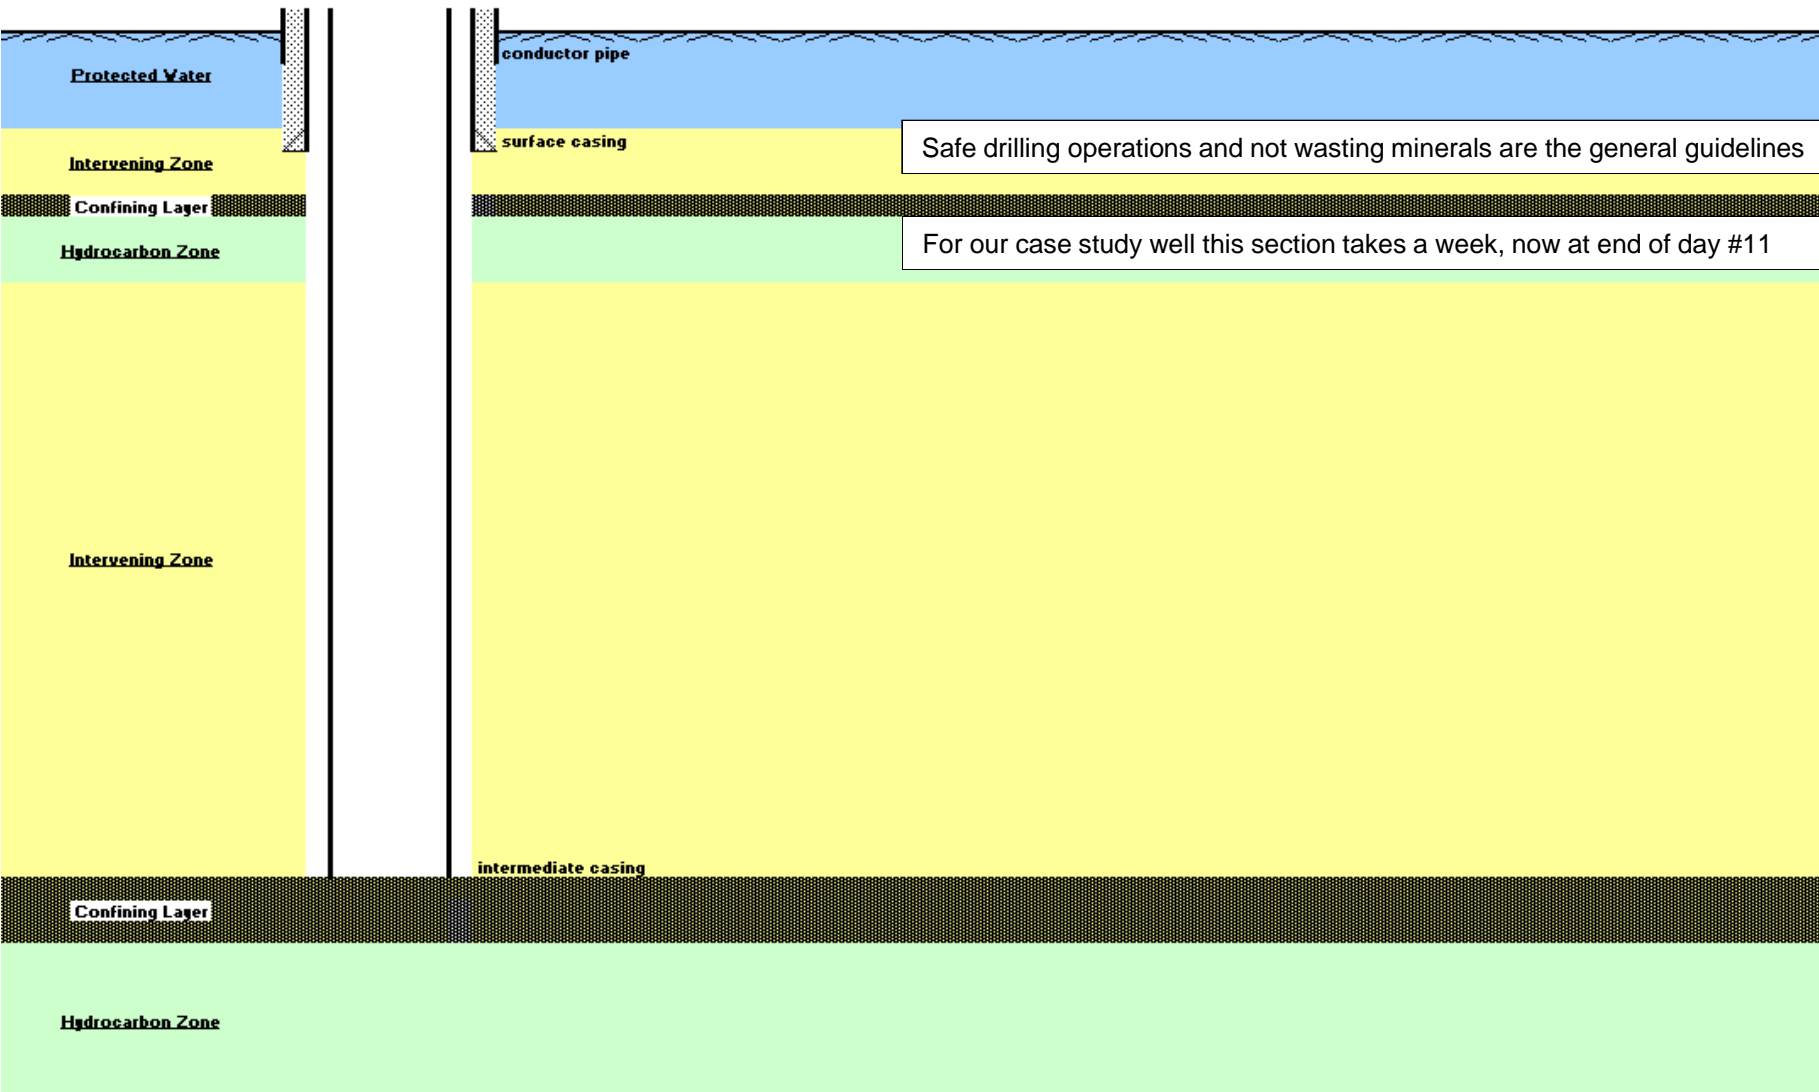
Slide 10 of 22 – Intermediate string of casing is run

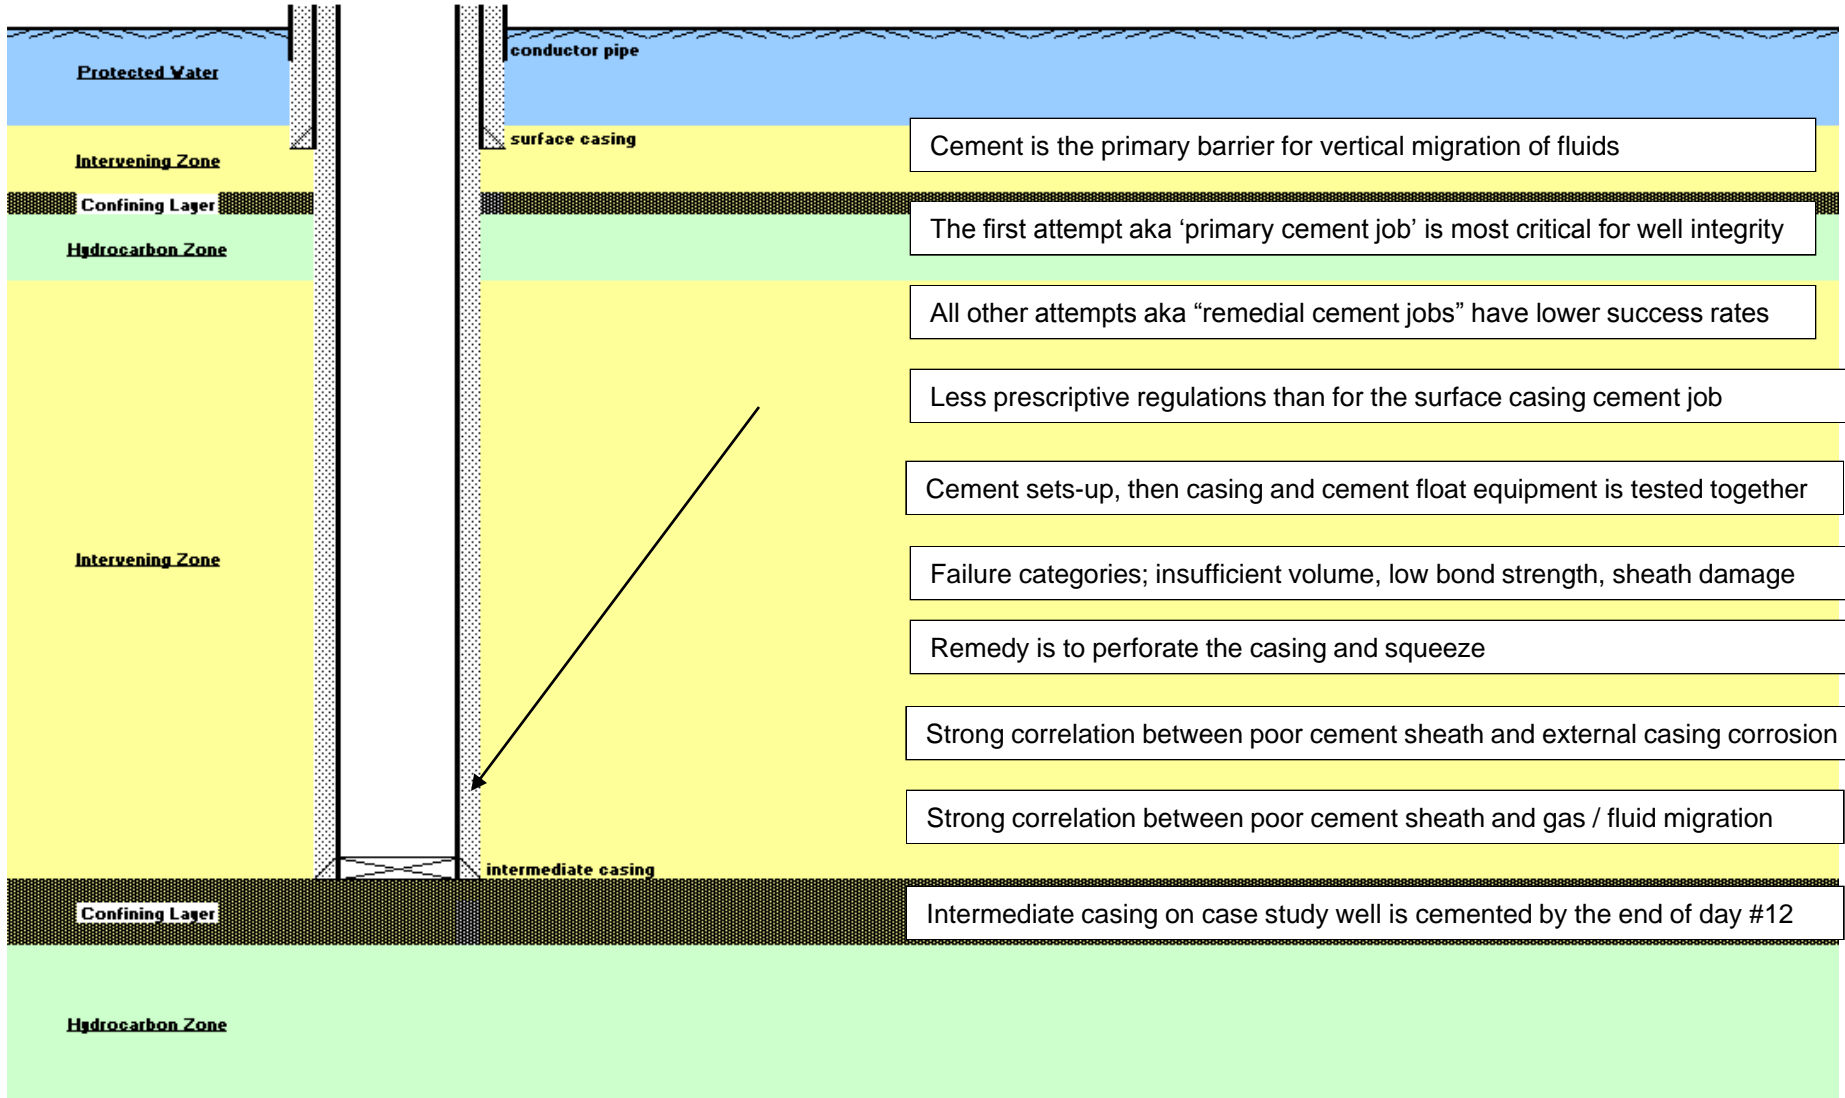
Slide 11 of 22 – Intermediate casing is cemented and tested

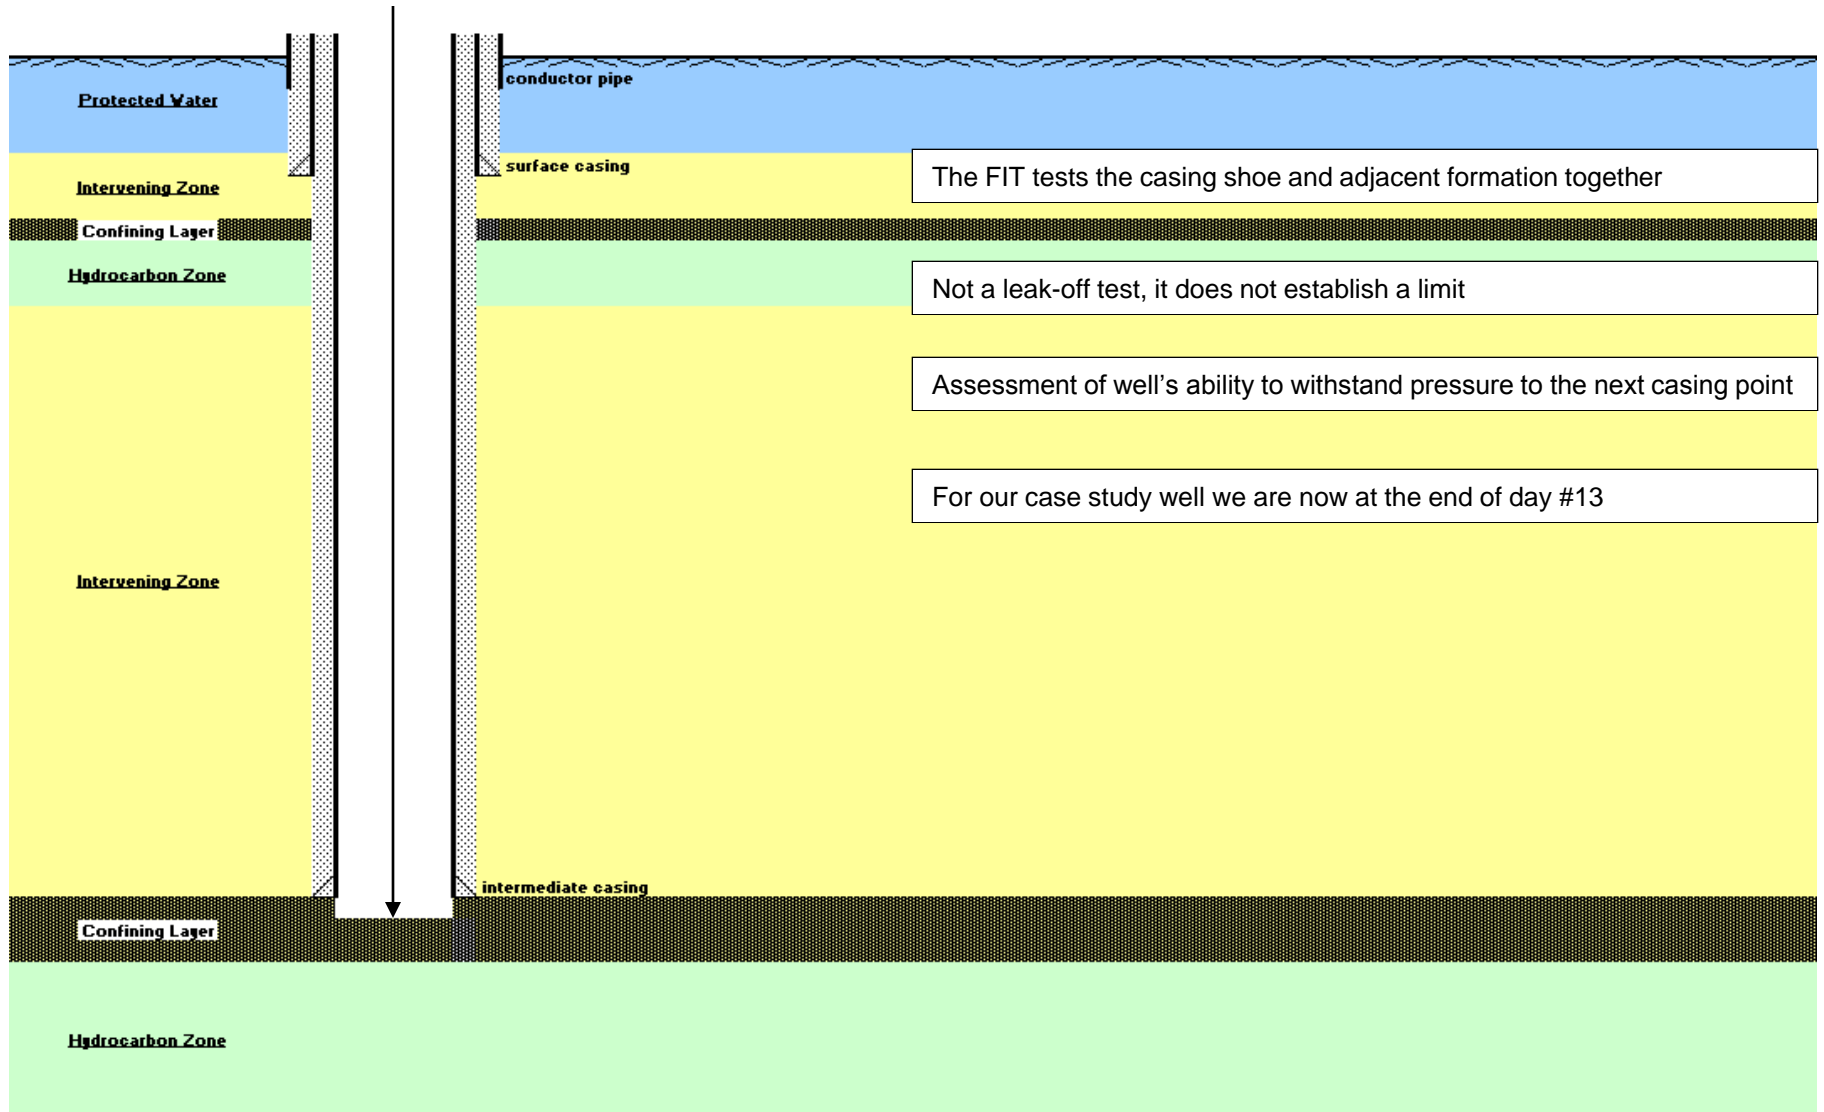
Slide 12 of 22 – Intermediate casing shoe and formation integrity are tested

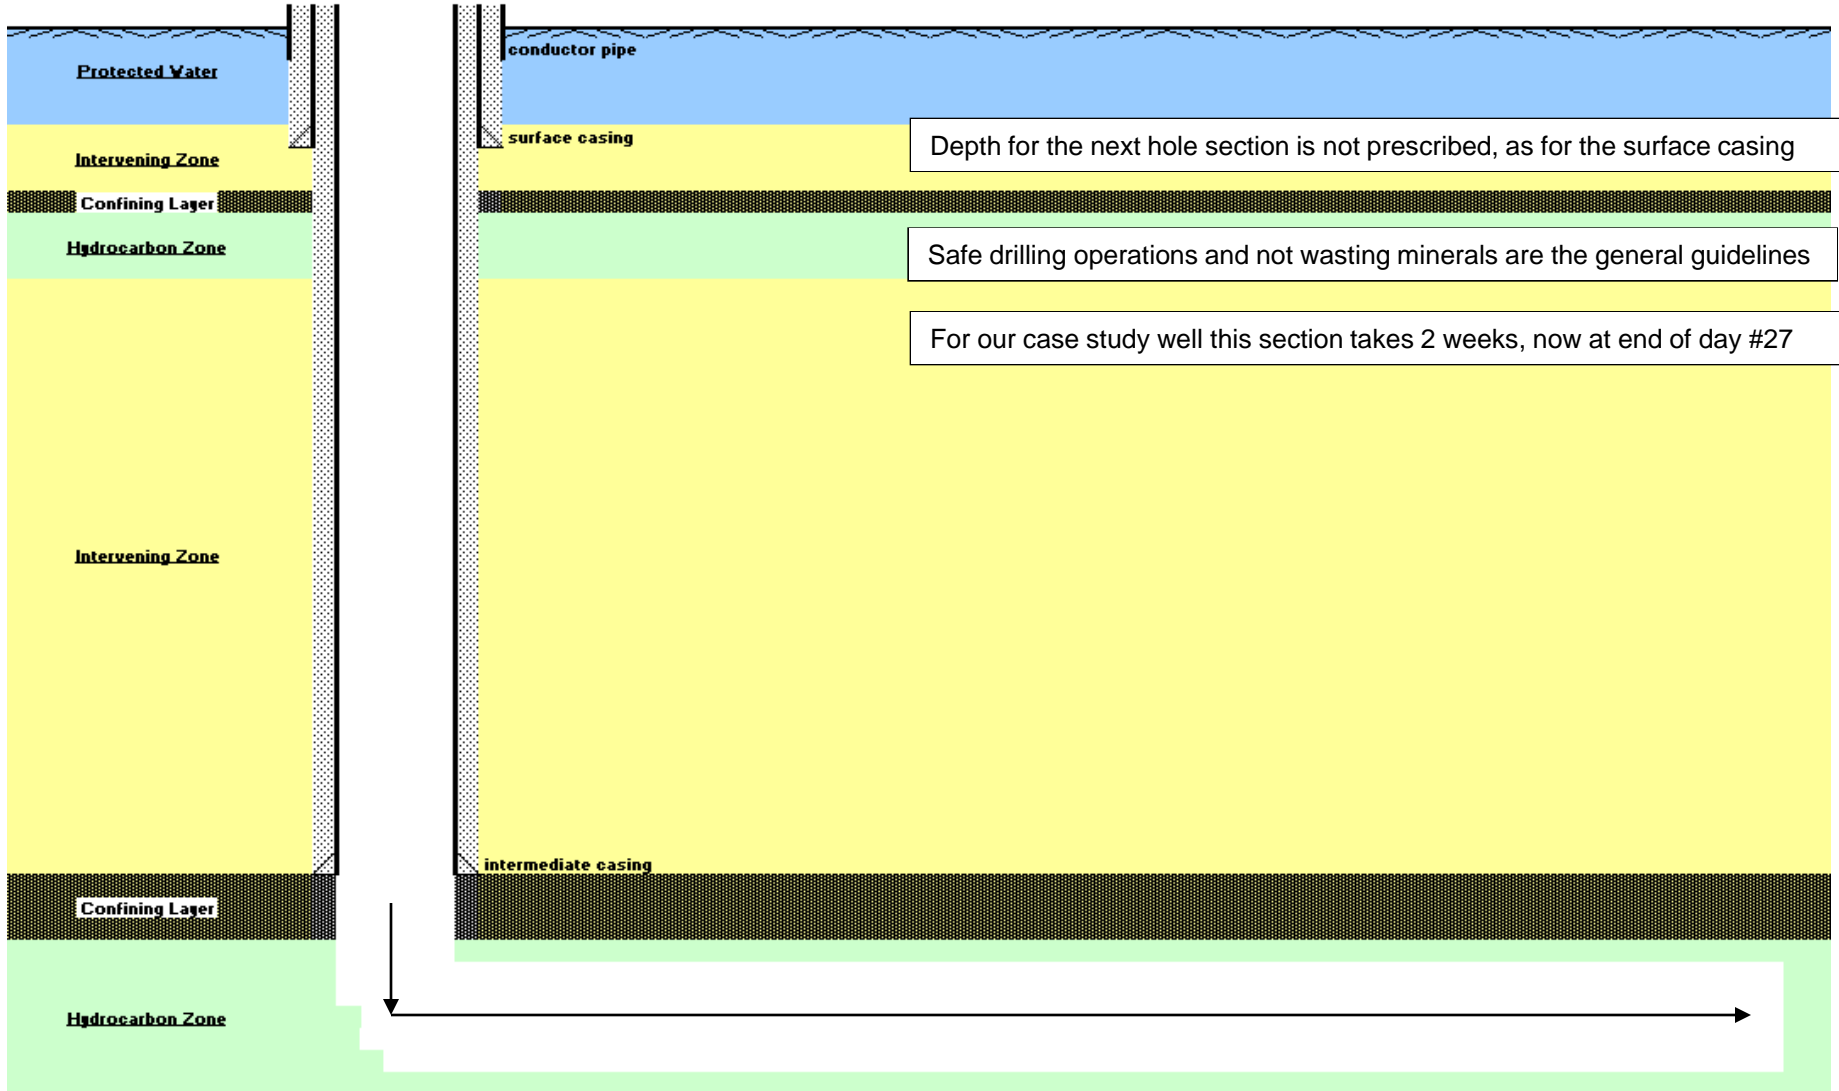
Slide 13 of 22 – Next section of hole is drilled
