Slide 1 of 22 – Well Integrity Narrowly Defined as the Prevention of Fluids Migration into Protected Water

Case Study for Well Integrity over a Full Life Cycle

Lloyd H. Hetrick, PE, CSP
Newfield Exploration Company

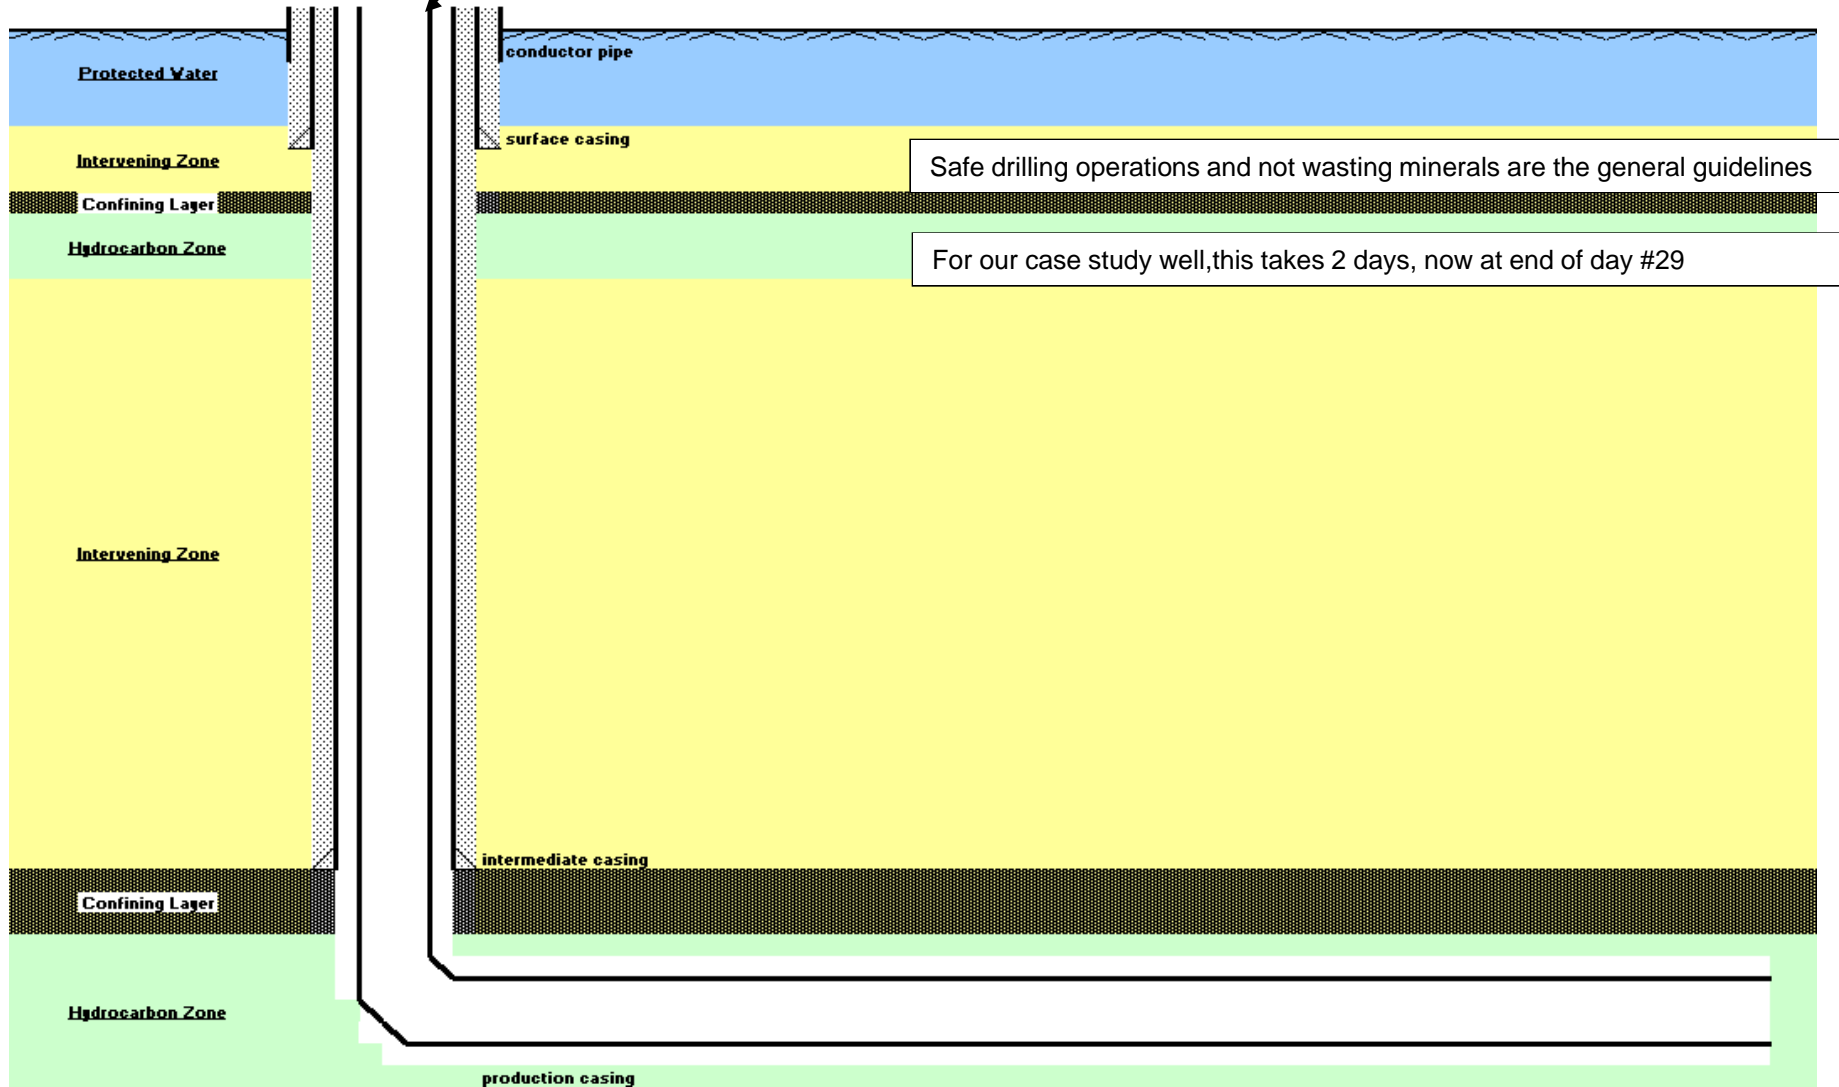
Slide 14 of 22 – Production casing is run

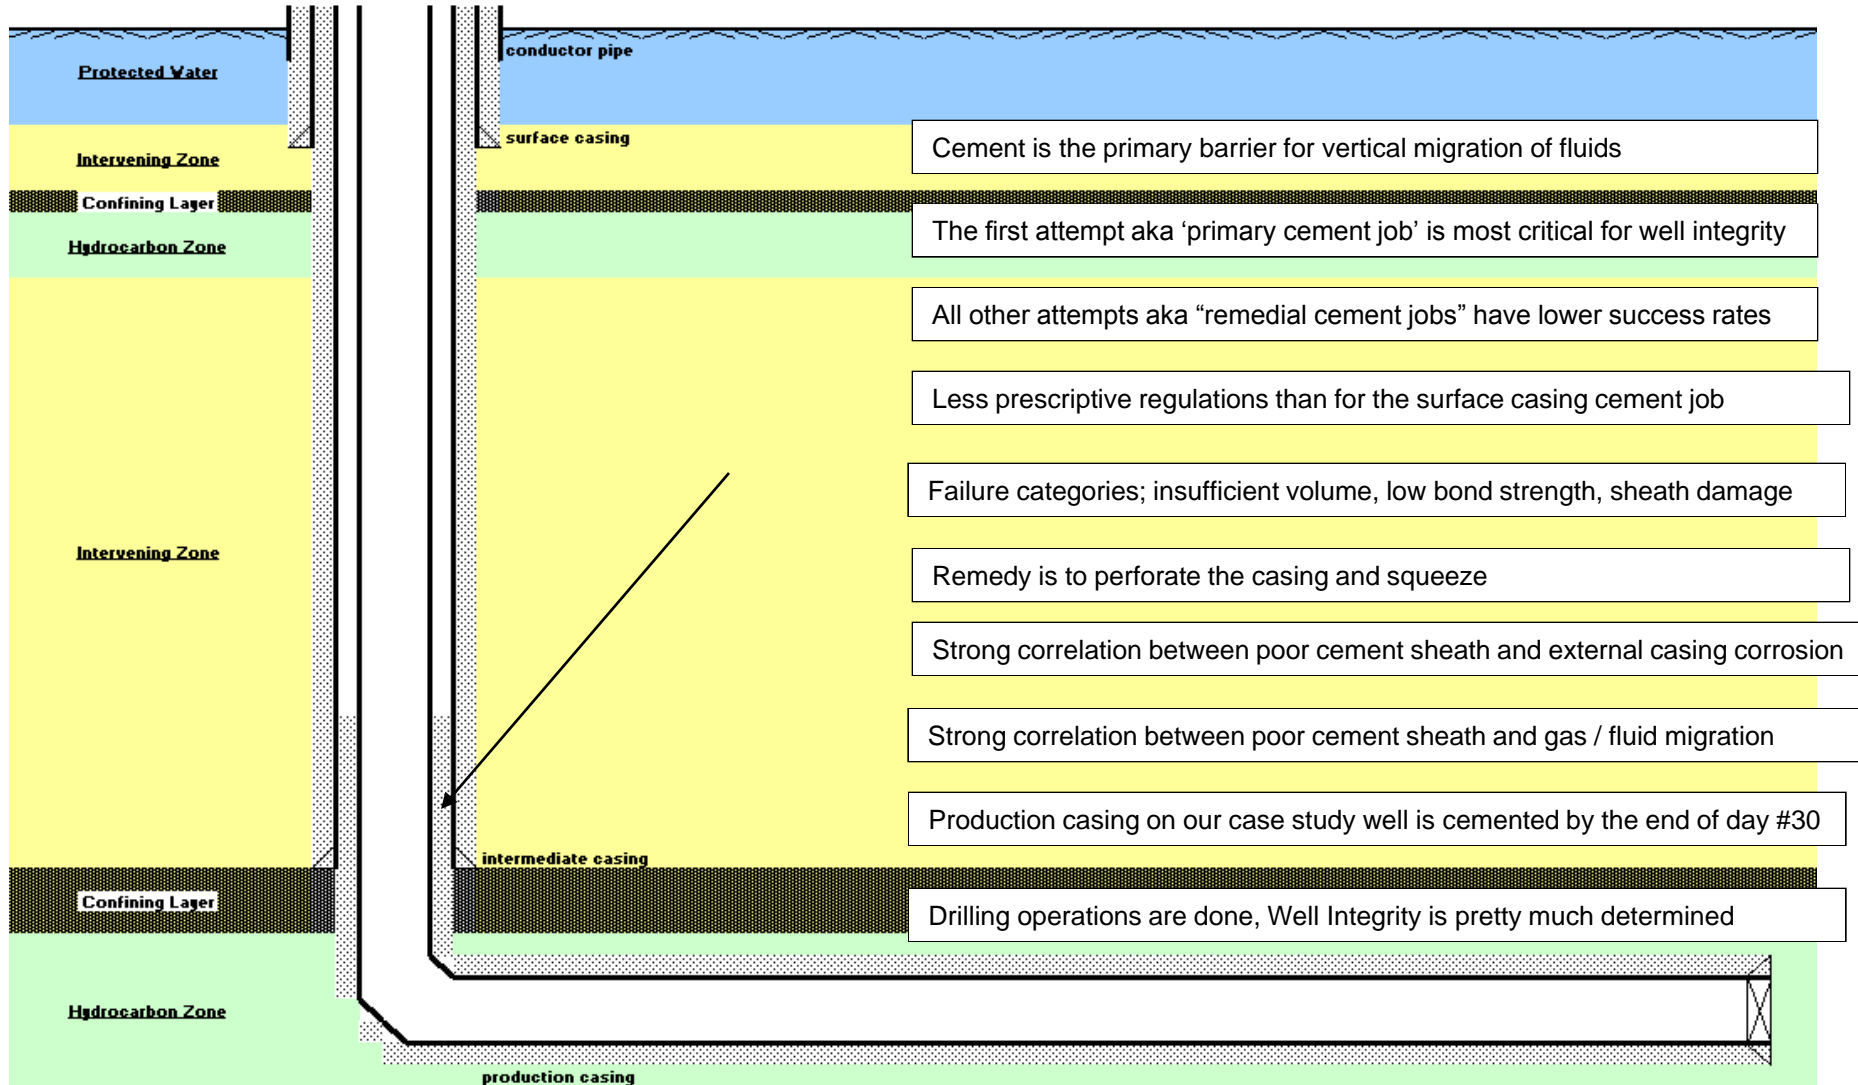
Slide 15 of 22 – Production casing is cemented, Drilling phase is done

Although this case study well has been drilled, cased, and cemented over a 30 day period, the first two days are the most critical for zonal isolation of USDWs where the foundation for well integrity is determined.

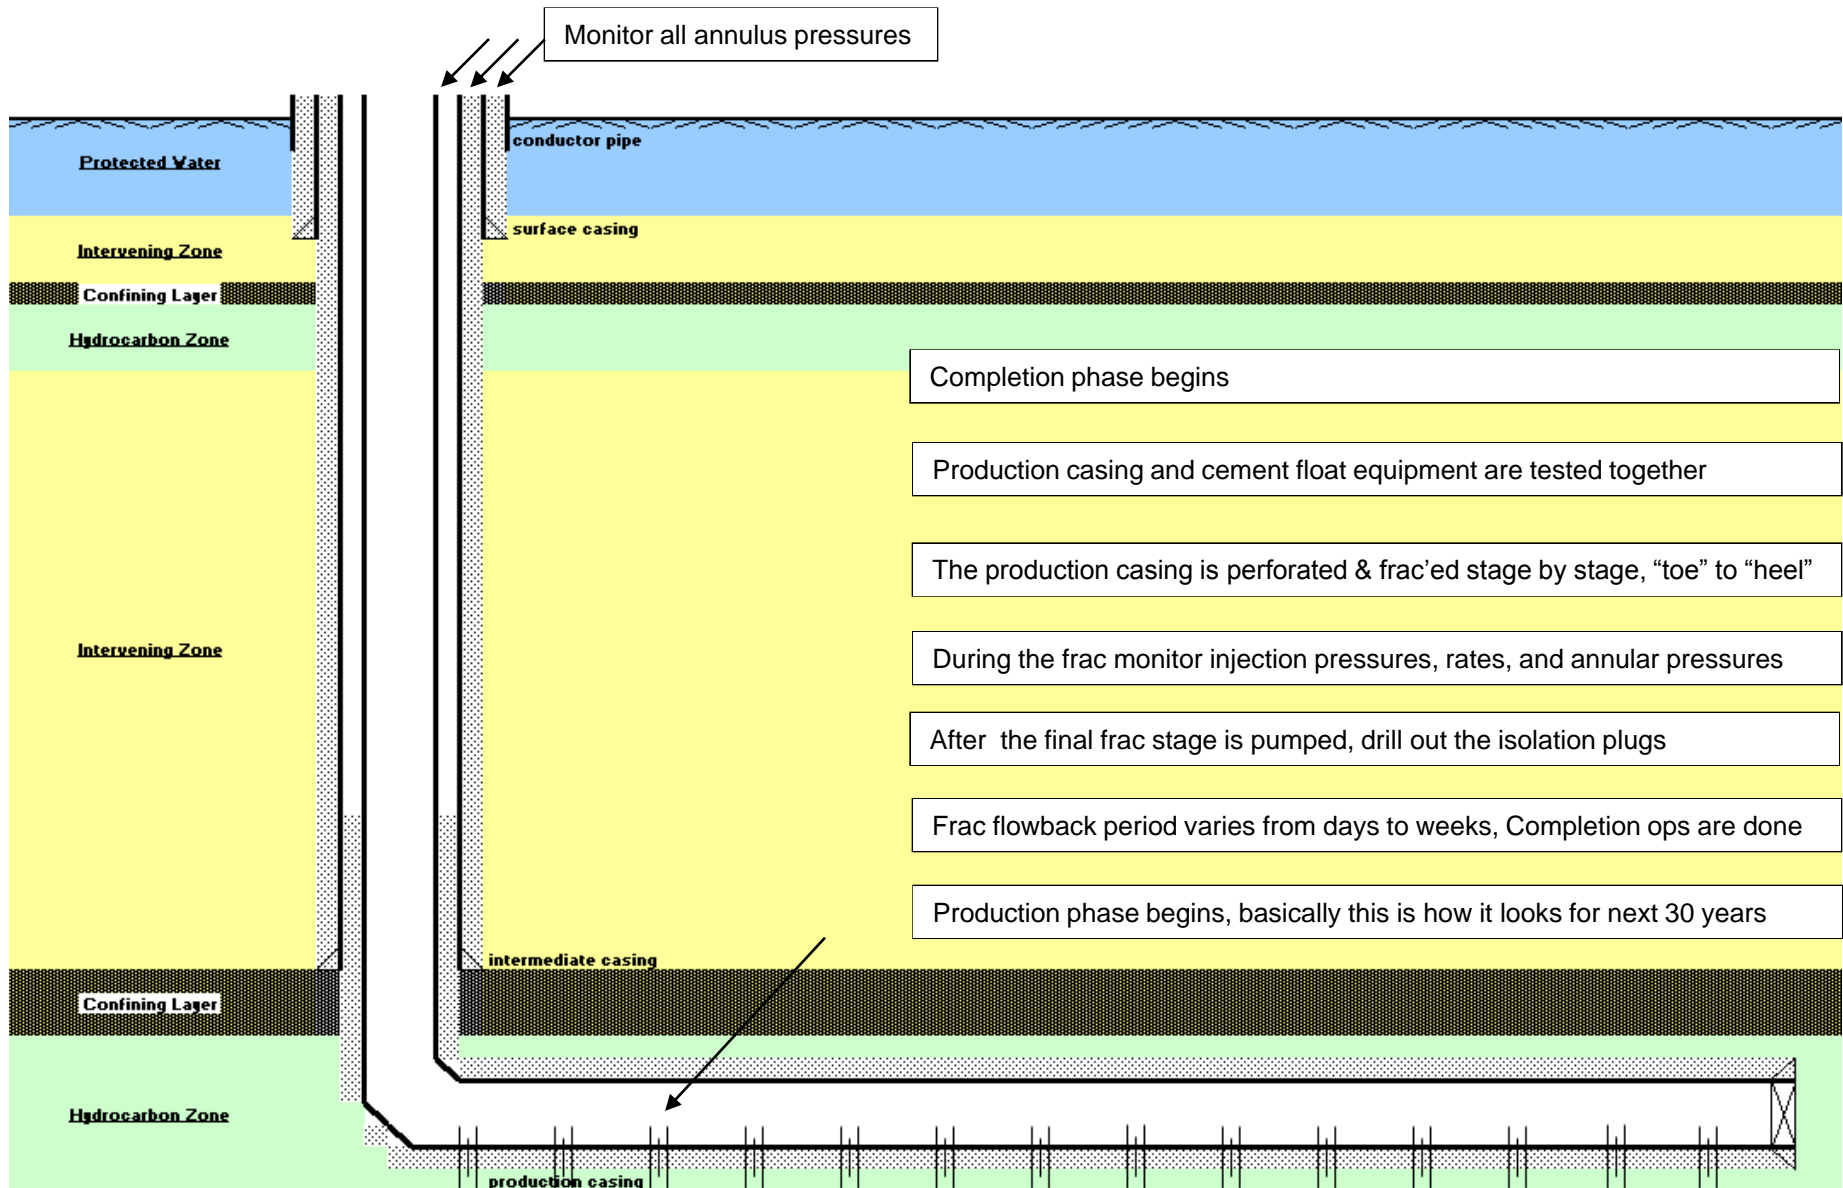
Slide 16 of 22 – Completion phase: perforate, hydraulically frac, flowback, production begins

Well completion is the where the production casing is perforated, the formation is hydraulically fractured, frac fluids are unloaded from the formation, and production operations commence. This is basically the well's configuration for the rest of its life as it relates to protecting USDWs.

Prior to performing the hydraulic frac, the production casing is tested to anticipated frac pressure plus a safety factor, as is the frac tree and all the surface pumping equipment and lines. During the frac, all casing annuli are monitored, as is the injection rate, injection pressure, and slurry properties. If during the frac job, significant pressure is found on the intermediate casing annulus, or there is any indication of communication with the surface casing annulus, the frac job is shut down and not resumed until corrective actions are made that only the intended zone is subject to frac pressures.

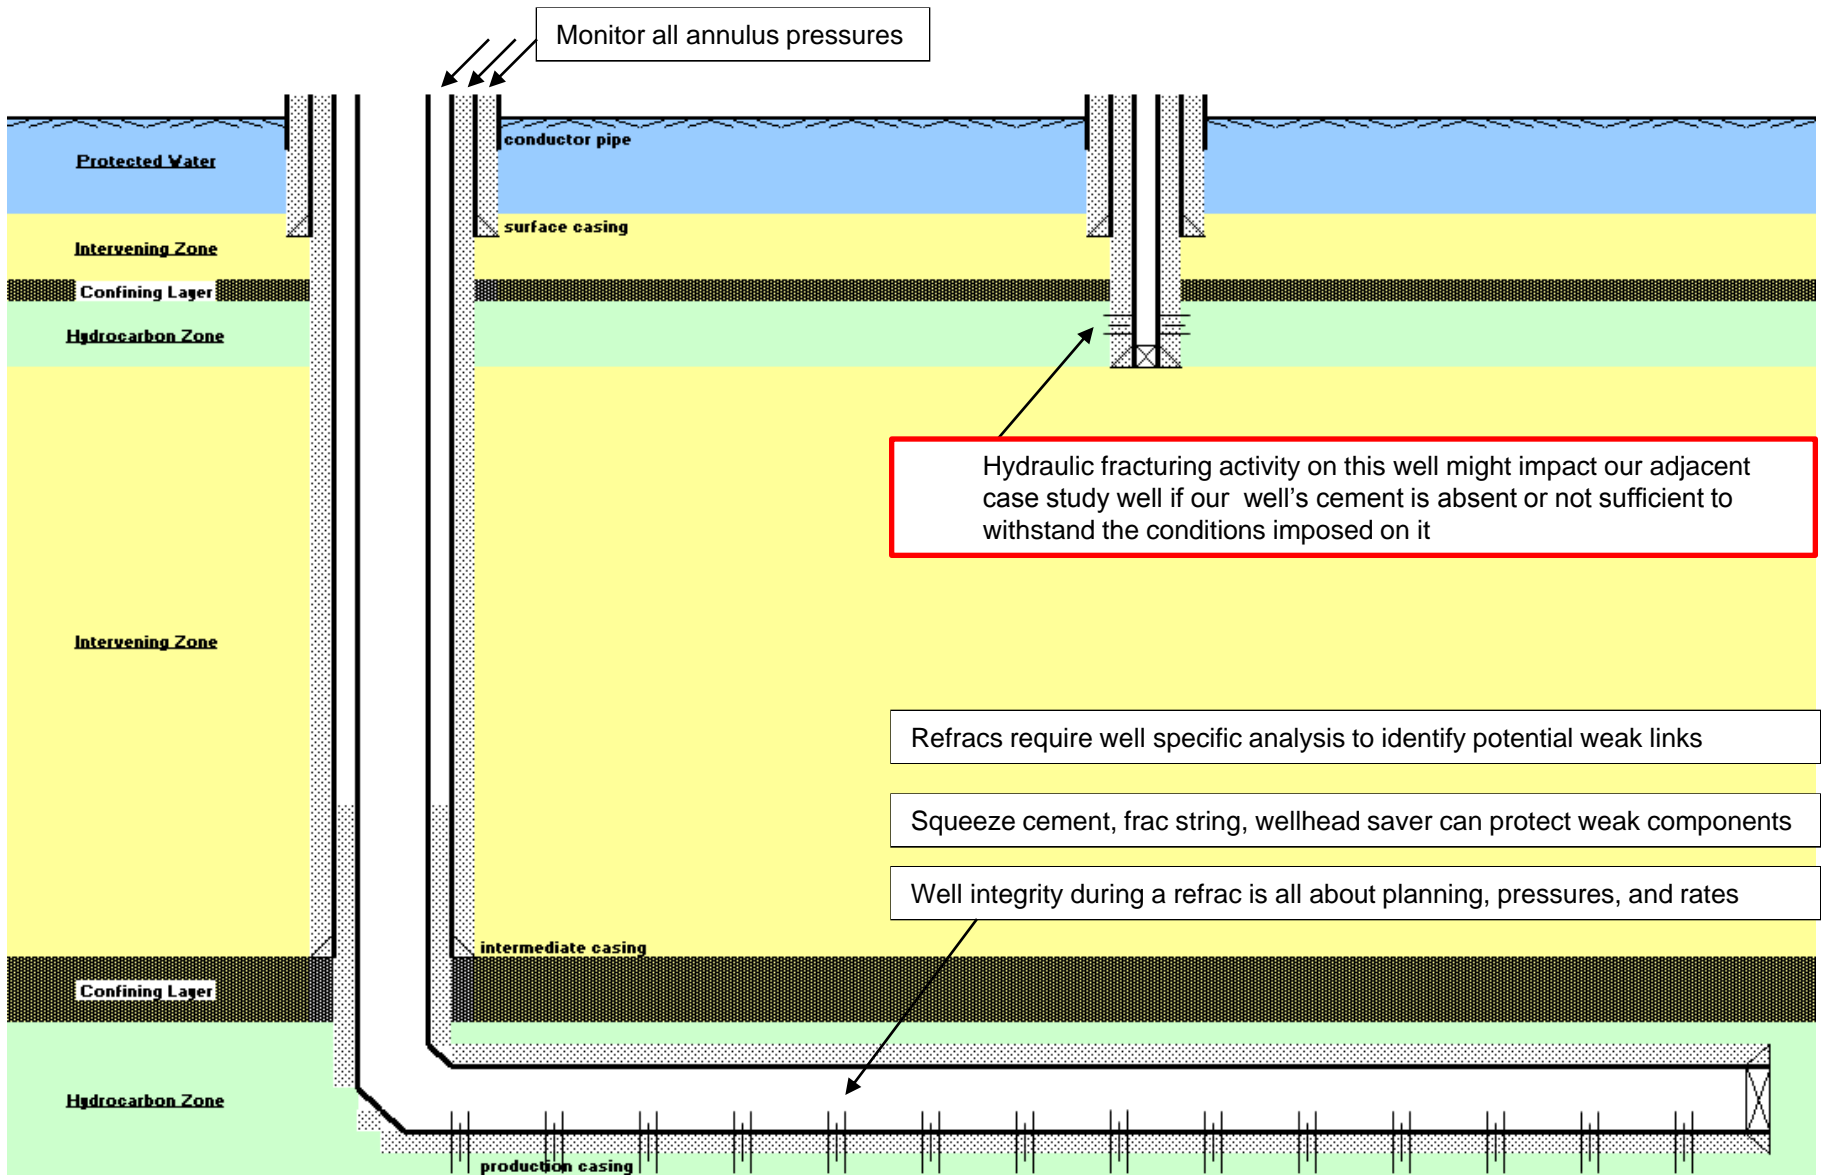
Slide 17 of 22 – Refrac and Adjacent Well Frac Scenarios

Refracs are similar to original fracs as discussed above with the exception that a frac string or wellhead saver might be used to protect older production casing strings and wellheads from frac pressures. This is a case by case situation that requires additional testing and engineering analysis in order to protect both the well and USDWs during refrac operations.

Adjacent wells and the potential for unwanted communication during hydraulic fracturing is a concern. State and federal regulations are largely silent on this issue, as are industry studies and best practices.

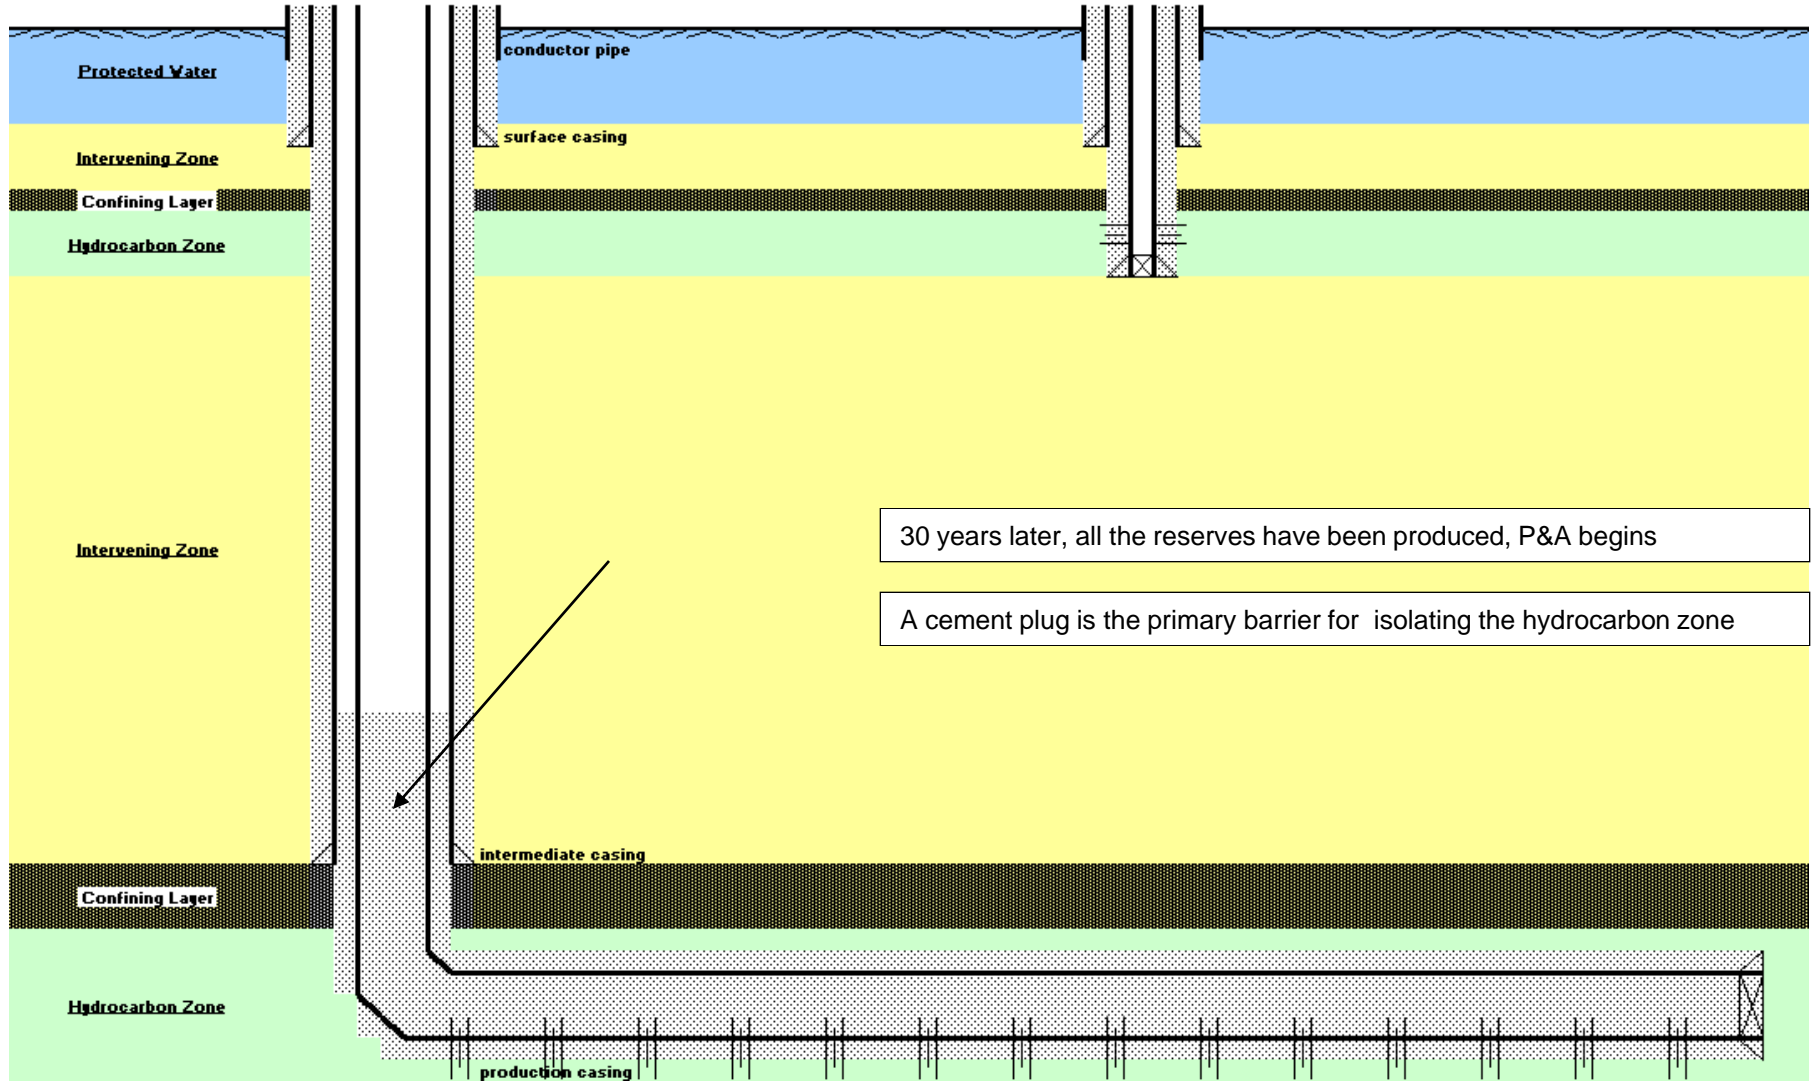
Slide 18 of 22 – Plug and Abandonment begins, producing zone is plugged and tested

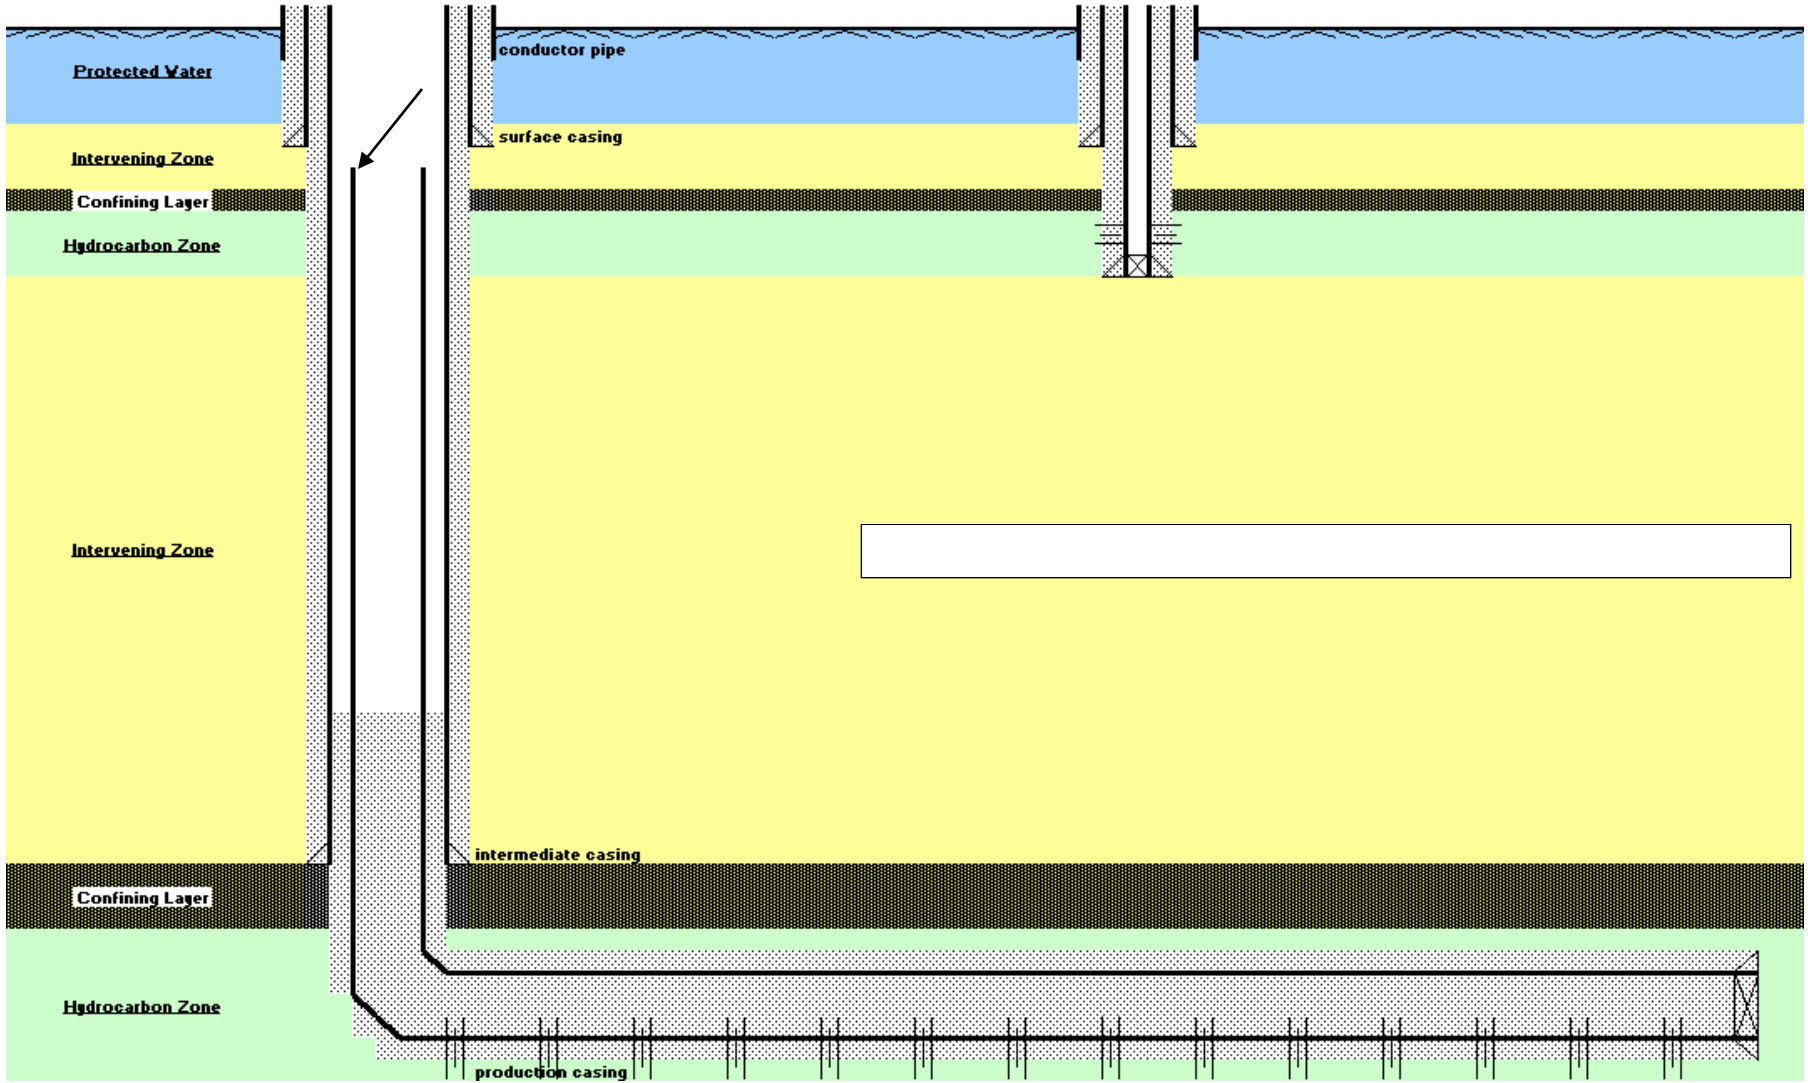
EPA Hydraulic Fracturing Study Technical Workshop #2 March 10-11, 2011
Well Integrity Case Study by Lloyd H. Hetrick
Slide 19 of 22 – Casing is cut or perforated near the surface casing shoe

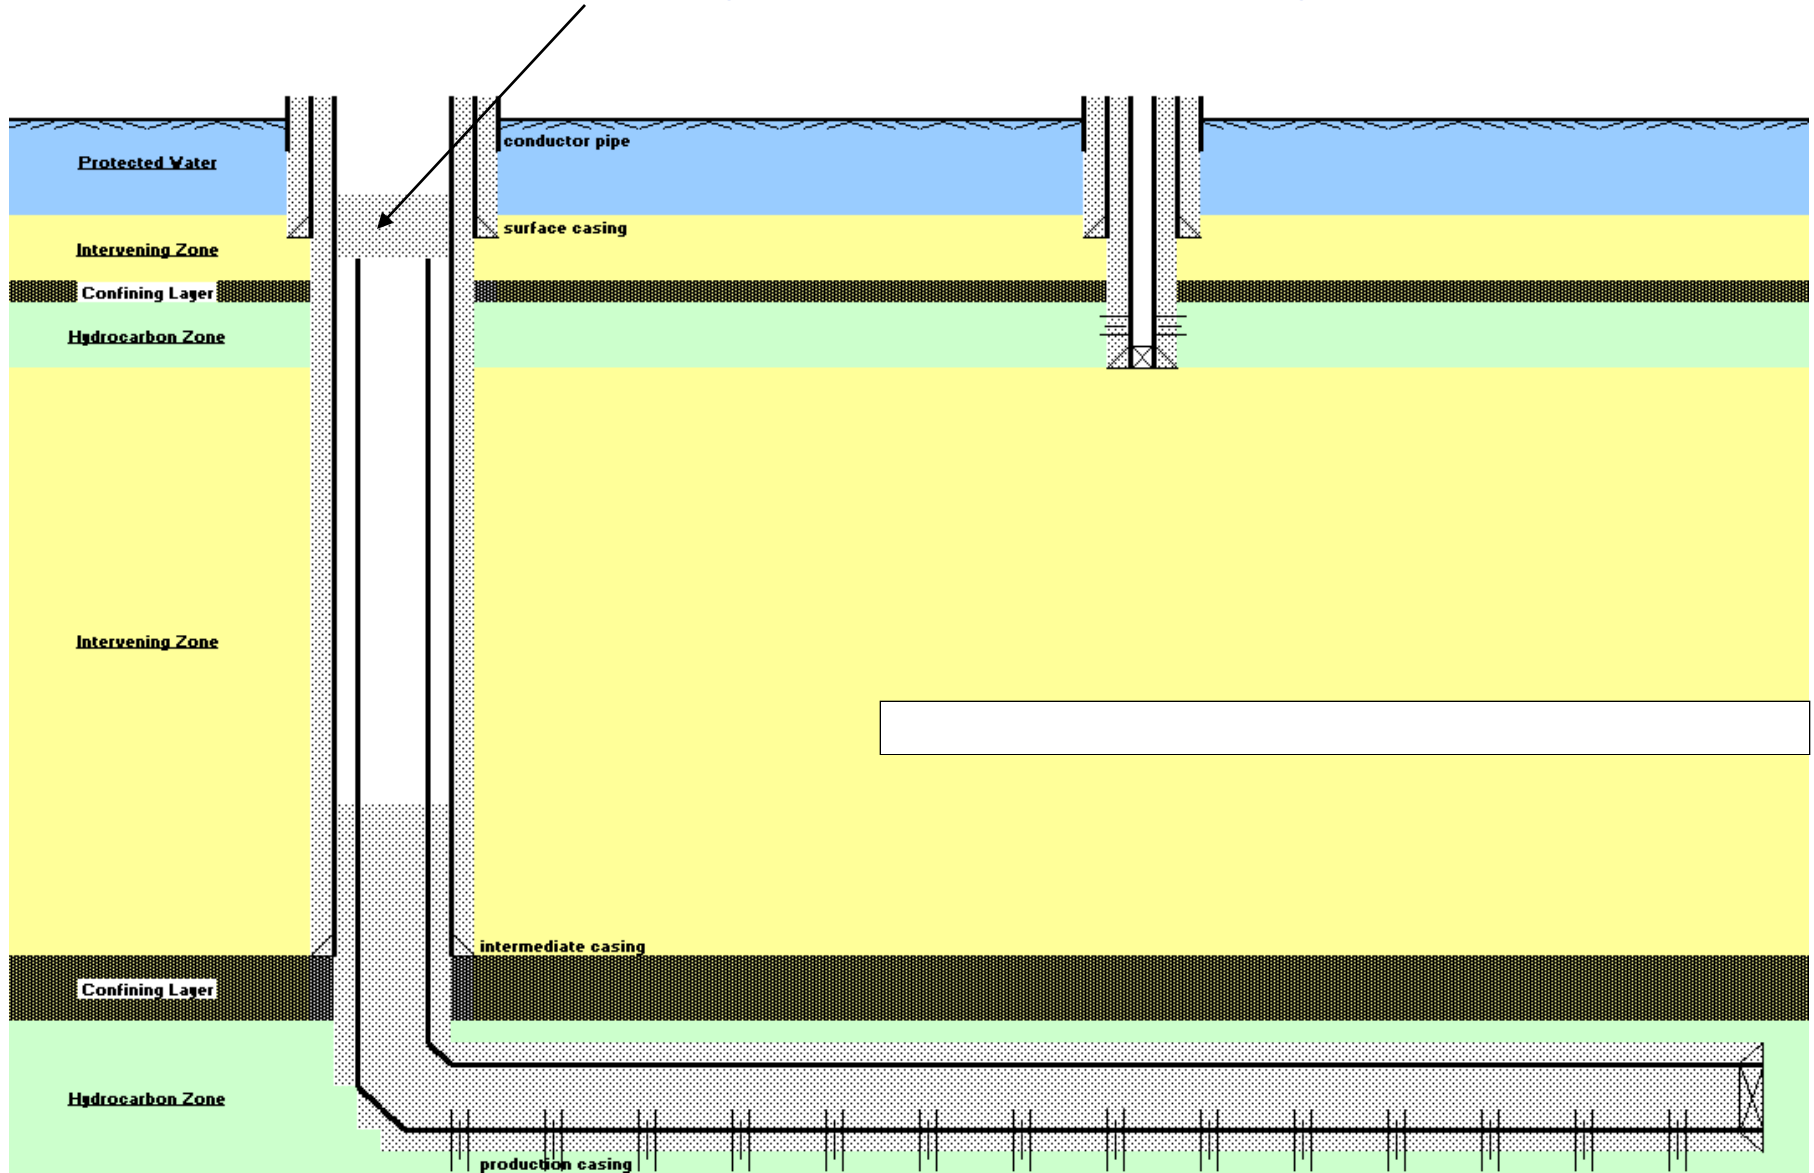
Slide 20 of 22 – Cement plug is set across the surface casing shoe and tested

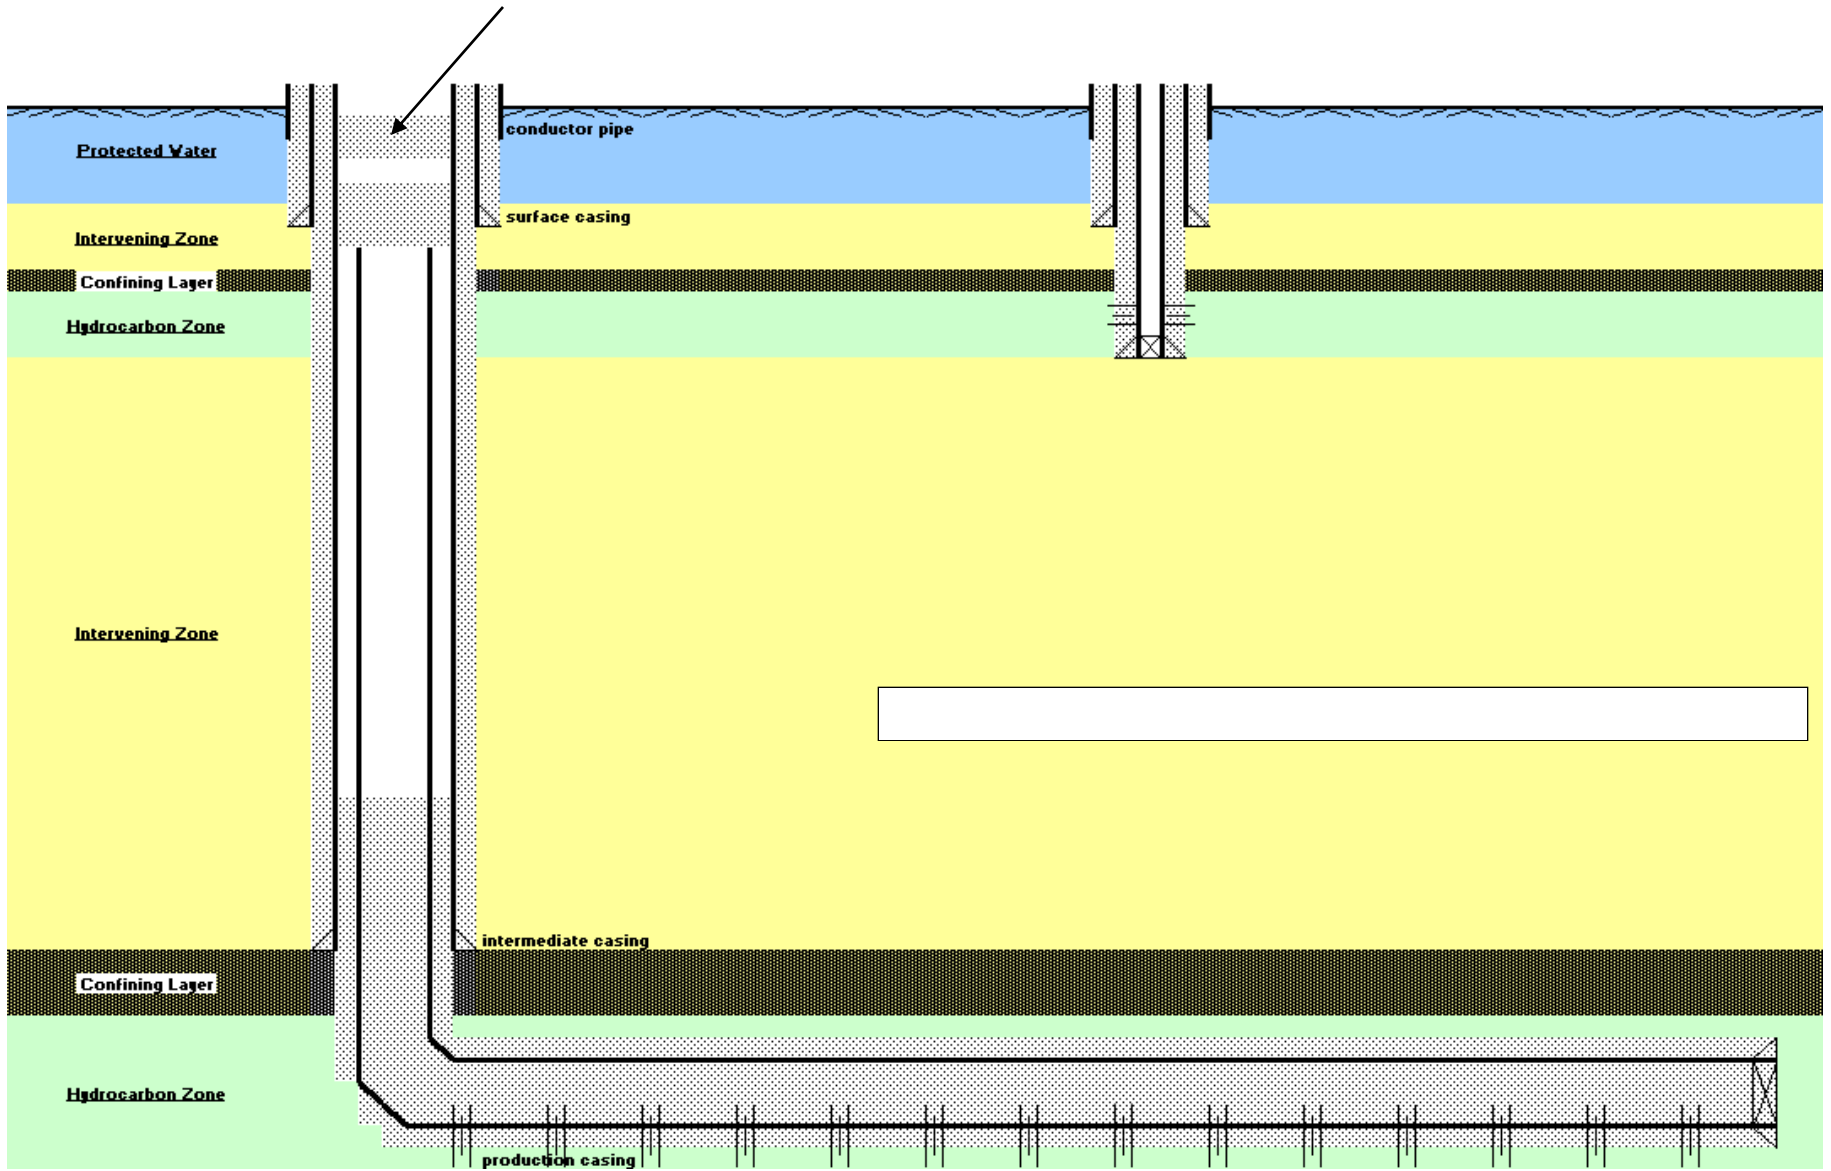
Slide 21 of 22 – Shallow surface plug is set and tested

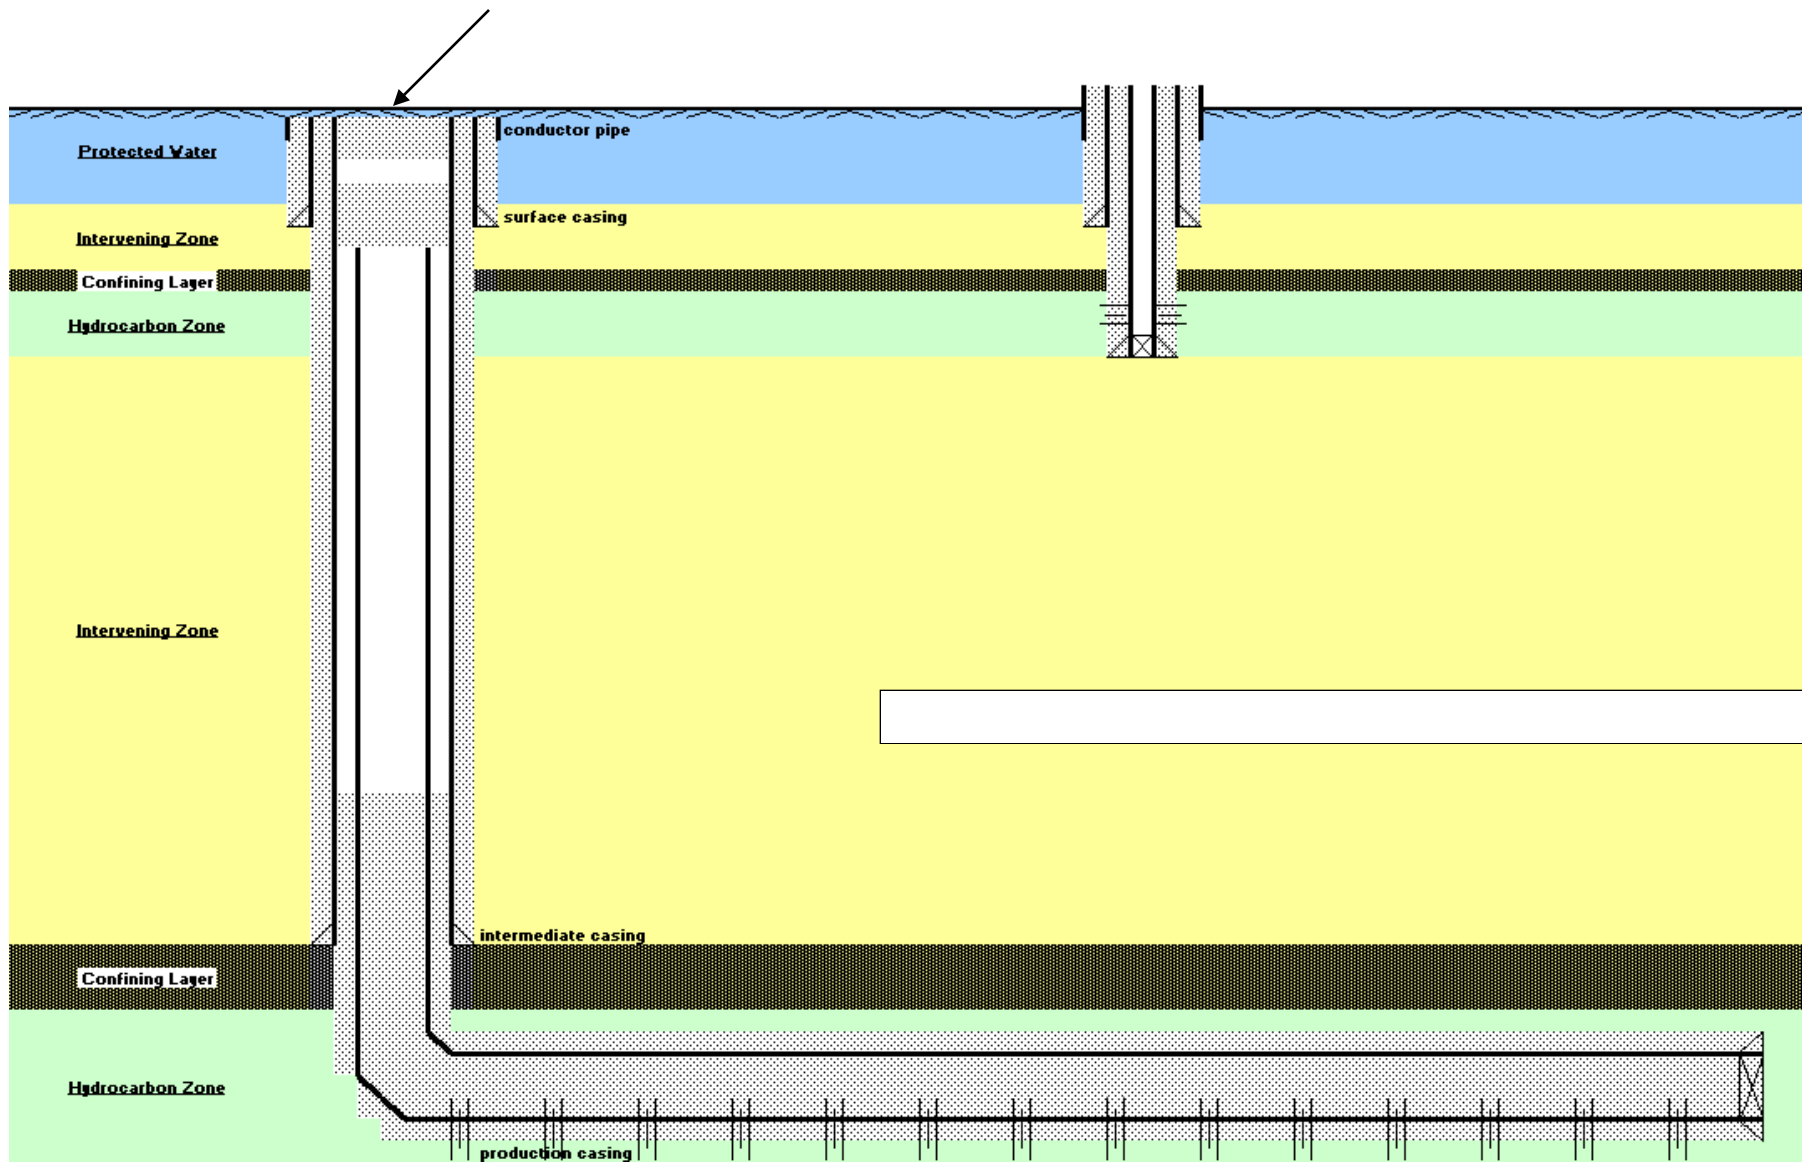
Slide 22 of 22 – Pipe cut-off, cap welded, well ID marker, backfill

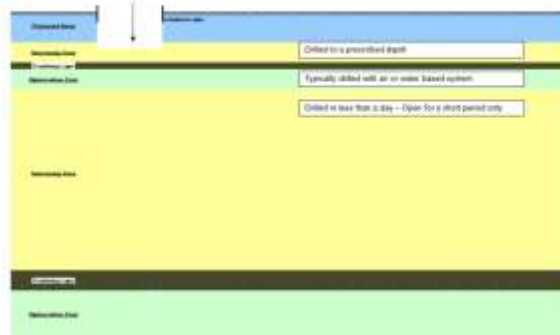
EPA Hydraulic Fracturing Study Technical Workshop #2 March 10-11, 2011
 Well Integrity Case Study by Lloyd H. Hetrick
 Slide 5 of 22 – Well is drilled to a prescribed depth below Protected Water

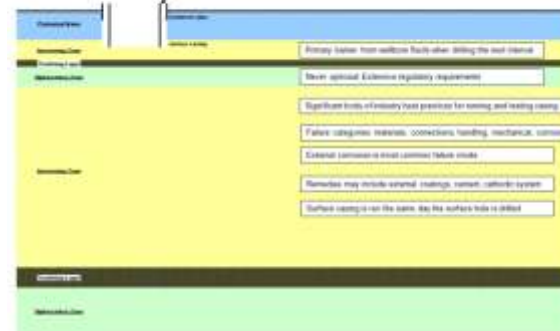
EPA Hydraulic Fracturing Study Technical Workshop #2 March 10-11, 2011
 Well Integrity Case Study by Lloyd H. Hetrick
 Slide 6 of 22 – Surface casing is run

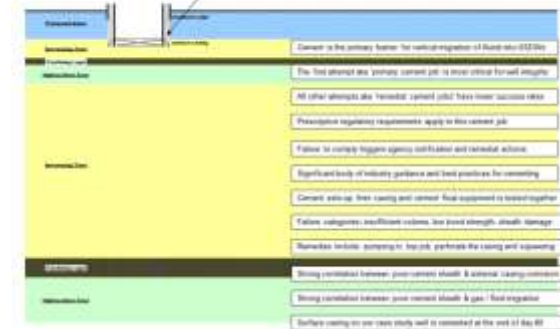
EPA Hydraulic Fracturing Study Technical Workshop #2 March 10-11, 2011
 Well Integrity Case Study by Lloyd H. Hetrick
 Slide 7 of 22 – Surface casing is cemented and tested

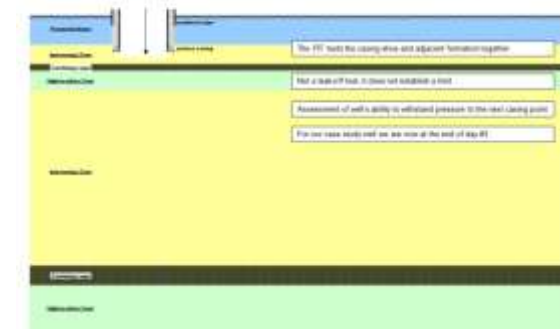
EPA Hydraulic Fracturing Study Technical Workshop #2 March 10-11, 2011
 Well Integrity Case Study by Lloyd H. Hetrick
 Slide 8 of 22 – Surface casing shoe and formation are integrity is tested

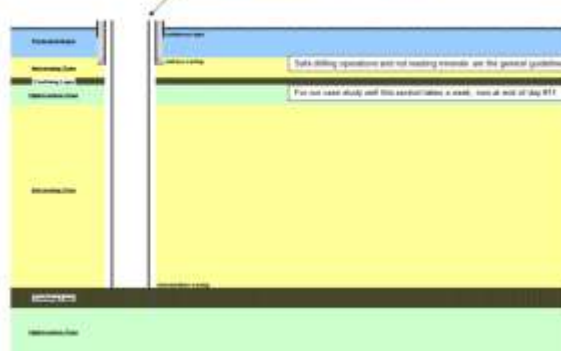
EPA Hydraulic Fracturing Study Technical Workshop #2 March 10-11, 2011
Well Integrity Case Study by Lloyd H. Hetrick
Slide 10 of 22 – Intermediate casing is run

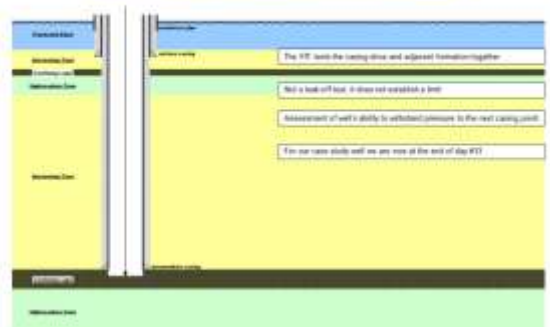
EPA Hydraulic Fracturing Study Technical Workshop #2 March 10-11, 2011
Well Integrity Case Study by Lloyd H. Hetrick
Slide 12 of 22 – Intermediate casing shoe and formation integrity are tested

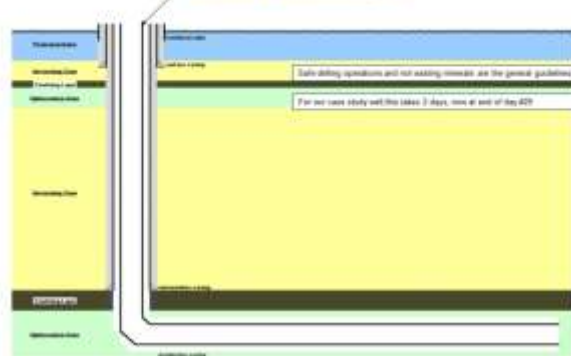
EPA Hydraulic Fracturing Study Technical Workshop #2 March 10-11, 2011
Well Integrity Case Study by Lloyd H. Helrick
Slide 14 of 22 – Production casing is run

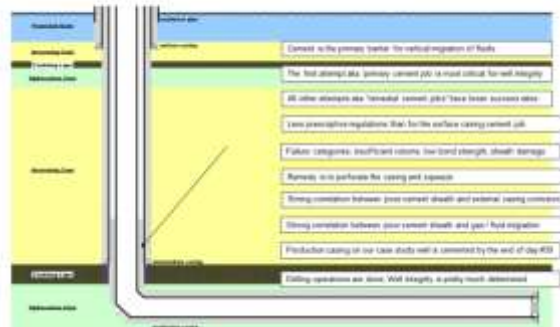
EPA Hydraulic Fracturing Study Technical Workshop #2 March 10-11, 2011
Well Integrity Case Study by Lloyd H. Helrick
Slide 15 of 22 – Production casing is cemented, Drilling phase is done

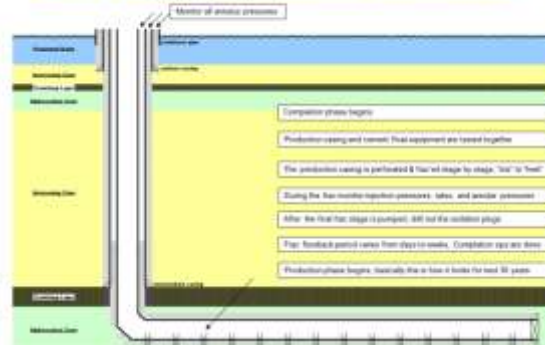
EPA Hydraulic Fracturing Study Technical Workshop #2 March 10-11, 2011
Well Integrity Case Study by Lloyd H. Helrick
Slide 16 of 22 – Completion phase: perforate, hydraulically frac, flowback, production begins

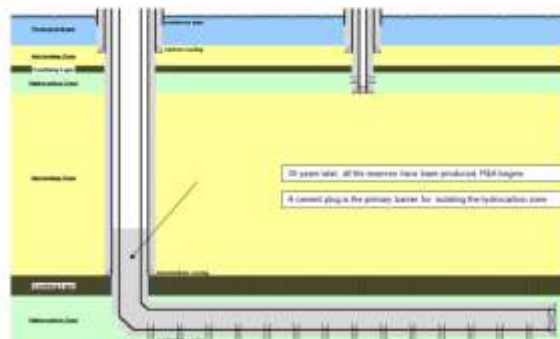
EPA Hydraulic Fracturing Study Technical Workshop #2 March 10-11, 2011
Well Integrity Case Study by Lloyd H. Hetrick
Slide 18 of 22 – Plug and Abandonment begins, producing zone is plugged and tested

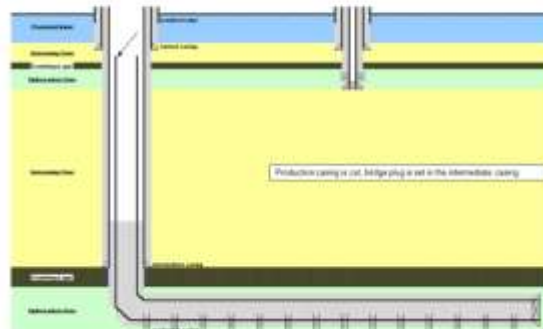
EPA Hydraulic Fracturing Study Technical Workshop #2 March 10-11, 2011
Well Integrity Case Study by Lloyd H. Hetrick
Slide 19 of 22 – Casing is cut or perforated near the surface casing shoe

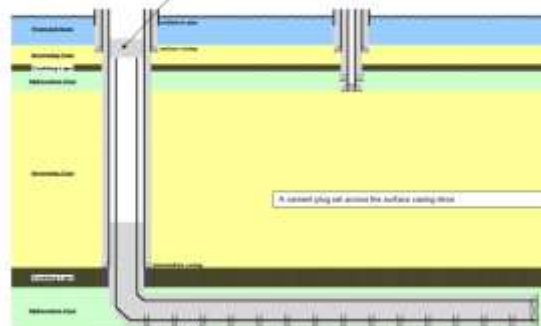
EPA Hydraulic Fracturing Study Technical Workshop #2 March 10-11, 2011
Well Integrity Case Study by Lloyd H. Hetrick
Slide 20 of 22 – Cement plug is set across the surface casing shoe and tested

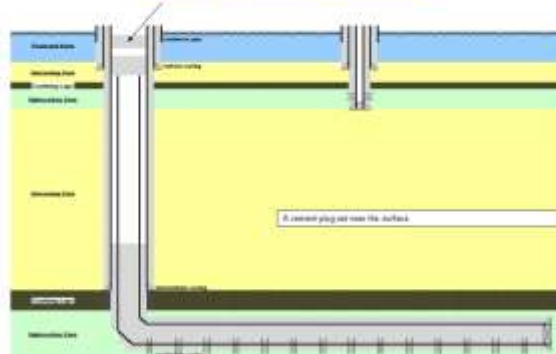
EPA Hydraulic Fracturing Study Technical Workshop #2 March 10-11, 2011
Well Integrity Case Study by Lloyd H. Helrick
Slide 21 of 22 – Shallow surface plug is set and tested

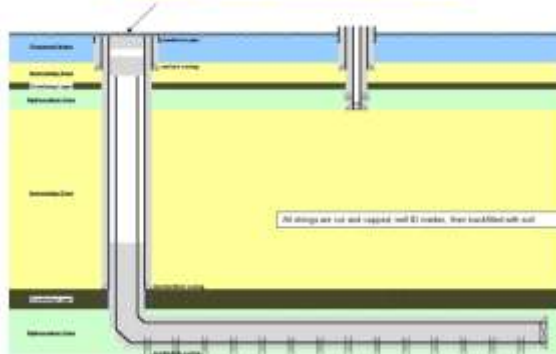
EPA Hydraulic Fracturing Study Technical Workshop #2 March 10-11, 2011
Well Integrity Case Study by Lloyd H. Helrick
Slide 22 of 22 – Pipe cut-off, cap welded, well ID marker, backfill
