Navajo Abandoned Uranium Mine

Site Screen Report

Cisco Mine AUM Site

March 2010

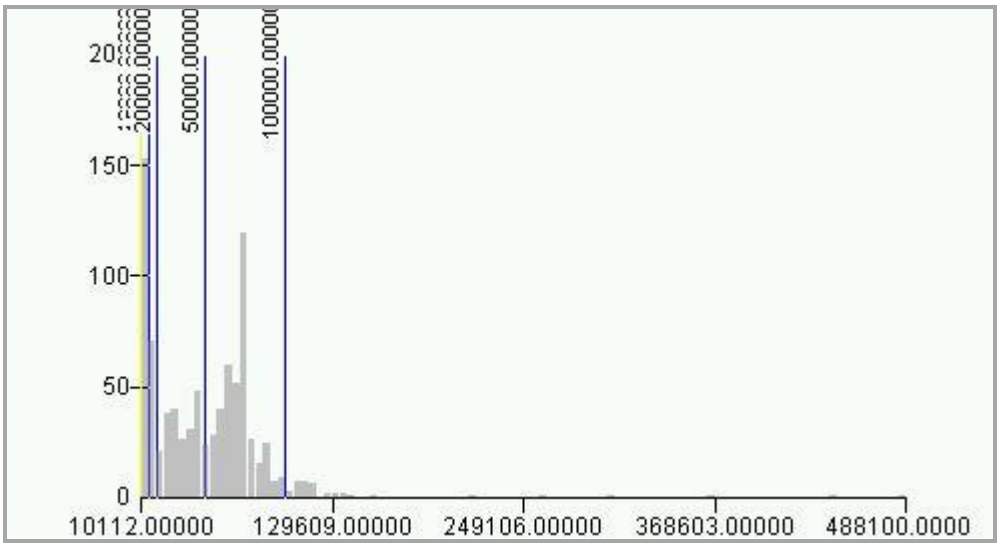
The following chart and statistics were generated by ESRI ArcGIS 9.3.1, and show the general distribution of the site gamma radiation measurements. The horizontal X axis represents the gamma radiation reading levels in cpm (lowest levels to the left). The vertical Y axis represents the frequency of each gamma radiation level.

Count:	868
Minimum:	10112.00000
Maximum:	488100.00000
Sum:	44465882.00000
Mean:	51227.97465
Median:	49547.50000
Standard Deviation:	38849.31015

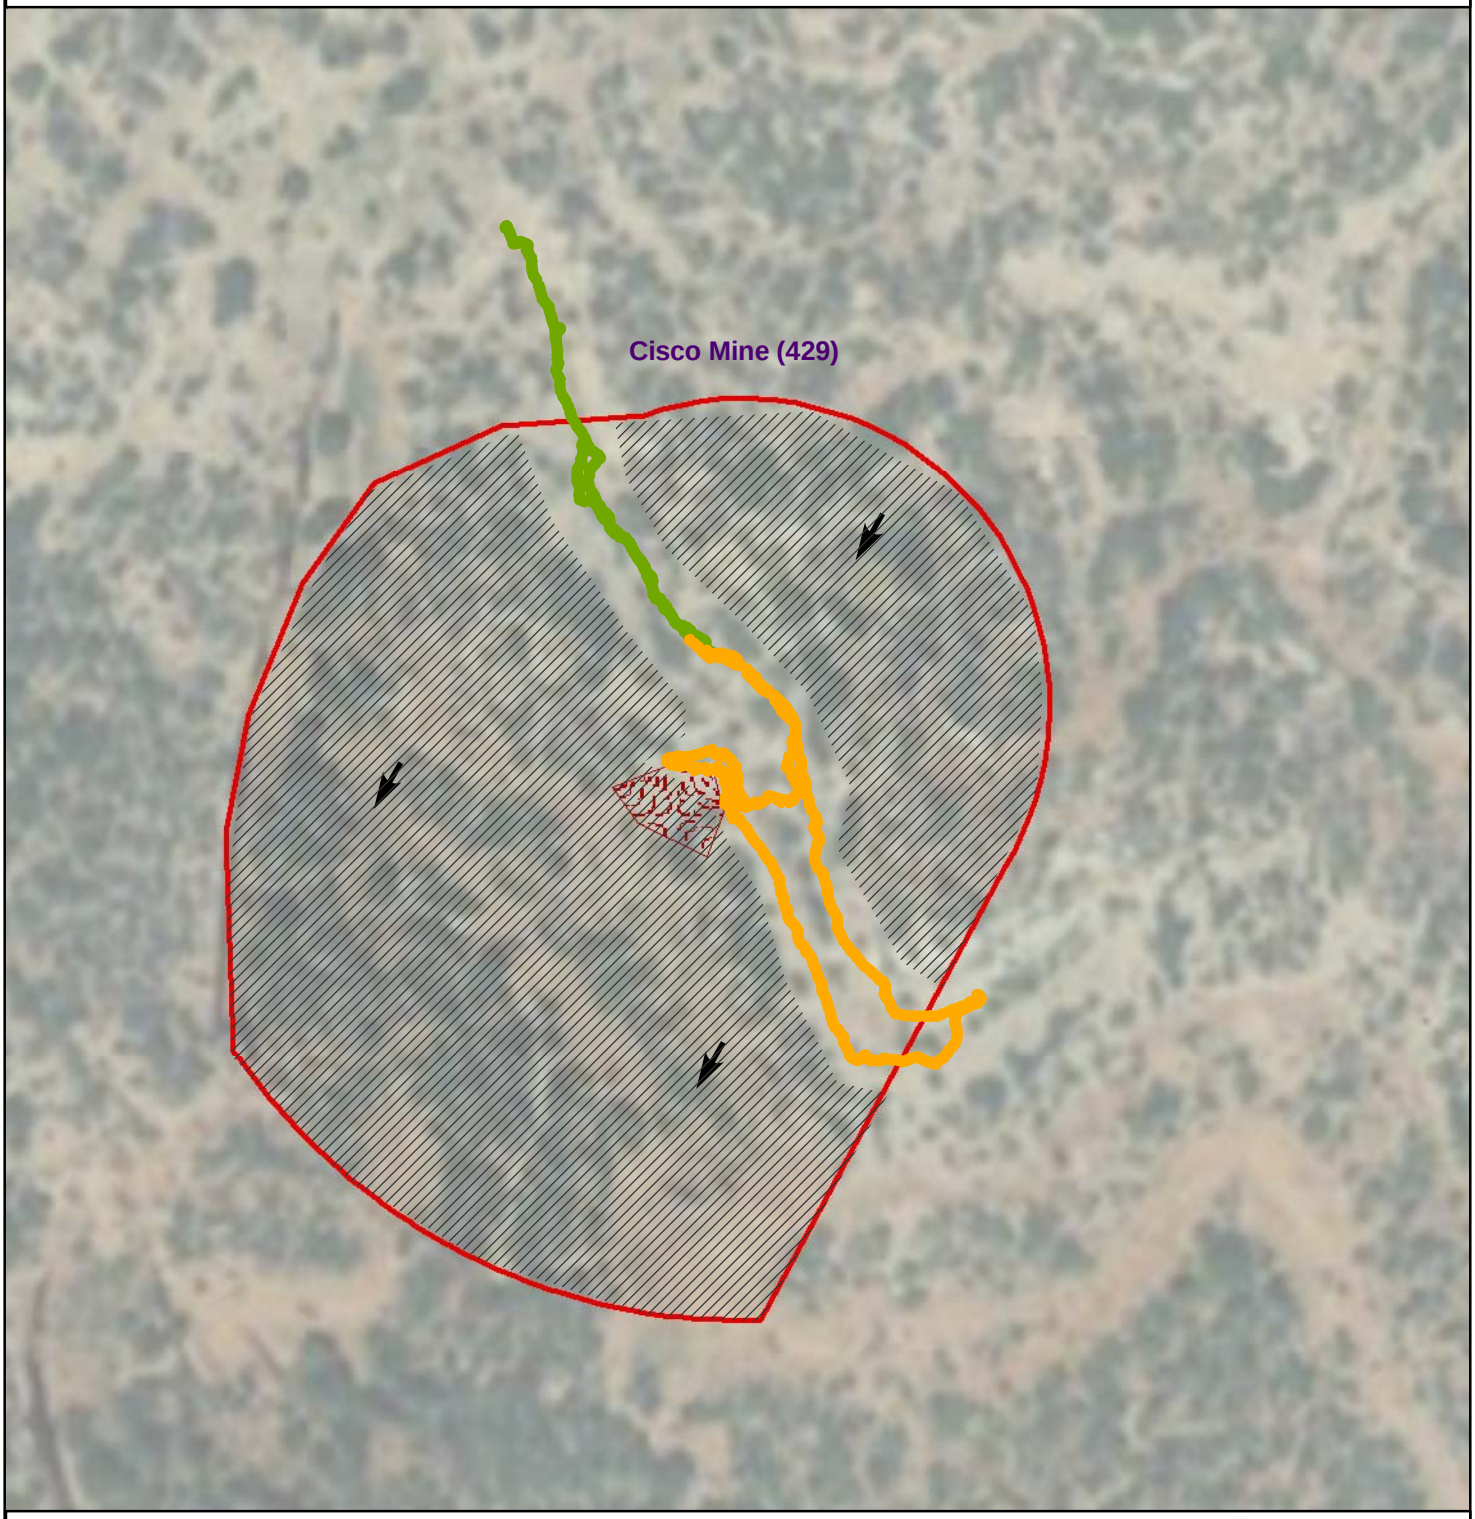
Figure 1 - Gamma Radiation Measurements, Above Two Times Background
Cisco Mine (429)
Round Rock Chapter, Navajo Nation, Arizona

A total of 868 gamma radiation measurements were collected from the mine site, ranging from 10,112 cpm to 488,100 cpm. Measurements in the vicinity of the waste debris were found at levels above 100,000 cpm, measurements at exposed yellow rock east of site were above 400,000 cpm. The measurements are represented in Figures 1 and 2.
