Navajo Abandoned Uranium Mine

Site Screen Report

Sandy K AUM Site

August 2010

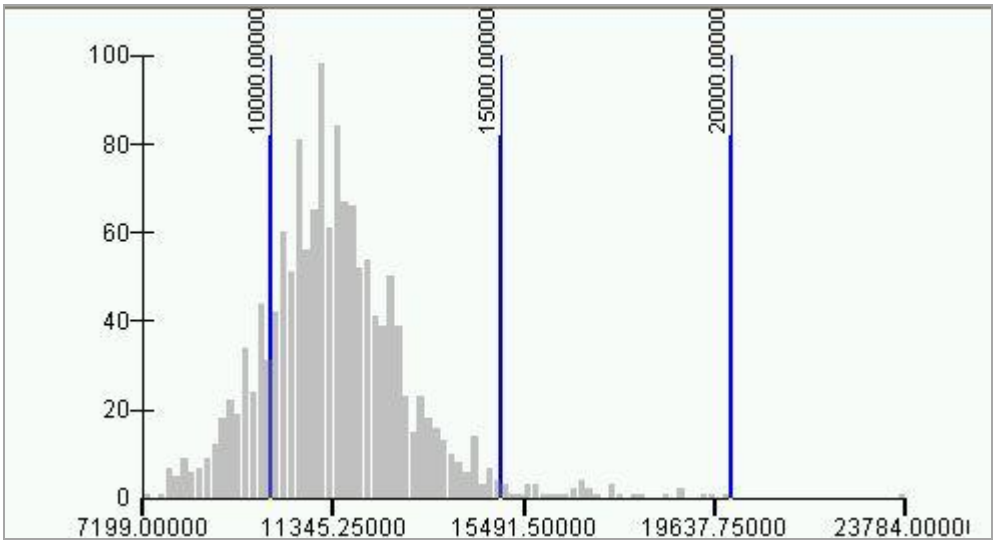
The following chart and statistics were generated by ESRI ArcGIS 9.3.1, and show the general distribution of the site gamma radiation measurements. The horizontal X axis represents the gamma radiation reading levels in cpm (lowest levels to the left). The vertical Y axis represents the frequency of each gamma radiation level.

Count:	1452
Minimum:	7199.00000
Maximum:	23784.00000
Sum:	16534858.00000
Mean:	11387.64325
Median:	11247.50000
Standard Deviation:	1646.98628

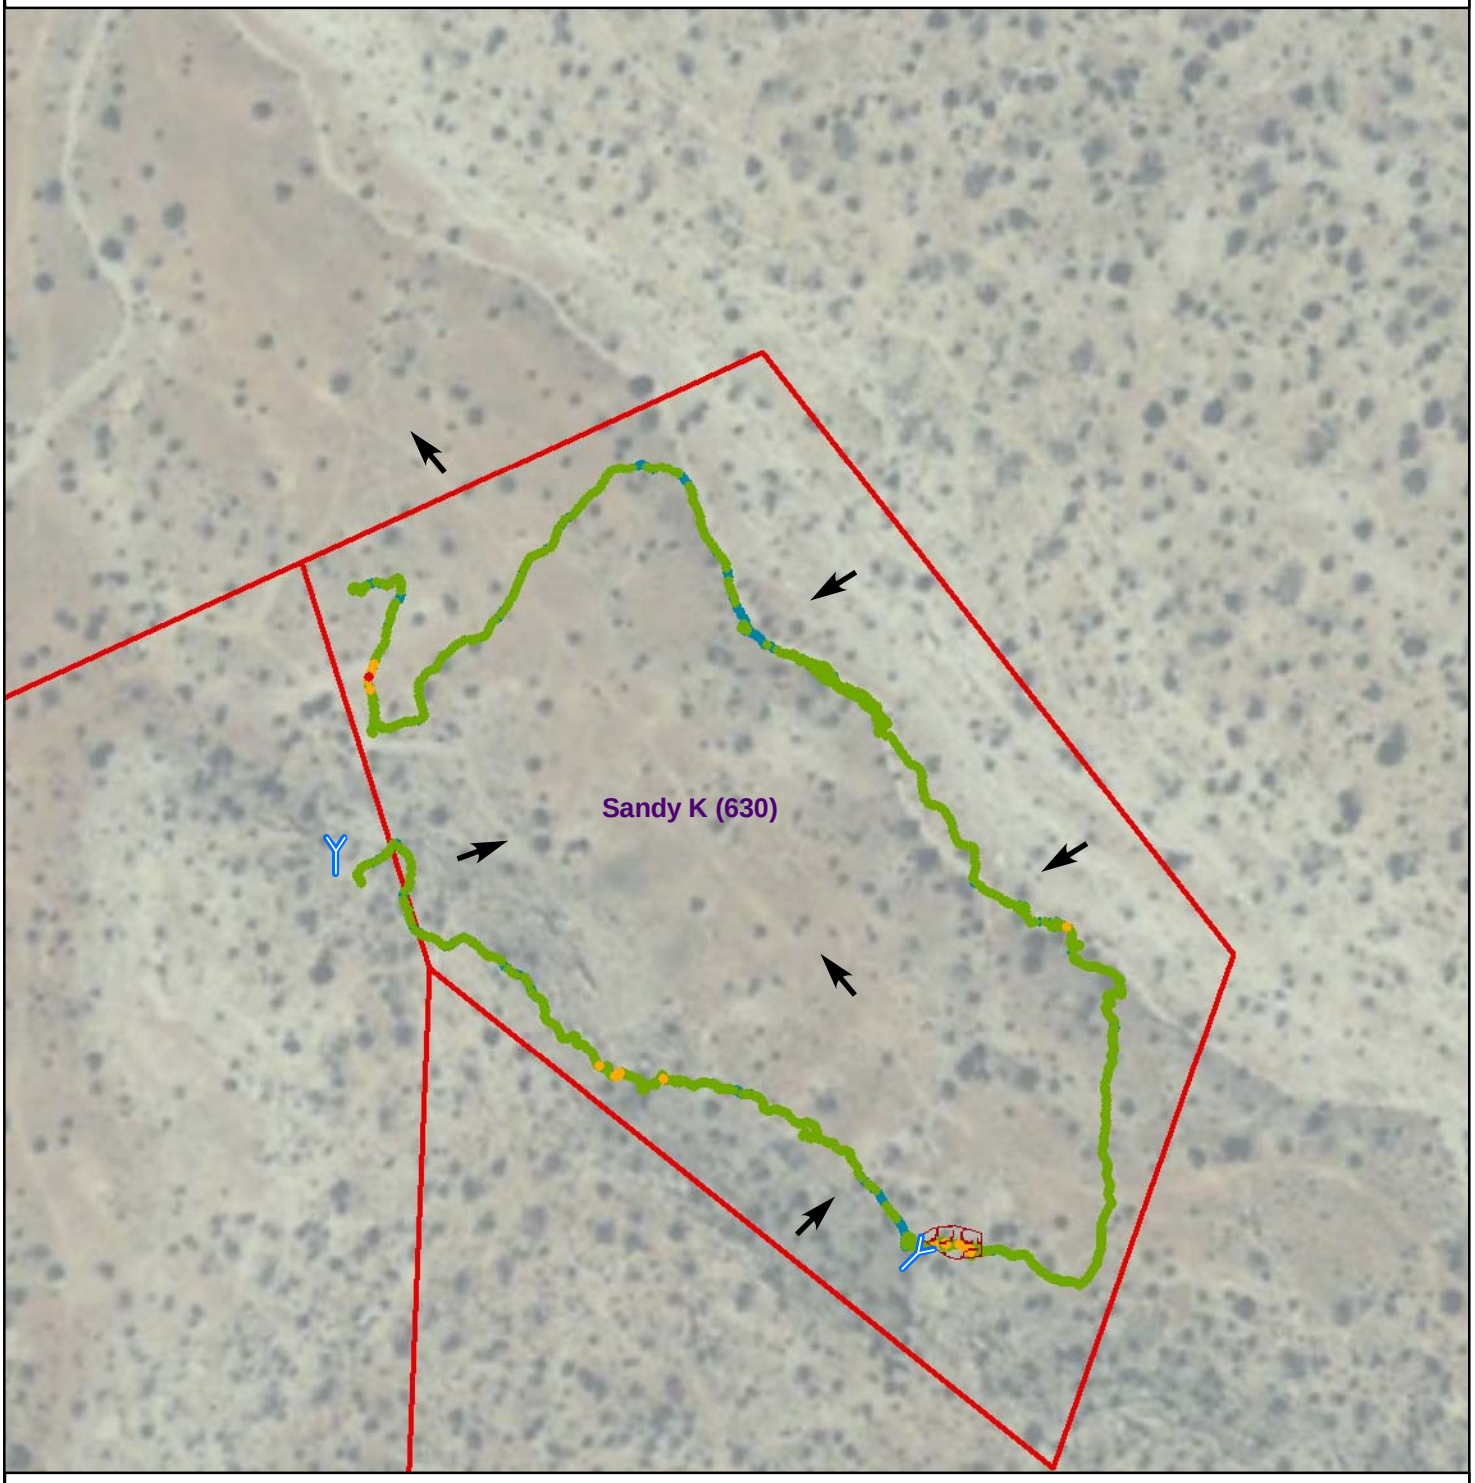
Figure 2 - Gamma Radiation Measurements
Sandy K (630)
Teec Nos Pos Chapter, Navajo Nation

A total of 1,452 gamma radiation measurements were collected from the mine site, ranging from 7,199 cpm to 23,784 cpm. Measurements collected in the vicinity of the waste debris were found at levels up to approximately 25,000 cpm. The measurements are represented in Figures 1 and 2.
