UNITED STATES ENVIRONMENTAL PROTECTION AGENCY

SUBJ: Coronet Industries Incorporated
Plant City, Florida

United States Environmental Protection Agency
 Washington, D.C. 20460
Water Compliance Inspection Report

Water Compliance Inspection Report

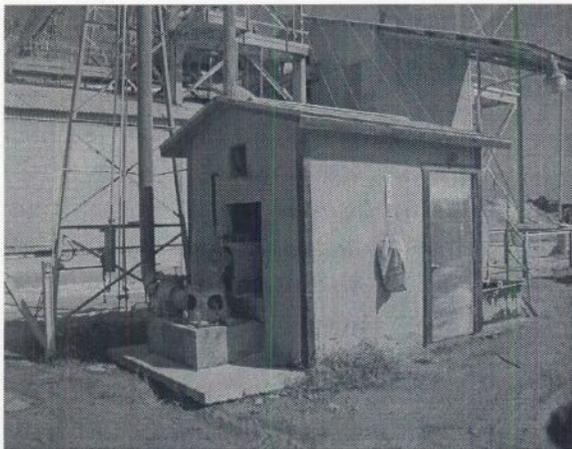
Mr. Carl Brown, Coronet's consulting geologist, escorted Mr. Baker and Mr. Watson to the drinking water system. Mr. Brown was initially unable to locate the drinking water well. Picture 1 and Picture 2 are of one of the industrial process water wells described as well "C4."
