**Explosives Safety Technical Assistance Visit  
(March 9 to 11, 2015)**

**Louisiana National Guard's  
Camp Minden**

1                   **Final Report of Explosives Safety Technical Assistance Visit to Camp Minden**  
2                   **(March 9 to 11, 2015)**

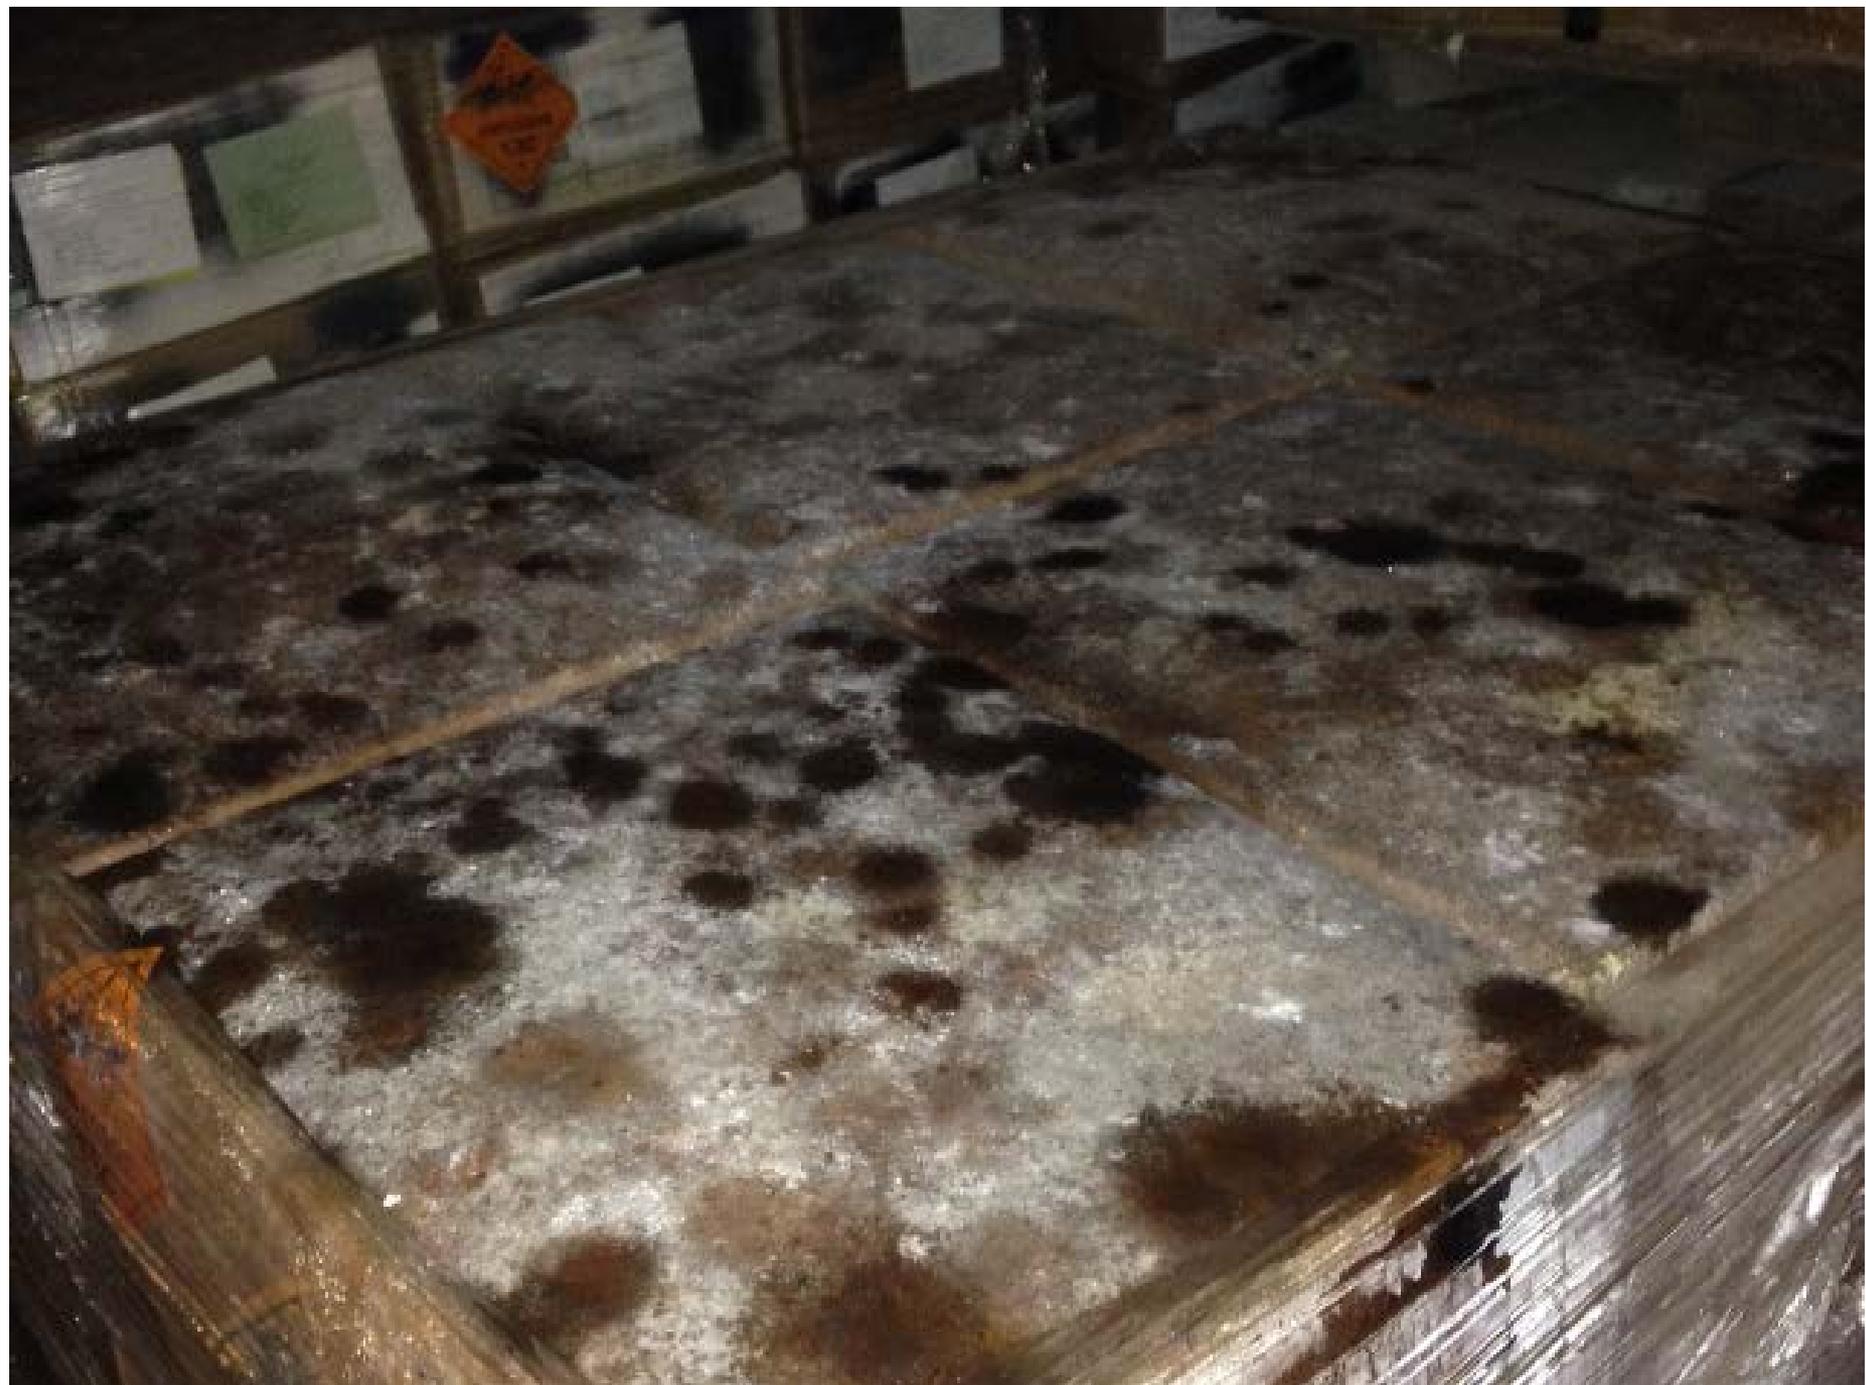
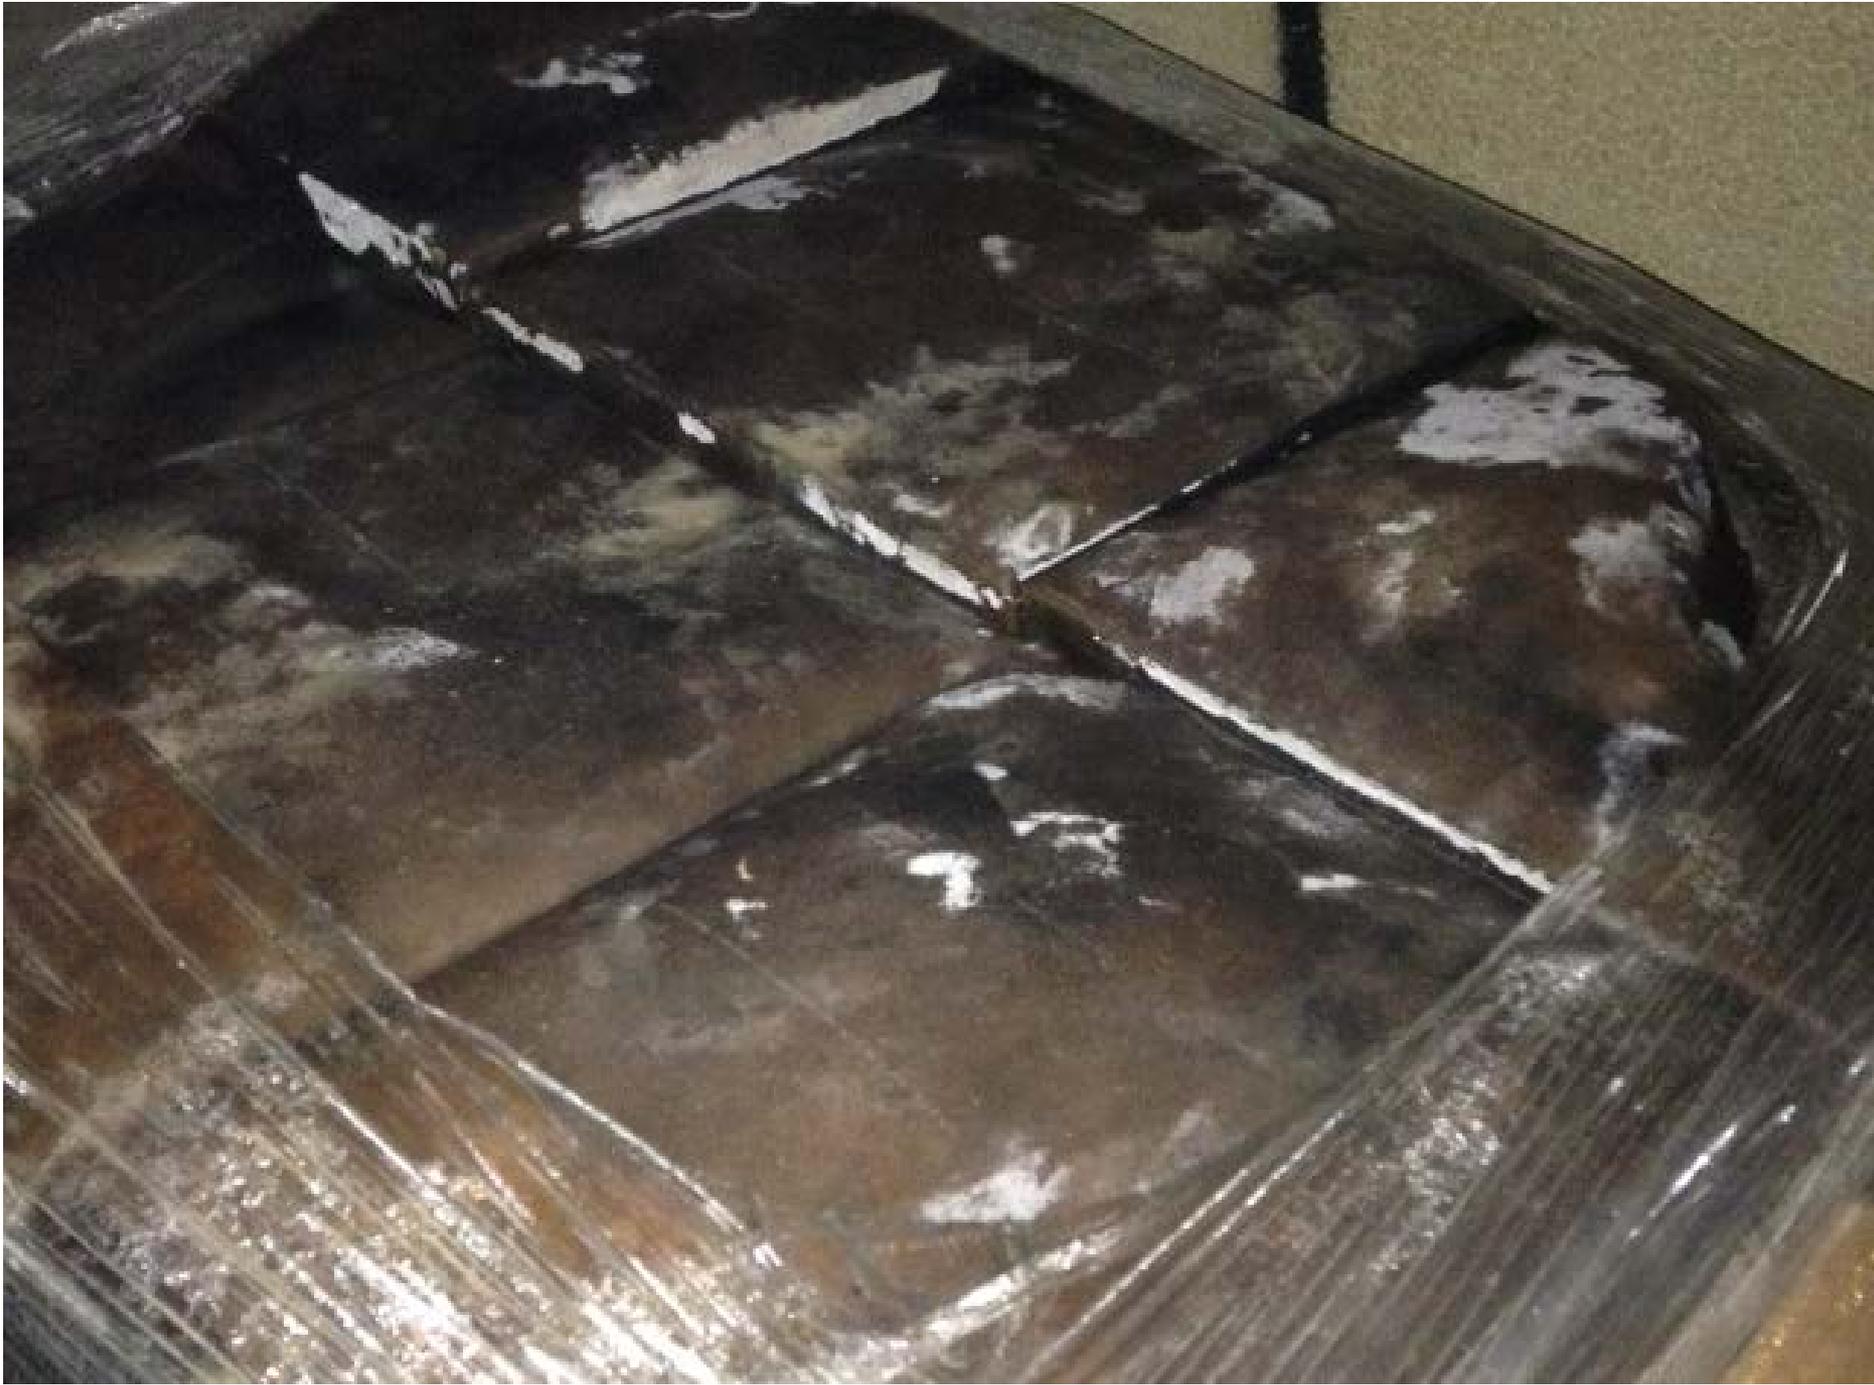
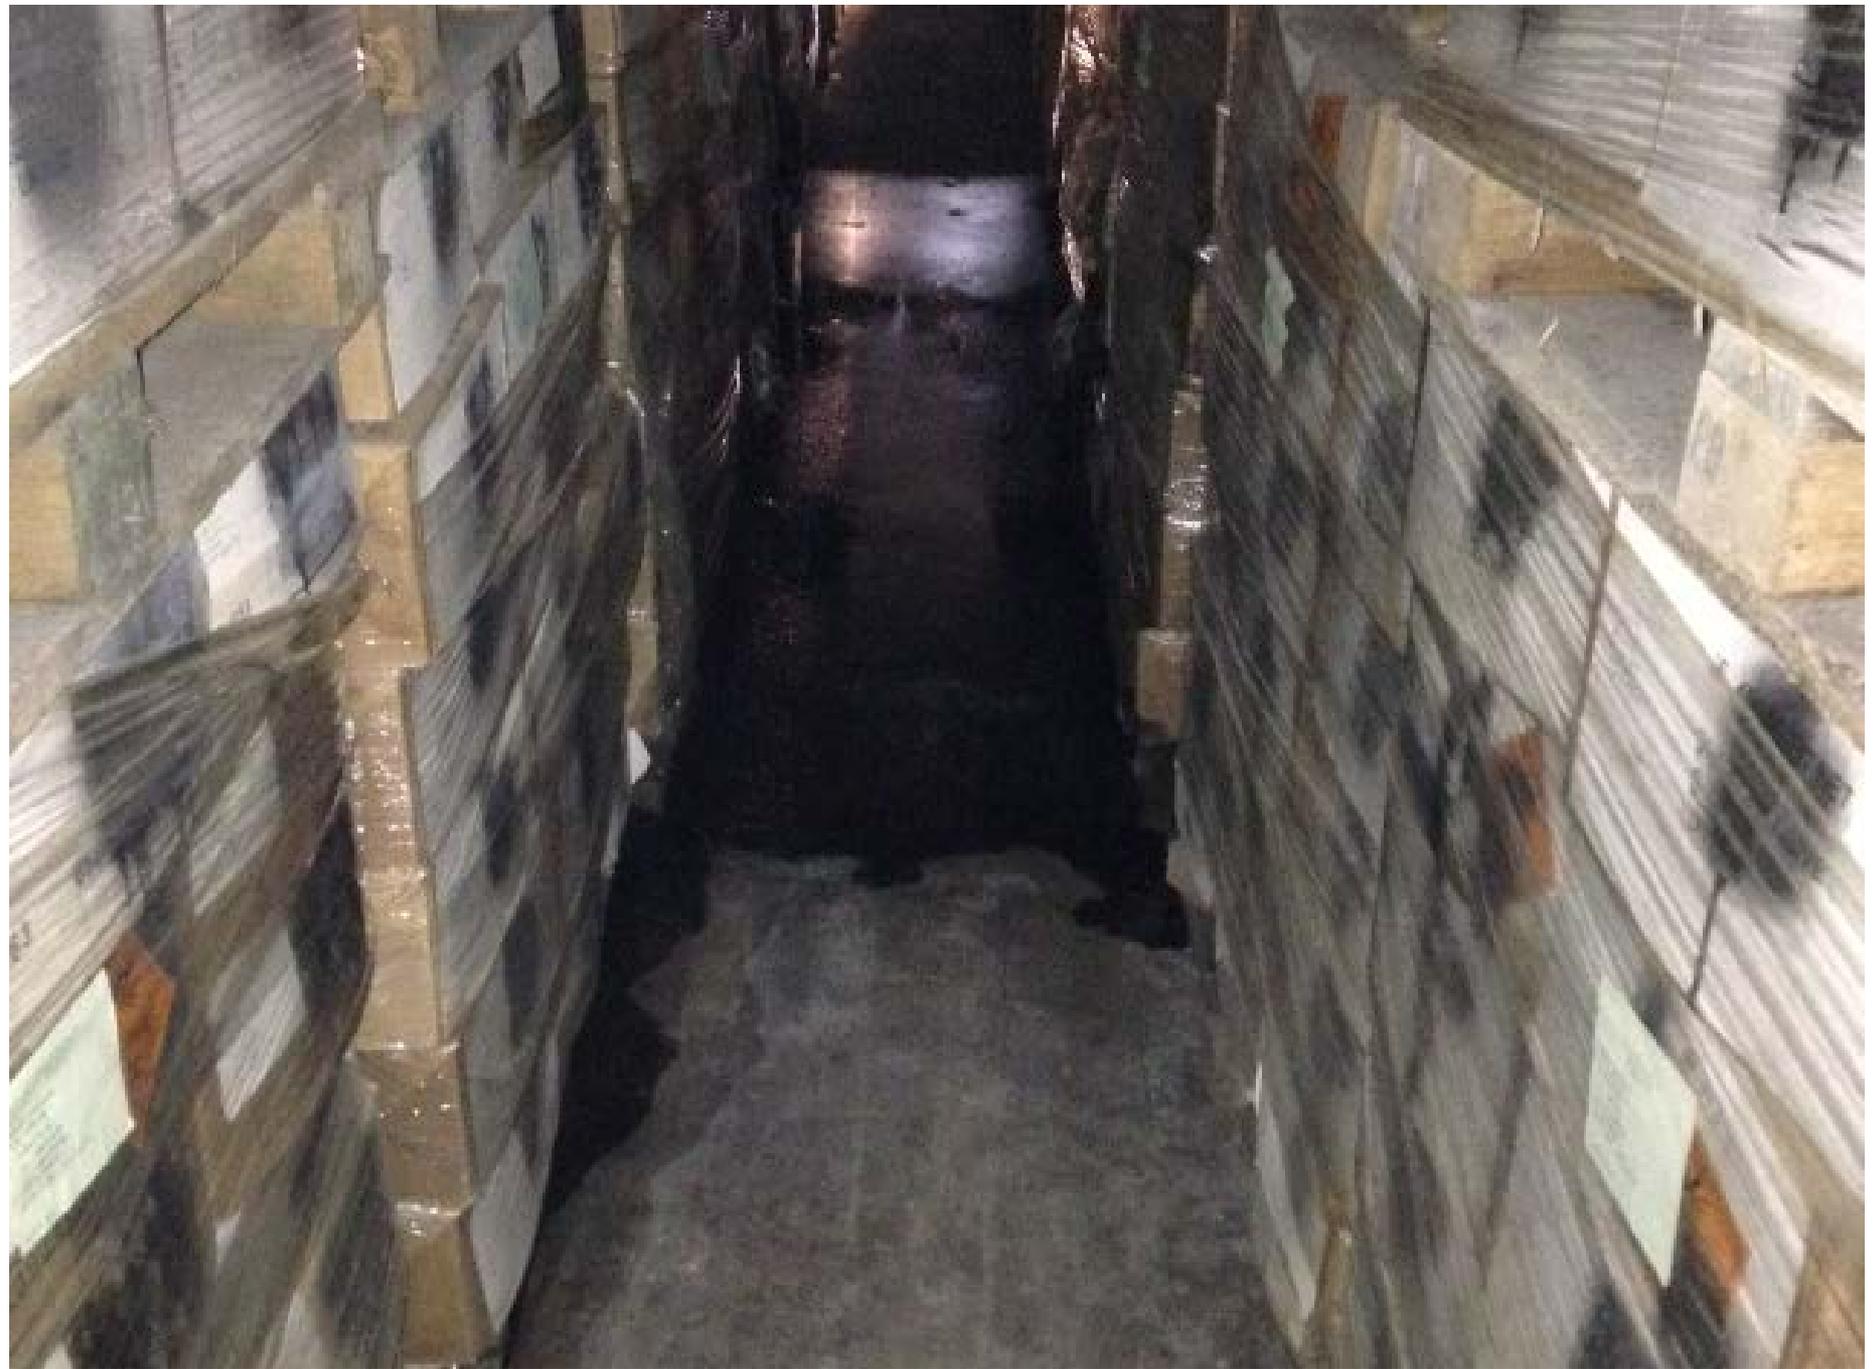
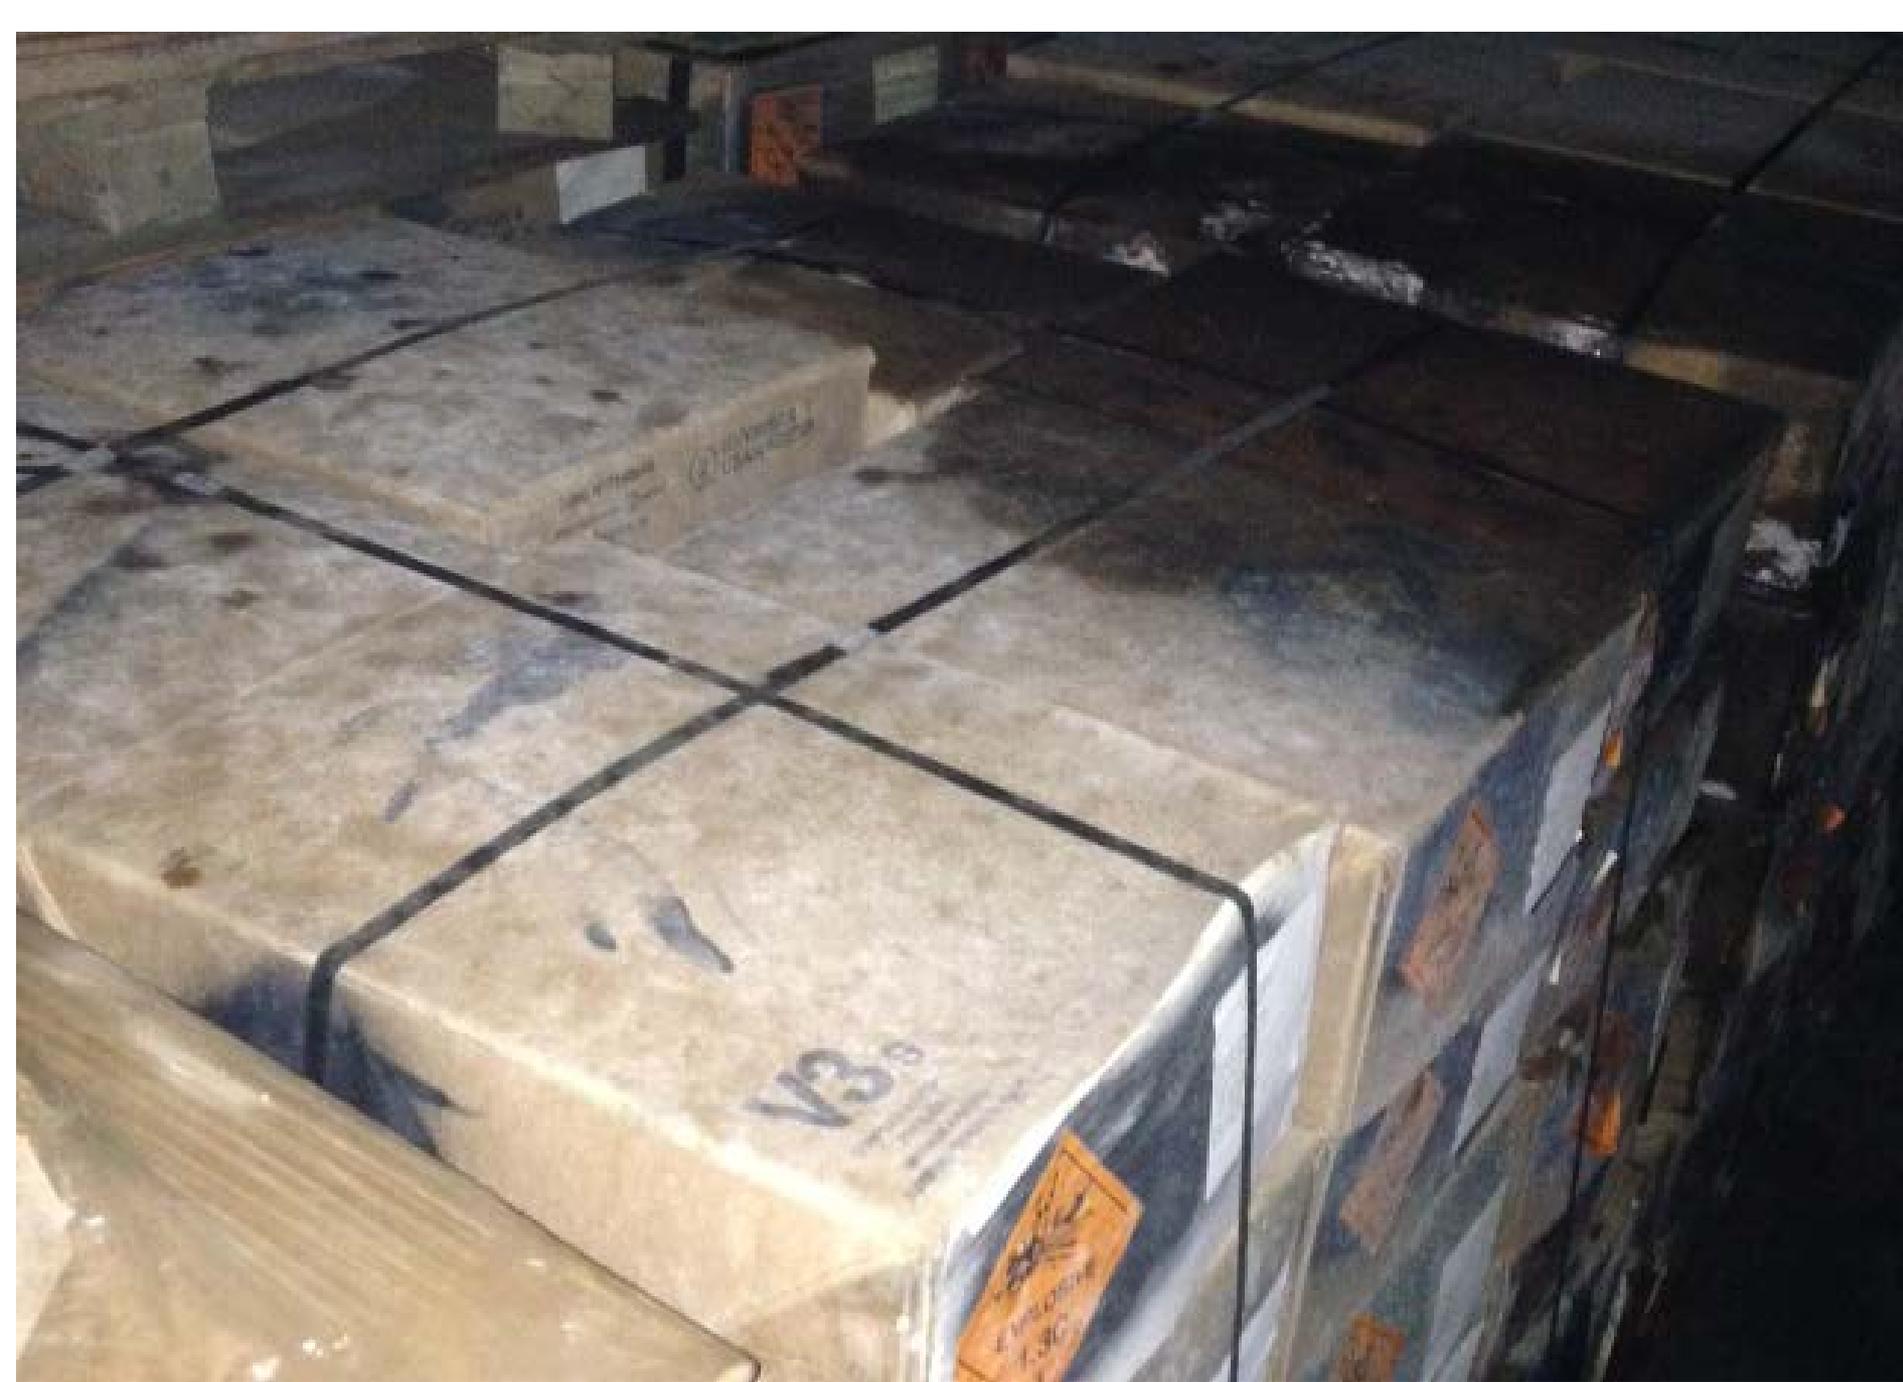
ENCLOSURE 2, ATTACHMENT

The mold, which is using the packaging as a nutrient source, is not of itself a concern. However, the mold is an indication of prevalent moisture which is known to accelerate propellant decomposition

CBI is 98% nitrocellulose and 1.5% diphenylamine (stabilizer). Nitrocellulose is slightly hygroscopic (absorbs water) and water causes the nitrocellulose to deteriorate faster. Other factors being equal, moisture-induced deterioration of nitrocellulose may raise the risk of an inadvertent auto-ignition. Given the cardboard boxes are wet and not water tight, EPA should consider the fact that there is most likely an elevated risk of auto-ignition of the damp CBI. An auto-ignition (fire) inside a magazine would quickly involve everything stored within the magazine. The amount of time remaining before an auto-ignition could occur is not known.

EPA should consider destroying CBI and M6 propellant in compromised packaging that has gotten wet or been in high humidity or wet magazines immediately. LOT identity for this material is unknown. Given the higher nitrocellulose content of CBI, EPA should consider destroying the CBI first. Additionally, much of this material has already experienced an abnormal storage environment that most likely increased its rate of decomposition.
