# Corsica River Watershed Restoration Action Strategy: Final Report

## **Excerpt Showing an Example of Stream Sampling Documentation**

**September 2004**

**CORSICA RIVER WATERSHED  
SCA SURVEY RESULTS**

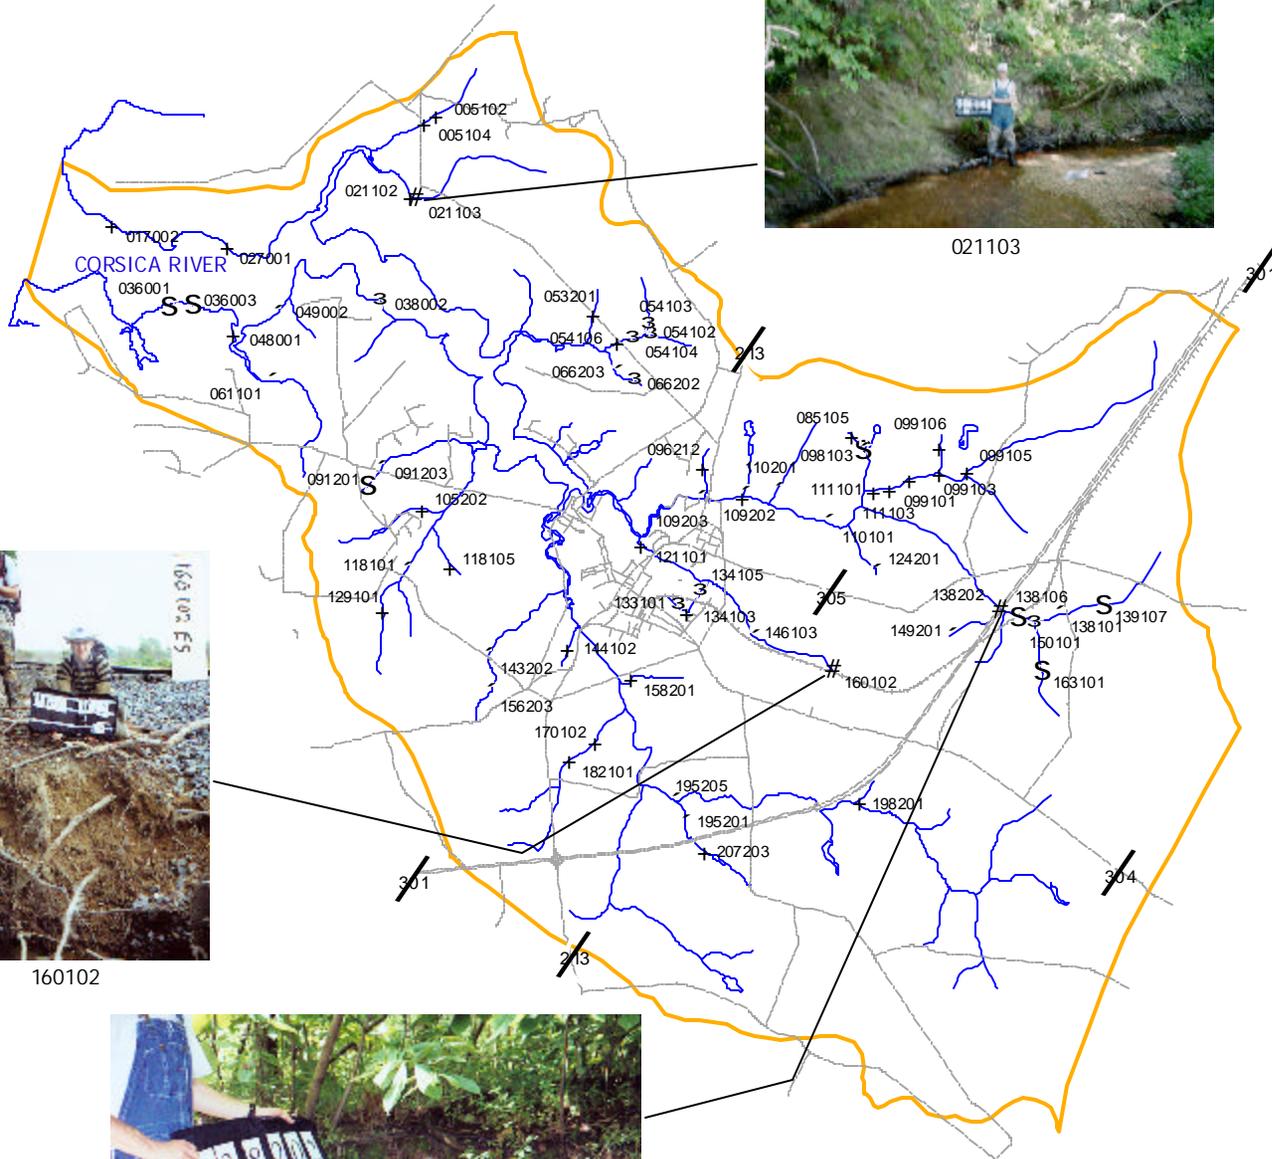
Problem	Site	Date	Type	Possible Cause	Length(ft)	Height(ft)	Landuseight	Landuseleft	Infrastructure Threatened?	Describe	Severity	Correctability	Access
Erosion Site	021103	06/25/2003	Widening	Natural	1037	4	Forest	Forest	No		1	2	2
Erosion Site	138202	06/09/2003	Widening	Below Channelization	7230	4	Forest	Forest	No		1	5	4
Erosion Site	160102	06/03/2003	Widening	Below Road Crossing	3430	4	Crop Field	Forest	No		1	4	2
Erosion Site	061101	06/24/2003	Widening	Bend at Steep Slope	4380	1	Forest	Forest	No		2	2	4
Erosion Site	066203	07/07/2003	Downcutting	Bend at Steep Slope	1000	1.5	Forest	Forest	No		2	2	4
Erosion Site	091203	06/24/2003	Downcutting	Bend at Steep Slope	3200	1	Forest	Forest	No		2	2	2
Erosion Site	098104	05/12/2003	Widening	Bend at Steep Slope	1720	2	Forest	Forest	No		2	3	4
Erosion Site	109102	05/27/2003	Widening	Land Use Change Upstream	1720	3	Forest	Forest	No		2	4	3
Erosion Site	109203	06/03/2003	Widening	Bend at Steep Slope	1480	2	Forest	Forest	No		2	3	2

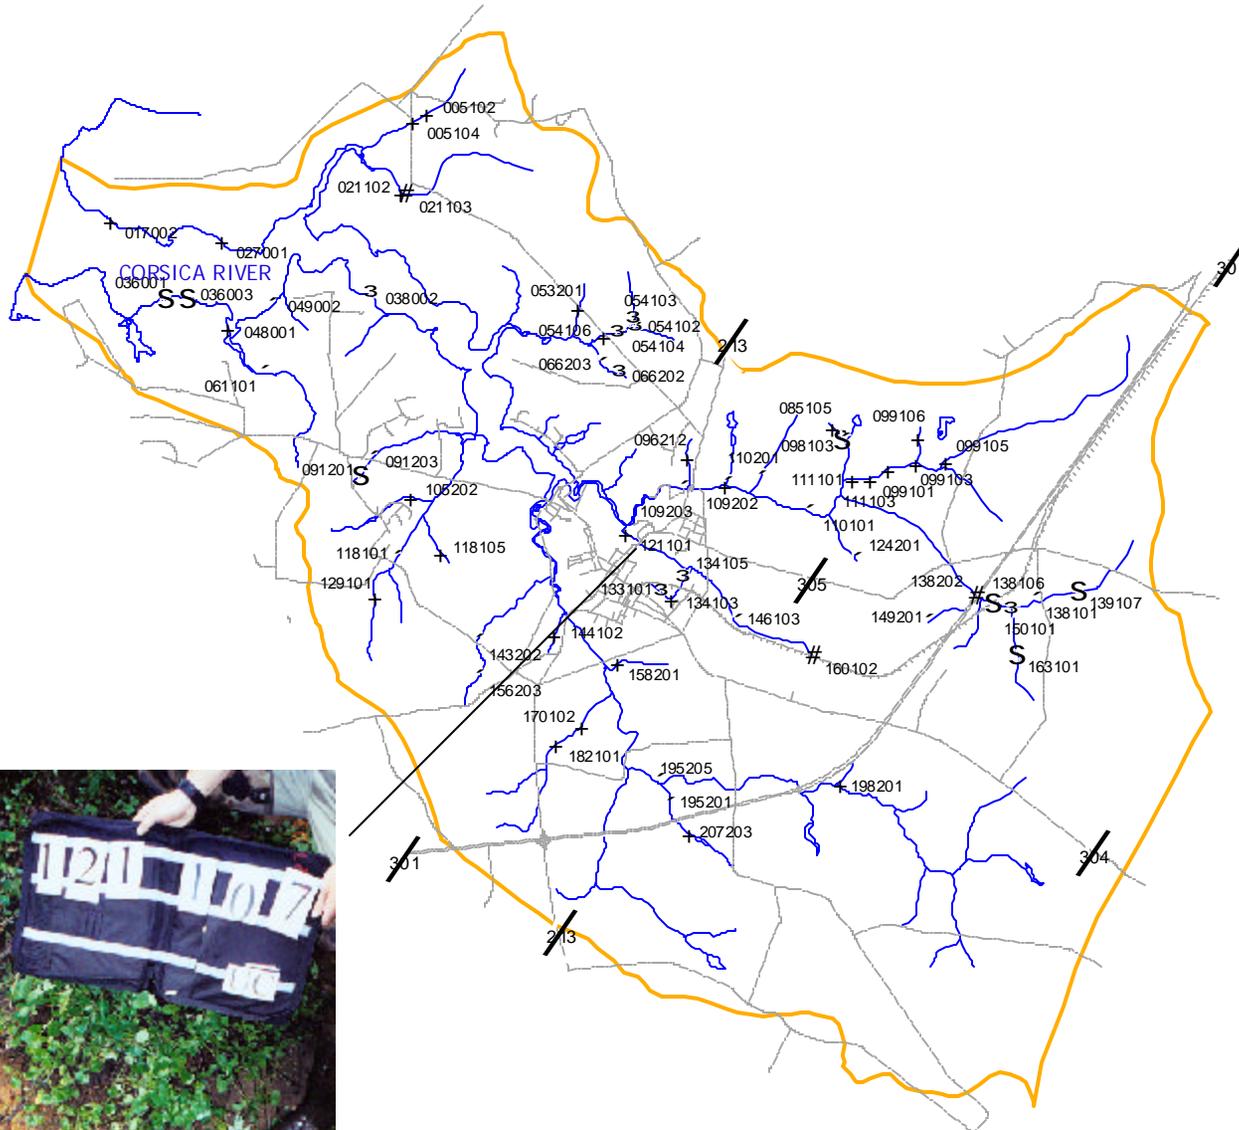
Problem	Site	Date	Type	Description	Potential Cause	Severity	Correctability	Access
Unusual Condition	121107	05/28/2003	Abnormal Seep From Bank	Musky Smelling Seep 3ft long, 10 inches side	Land Use Change Upstream	2	2	2
Unusual Condition	085102	05/12/2003	Red Flock	Red Flock In Stream below instream pond	eutrophication in pond	3	3	2
Unusual Condition	134106	06/03/2003	Red Flock	Excessive Red Flock Present	Iron Oxides	3	3	2
Unusual Condition	139106	06/11/2003	Channel Discharging into Stream	Dark Brown Discharge in Channel entering stream	Unknown	3	3	2
Unusual Condition	143206	06/17/2003	Orange Substance Leaking from Bank	Orange Substance leaking from bank in many different places along section of bank	Runoff from field	3	4	3
Unusual Condition	098105	05/12/2003	Black Organic Material	Stream has large amount of black organic material present		4	3	3
Unusual Condition	109101	05/27/2003	Excessive Sediment	Whole Tributary w/excessive sediment from upstream construction	Upstream Construction	4	4	3
