Drainage Master Plan

*Prepared for:
Town of Tisbury, Massachusetts*

January 2018

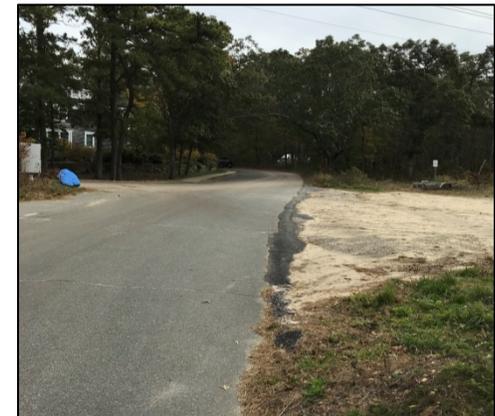
Lake Street Berm above Tennis Courts

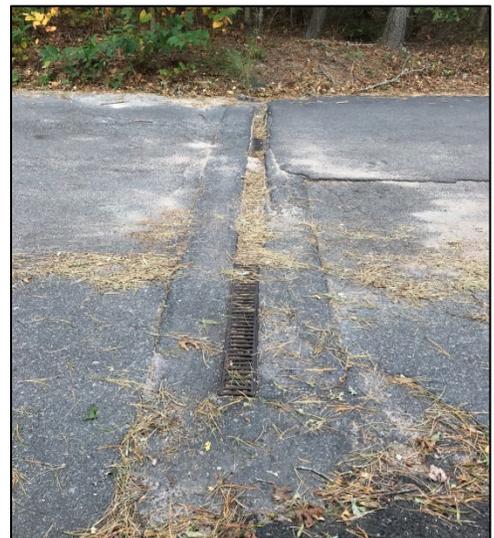
Trench Drain Across Lake Street

- Hold /Infiltrate runoff
 - Possible bio-swale with check dams along east side of Lake Street
 - Direct runoff to existing BMP, add sediment forebay/trap at BMP
- Redirect flow
 - Add leaching chamber between parking areas at tennis court
 - Pave road to provide crown in center
- Infrastructure to capture uphill sediment and flow
 - Add deep sump catch basins on road between gravel and paved parking areas
 - Add bio-swale along east side of Lake Street north of power lines
 - Direct swale flow through pipe to existing BMP with sediment trap/forebay
- Infrastructure to convey additional flow downstream
 - Add deep sump catch basins with double grates to replace trench drain
 - Add deep sump catch basins at boat landing

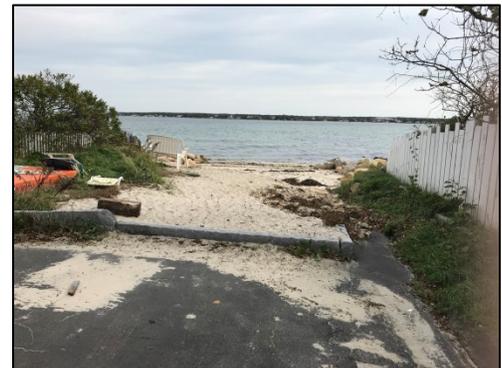
- Sediment carried to bottom of Grove Ave
- Paving is in poor condition throughout the neighborhood
- Washout at the beach due to curbing directing overland flow to edge of road
- Grove Ave beyond Harbor View Lane is used as a parking area
- Beach is heavily used – not just by neighborhood

Grove Ave Discharge Location
