Subject: August 22, 2019 Reconnaissance Inspection Report for ArcelorMittal Burns Harbor

**CWA RECONNAISSANCE INSPECTION REPORT  
U.S. ENVIRONMENTAL PROTECTION AGENCY (EPA), REGION 5**

**Facility:** ArcelorMittal Burns Harbor, LLC  
250 West U.S. Highway 12  
Burns Harbor, IN 46304

**Date of Inspection:** August 22, 2019

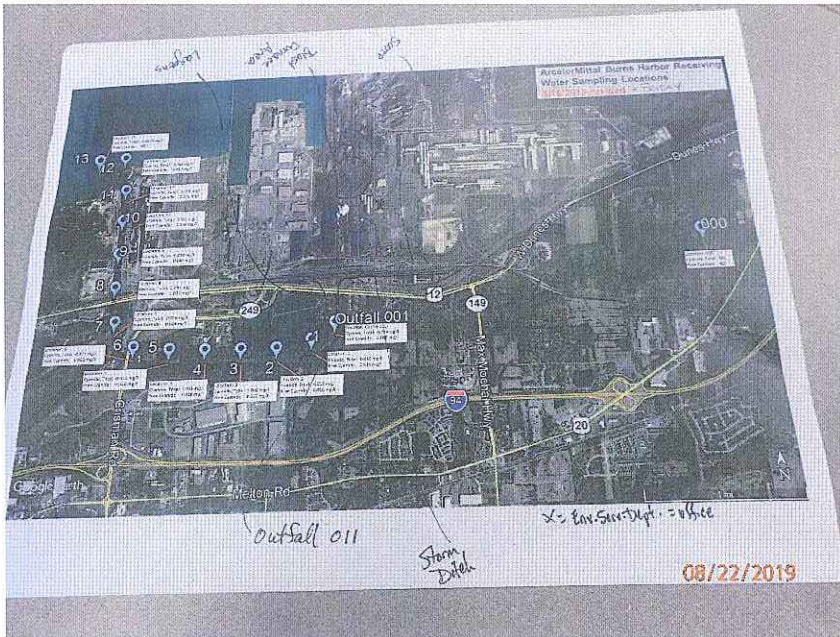
1: P8220001

Description: A map of the facility with hand drawn labels of the parts of the facility that were the focus of the inspection.

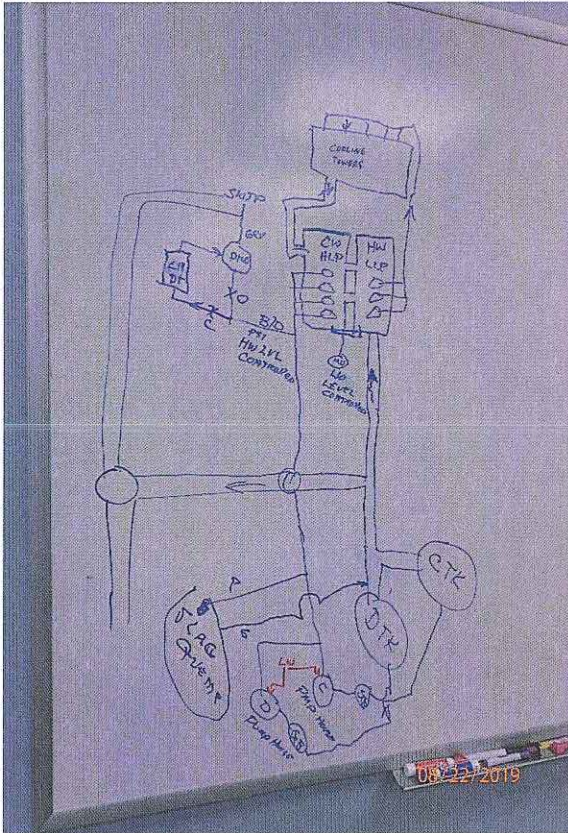
2: P8220002

Description: Photo of the hand drawn recirculation pump system on the white board in the office.

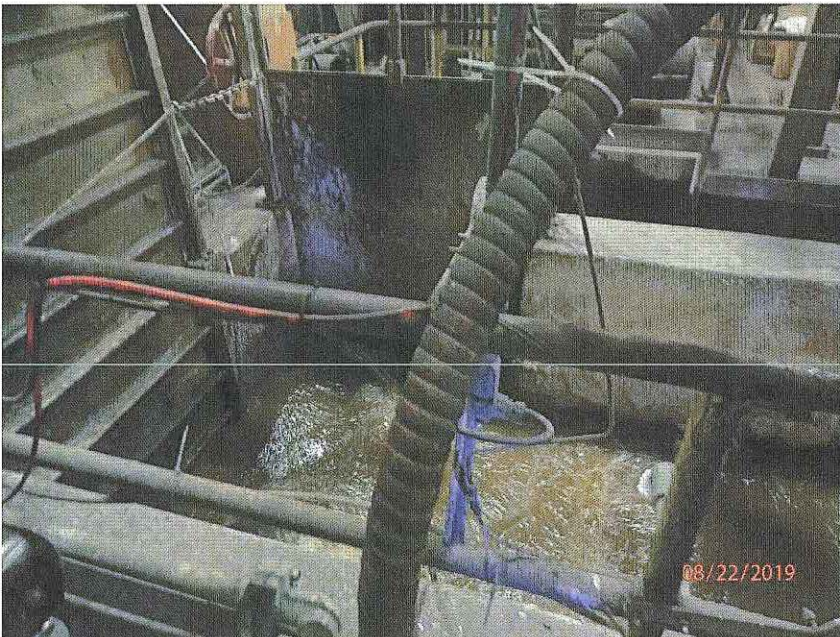
3: P8220003

Description: Hot Mill Sewer/ Hot Mill Flume from Wastewater Pump Station 2. This wastewater exits to the clarifiers.

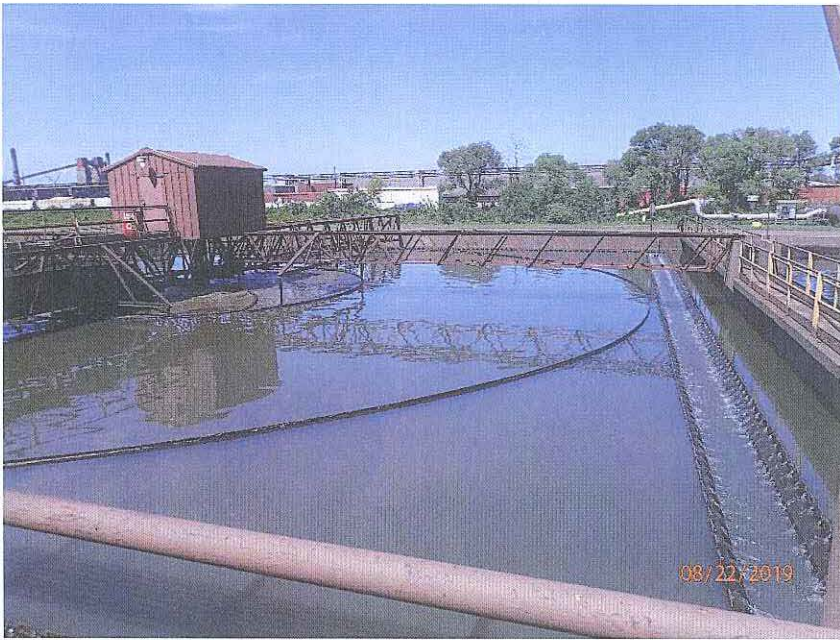
4: P8220004

Description: Cold Mill Clarifier #3.

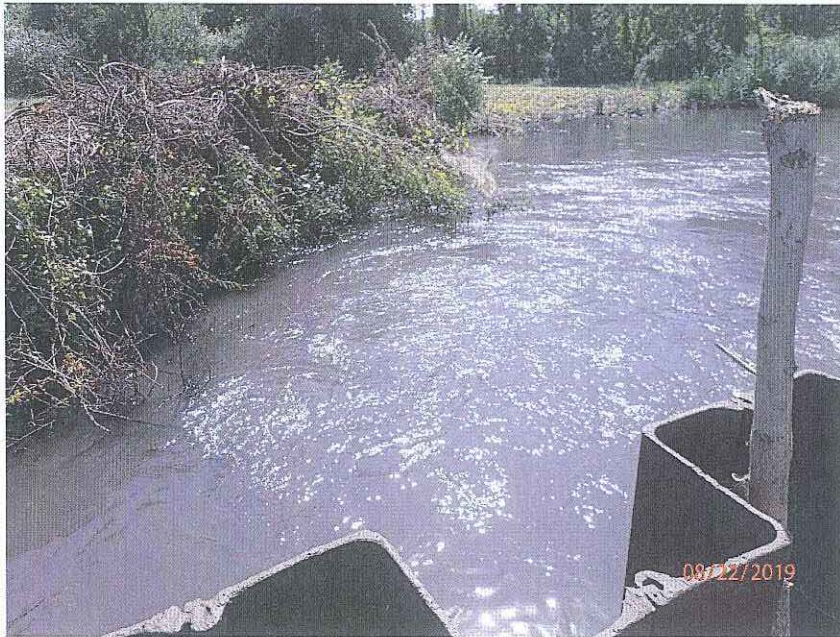
5: P8220005

Description: Influent Channel to the Lagoons.

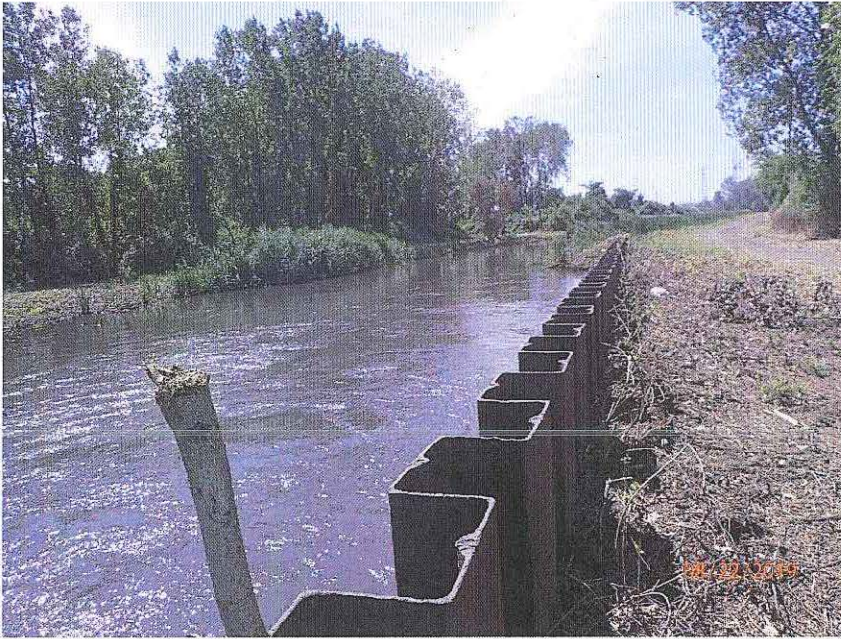
6: P8220006

Description: Influent channel flows west along the northern edge of the Lagoons. Influent flows into the Lagoons on the west side and exits on the east.

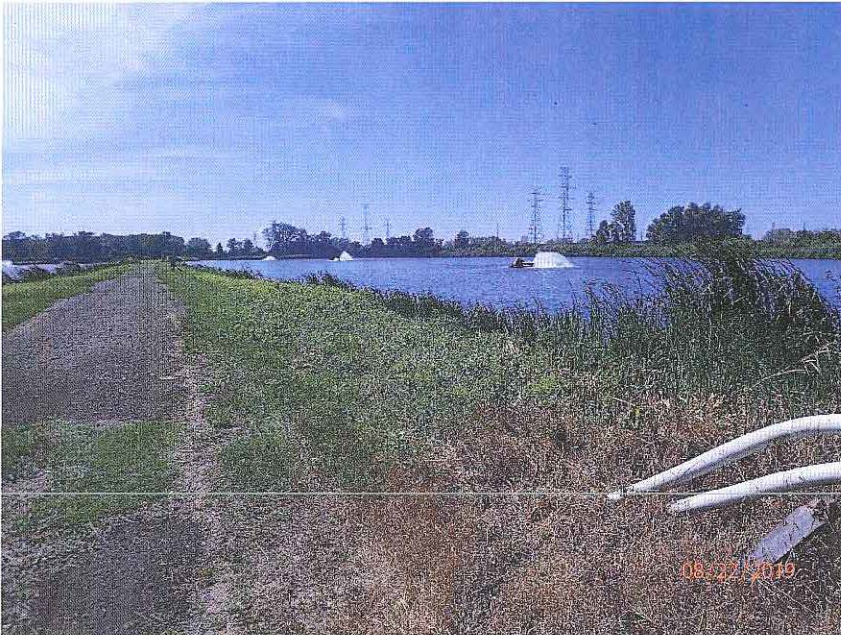
7: P8220007

Description: North Lagoon.

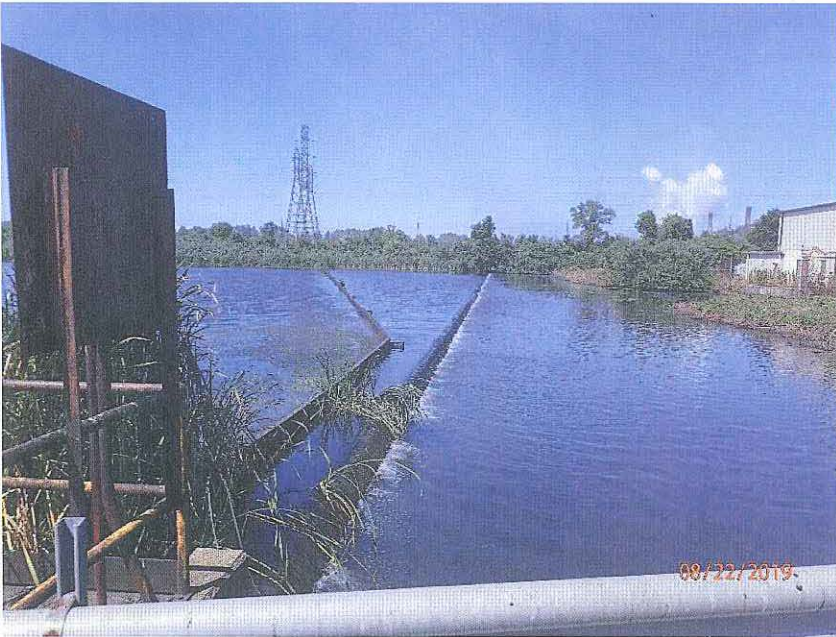
8: P8220008

Description: Overflow from the North Lagoon. This flow combines with the overflow from the South Lagoon and then travels to Outfall 001.

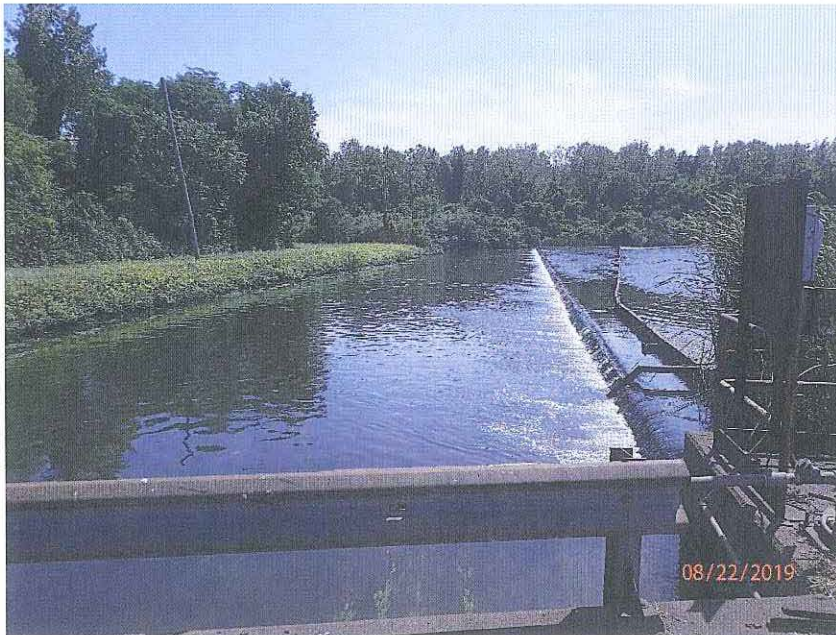
9: P8220009

Description: Overflow from the South Lagoon. The channel also contains the overflow from the North Lagoon which flowed south under the bridge the inspectors are standing on for this photo. Combined flow is to the south and to Outfall 001.

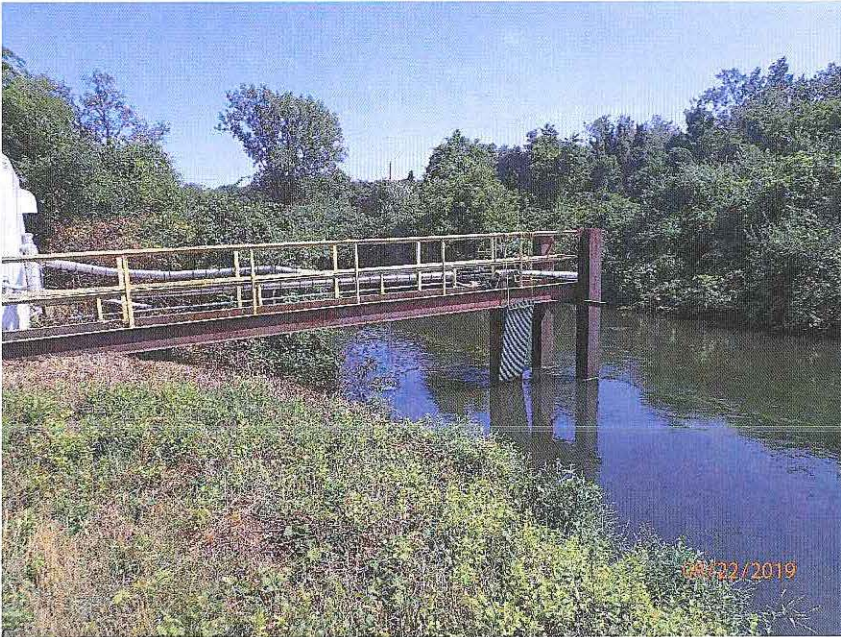
10: P8220010

Description: Monitoring Station 011 is in the channel after the flow leaves the Lagoon and before it combines with the effluent from the Town of Burns Harbor Sanitary Wastewater Plant.

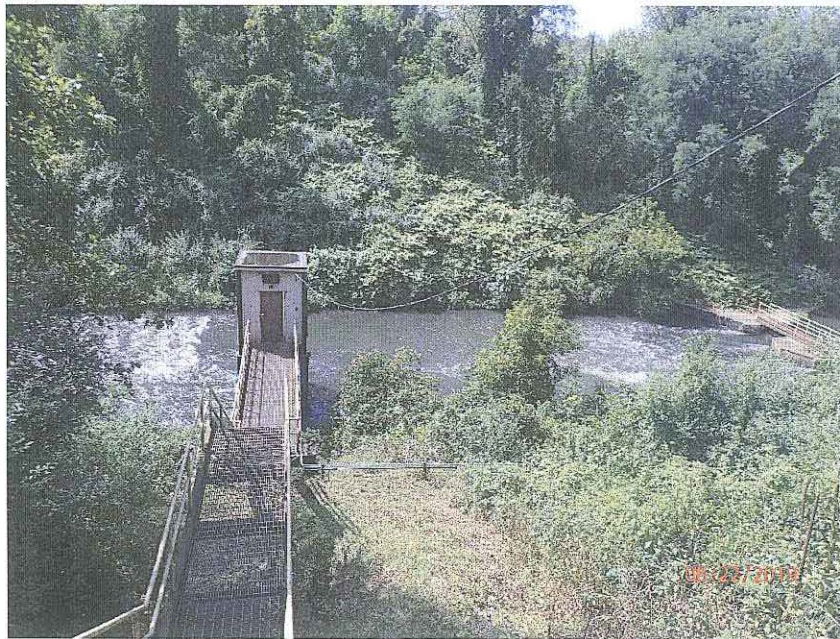
13: P8220013

Description: Sampling location for Outfall 001.

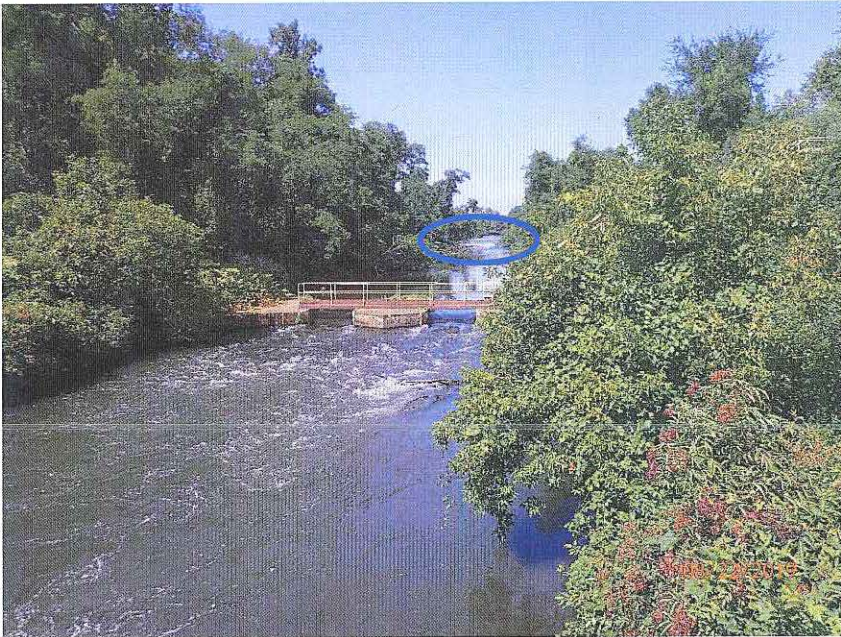
14: P8220014

Description: Outfall channel 001. The flow from the Storm Ditch joins the flow before the dam that is visible far upstream in the photo. Dam is circled with a blue circle.

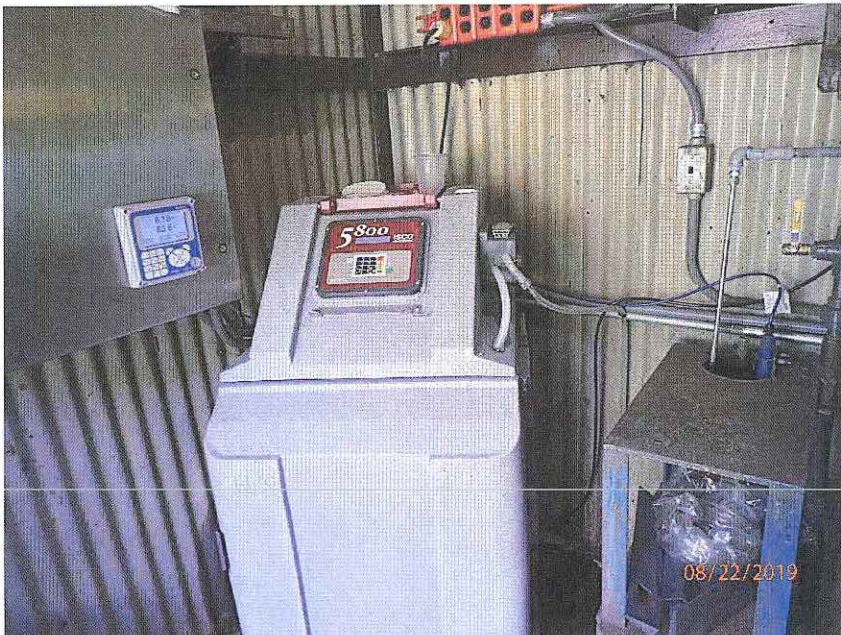
15: P8220015

Description: Sampling equipment inside the building for Outfall 001. Temperature is taken in the stream. Flow is measured at the weirs.

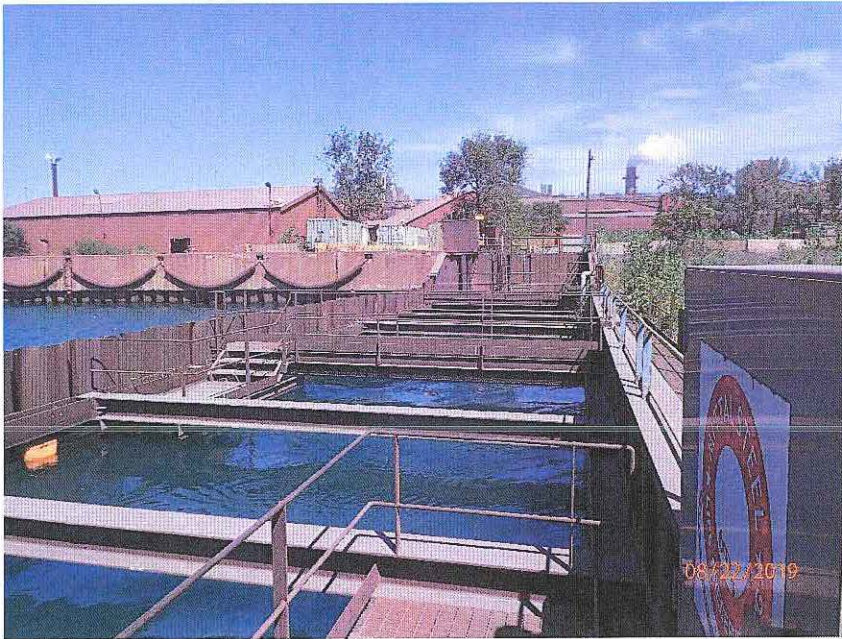
18: P8220018

Description: Pilings on either side of Outfall 002 go all the way to the bottom of Burns International Harbor.

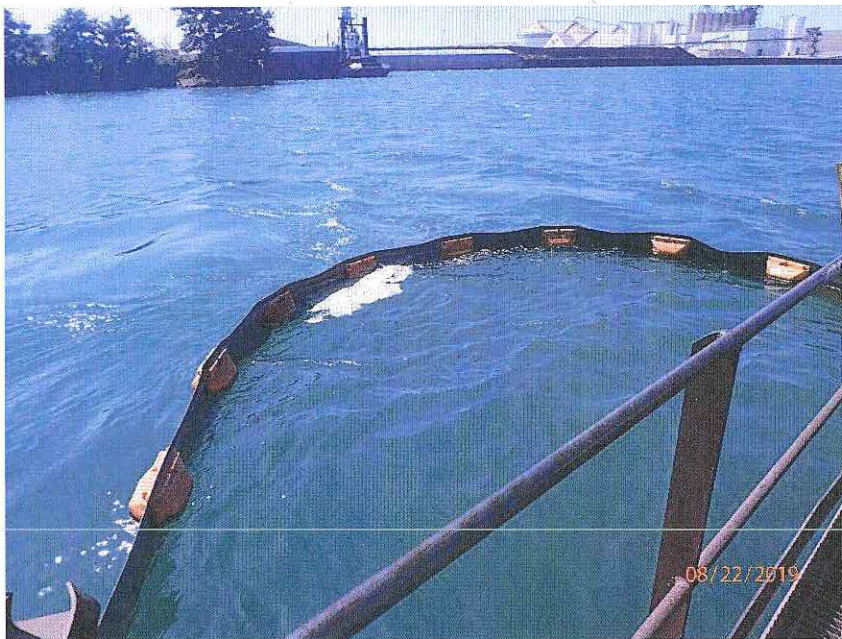
19: P8220019

Description: Permanent boom installed at the end of Outfall 002.

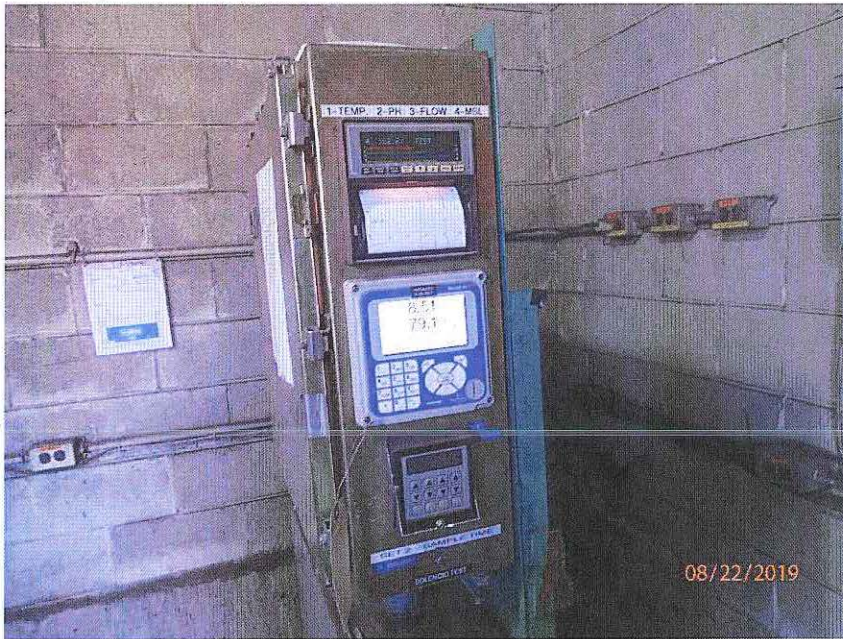
22: P8220022

Description: Control panel in sample house for Outfall 002.
