# ***Section 17 Projects: Old Church Rock Mine and Downwind Structures***

Presenter: Eugene Esplain

**Navajo Superfund Program - Site Assessment**

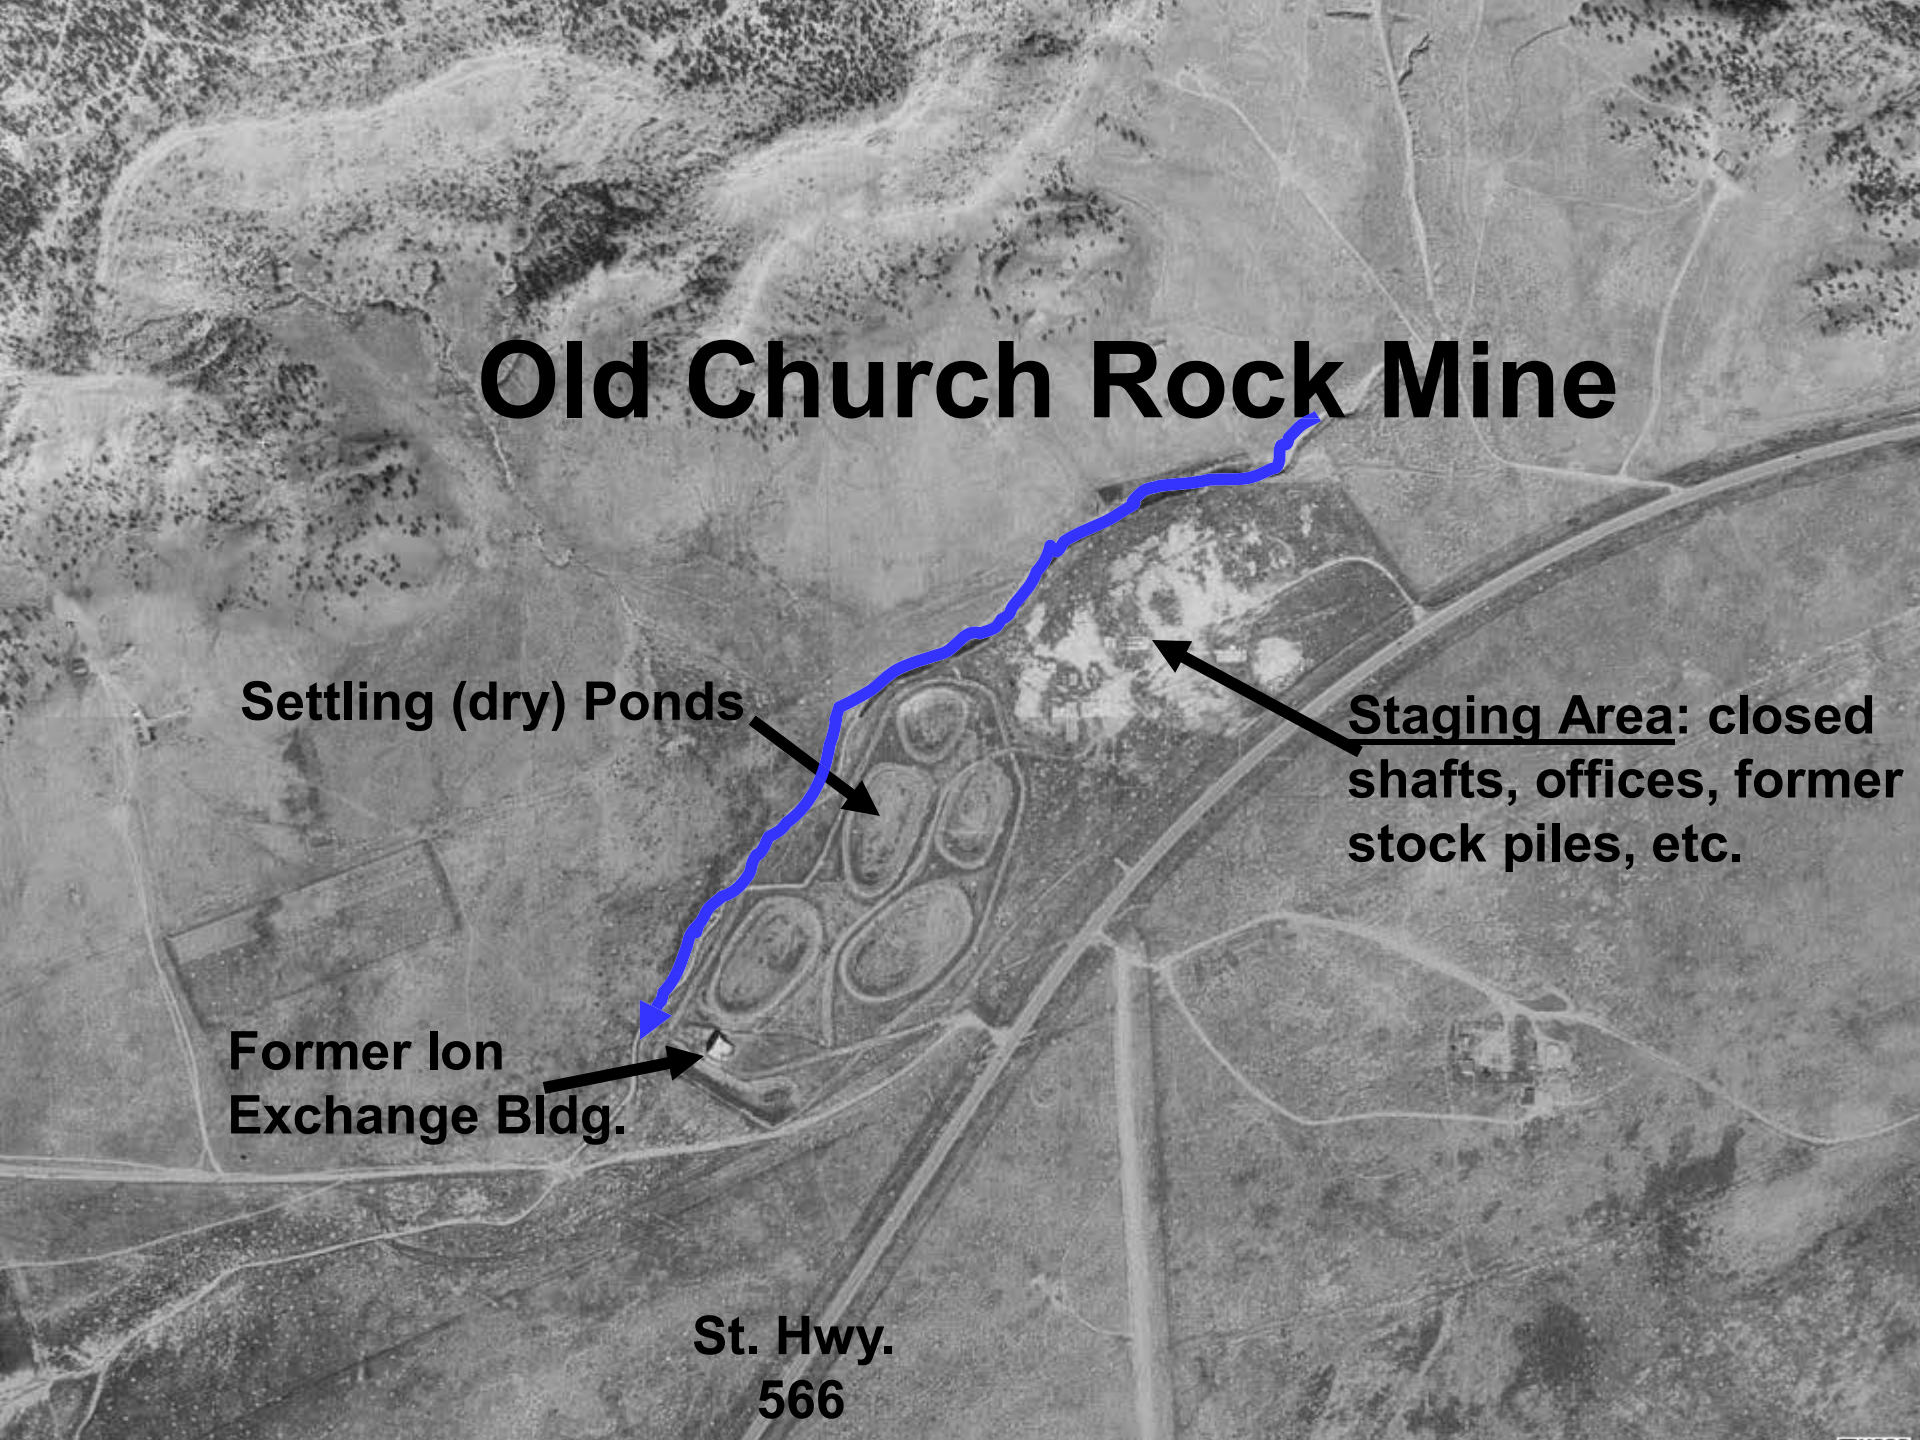
# Old Church Rock Mine

**Waste Material:**  
**Height: 8-12 feet**  
**Length: 370 feet**

**Exposure Measurements:**  
**65-110  $\mu\text{R/hr}$  (bank)**  
**30-65  $\mu\text{R/hr}$  (sediment)**

**Background=12-15 microRoentgens per hour ( $\mu\text{R/hr}$ )**

**Dry Ponds On-site  
(unreclaimed)**

**320  $\mu$ R/hr**

**White Waste Material in Bank  
(Stratum: 3' thick & 30' length)**

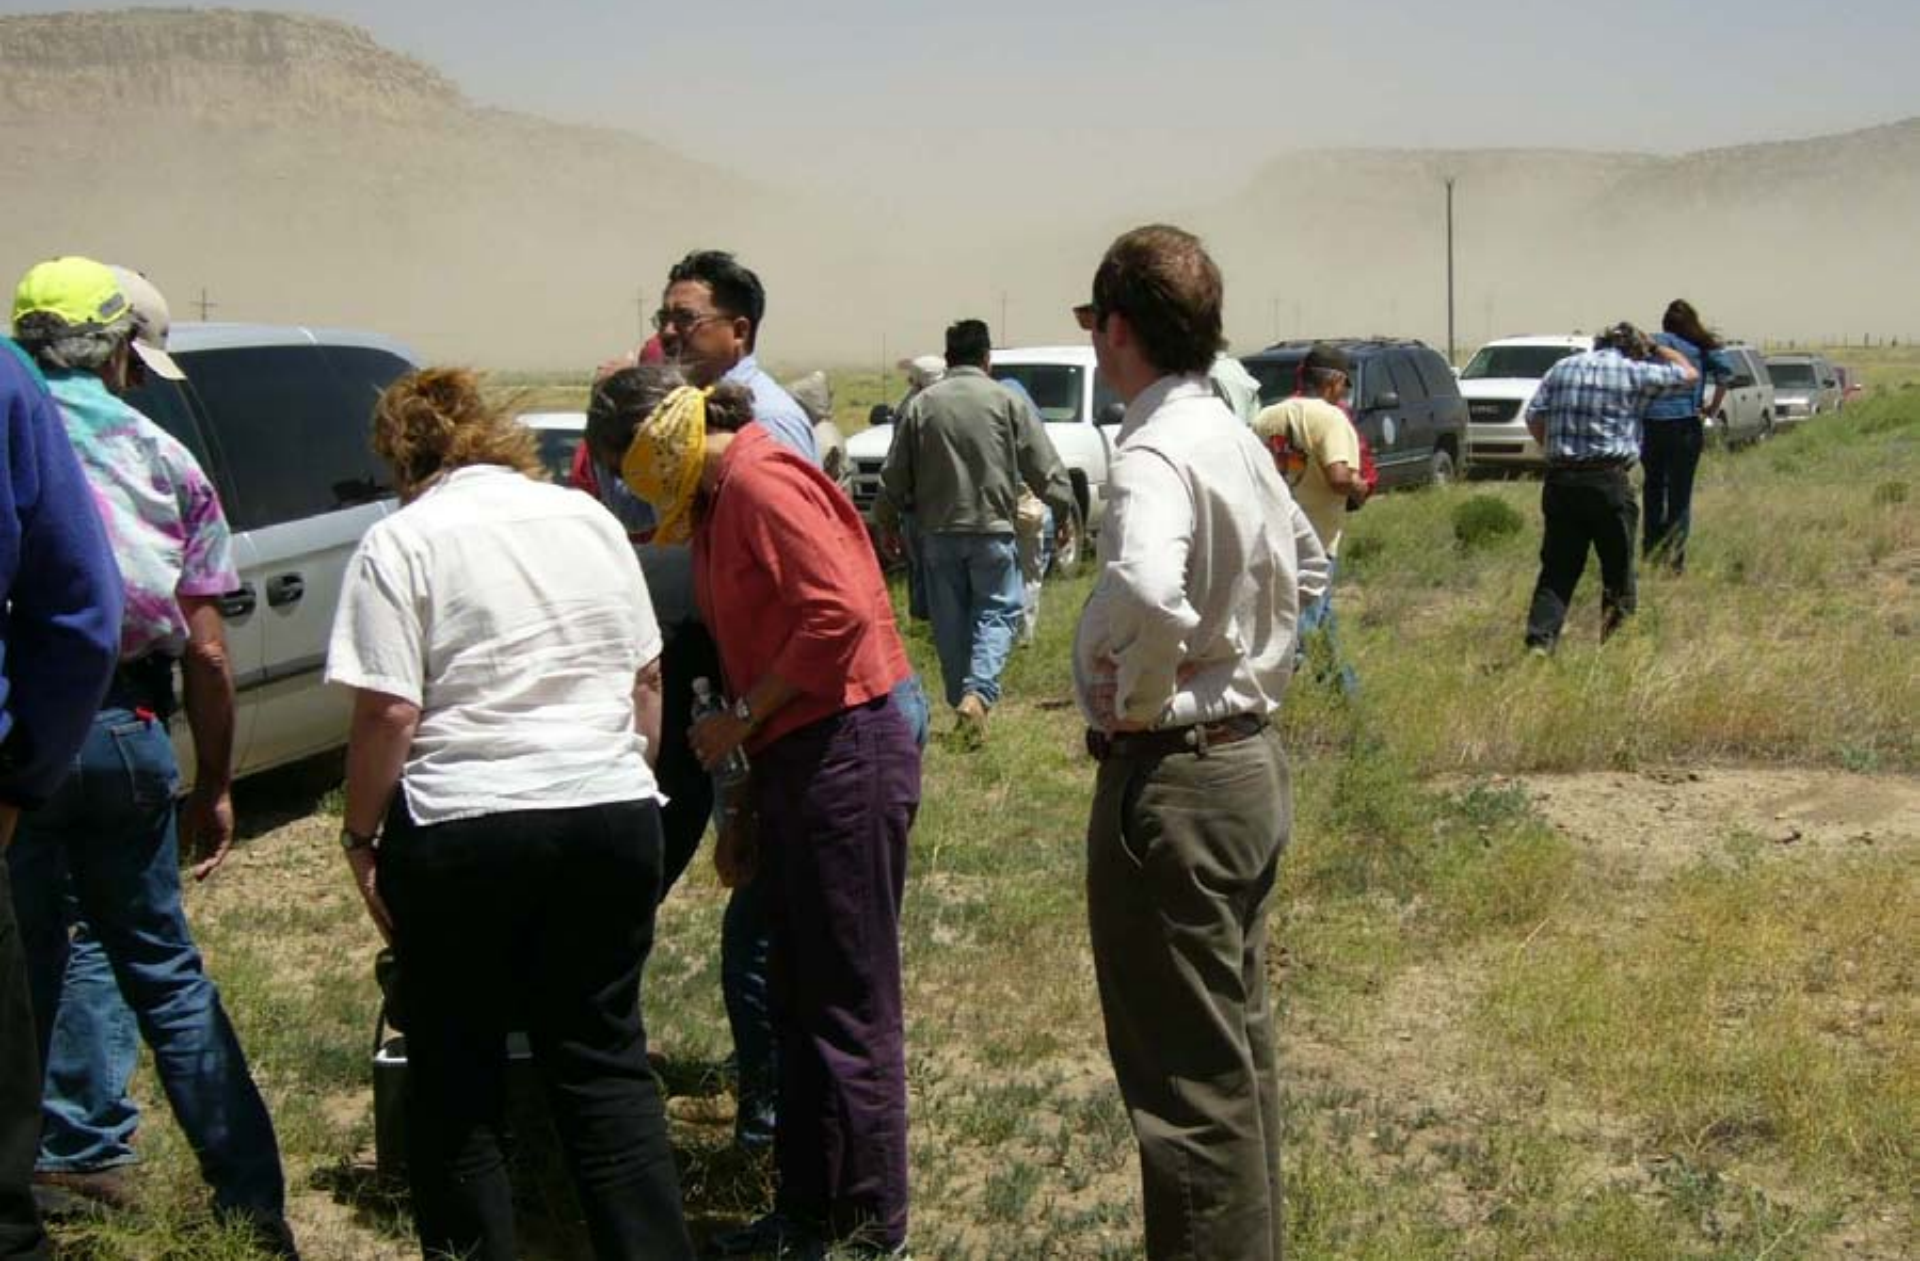
**Just So Happened ... 60+ MPH Winds That Day**

**July 6, 2006 – Visit to Section 17 by the  
New Mexico Environment Department**

**This event brought out the concern of  
windblown sand from Section 17  
depositing at residences downwind**
