## **Appendix E**

### **Maintenance Program Site Visit Reports**

**Site Visit No. 16**

**Caltrans MS4 (SWRCB Order No. 99-06-DWQ)**  
**Willow Creek Highway Maintenance Facility**  
**Caltrans District 1**

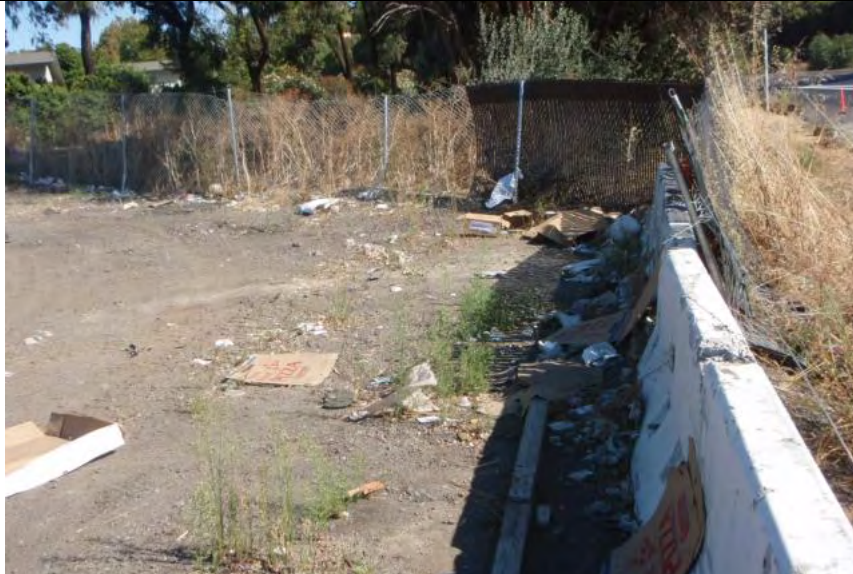
Photograph 5 – Example of fugitive trash and debris

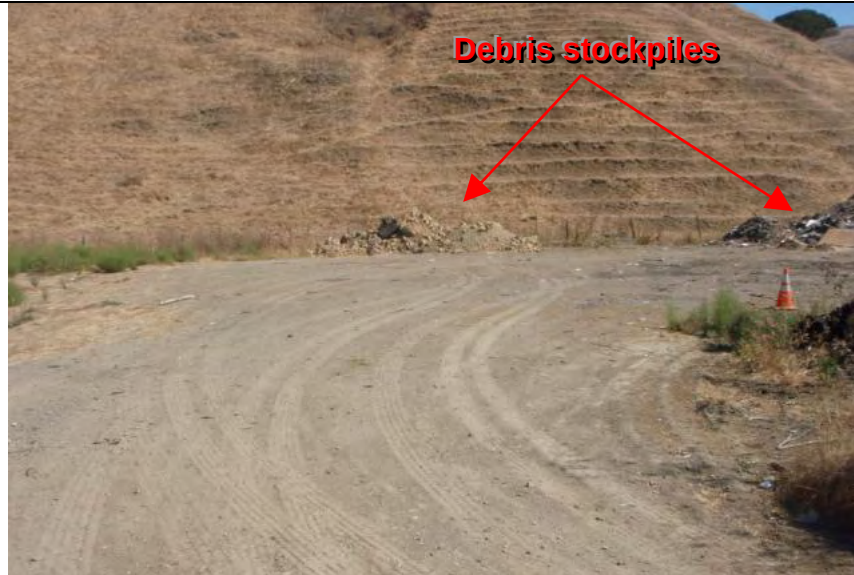
Photograph 1 – Entrance to temporary storage site

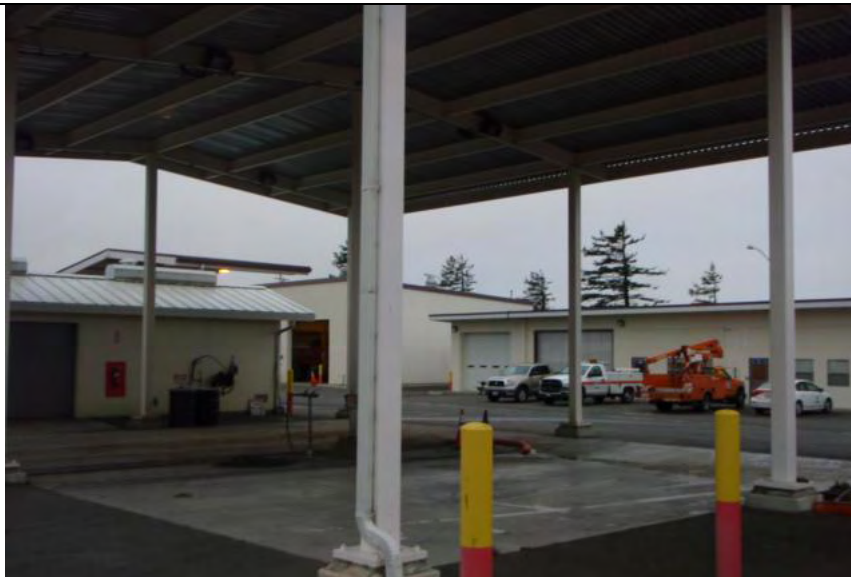
Photograph 1 – Covered wash rack

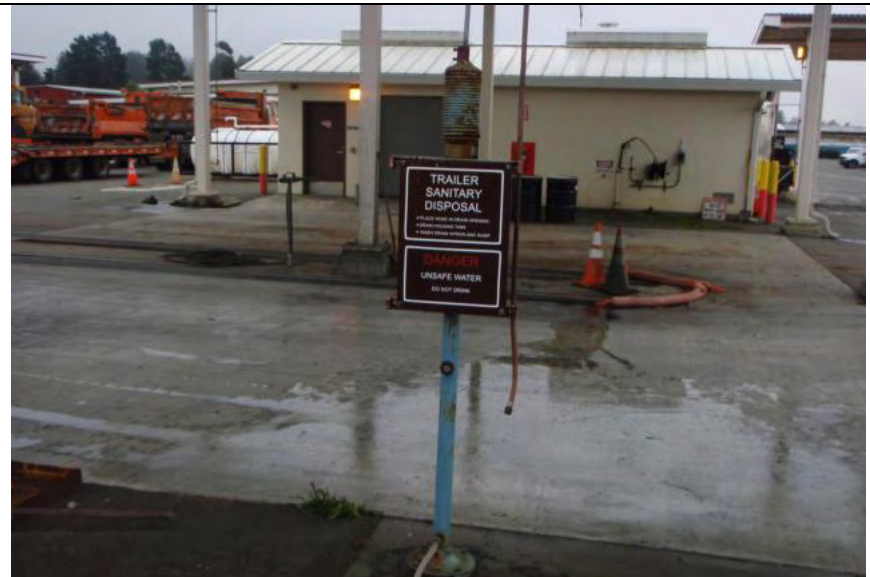
Photograph 2 – Another view of covered wash rack

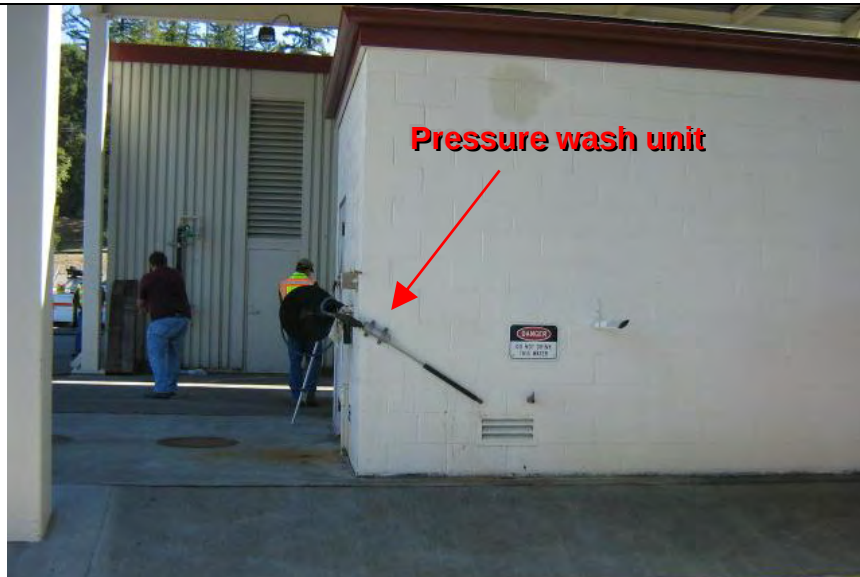
Photograph 1 – Covered wash rack

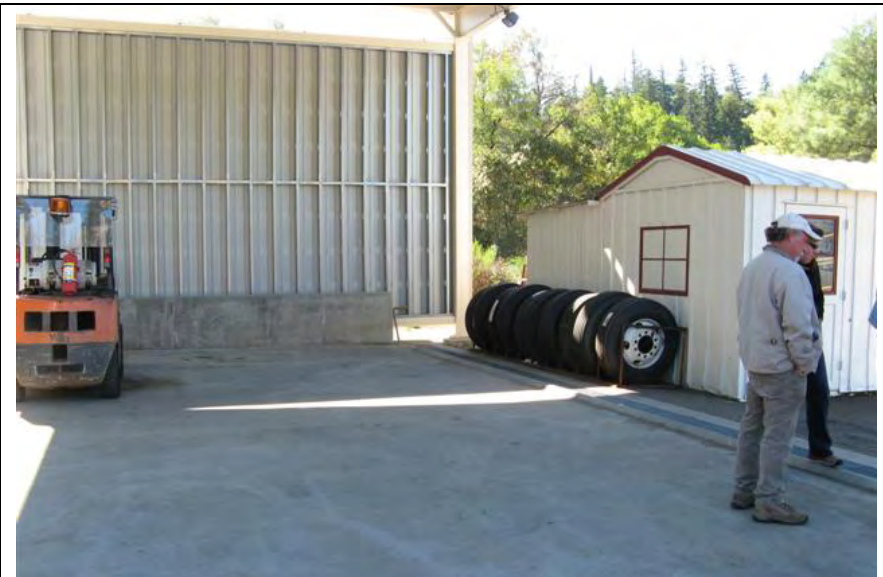
Photograph 2 – Covered wash rack

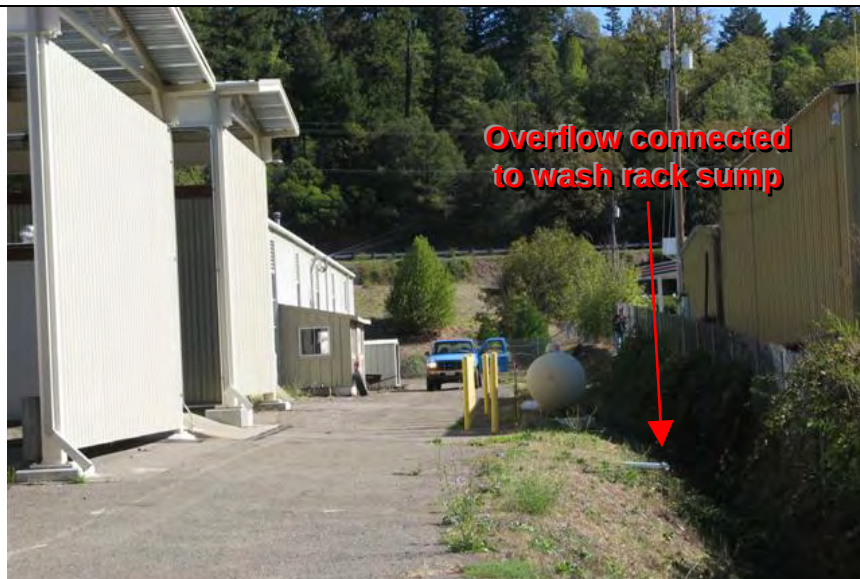
Photograph 3 – Sump overflow leading to drainage ditch

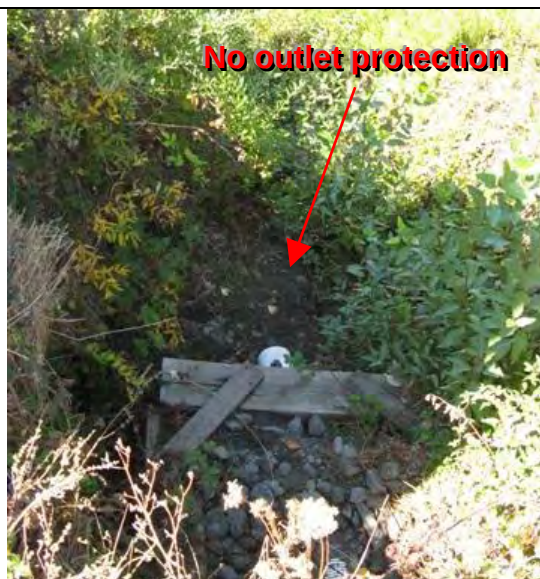
Outlet protection and flow dissipation BMPs were not in place below a drainage pipe leading from the facility (see Photograph 10). As a result, there was a potential for erosion and scouring at the pipe outlet leading to the South Fork Eel River (see Photographs 11 and 12).

Photograph 11— Outlet pipe down-gradient of facility outfall

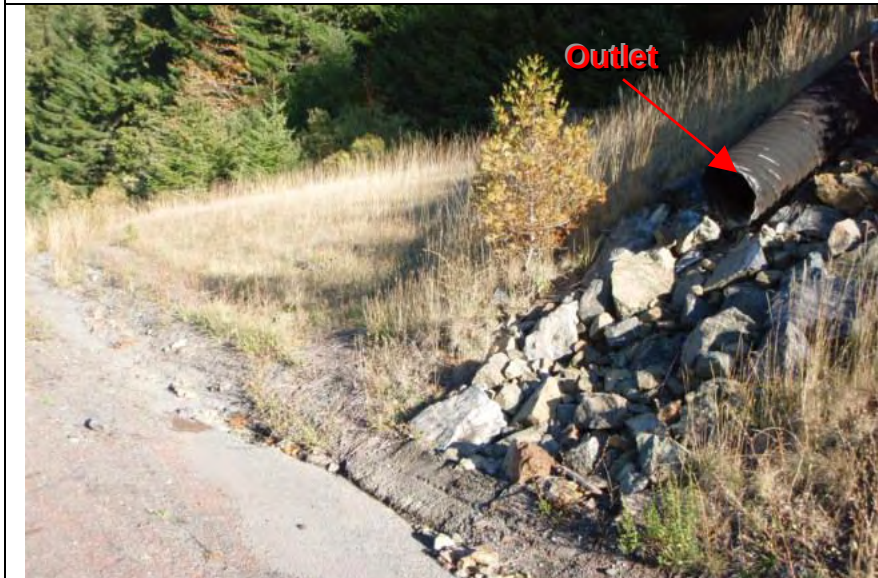
Photograph 3 – Discharge location from inlet shown in Photograph 2

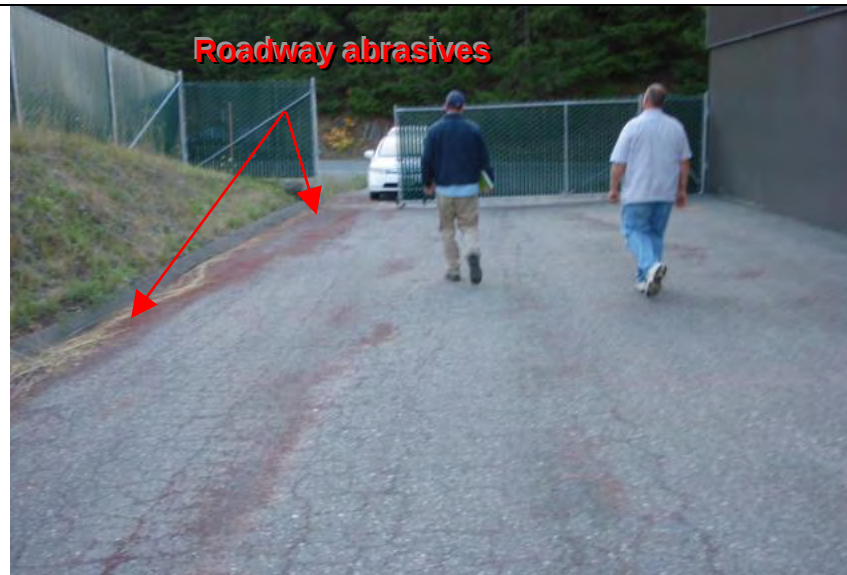
Photograph 6 – Roadway abrasives on impervious ground surface

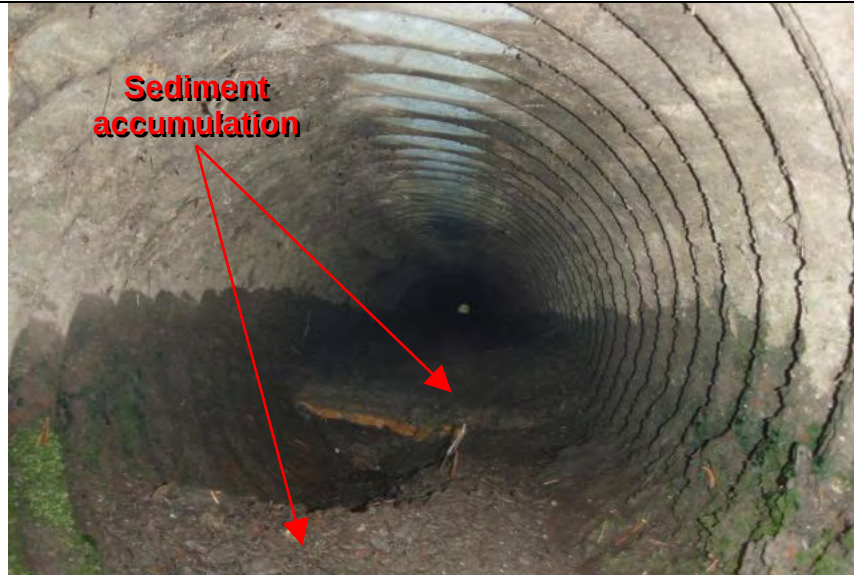
Photograph 5— View into storm drain pipe from outlet

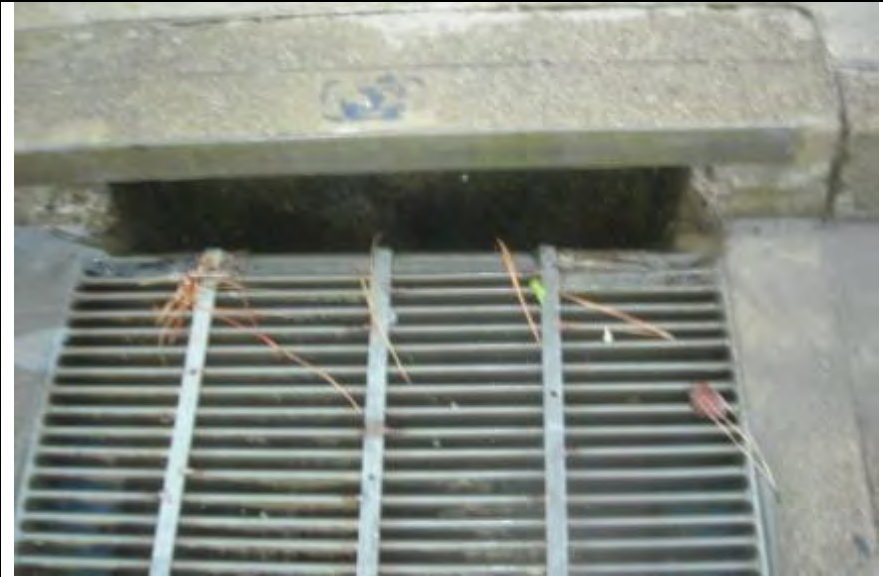
Photograph 2 – Storm drain from Photograph 1

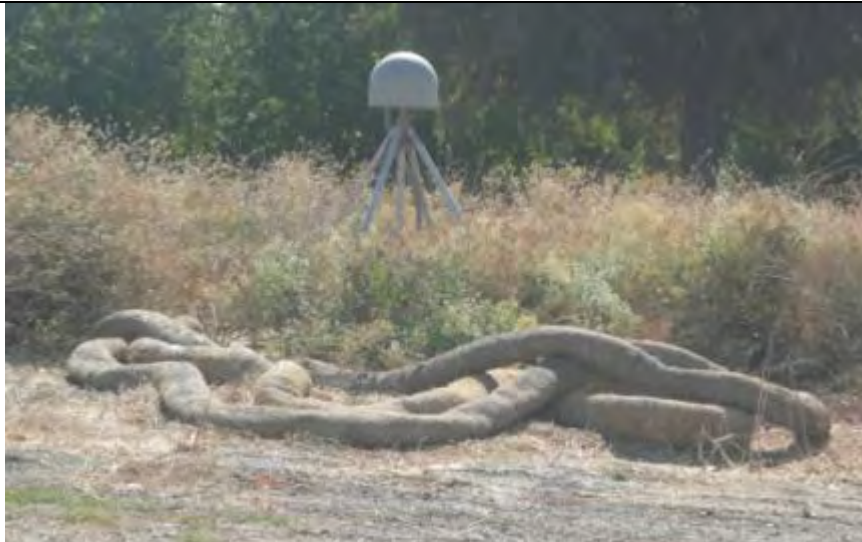
Photograph 1 – View of BMP stockpile
