**UNITED STATES ENVIRONMENTAL PROTECTION AGENCY**  
**REGION IX**  
**75 Hawthorne Street**  
**San Francisco, CA 94105**

**WASTE MANAGEMENT DIVISION**  
**RCRA ENFORCEMENT OFFICE**

Purpose: RCRA Investigation

Facility: Chemical Waste Management, Inc.

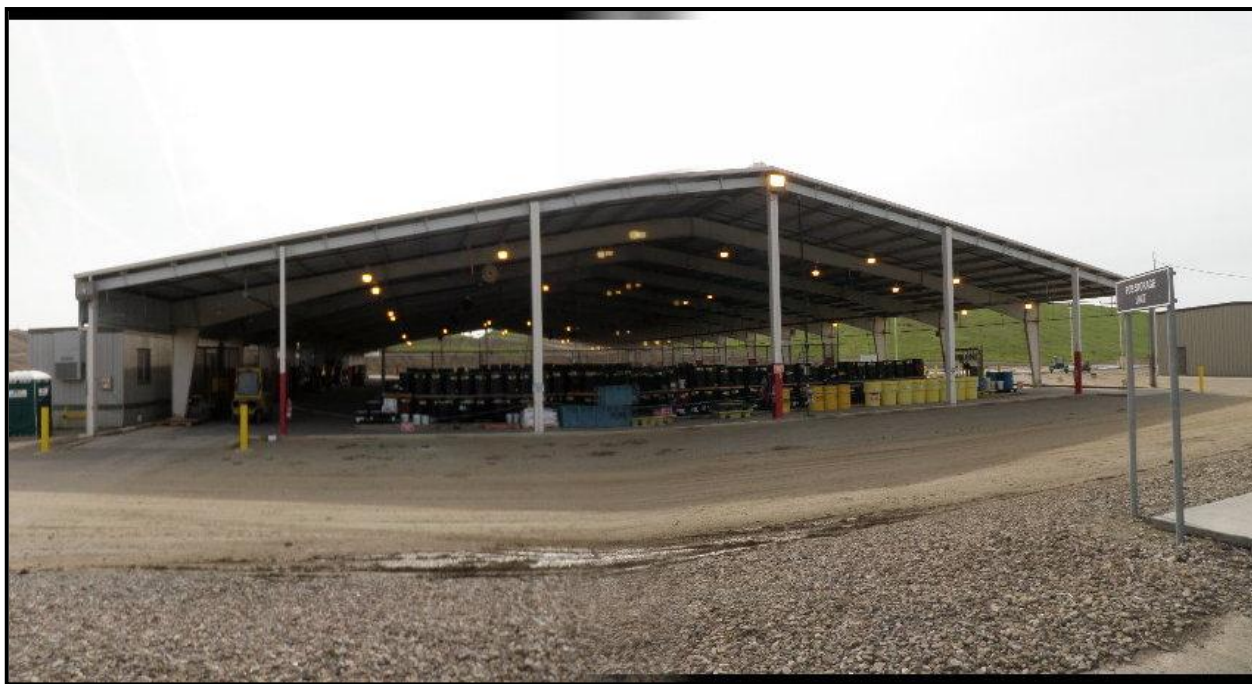
The base of the unit consists of a concrete pad underlain by a high density polyethylene (HDPE) liner. The pad is equipped with an HDPE-lined sump. The inspectors noted some cracks in the concrete flooring and in the berm which runs along the perimeter of the DSU (see photographs below).

EPA's review of the DSU's as-built diagram verified that the secondary containment capacity calculations were based on the footprint of each cell and not the perimeter of the DSU where the cracks in the above photographs were observed.

EPA observed that cracks located within the secondary containment area were repaired.

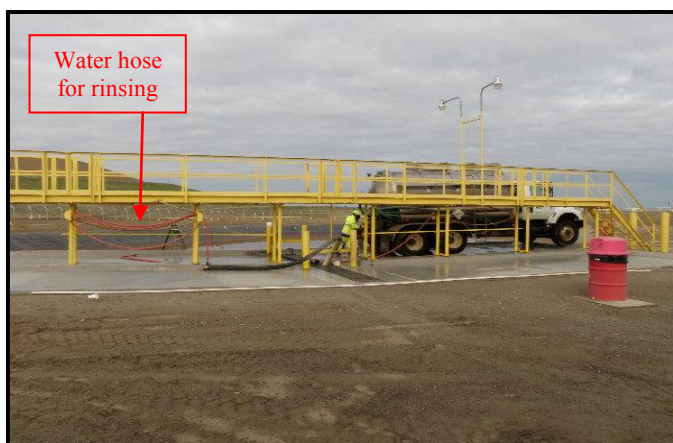
P-9 Unloading Area (facing east)

At the time of the investigation, the inspectors observed a vehicle in the bermed unloading pad. The driver of the truck was in the process of cleaning out the vehicle. Mr. Turek informed the inspectors that one connection (connected to a pipe leading into P-9) is used to transfer the contents of the vehicle into the surface impoundment (gravity-fed; submerged fill). Another pipe conveys the liquid which may accumulate in the unloading area into the surface impoundment (gravity-fed; submerged fill).

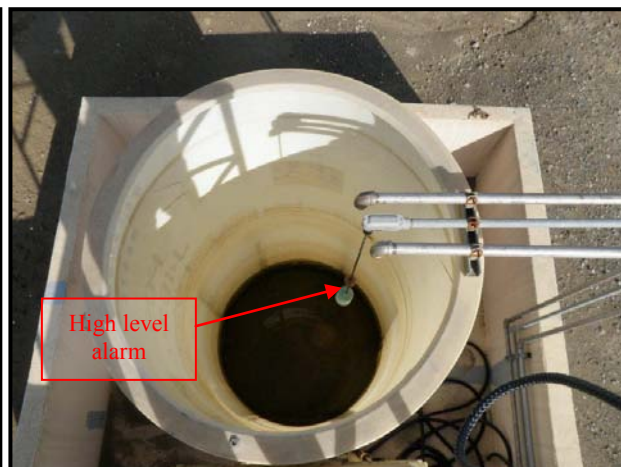
The leachate collection tank at P-9 is an open-top tank. Three pipes are located on top of the tank. One pipe is from the P-9 riser assembly, one pipe is from the P-9 tank sump, and the middle pipe is the high level alarm which ensures that the two-foot freeboard is maintained. The inspectors observed several inches of rainwater on the bottom of the tank, as described on the label.

The inspectors noted cracks on the outside wall of the secondary containment system (see cropped and enlarged inset). The inspectors also noted that the cracks on the inside walls and floor of the secondary containment system were repaired.

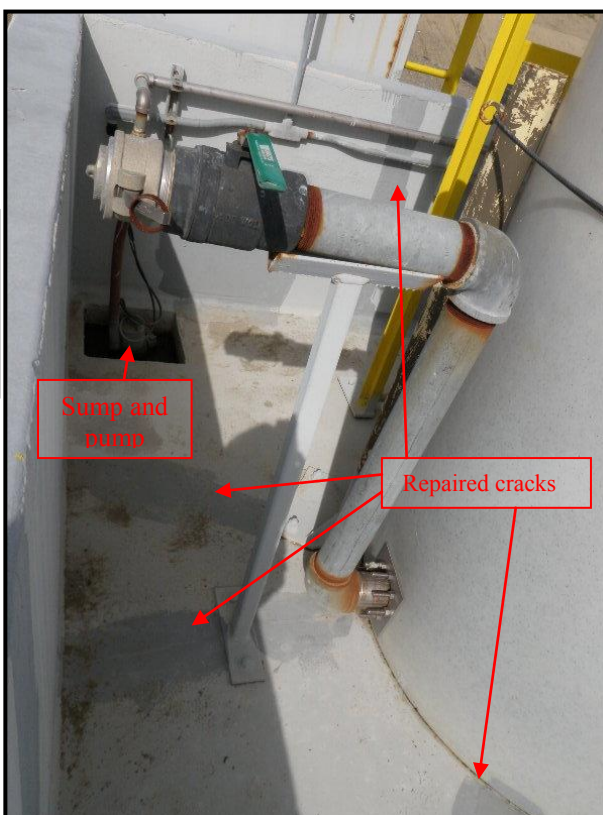
P-14: Pump-out connection used to remove the contents from the 90-day hazardous waste storage tank (facing north). Note: The sump has a pump which is used to transfer any fluid which may accumulate from rainfall events into the P-14 leachate collection tank. The inspectors noted several areas where the secondary containment system was repaired.

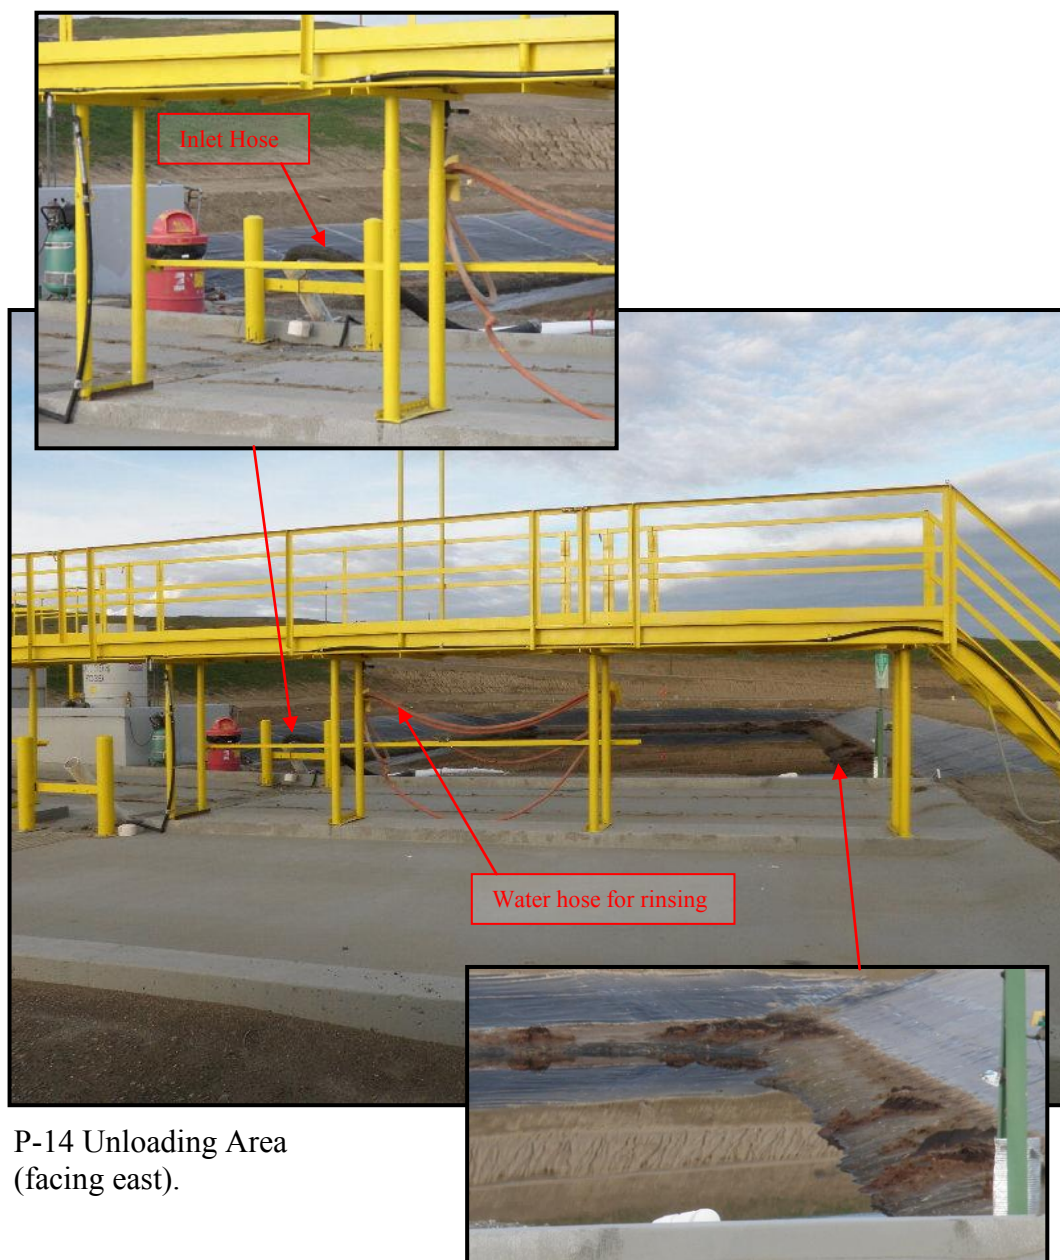
P-14 Unloading Area  
(facing east).

The top inset photograph shows the hose which is connected to the vehicles for off-loading. The bottom inset photograph (cropped and enlarged) shows areas where unknown material is accumulating along the waterline of P-14.

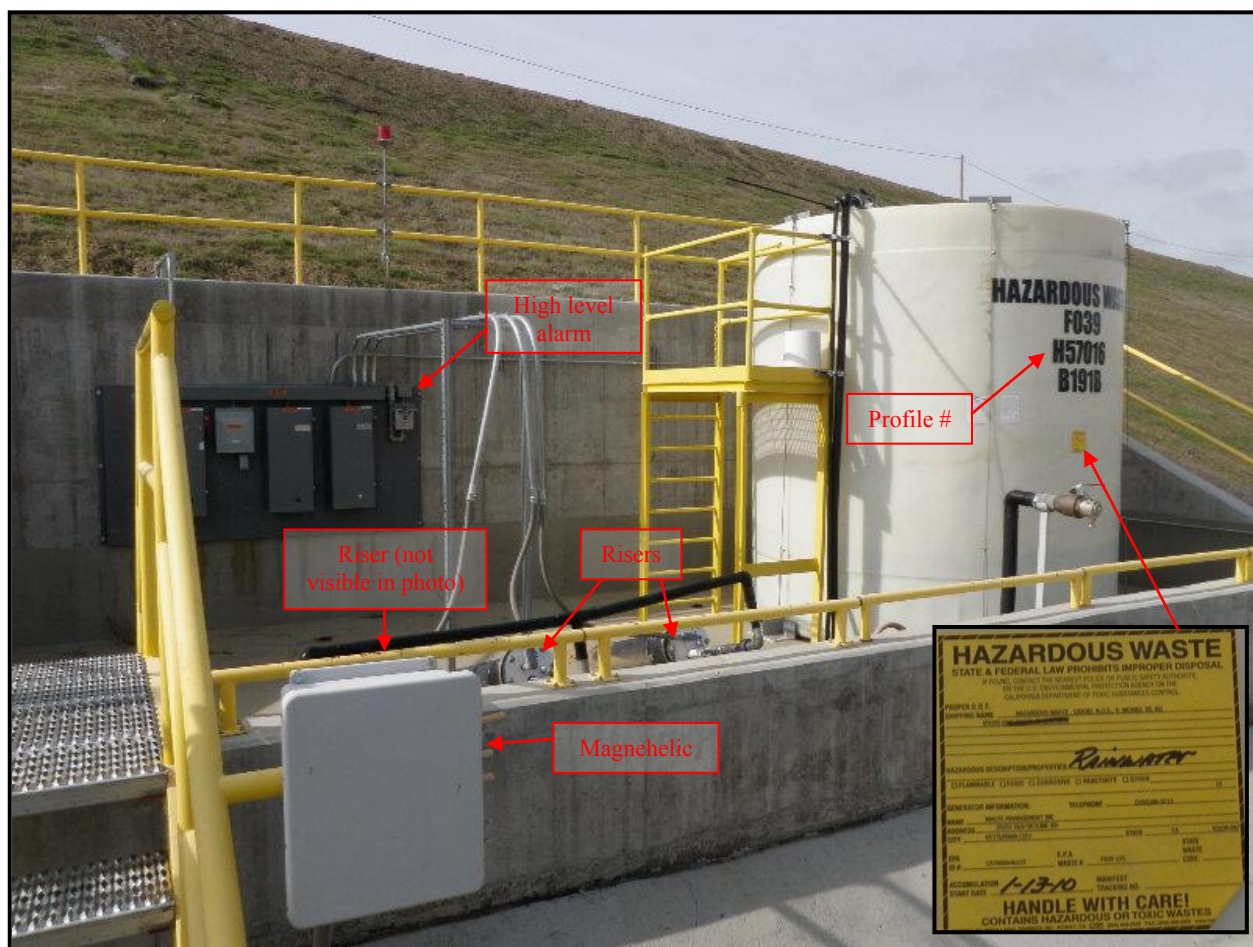
#### Landfill B-19 Leachate Collection Tank 1B

As stated above, landfill B-19 has three landfill leachate collection tanks which collect the leachate from the three hazardous waste phases of the landfill (Phases 1B, 2, and 3). Phase 1B is located on the northeast section of B-19. The layout of the leachate collection tank system (i.e., risers, above-ground hazardous waste storage tank, secondary containment system, pad sump, etc.) is similar to the layout of the systems for the landfill B-18 leachate collection tanks. Photographs and details of the Phase 1B leachate collection Tank 1B area are provided below. The inset photograph of the hazardous waste label is cropped and enlarged.

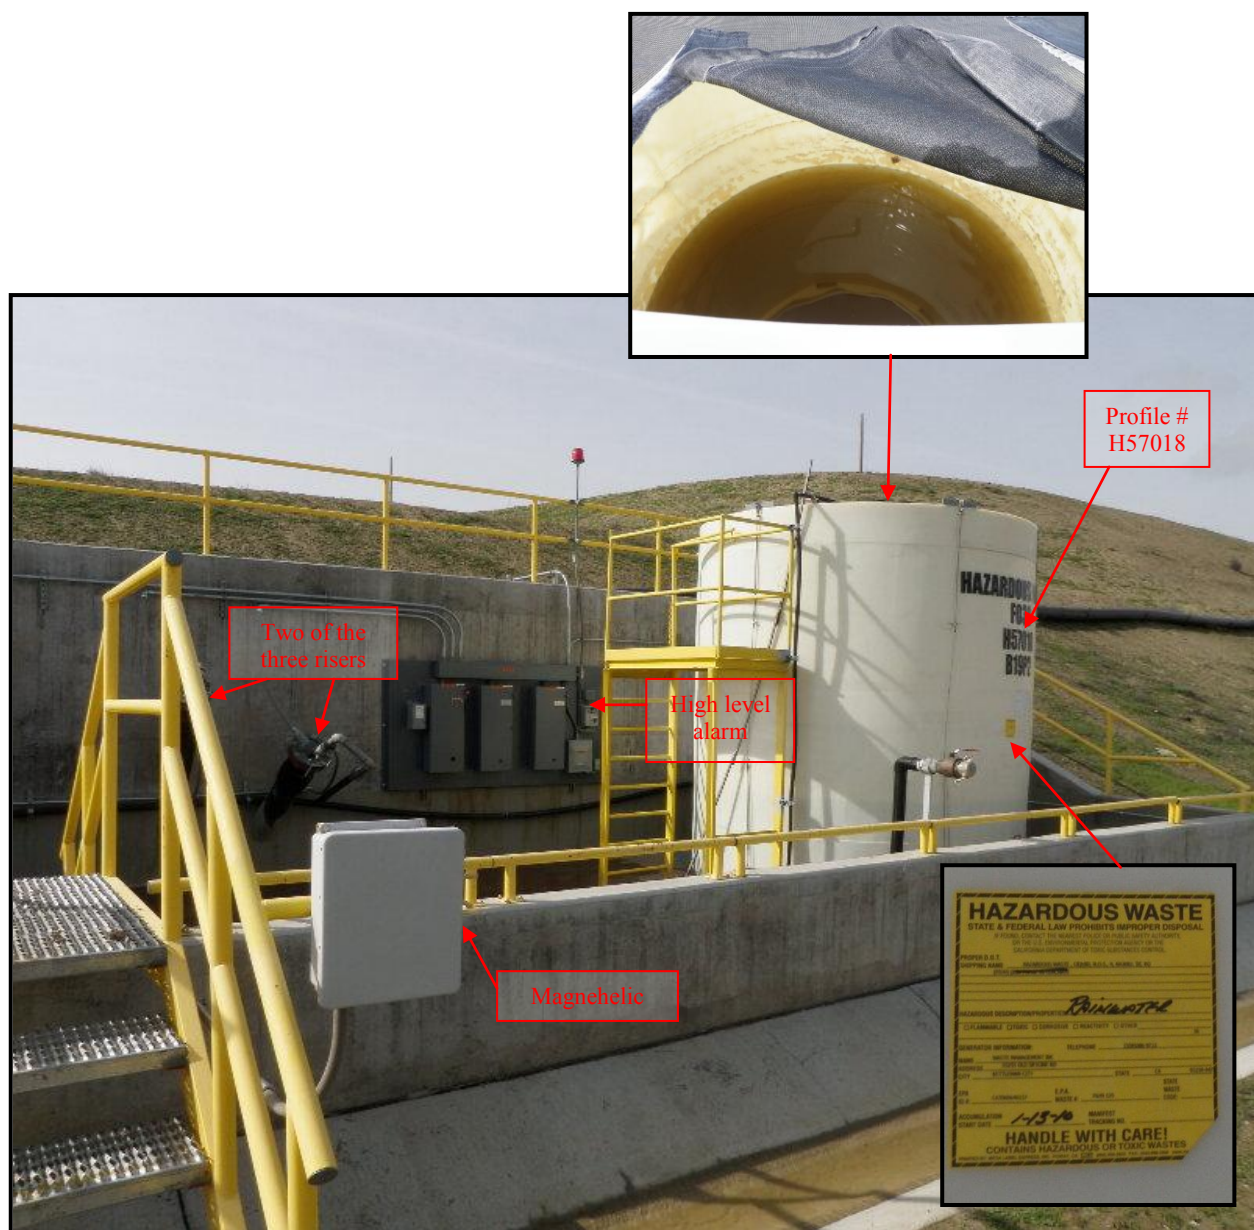
## Landfill B-19 Leachate Collection Tank Phase 2

Phase 2 is located on the southeast section of B-19. The layout of the leachate collection tank system (i.e., risers, above-ground hazardous waste storage tank, secondary containment system, pad sump, etc.) is similar to the layout of the system for leachate collection Tank 1B. Photographs and details of the Phase 2 leachate collection Tank P2 area are provided below. The inset photograph of the hazardous waste label is cropped and enlarged.

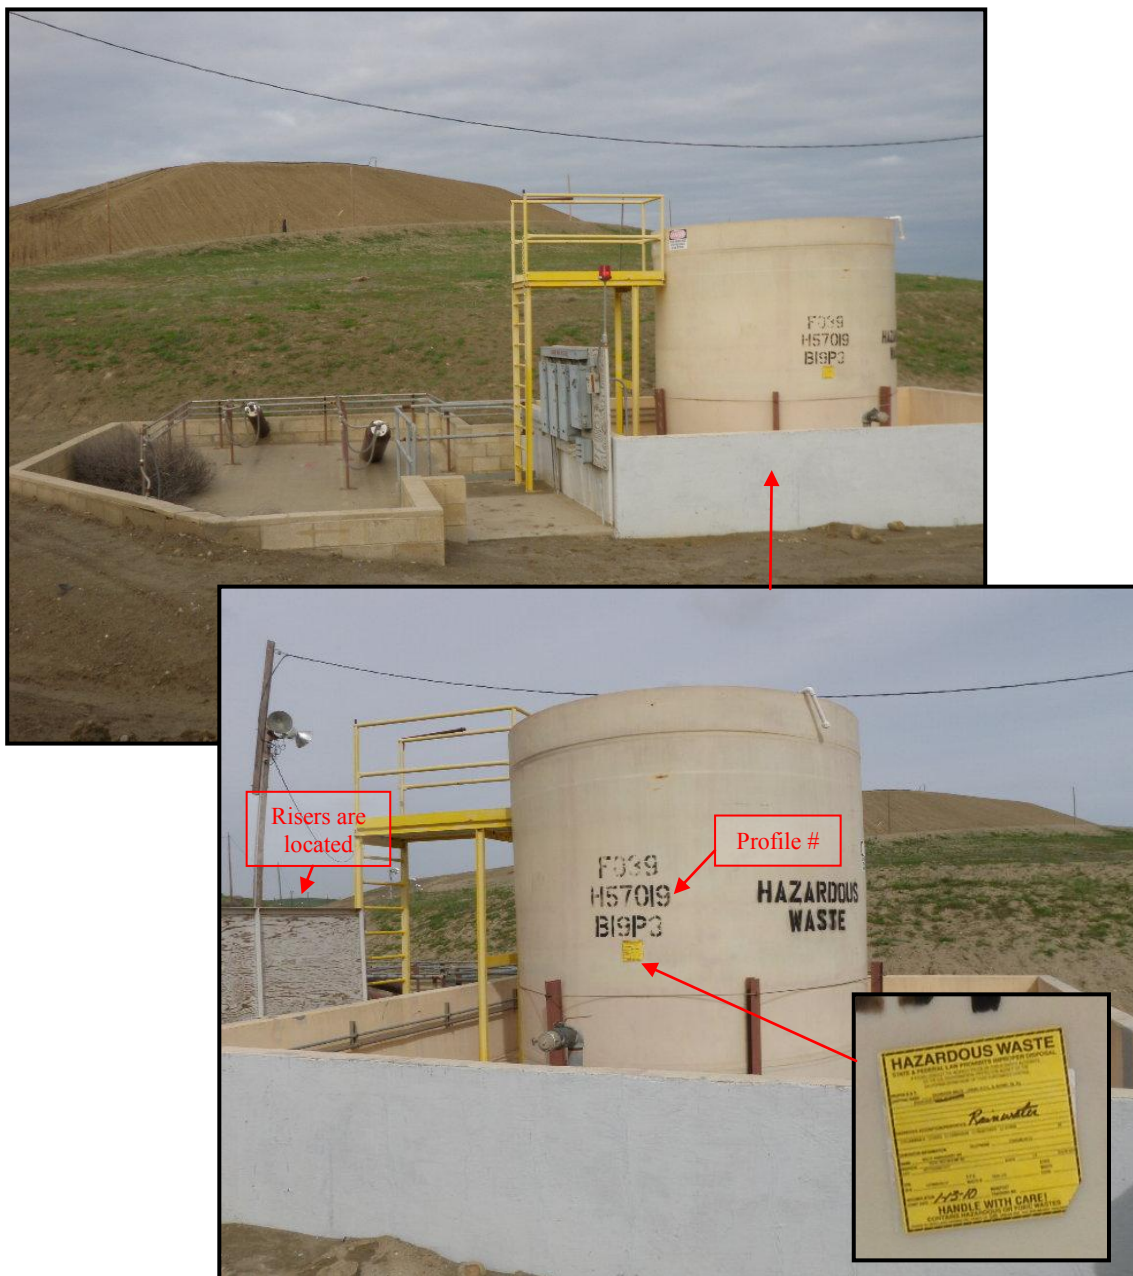
### Landfill B-19 Leachate Collection Tank Phase 3

Phase 3 is located on the southwest section of B-19. The layout of the leachate collection tank system (i.e., risers, above-ground hazardous waste storage tank, secondary containment system, pad sump, etc.) is similar to the layout of the systems for leachate collection Tanks 1B and P2 (see photograph below – facing north). However, unlike the other leachate collection tanks for landfill B-19, the risers are located outside of the secondary containment pad for the tank. The risers are located on a separate containment area located on the west side of the tank. Photographs and details of the Phase 3 leachate collection Tank P3 area are provided below. The inset photograph of the hazardous waste label is cropped and enlarged.

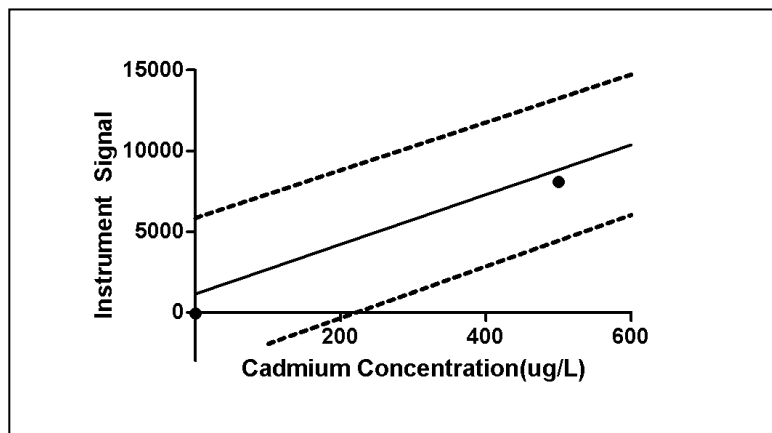
**95% Confidence Interval for Cadmium Calibration With Expanded Scale Around the Decision Point of 110 ug/L**

The figure below, based on the calibration used to report sample 6061-16, illustrates how this discrepancy results in waste being determined to meet UTS when it actually exceeds UTS. Specifically, it depicts a significant negative bias at the UTS concentration. A clean water sample (no cadmium instrument signal) would be reported as a negative concentration, unless the water was spiked to have a concentration of 70 ppb cadmium. This is analogous to weighing something on a scale that has been dialed back.
