Transmittal of "Port of Stockton Municipal Separate Storm Sewer Audit

Report"

On March 18-20, 2008, representatives from EPA Region 9, the Regional Water Quality Control Board, Central Valley Region, and EPA contractors (PG Environmental, LLC) conducted a compliance audit of the Port of Stockton's implementation of its Municipal Separate Storm Sewer System (MS4) stormwater management program required by the NPDES permit issued by the Regional Board (NPDES Permit No. CAS0084077). File reviews, interviews of program staff, field verification of program activities, and compliance inspections of Port tenant facilities were conducted. I appreciate the excellent cooperation that our audit team received from your staff throughout this effort.

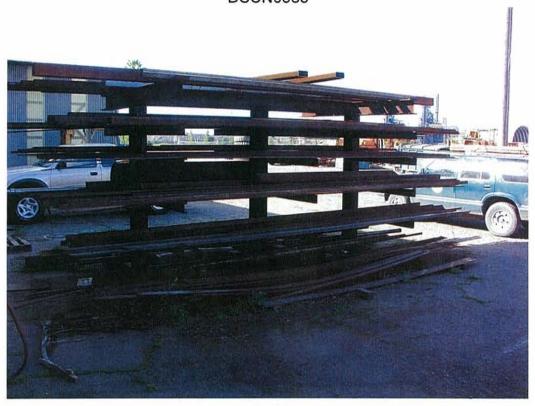
## **DSCN0585**

DSCN0584.JPG	Exposed cans of paint and roofing material not under cover.
DSCN0585.JPG	Exposed rusting metal.
DSCN0586.JPG	Covered fueling area. Inspectors noted that the drums in the foreground of this photograph were not fully under cover.

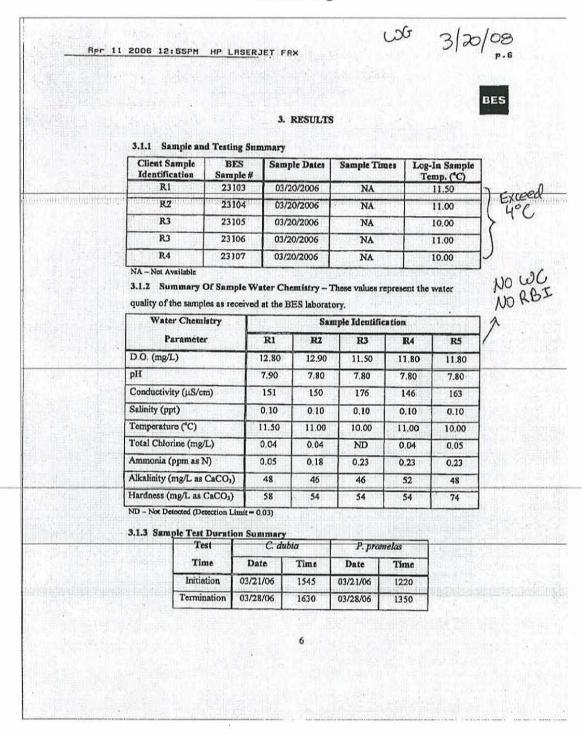
Exhibit 7 – Toxicity results page from Block Environmental Services demonstrating a failure to adequately preserve samples and the failure to analyze samples from the WC and Retention Basin monitoring stations.

The Port must conduct all sampling, sample preservation, and analyses according to approved 40 CFR Part 136 test procedures. In addition, it is recommended that a quality assurance plan be developed (or improved, if one already exists).

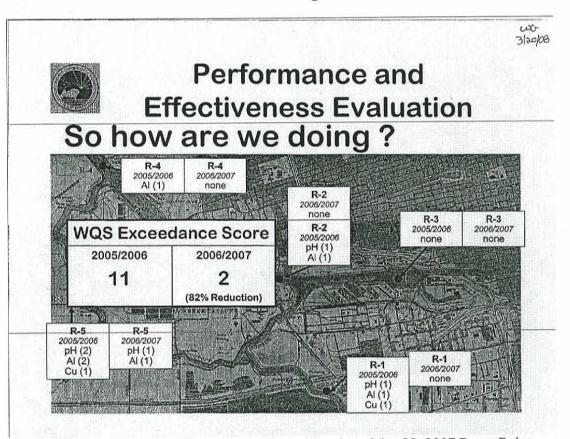
Exhibit 8 (continued) – Excerpt from Port of Stockton May 23, 2007 PowerPoint Presentation to Central Valley Regional Water Board.
