REMEDIATION SYSTEM EVALUATION (RSE)

AMERICAN CREOSOTE WORKS SITE

PENSACOLA, FLORIDA

Report of the Remediation System Evaluation

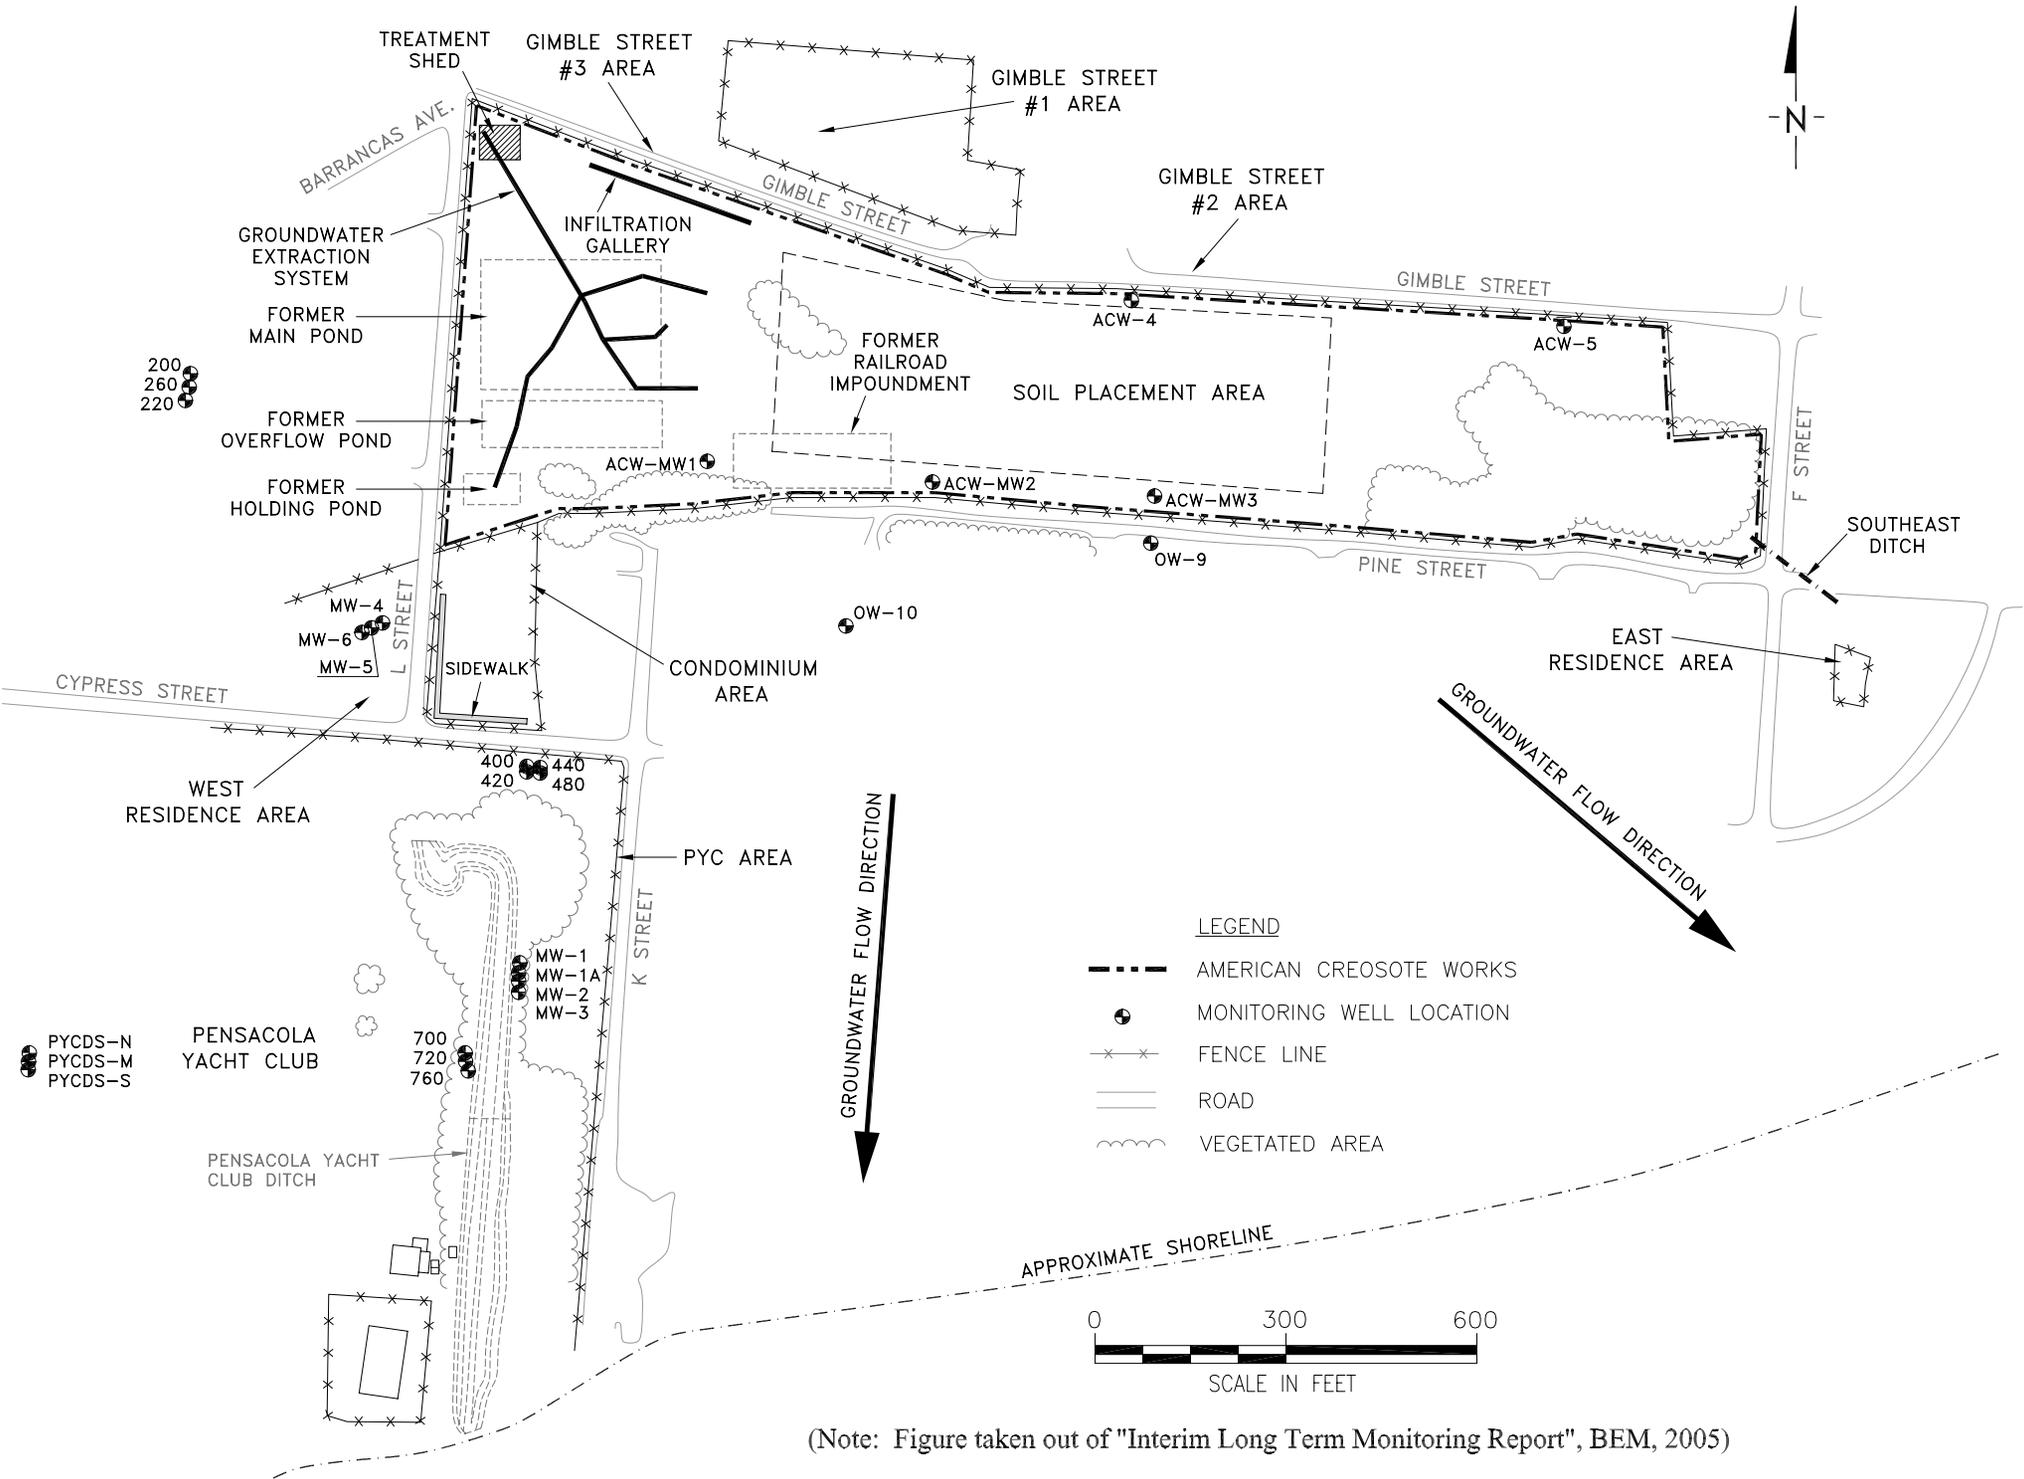
FIGURE 1-1. SITE PLAN.

(Note: Figure taken out of "Interim Long Term Monitoring Report", BEM, 2005)

The ACW site is located on 1800 Gimble Street on the abandoned American Creosote Works wood preserving plant in Pensacola, Florida. The site is approximately 18 acres in area. The site is bounded by Gimble Street to the north, F Street to the east, Pine Street and an apartment condominium complex to the South, and L Street to the west. A lumber company, an auto body shop, a produce distributor, and an appliance sales and repair shop lie to the north of the site, residential areas are to the south and east, and the Pensacola Yacht Club (PYC) lies to the southwest of the site. The site is about 600 yards north of Pensacola Bay and Bayou Chico. A site plan is included as Figure 1-1.

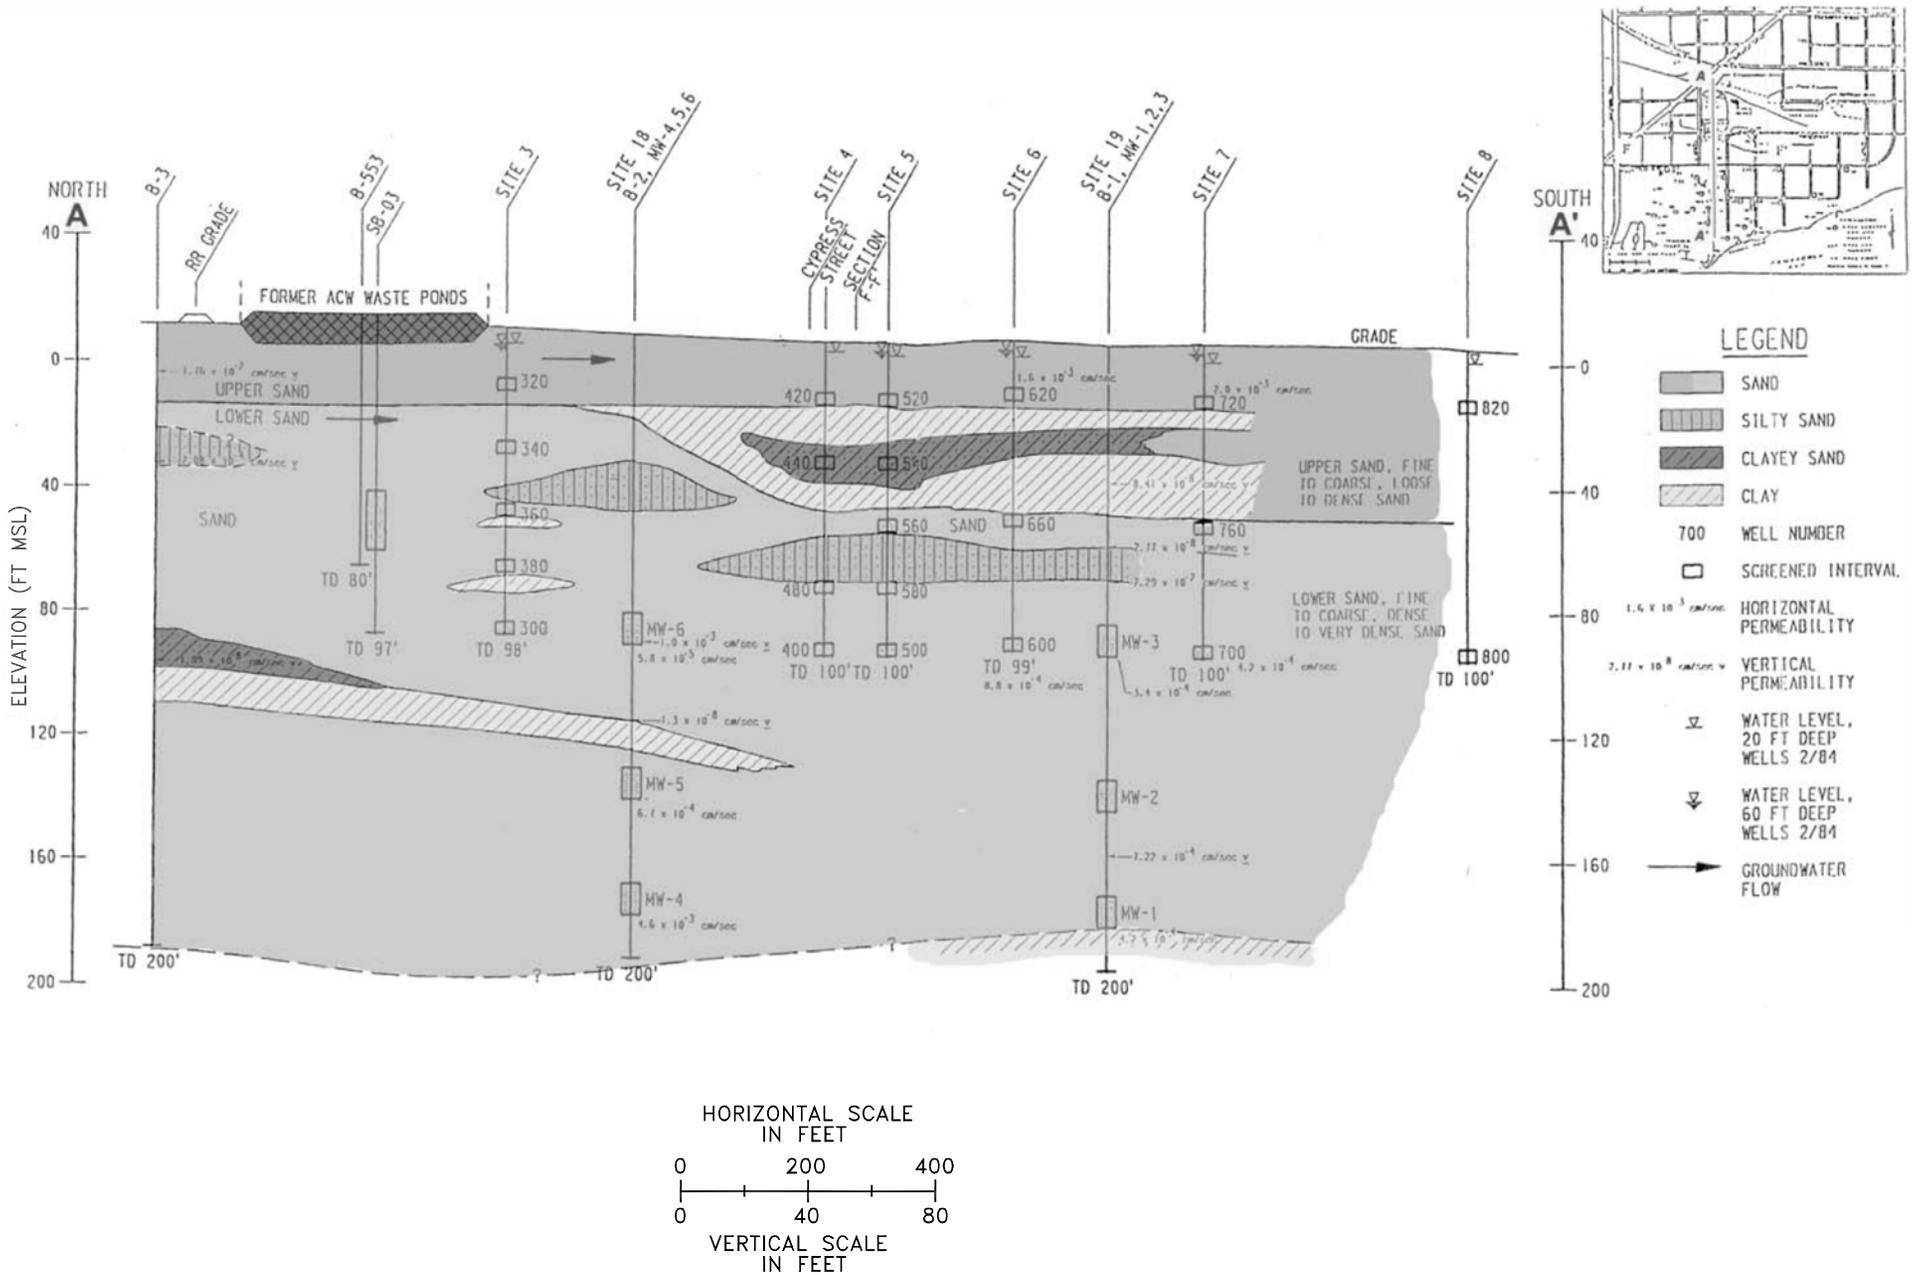
FIGURE 1-2. NORTH SOUTH GEOLOGIC CROSS SECTION (BECHTEL, 1996)

(Note: Figure originally generated by Bechtel, 1996, and extracted by the RSE team from the "SCAPS Investigation Report", USACE, 2002.)
