Pueblo de Cochiti Green Infrastructure Concept Design

Improving Stormwater Management and Water Quality in the Community while Preserving Cultural History

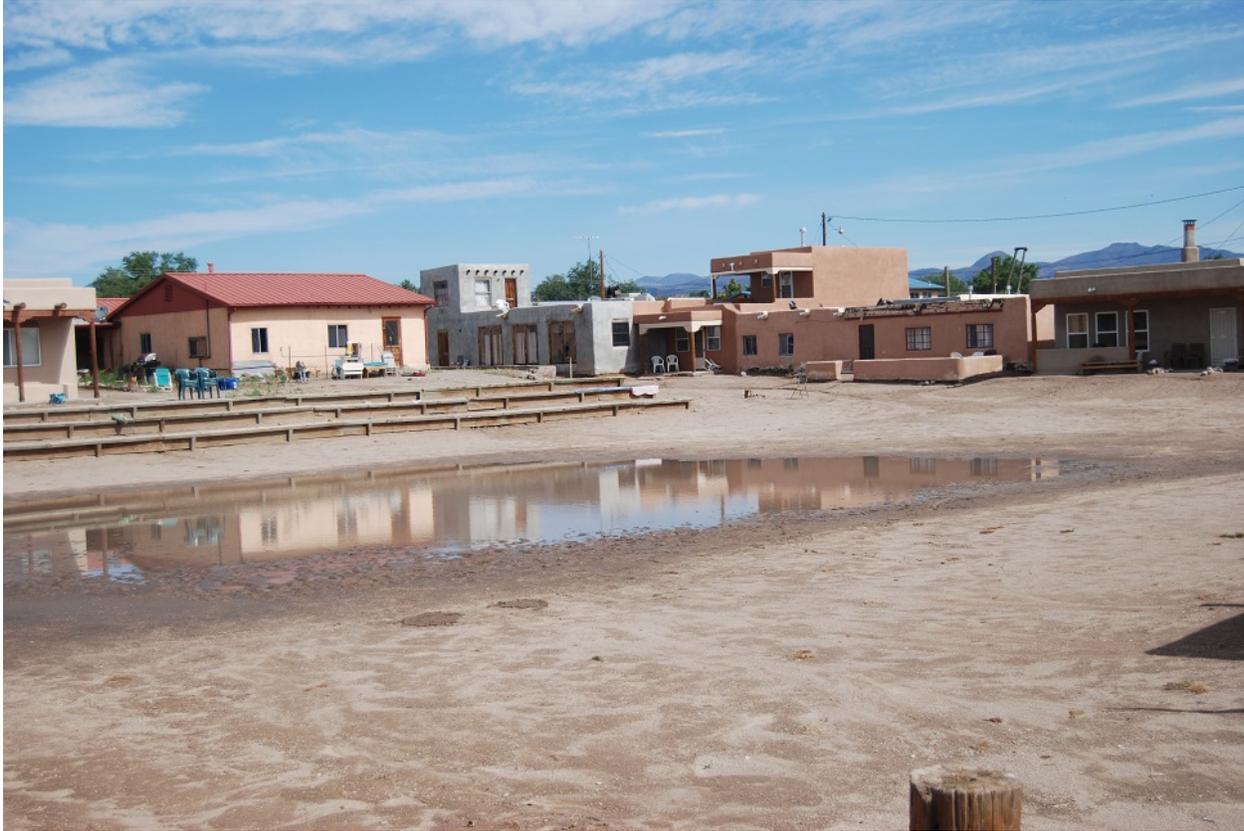
There is very little pavement on the Plaza and very limited stormwater control of either paved or nonpaved areas. Water drains from canales directly onto the ground with no way to capture or store the rainwater. The majority of the roads are dirt and provide some infiltration of rainwater and drainage. During the rainy season and winter months, however, much of the drainage flows to the center of the Plaza and forms a large shallow pool (see Figure 3-1). That phenomenon has positive associations for many community members who grew up near the Plaza and played in the pool.

Figure 3-1. Runoff collected in Plaza center.

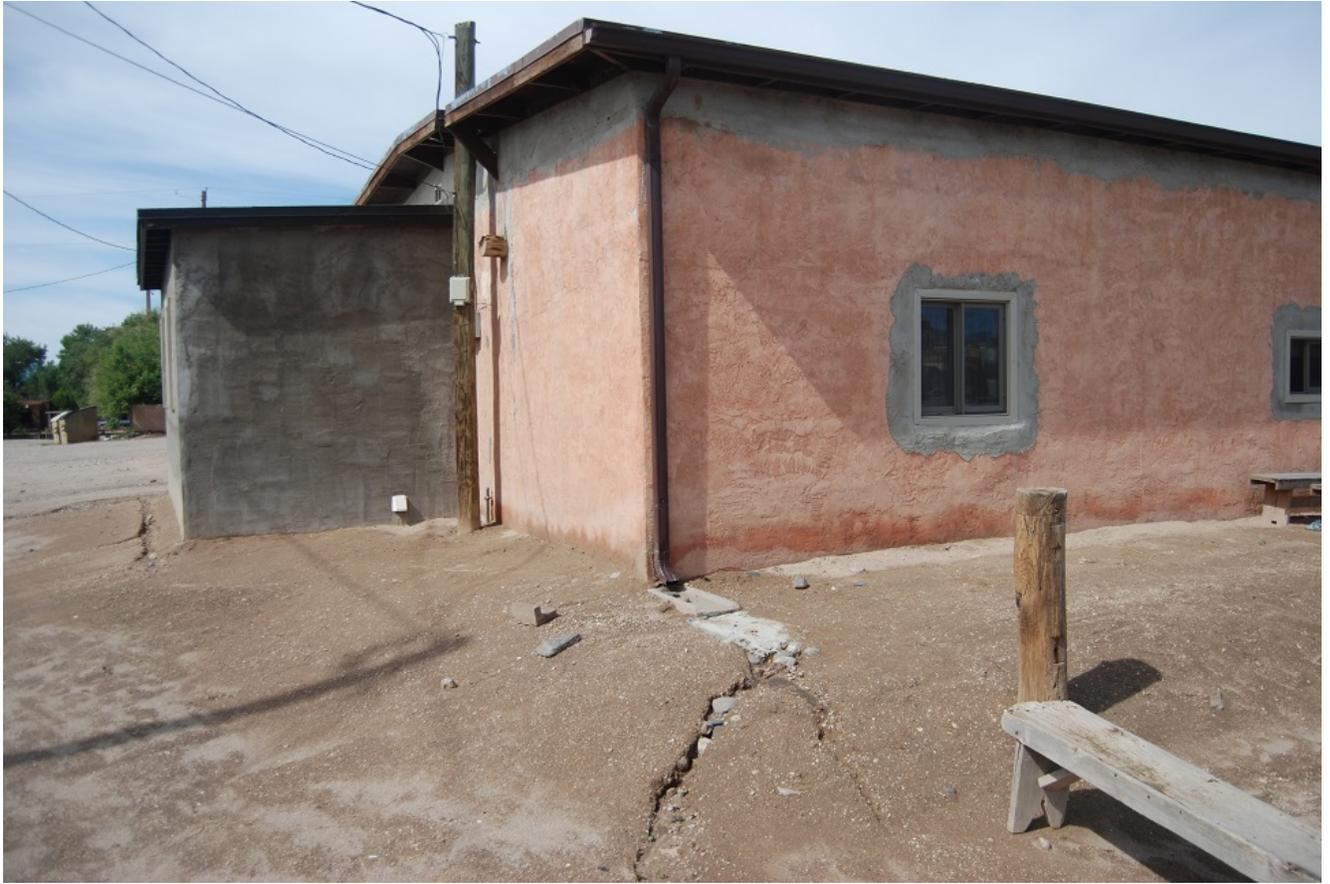
Outside of the Plaza center, the primary stormwater-related issue is erosion along building foundations resulting from rooftop runoff. Figure 3-2 shows a modern design with a gutter and downspout, which the community does not prefer. Discussions with Pueblo residents indicated a perception that runoff volumes from rooftop surfaces might have increased with the recent adoption of modern roofing materials such as impermeable membrane roofs. Historically, adobe roofing structures were topped with a layer of soil that could have retained some portion of each storm event rather than directly discharging runoff like a modern roofing system; however, a search of published literature could not confirm that practice.

Figure 3-2. Rooftop runoff results in scour along building foundations.

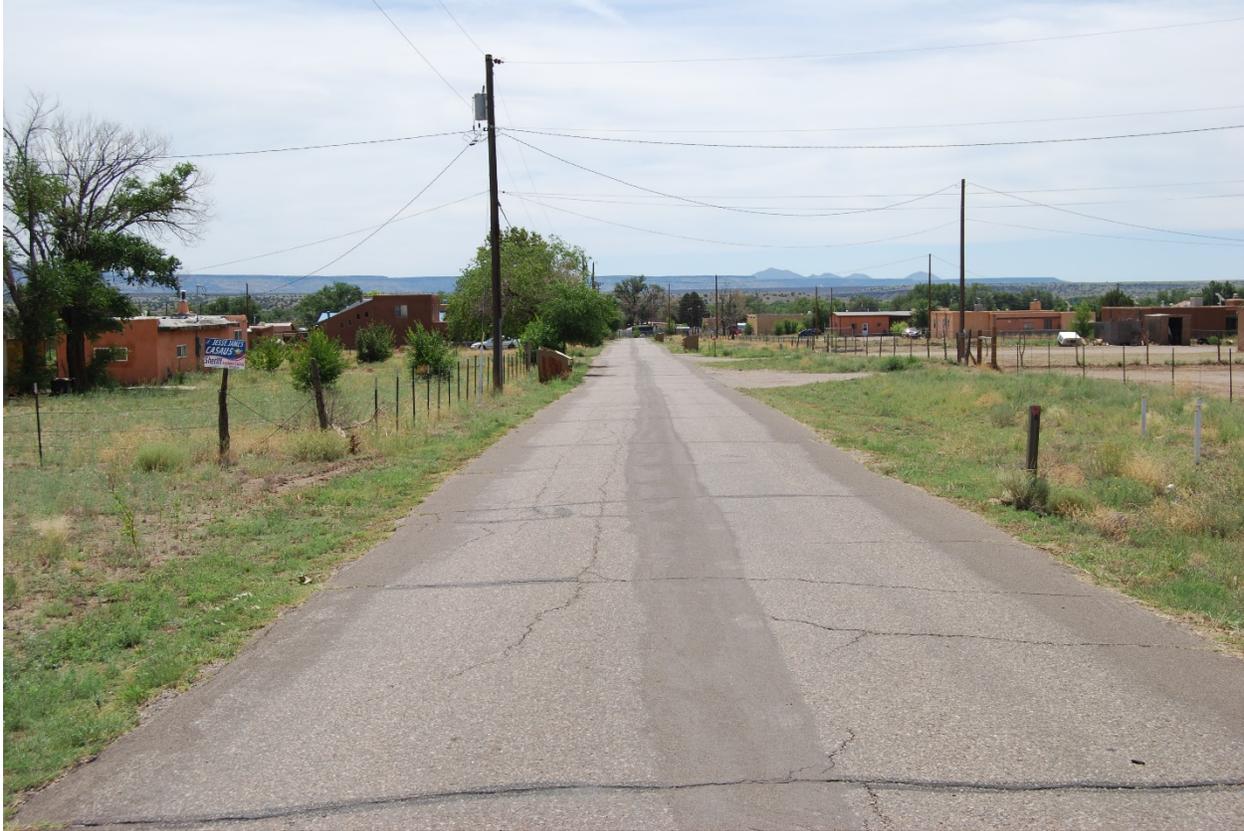
Turquoise Street is a two-lane road connecting Pueblo Route 85 and Plaza Street. It serves as a primary route between the Plaza and the remainder of the Pueblo. Turquoise Street is located within a 40–60-foot- (ft-) wide corridor between adjacent residential areas and is paved its entire 1,800-ft length. Single-family homes, in the traditional adobe and pueblo styles, are located on both sides of the street. There are no sidewalks or other pedestrian access along the street. Most homes have mature trees and some local vegetation on their properties. Fences surrounding the homes limit pedestrian access through the community. See Figure 3-3 for a view of Turquoise Street.

Figure 3-3. Existing conditions on Turquoise Street.

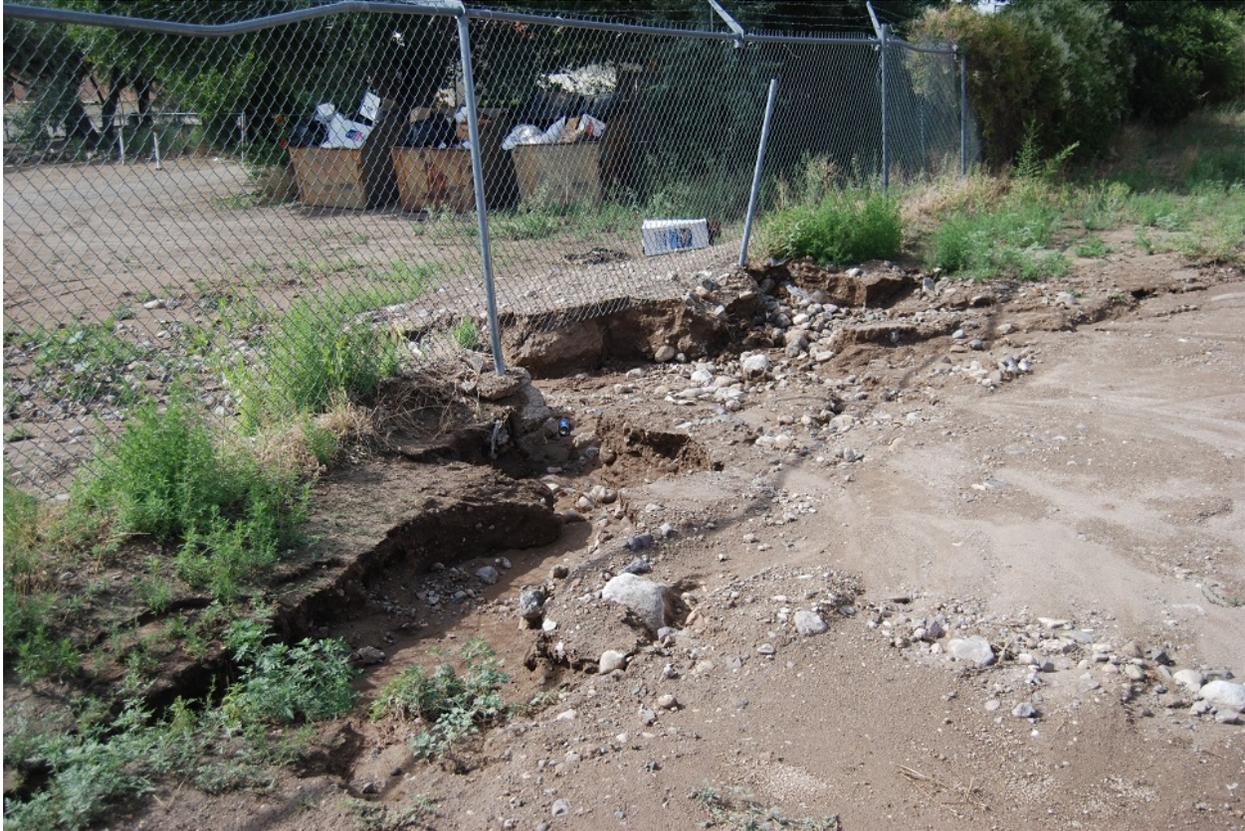
The lack of active stormwater management along Turquoise Street is believed to be a source of significant erosion problems, including issues in the area where Turquoise Street meets Cochiti Plaza. A site visit revealed the most severe erosion to be along the fence at the Plaza end of the street, shown in Figure 3-4.

Figure 3-4. Erosion near the intersection of Turquoise and Plaza Streets.

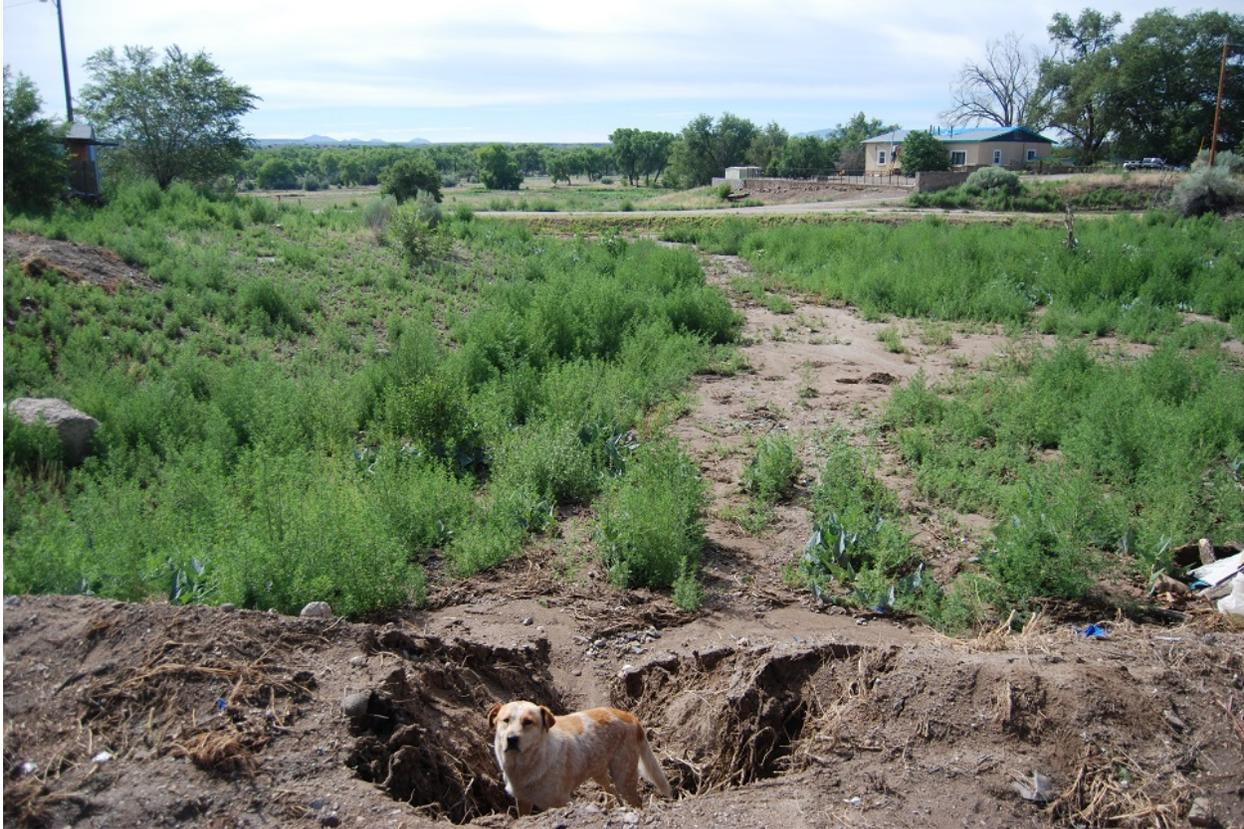
Stormwater runoff throughout the Pueblo generally flows in a southeast direction. In addition to the area of Turquoise Street near the Plaza, other locations including the area east of the Plaza near a former fill site show signs of significant erosion and sediment deposition (see Figure 3-5). Conditions such as these emphasize how greatly a stormwater management plan could benefit Pueblo de Cochiti.

Figure 3-5. Stormwater impacts downslope of the Pueblo.

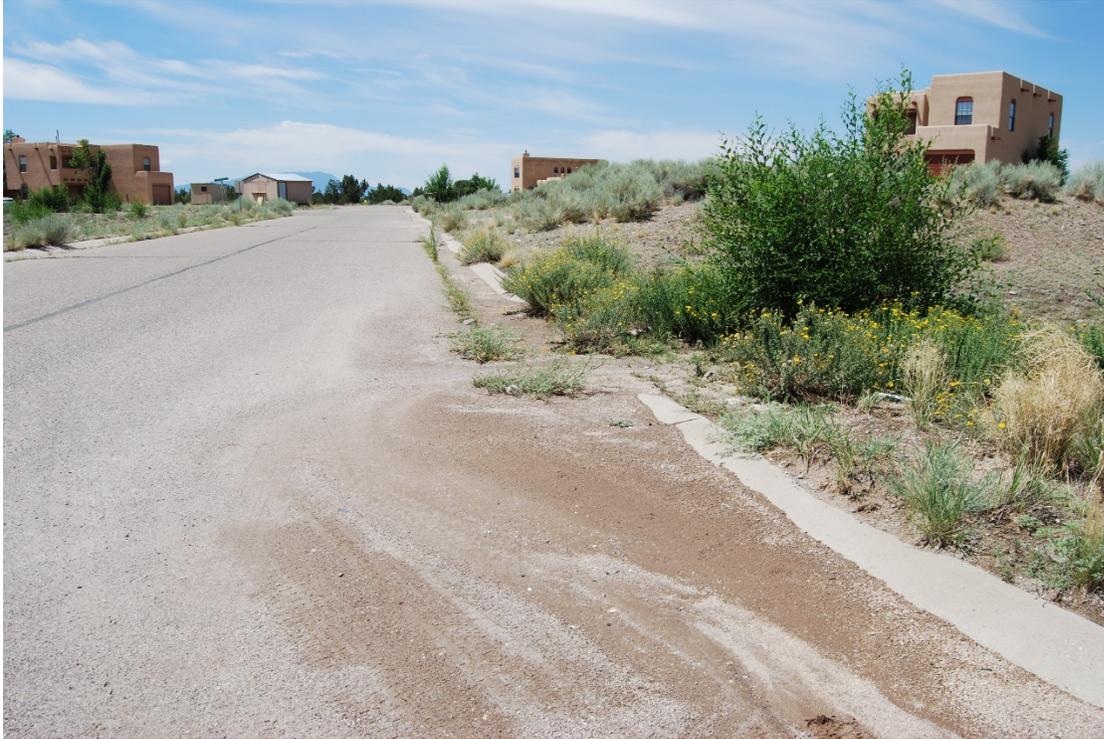
Robin Street is part of a residential development of single-family homes in the western portion of the community, across Pueblo Route 85 from Cochiti Plaza. The Robin Street neighborhood was constructed in the late 1970s on an area of alluvial deposits from the Peralta Creek watershed. During construction, the street network was excavated several feet below the ground surface to provide surface drainage away from the residences. In that manner, the roadway network served as the drainage conveyance system for the neighborhood. Runoff collected in the ditches is ultimately routed into one of several infiltration basins constructed adjacent to the streets. As a result, there is no off-site discharge of stormwater from the neighborhood. There still, however, are several localized issues resulting from stormwater runoff. The excavation of the road network resulted in sloped driveways and other areas adjacent to the street that often exhibit evidence of scour, as well as sediment deposition on the roadway itself (see Figure 3-6, Figure 3-7, and Figure 3-8). Some residents have attempted to direct rooftop runoff into vegetated areas to minimize flow into the road. But drainage from driveways and other impervious surfaces at many houses along Robin Street contributes to the burden on the stormwater drainage system, including sediment deposition into the infiltration basins, which are poorly maintained and being filled in due to the erosion occurring in upland areas.

Figure 3-6. Deposited sediment from upland areas often plugs infiltration basin inlets.

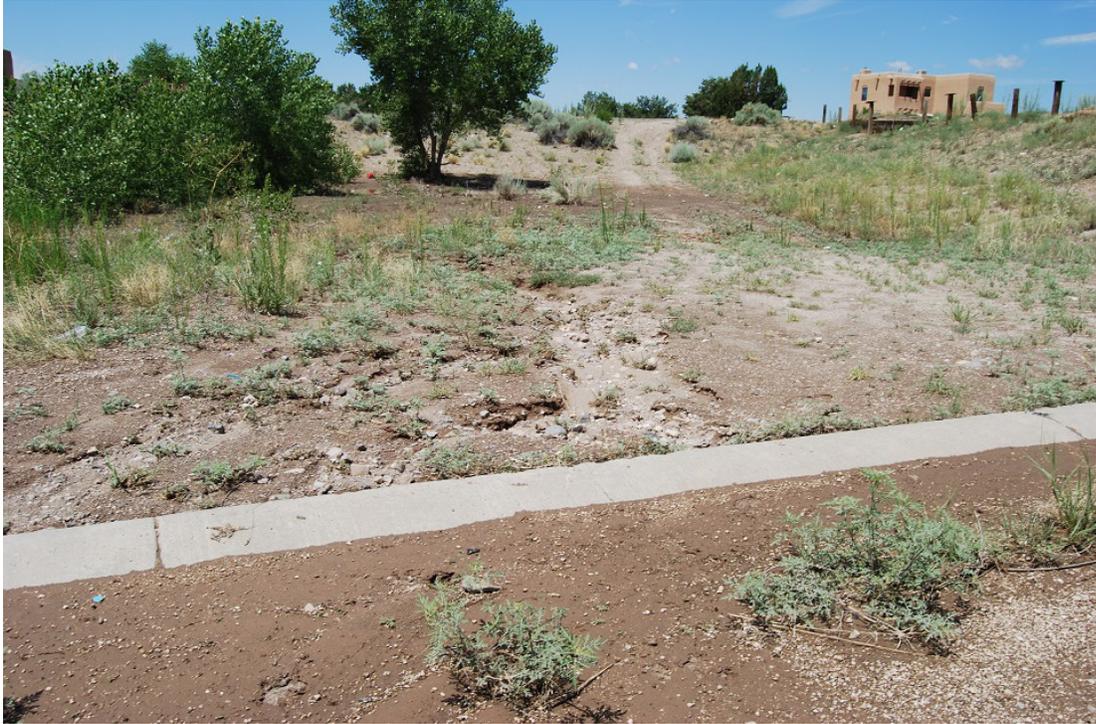
Figure 3-8. Example of stormwater erosion on Robin Street.

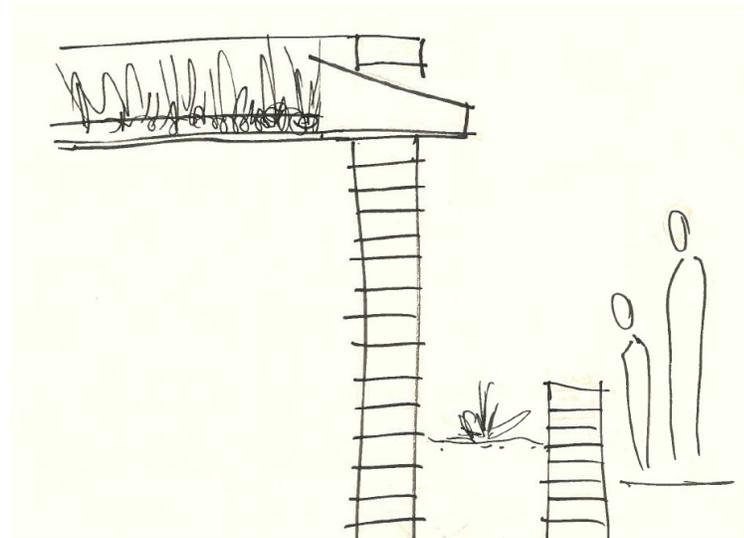
Figure 4-1. Student sketch of raingarden in Pueblo setting.

To integrate green infrastructure successfully into a traditional community such as Pueblo de Cochiti, it will be essential to obtain feedback from the community. This community perspective and historic context will clearly influence the concept design approach. A communitywide charrette took place the evening of July 16, 2014, to present the green infrastructure concept and provide a format for community input into the development of the green infrastructure plan for the Pueblo. Prior to the charrette, a discussion was held with a group of students who were participating in the summer native language program. As part of the discussion, the students were asked to provide sketches of how green infrastructure practices could be integrated into Pueblo de Cochiti (see Figure 4-1 and Figure 4-2).

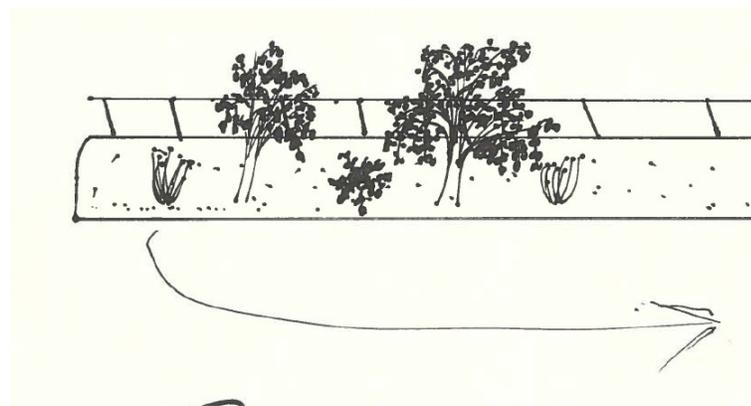
Figure 4-2. Student sketch of roadside swale.

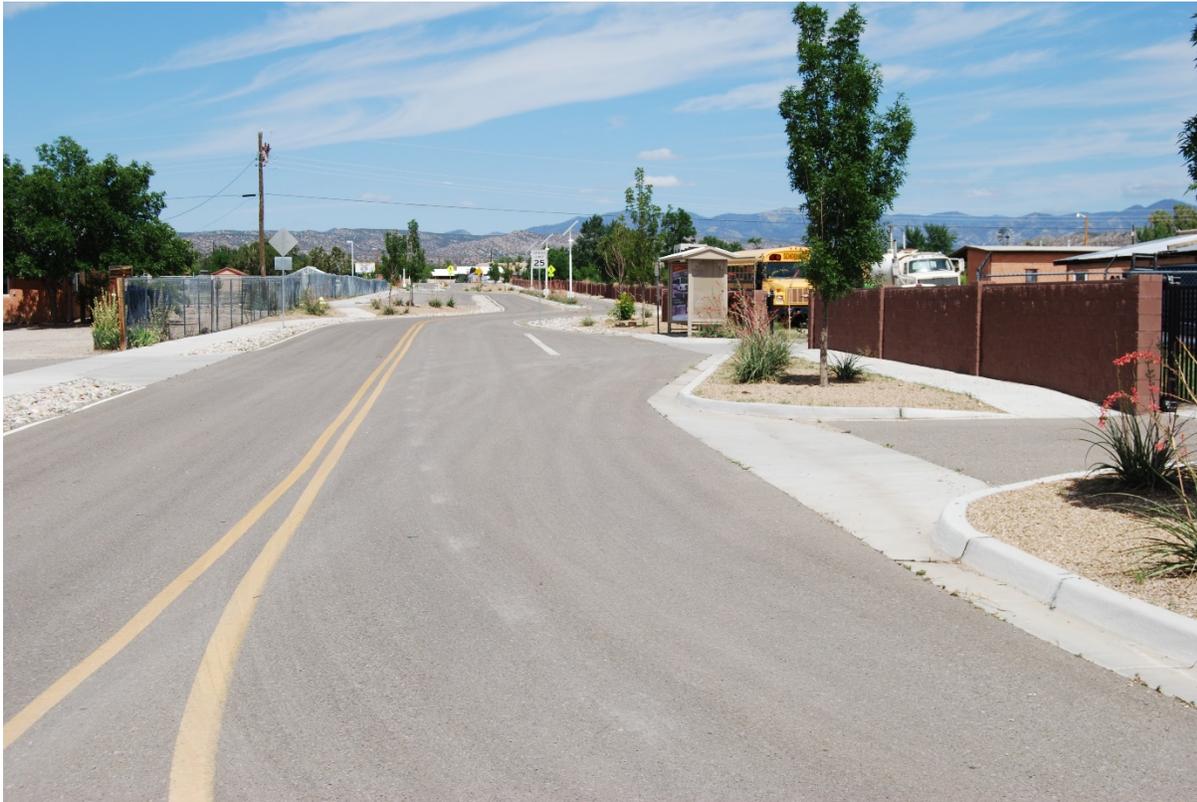
The discussion touched on several areas of potential green infrastructure activities. As a guiding principle, the group agreed that the modern look of the recently redeveloped Cochiti Street was not appealing or consistent with the Pueblo style (see Figure 4-3). Specific complaints about Cochiti Street included the concrete, large curbs, speed bumps, and dark asphalt. Instead, the community preferred designs that include gentle curbing, no pavement, and more natural-looking roads. Participants agreed that preserving the traditional look of the community was very important.

Figure 4-3. View of Cochiti Street, including the heavy infrastructure features that Pueblo members expressed a desire to avoid.

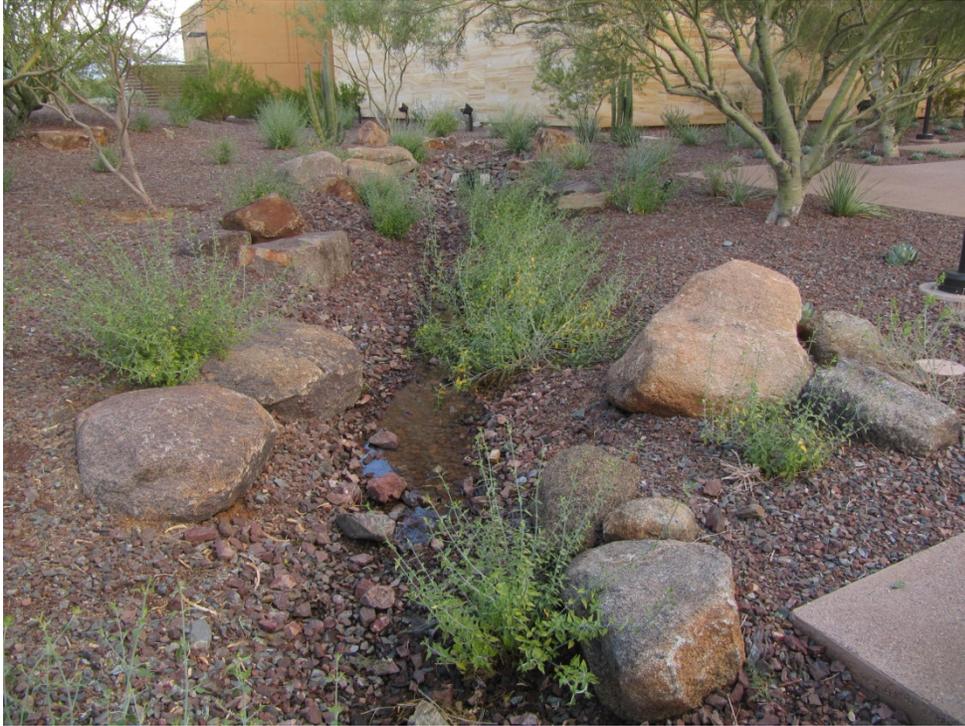
Stormwater runoff is conveyed to rain gardens via sheet flow or can be directed from a downspout, driveway, or sump pump. By infiltrating and temporarily storing runoff water, rain gardens not only remove pollutants but also can reduce a site's overall runoff volume and help to maintain the predevelopment peak discharge rate and timing (a key component of many stormwater program requirements).

Figure 4-4. Typical rain garden design.

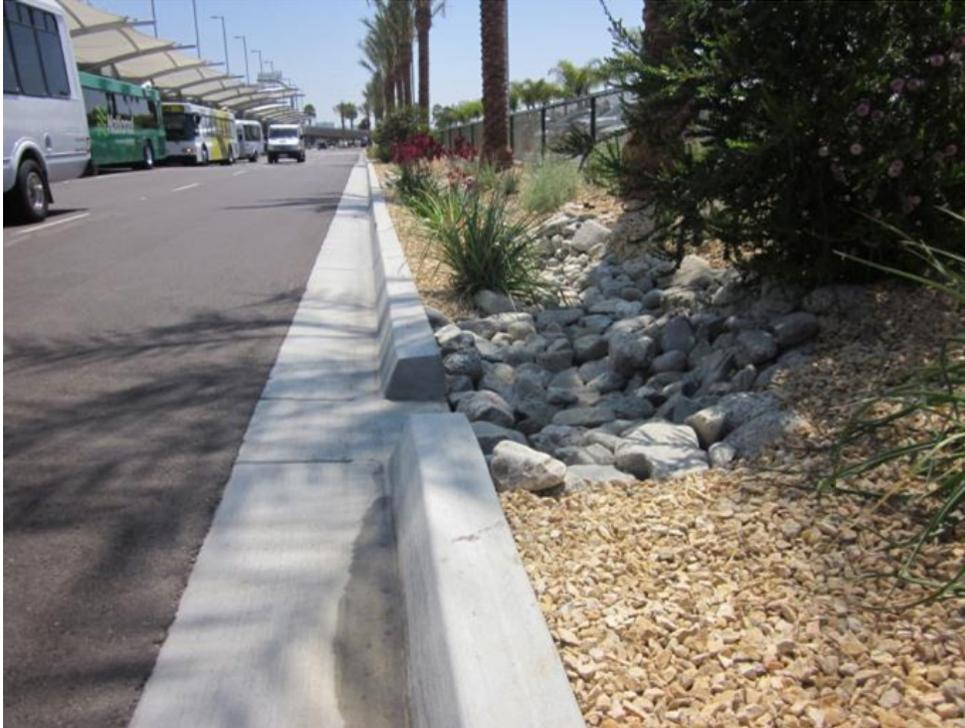
One of the key green infrastructure practices proposed as part of the green street design for Pueblo de Cochiti is the use of infiltration swales. These long, shallow vegetated depressions are slightly sloped to convey stormwater. Swales are different from rain gardens in that they are linear in geometry and are designed to allow water to travel downslope. Stormwater flow through the swale is reduced as it encounters plants and soil, which allows for the settling of sediment and pollutants. Water is absorbed into the soil and taken up by plants; it can infiltrate fully if native soil conditions permit (USEPA 2009, 2010). As with rain gardens, vegetation selection is critically important for swale design in arid and semiarid climates.

Figure 4-5. Example green street design incorporating curb cuts leading to roadside infiltration swales.

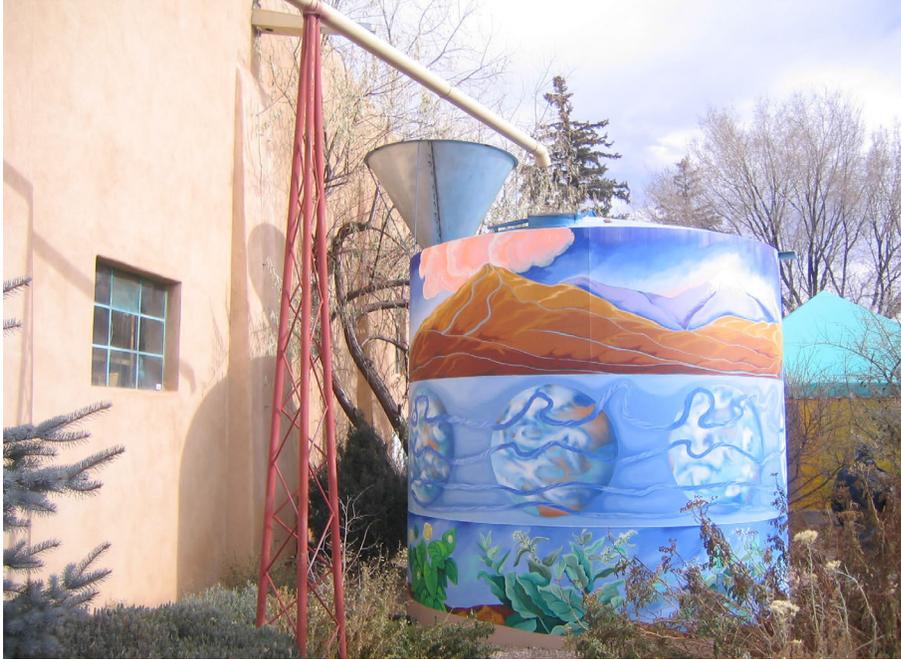
Cisterns are a type of rainwater harvesting system that enables the collection and storage of rainfall for later use. When properly designed, they slow and reduce runoff and can provide an alternate source of water for irrigation or other uses. That feature is of particular interest in arid regions such as the Southwest, where water recycling can reduce demands on limited water supplies (USEPA 2014). Cisterns can be constructed both above and below ground from a variety of materials including concrete, metal, wood, and plastic (see Figure 4-6). Storage volumes typically range from several hundred to several thousand gallons, an appropriate size for concurrent use by multiple single-family residences. Cisterns can be designed to store stormwater for irrigation or infiltration between storms, or to slowly release water through a permanently open outlet. To maximize storage and hydrologic performance, systems should drain fully between rain events, ideally via slow release into another green infrastructure practice or landscaped area for irrigation and treatment. An overflow structure also is necessary for cases in which the volume of stormwater exceeds the cistern's capacity. Overflow can then be routed to another green infrastructure practice or to the conventional stormwater drainage system.

Figure 4-6. Decorative cistern.

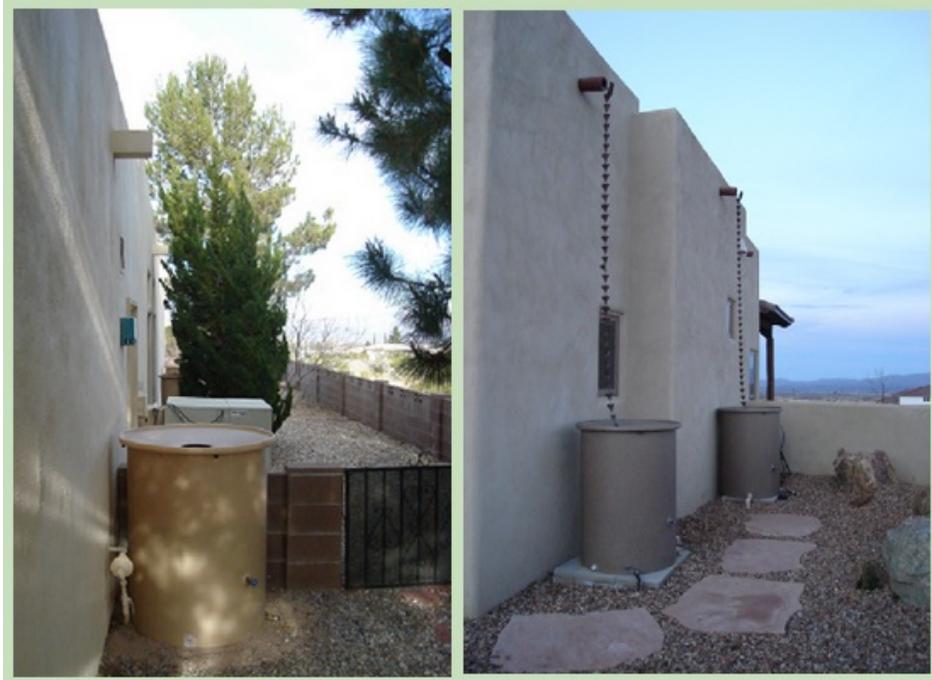
On a smaller scale, *rain barrels* typically store less than 100 gallons and are generally appropriate for use by individual residences (see Figure 4-7). To maximize hydrologic benefit, however, rain barrels either must be appropriately sized or multiple units must be used to fully capture runoff from the contributing roof area.

Figure 4-7. Example rain barrel installations.

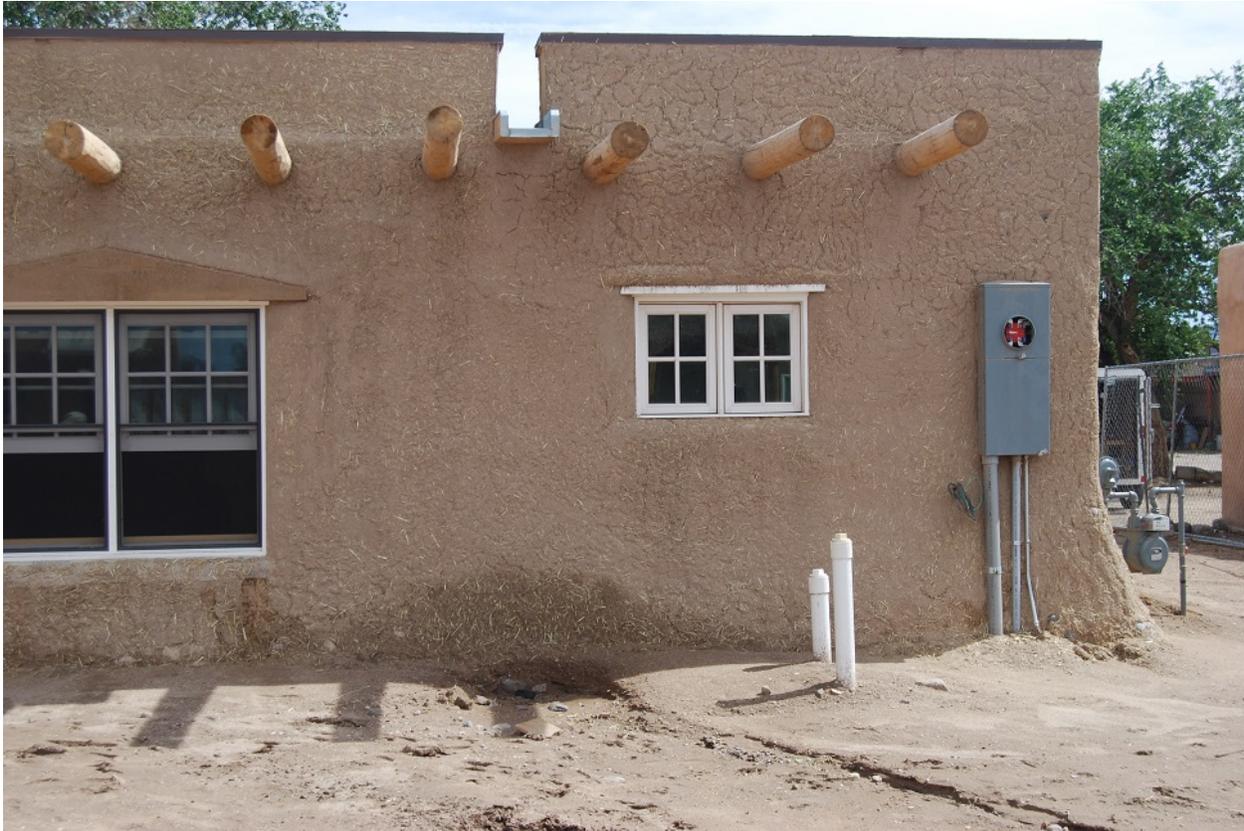
Under the existing conditions, roof runoff that accumulates during rainfall events causes scour and erosion around building foundations in the community (see Figure 5-1). Residents have emphasized that any green infrastructure practices proposed for Cochiti Plaza should avoid digging and grading. To address those conditions, two green infrastructure practice types—cisterns and rain gardens—are recommended for consideration.

Figure 5-1. Photos illustrating scour and erosion at adobe foundations under a canales.

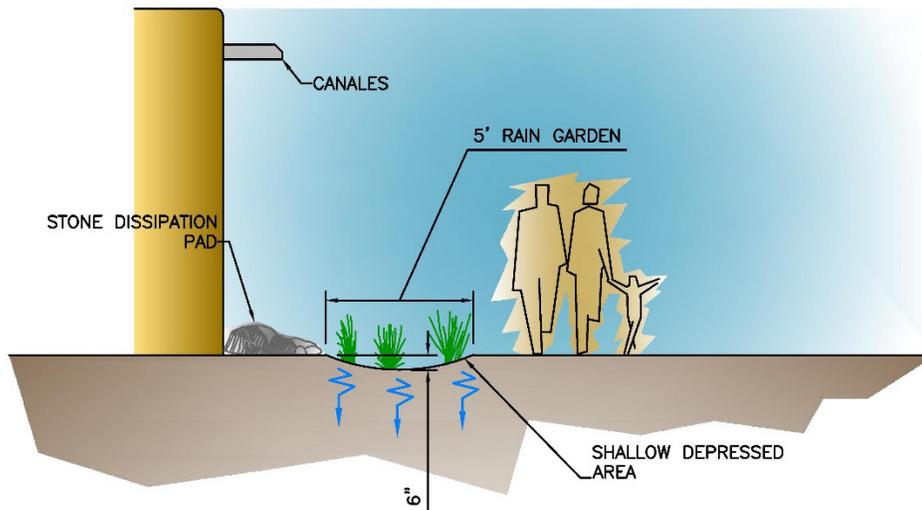
Small-scale rain gardens were more warmly received by residents as a potential green infrastructure practice within the Plaza area. The rain gardens would consist of shallow depressions adjacent to the building into which rooftop runoff from canales would collect and infiltrate (see Figure 5-2).

Materials such as native stones should be placed under the canales to dissipate energy and route runoff into the rain garden. The rain gardens would be planted with locally and culturally significant vegetation species (such as those described in section 4.4.4).

Figure 5-2. Rain garden schematic.

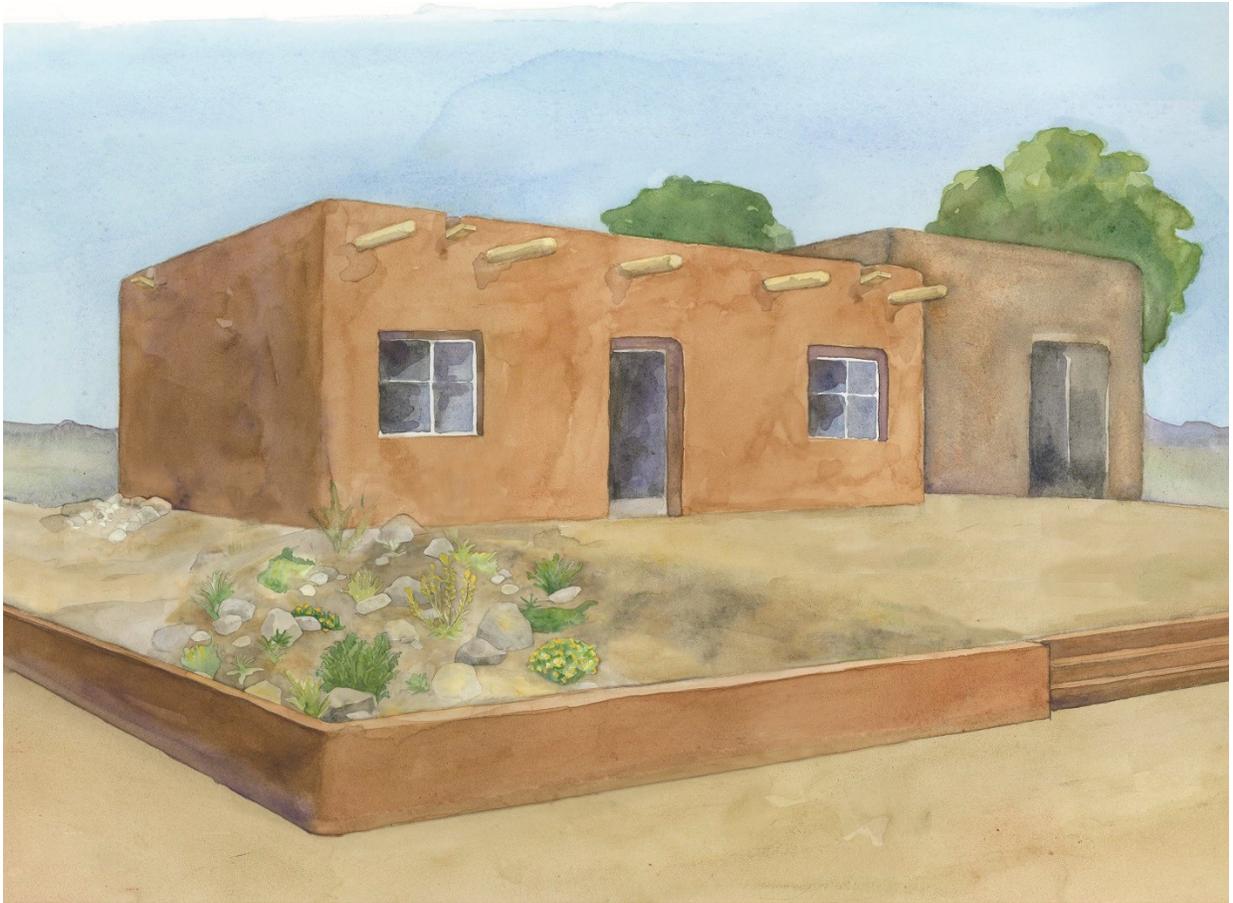
Many structures are slightly elevated relative to surrounding roadways and pathways, possibly a result of long-term erosion. In those instances, implementation of a rain garden could require a retaining wall system to provide a transition in elevation and protect the rain garden from erosion (Figure 5-3).

Retaining walls consisting of large timbers are used elsewhere in the Pueblo but are not preferred by the community. To address those concerns, the conceptual design proposes to construct the retaining wall of adobe brick and plaster consistent with building construction throughout the Pueblo. Adobe brick is emphasized as the community's preferred material. An additional benefit of adobe is that the community has a skilled adobe maker within the Pueblo and is actively building the capacity to conduct regular maintenance of adobe walls using community resources. In the construction of adobe brick retaining walls and implementation of rain gardens adjacent to existing buildings, the potential for implications to structural stability of the buildings and other infrastructure should be considered.

Figure 5-3. An artist's rendering of a rain garden incorporating an adobe retaining wall.

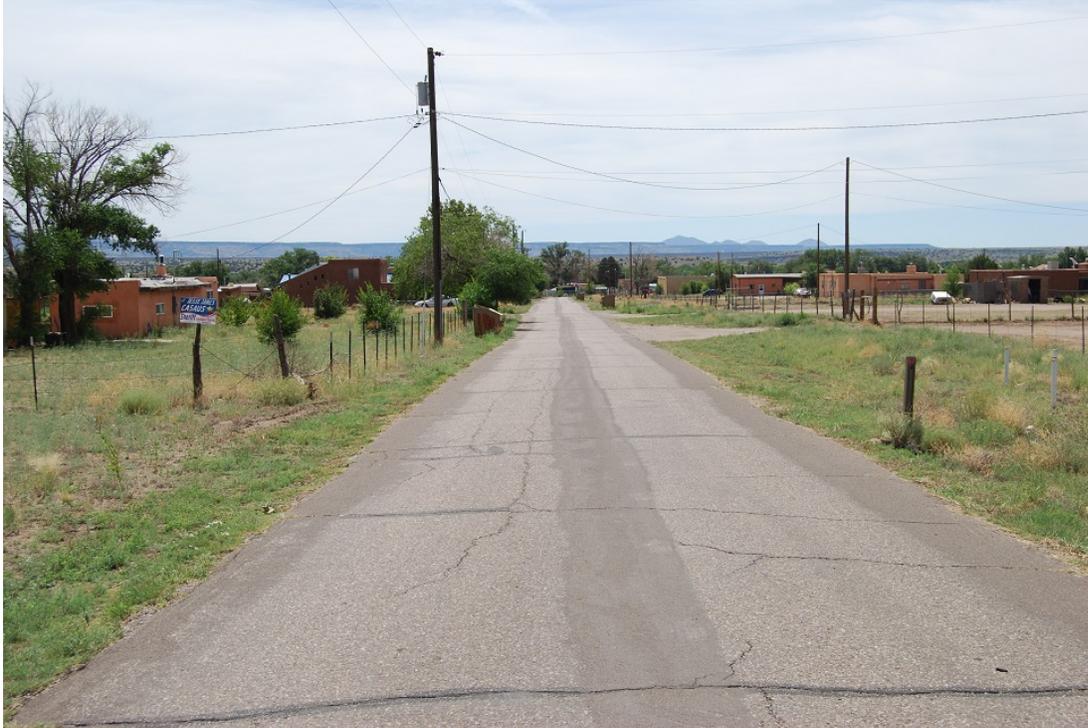
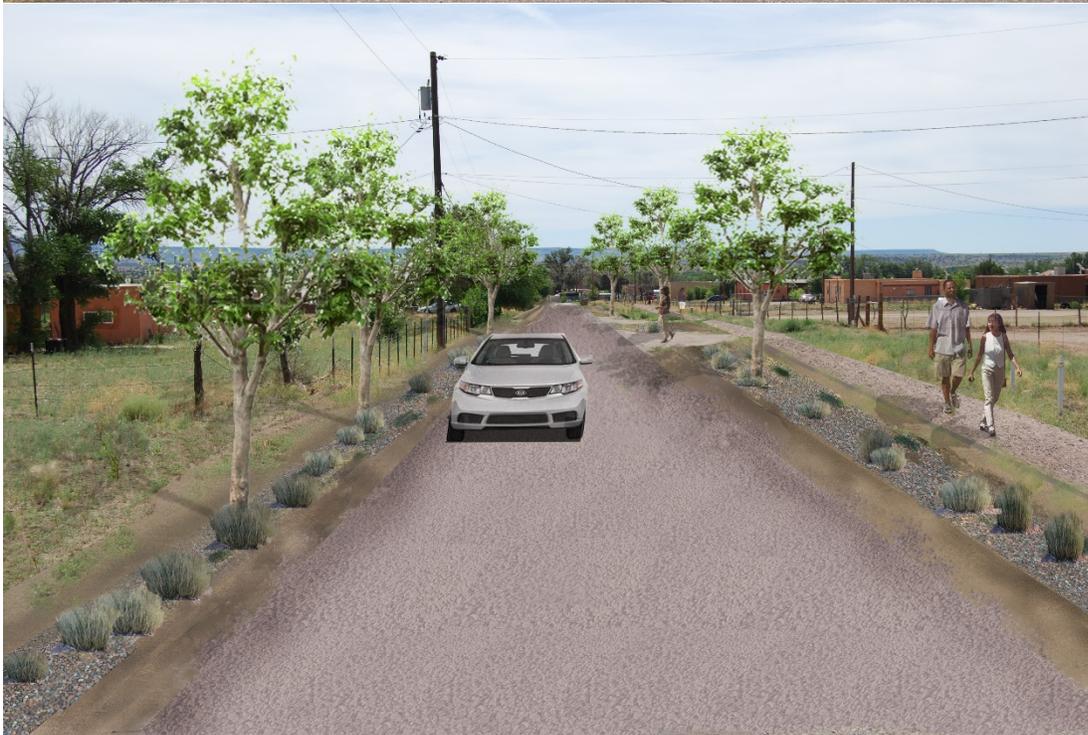
Figure 5-4 shows a current view of Turquoise Street and the projected view after implementation of the proposed green street design. Figure 5-5 presents a cross section of the proposed green street design.

Figure 5-4. *Top*, view of Turquoise Street near Pueblo Route 85 facing southeast; *bottom*, artist's rendering of green street design.

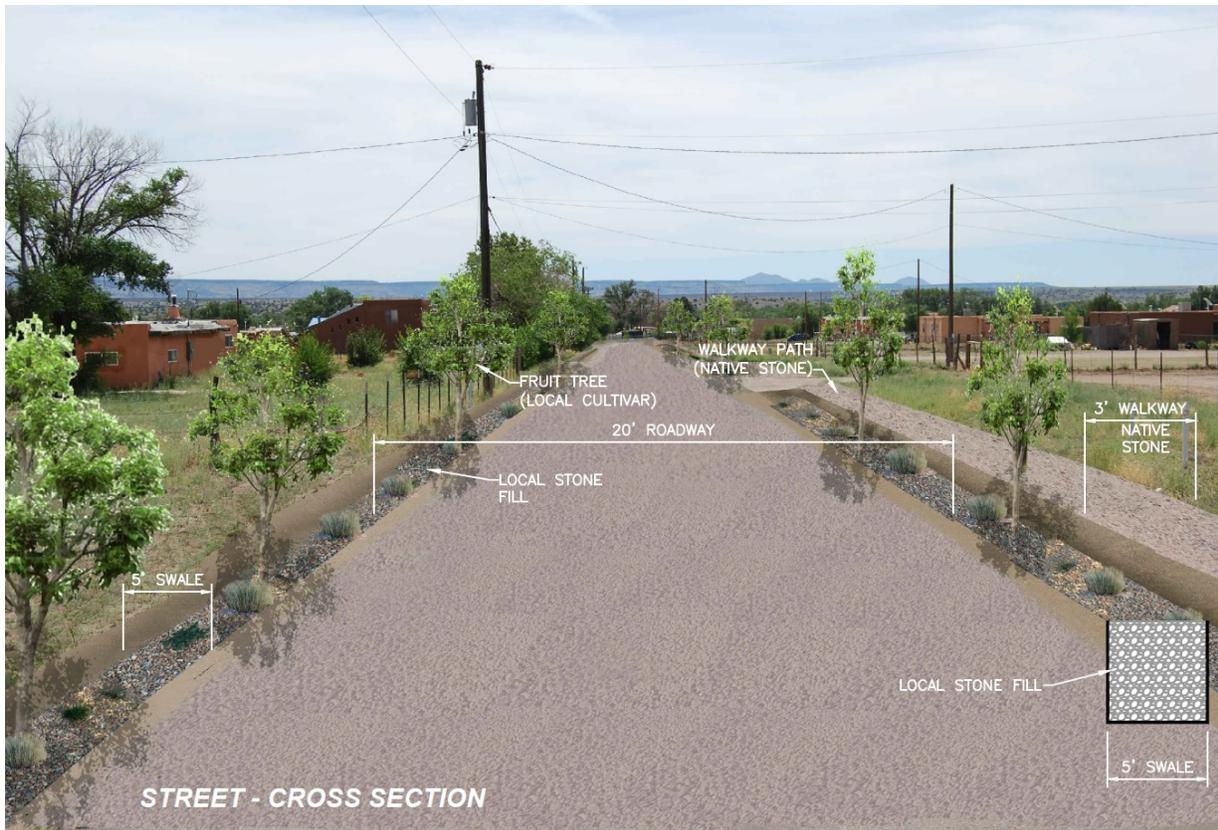
Figure 5-5. Proposed green street concept design cross section for Turquoise Street.

The City of Albuquerque’s stormwater design guidance was used as a preliminary reference for calculating the volume of stormwater storage required by the proposed infiltration swales. As noted in section 4.1, the Albuquerque MS4 permit requires treatment of the 90th percentile storm, which is equivalent to a rainfall depth of 0.62 inch. That criterion was used to provide preliminary sizing, summarized in Table 5-2.

Proposed Green Infrastructure Description: Proposed improvements to the roadway will include incorporation of infiltration swales along both sides of the roadway designed to capture and infiltrate roadway runoff. The swales will be partially filled with local native stone and planted with local fruit tree cultivars to utilize the captured runoff. A 3 ft wide stone walking path will be included on the southern side of the roadway.

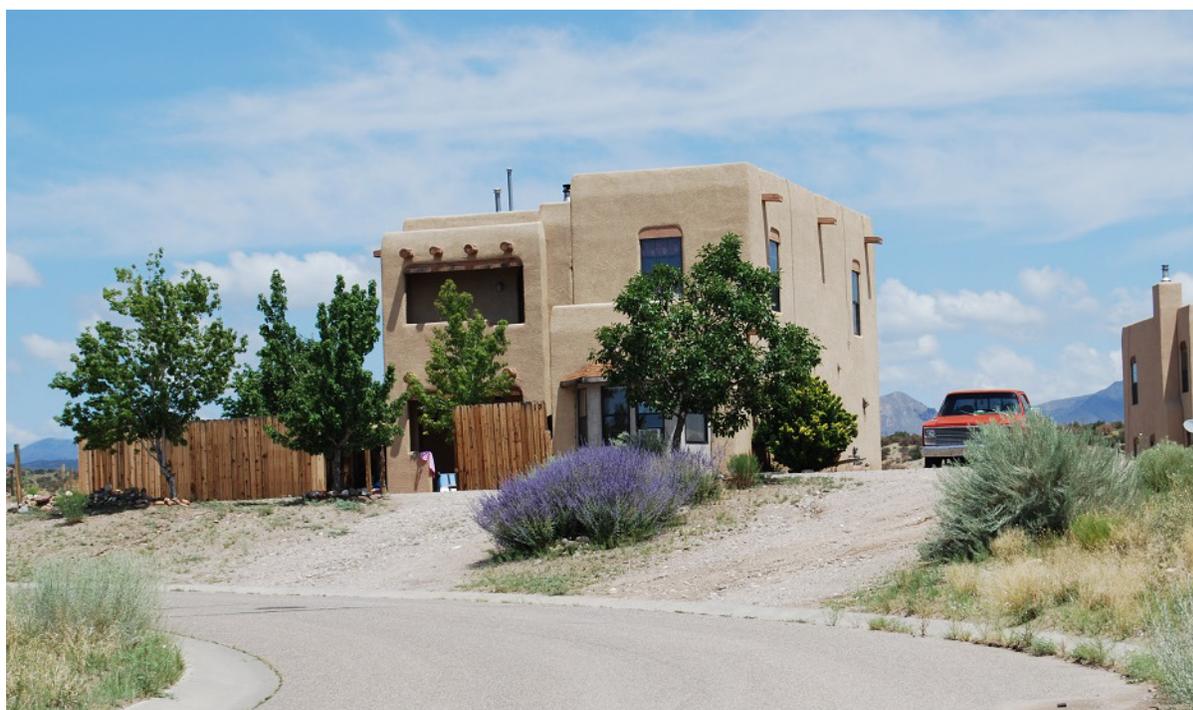
Figure 5-6. Desirable landscaping elements at a Robin Street home.

Nonstructural solutions recommended for this neighborhood include a reduction in sloped areas dedicated to driveways by replacing them with vegetation to increase stormwater infiltration and improve soil stability. Many driveways in the Robin Street area are excessively wide, resulting in vehicular traffic along a large area of sloped ground. The width of those areas should be limited to only what is necessary to provide access to residences and parking space for vehicles. That can be accomplished through either targeted planting of vegetation or placement of aesthetic stone or timber barriers that can blend into the landscape. Such vegetation reestablishment also is recommended for areas outside of existing driveways, which also could be denuded of vegetation or impacted by historic compaction or other activities. Figure 5-6 shows an example of aesthetically desirable landscaping at a Robin Street home that exhibits good vegetative cover and limits driveway width.
